PUBLIC UTILITIES COMMISSION

GI-2023-02-PGE-76-01ABC

SUBJECT: SED Closure Letter - General Order 112-F Inspection of PG&E's Bay Area South Transmission Area

Inspection Name: (2023) PG&E Bay Area South Transmission Audit

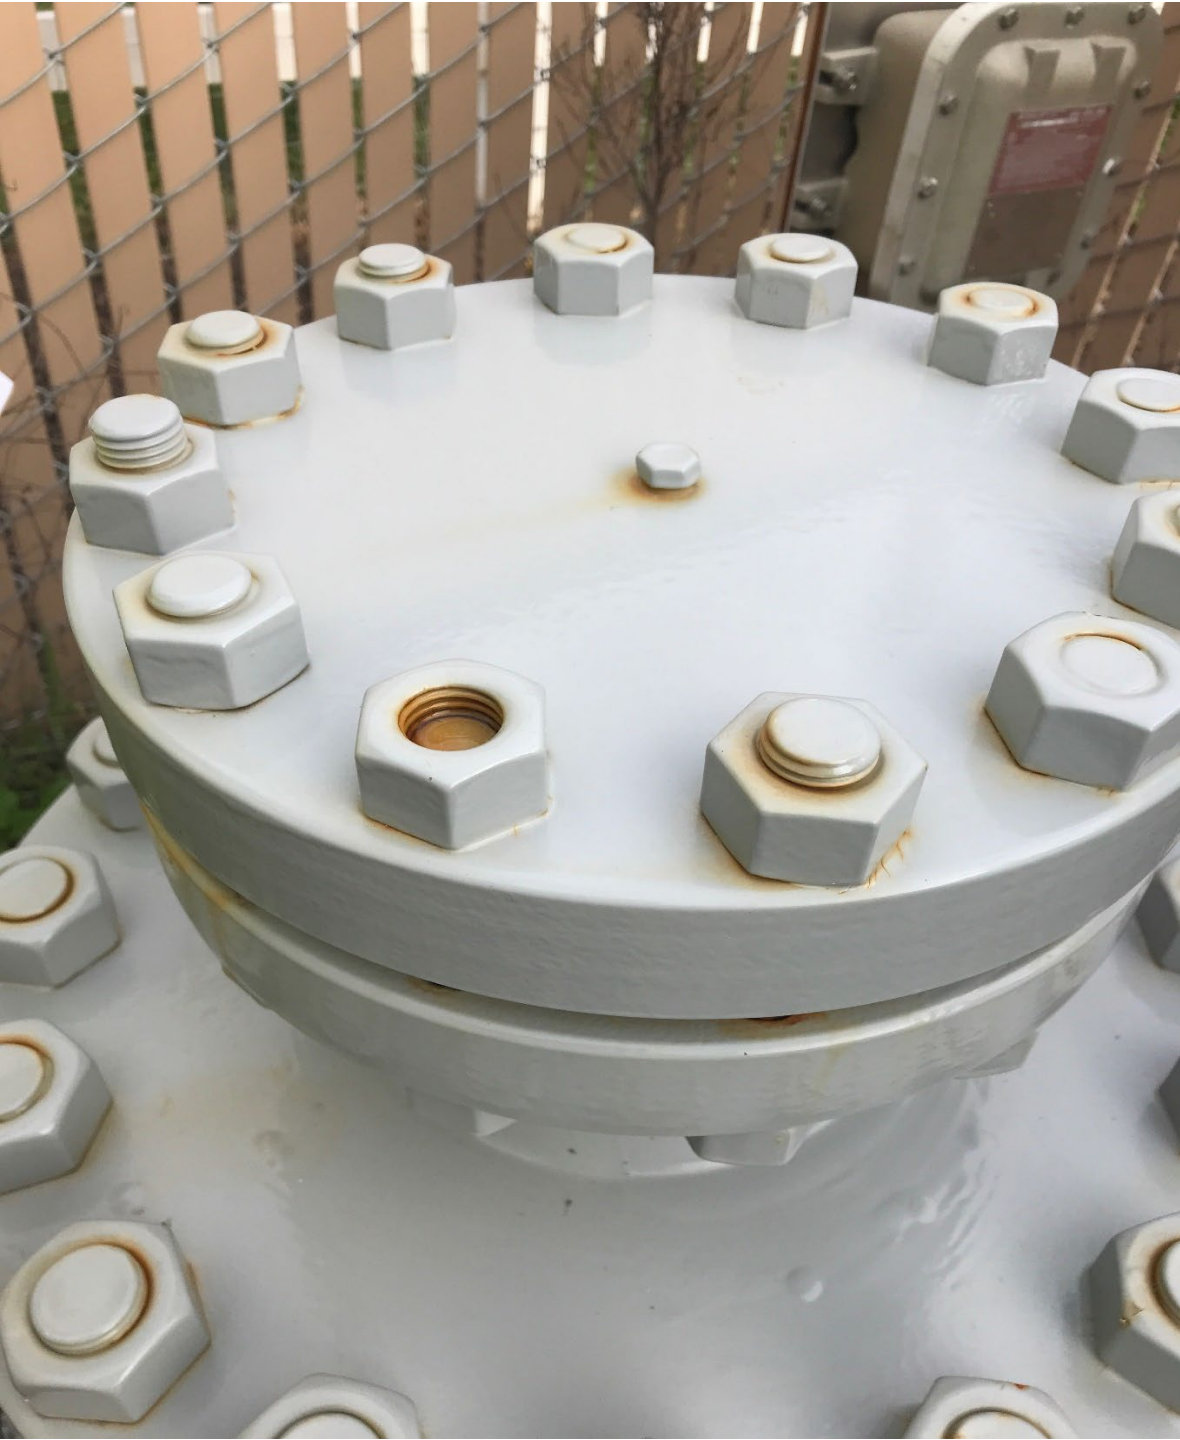
One of the bolts on valve V-C at Bannister Station.

Under PG&E Standard B-45.4, Section 2.1, Part E, "Bolts/studs must be fully engaged and extend completely through their nuts, with a recommended minimum of two threads exposed, as long as the bolt/stud does not extend beyond 1/2 inch (in.) from the nut face."

1. After review of photos taken at the two locations identified above, SED concludes that PG&E is mistaken in its assertion above. Attached please find photos taken at valve V-C at Bannister Station (the first photo below) and valve V-D at Bloomfield Station (the second photo below). Clearly, there is one bolt that is not completely through the nut for V-C. The second photo show a bolt that appears to be flush with nut, not with a minimum of one thread exposed. As a result, please identify how PG&E will correct these conditions. Please respond in writing.
2. SED accepts PG&E's response that the issue was resolved during the field inspection. SED will continue to monitor this non-compliance during future audits.

Therefore, PG&E is in violation of 49 CFR 192.13(c) for not following its own procedure, Standard B-45.4, Section 2.1, Part E. PG&E shall ensure the bolts and nuts on the flanges are fully engaged to maintain their designed strength. Please provide an update on the corrective actions that have been or will be taken.

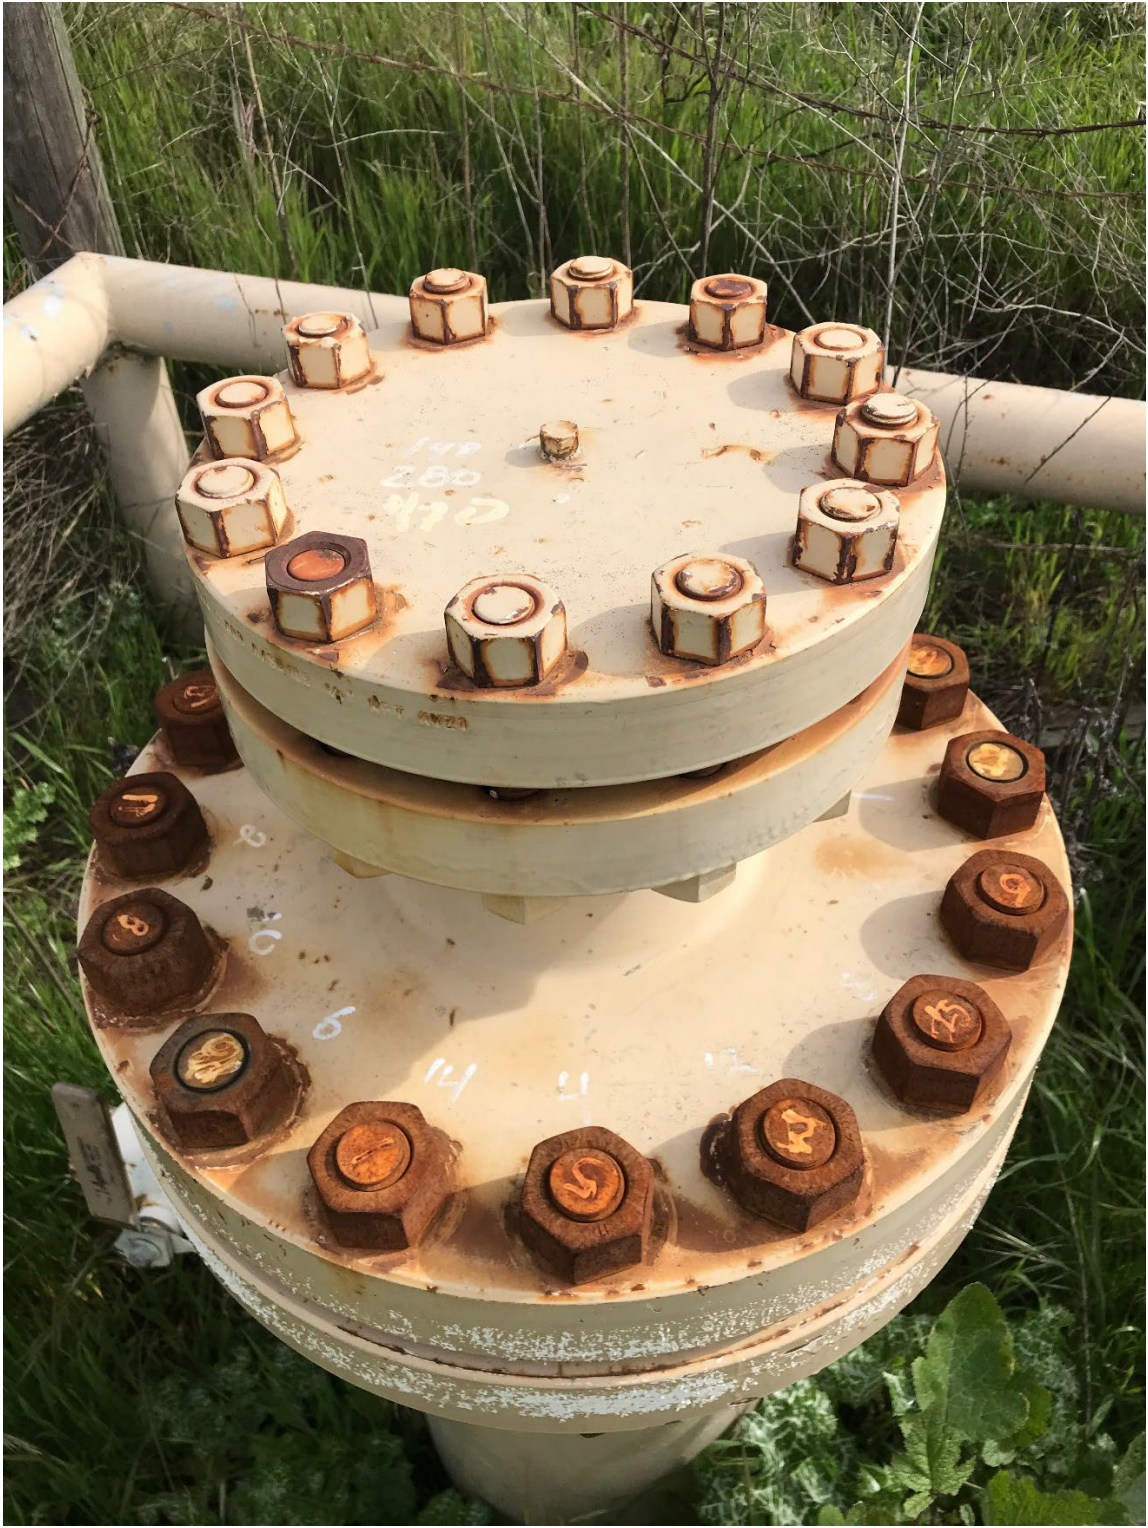
One of the bolts on valve V-D at Bloomfield Station.
