**INVESTIGATION REPORT
OF THE DECEMBER 7, 2017 WILDFIRE
IN MURRIETA, CALIFORNIA INVOLVING
SOUTHERN CALIFORNIA EDISON FACILITIES THAT CAME
TO BE KNOWN AS THE LIBERTY FIRE**

**SAFETY AND ENFORCEMENT DIVISION
ELECTRIC SAFETY AND RELIABILITY BRANCH
LOS ANGELES**

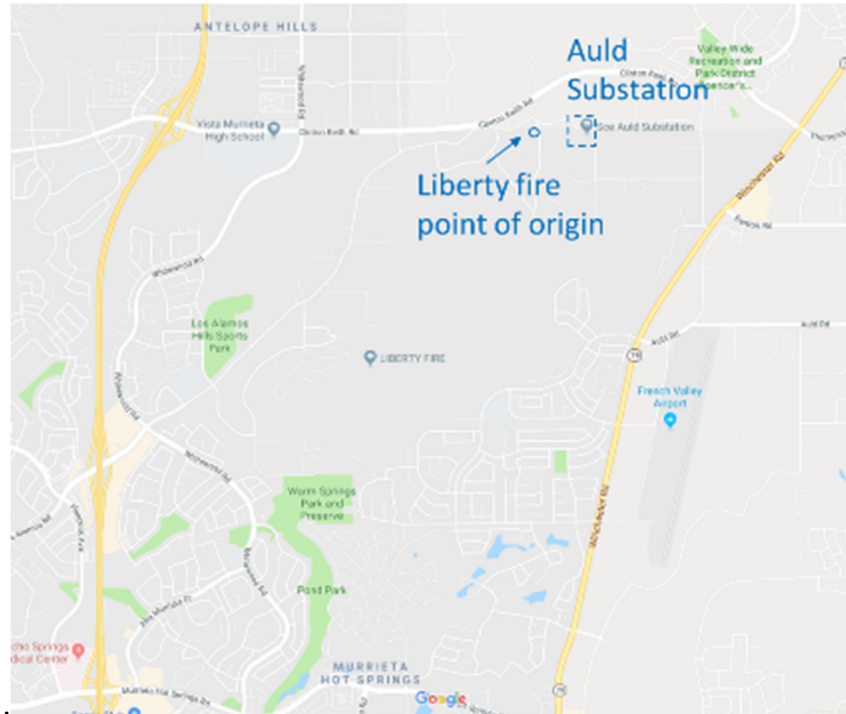
CAL FIRE investigated the cause and origin of the Liberty Fire and determined the point of origin to be at the base of Edison pole number 2090695E, located just east of the Edison Auld substation and adjacent to Los Alamos Road, which runs from east to west in the city of Murrieta, California.³⁷ Provided here are maps illustrating the point of ignition relative to the Edison Auld substation and Los Alamos Road.

Figure 5: Liberty Fire point of origin

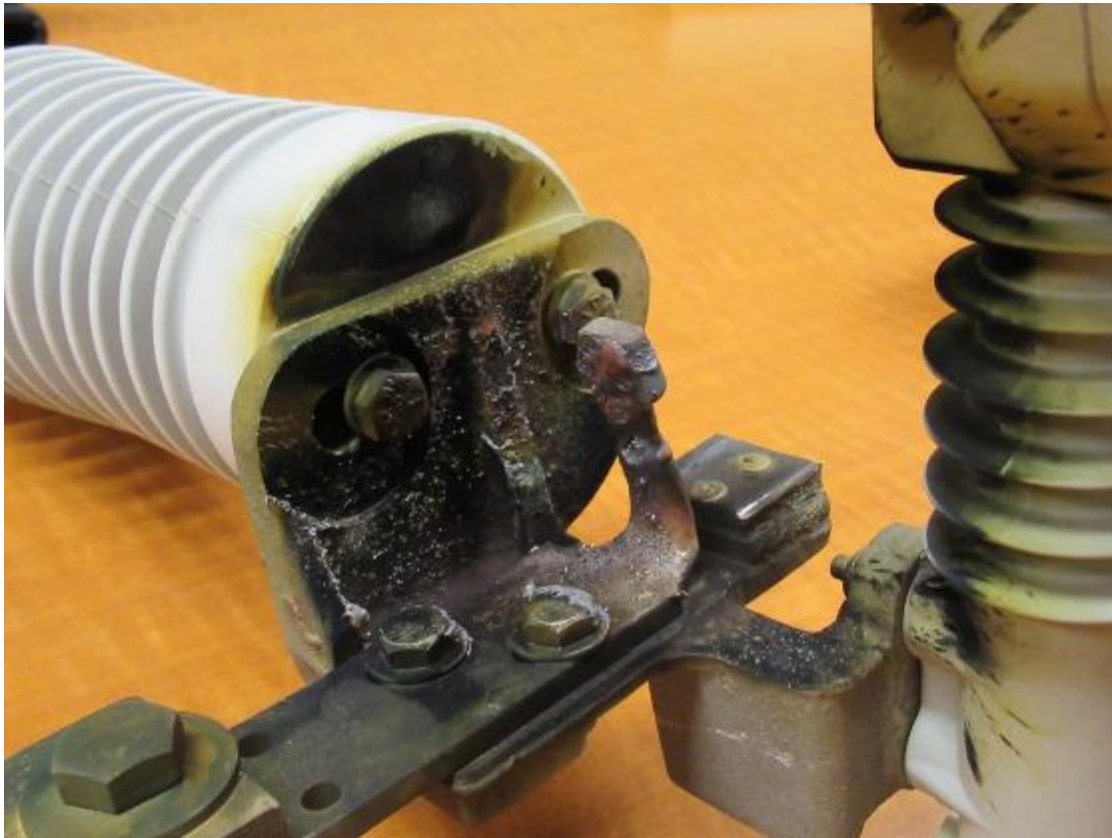
Figure 8: Receiving contact, east end, north conductor of pole switch PS 2191

SED also examined physical evidence collected by CAL FIRE on September 27, 2018. SED observed that the section of the switch that connects to the north conductor, both the rotating and receiving ends of the switch contacts, had significant damage. This section of the switch corresponds to phase C of the Clydesdale 12 kV circuit.⁴⁷ Both the receiving and rotating ends of the switch contacts that were collected by CAL FIRE show damage. The switch contacts were severely charred with some material missing from both ends as if burned, melted, or broken off. Such evidence indicates arcing and a subsequent cascading of sparks from the switch blades. Other adjacent switch components contained soot marks.

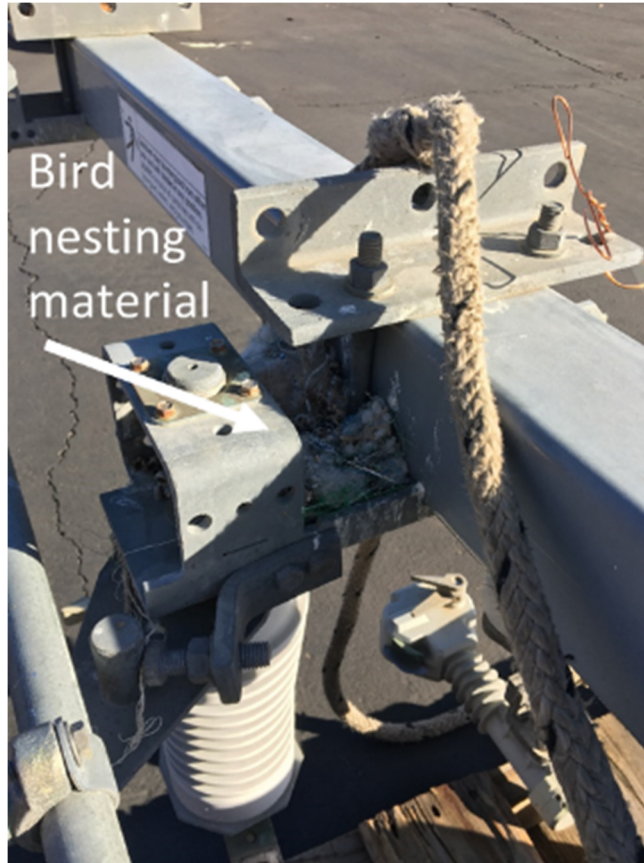
Edison as a potential factor that led to the incident.^{54,55} SED observed the bird nesting material on top of multiple sections of PS 2191 but did not find any evidence that the material may have been the cause of the arcing or fault condition.

Figure 10: Bird nesting material above the section of the switch that connects the middle conductor phase of pole switch PS 2191.⁵⁶

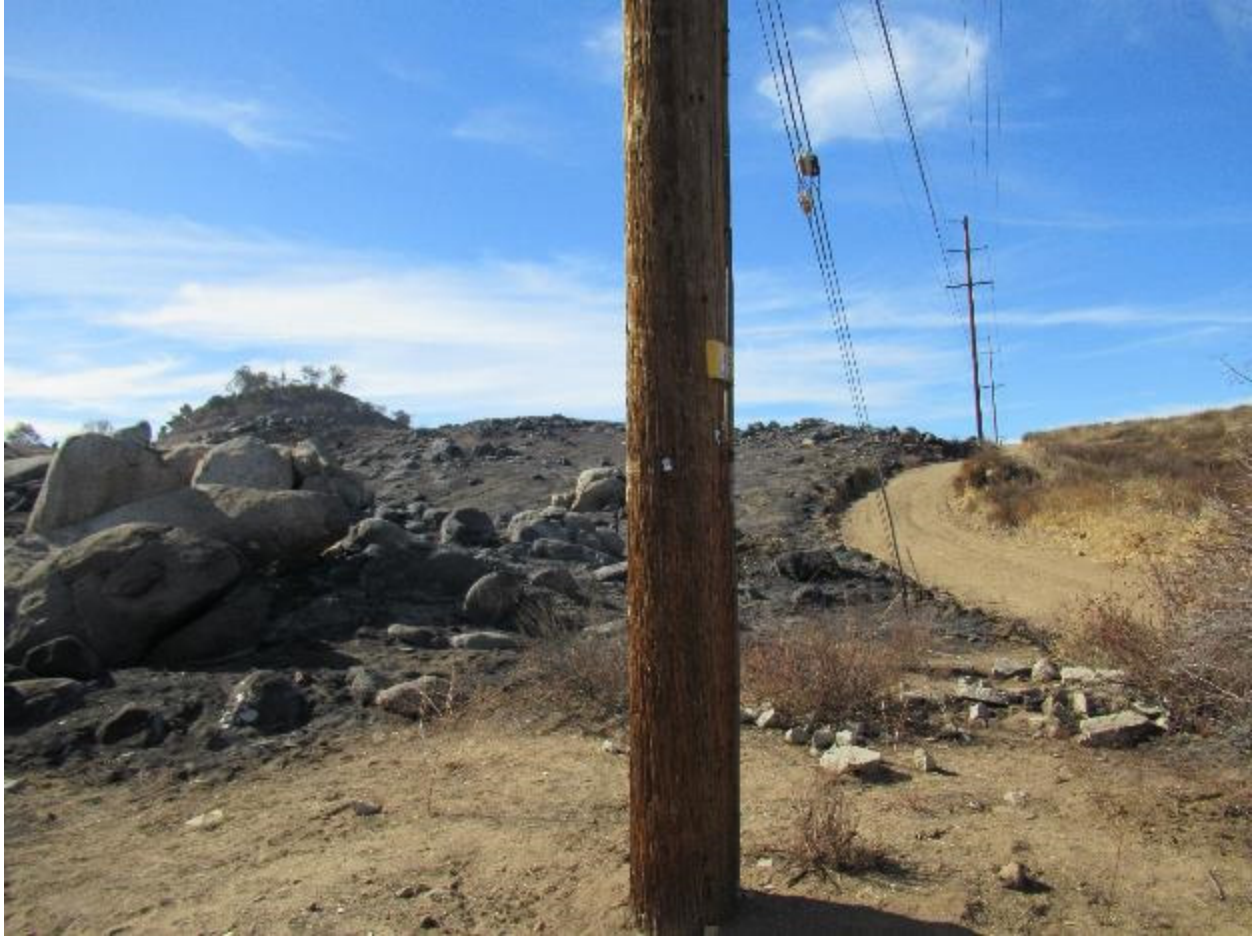
CAL FIRE's assessment of the Liberty Fire incident determined that Edison was in violation PRC § 4292, which requires a minimum radial vegetation clearance of 10 feet around a utility pole that has a pole switch mounted to it. Failure to abide by a PRC requirement, which describe best practices and other minimum requirements, is a violation of General Order 95. Rule 31.1 which specifically requires that accepted good practice be used in the design, construction, and maintenance of utility lines.

Figure 11: Brush at the base of Edison pole 2090695E

The SED investigation concluded that, based on CAL FIRE's determination of PR Code § 4292 violation, Edison is also in violation of General Order 95, Rule 31.1, for failing to maintain 10 feet radial brush clearance or best practice brush clearance around utility pole 2090695E. SED's investigation determined that following a series of recorded electrical fault events on the Clydesdale 12 kV circuit,⁵⁸ PS 2191 failed and resulted in arcing and sparks, which ignited vegetation beneath the pole. In accordance with PR Code § 4292, Edison should have cleared that vegetation.

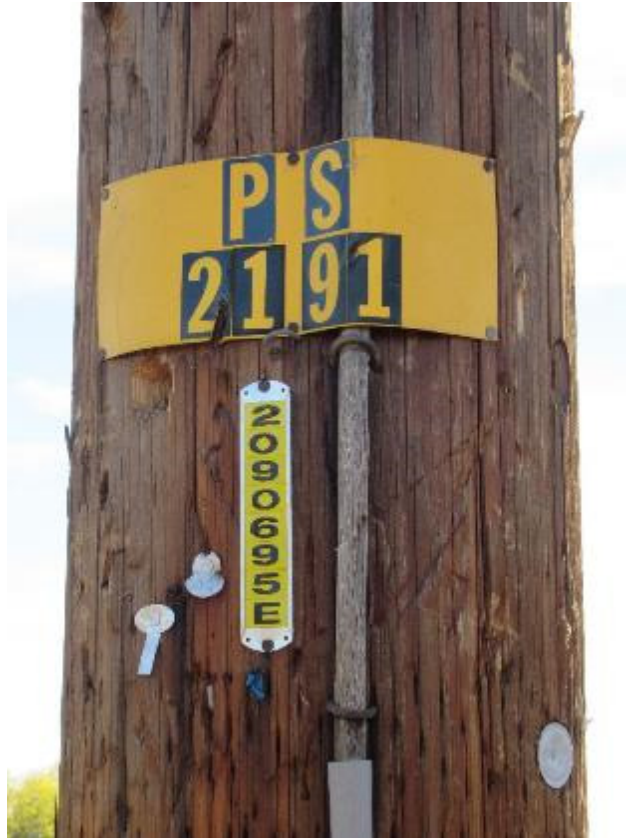
During the Liberty Fire incident investigation, SED found numerous typographical errors in Edison documents that mislabeled the pole number that the subject pole switch, PS 2191, was mounted on:

Figure 12: Edison pole number 2090695E and pole switch PS 2191 pole markers

In addition to preventing SED from properly reviewing and cross-referencing information about the structure in question, the errors in facility documentation reflects poor recordkeeping on behalf of Edison. Mislabeling facilities across documents impedes Edison's ability to perform adequate and thorough inspections on those facilities. Specifically, mislabeling can lead to errors in logging the history of a structure, which could affect the accuracy of work orders and inspection records as these are created based on structure number. This casts doubt on whether Edison's inspection records accurately reflect the condition of structures in the field.
