California Public Utilities Commission

**INVESTIGATION REPORT
OF THE DECEMBER 7, 2017 WILDFIRE
IN MURRIETA, CALIFORNIA INVOLVING
SOUTHERN CALIFORNIA EDISON FACILITIES THAT CAME
TO BE KNOWN AS THE LIBERTY FIRE**

**SAFETY AND ENFORCEMENT DIVISION
ELECTRIC SAFETY AND RELIABILITY BRANCH
LOS ANGELES**

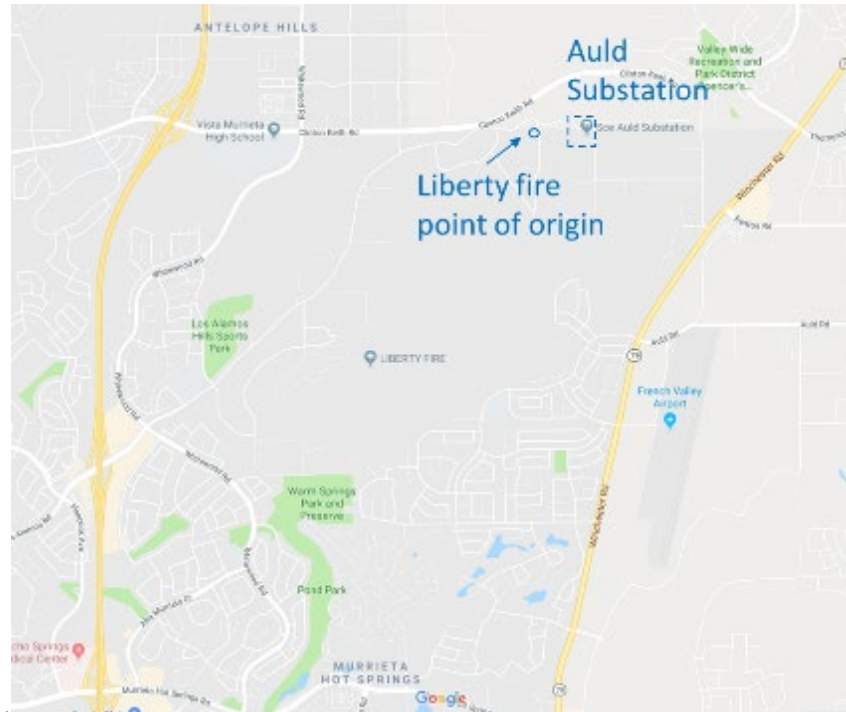
Figure 5: Liberty Fire point of origin

CAL FIRE investigated the cause and origin of the Liberty Fire and determined the point of origin to be at the base of Edison pole number 2090695E, located just east of the Edison Auld substation and adjacent to Los Alamos Road, which runs from east to west in the city of Murrieta, California.³⁷ Provided here are maps illustrating the point of ignition relative to the Edison Auld substation and Los Alamos Road.

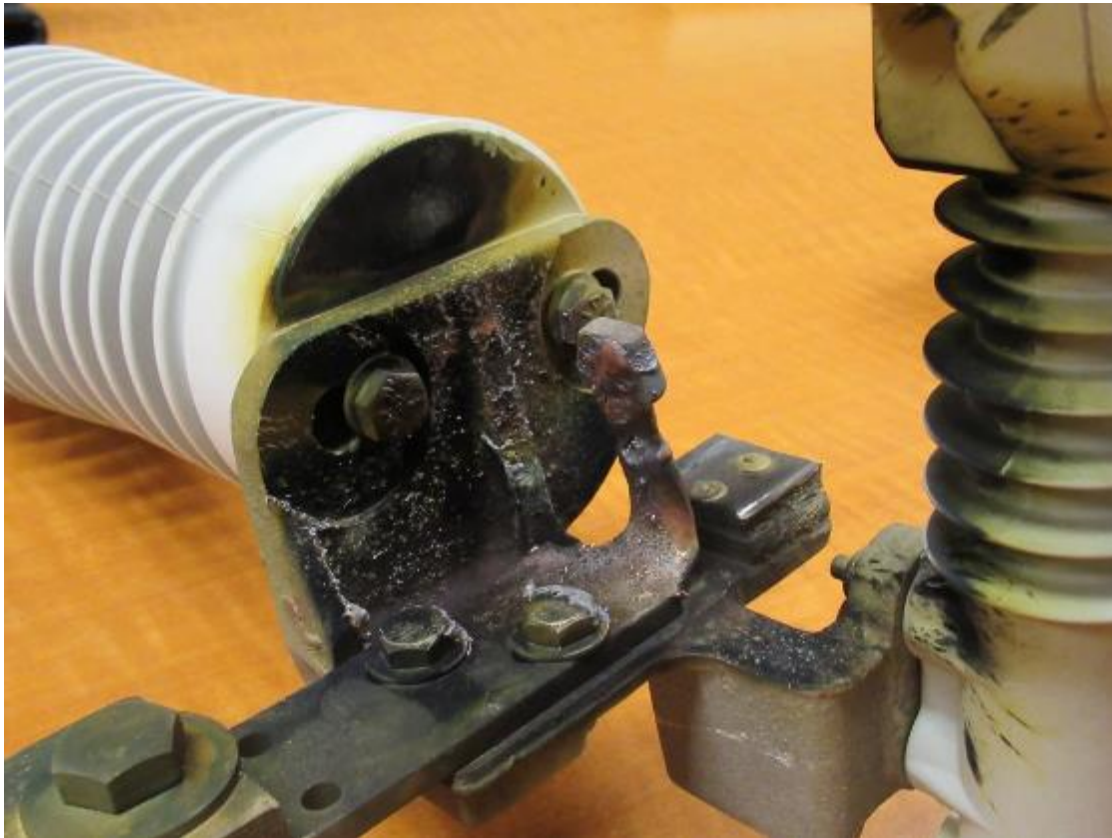
Figure 8: Receiving contact, east end, north conductor of pole switch PS 2191

SED also examined physical evidence collected by CAL FIRE on September 27, 2018. SED observed that the section of the switch that connects to the north conductor, both the rotating and receiving ends of the switch contacts, had significant damage. This section of the switch corresponds to phase C of the Clydesdale 12 kV circuit.⁴⁷ Both the receiving and rotating ends of the switch contacts that were collected by CAL FIRE show damage. The switch contacts were severely charred with some material missing from both ends as if burned, melted, or broken off. Such evidence indicates arcing and a subsequent cascading of sparks from the switch blades. Other adjacent switch components contained soot marks.

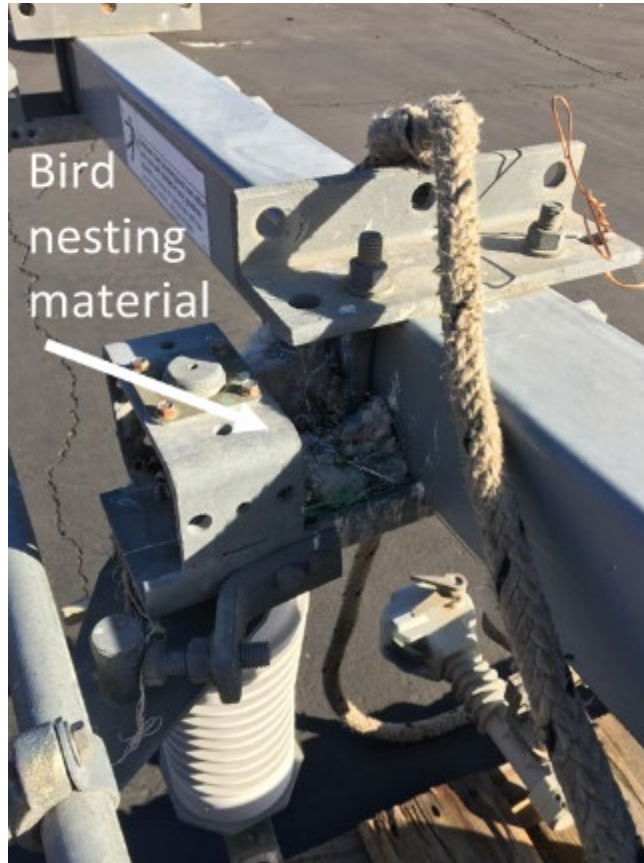
Figure 10: Bird nesting material above the section of the switch that connects the middle conductor phase of pole switch PS 2191.⁵⁶

Edison as a potential factor that led to the incident.^{54,55} SED observed the bird nesting material on top of multiple sections of PS 2191 but did not find any evidence that the material may have been the cause of the arcing or fault condition.

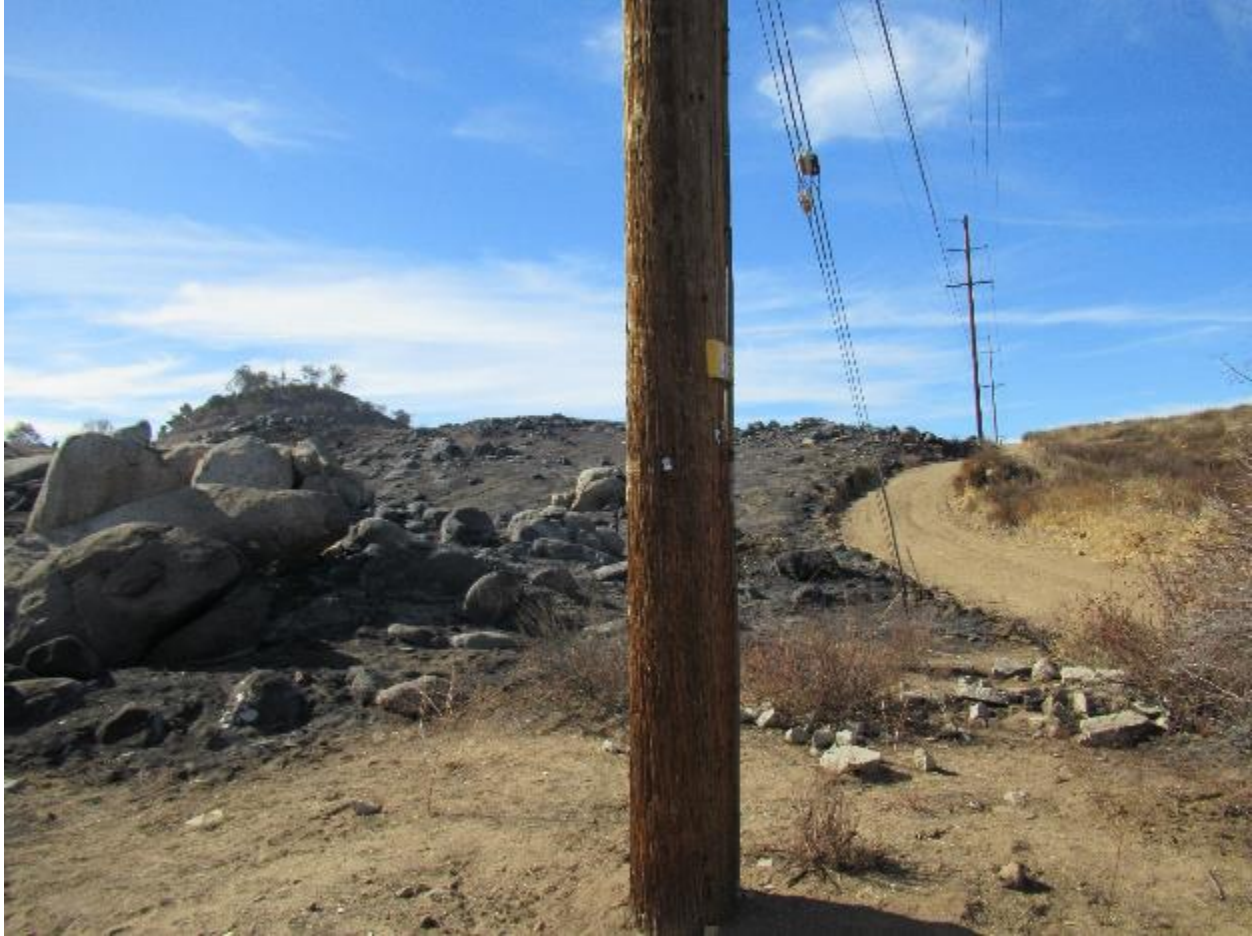
Figure 11: Brush at the base of Edison pole 2090695E

CAL FIRE's assessment of the Liberty Fire incident determined that Edison was in violation PRC § 4292, which requires a minimum radial vegetation clearance of 10 feet around a utility pole that has a pole switch mounted to it. Failure to abide by a PRC requirement, which describe best practices and other minimum requirements, is a violation of General Order 95. Rule 31.1 which specifically requires that accepted good practice be used in the design, construction, and maintenance of utility lines.

The SED investigation concluded that, based on CAL FIRE's determination of PR Code § 4292 violation, Edison is also in violation of General Order 95, Rule 31.1, for failing to maintain 10 feet radial brush clearance or best practice brush clearance around utility pole 2090695E. SED's investigation determined that following a series of recorded electrical fault events on the Clydesdale 12 kV circuit,⁵⁸ PS 2191 failed and resulted in arcing and sparks, which ignited vegetation beneath the pole. In accordance with PR Code § 4292, Edison should have cleared that vegetation.

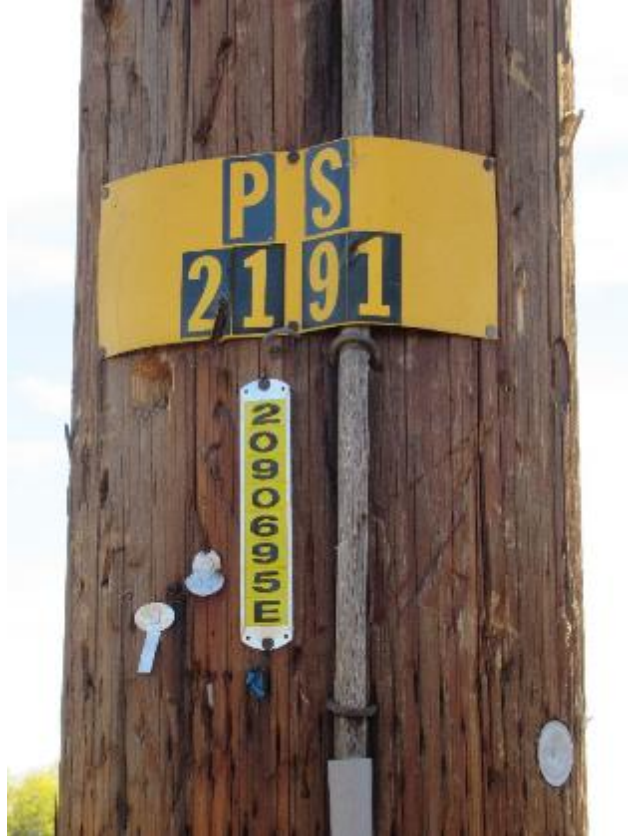
Figure 12: Edison pole number 2090695E and pole switch PS 2191 pole markers

As observed during a field visit to the incident location on December 11, 2017, pole switch PS 2191 was mounted on Edison pole number 2090695E, as shown in the next figure.

In addition to preventing SED from properly reviewing and cross-referencing information about the structure in question, the errors in facility documentation reflects poor recordkeeping on behalf of Edison. Mislabeled facilities across documents impedes Edison's ability to perform adequate and thorough inspections on those facilities. Specifically, mislabeling can lead to errors in logging the history of a structure, which could affect the accuracy of work orders and inspection records as these are created based on structure number. This casts doubt on whether Edison's inspection records accurately reflect the condition of structures in the field.

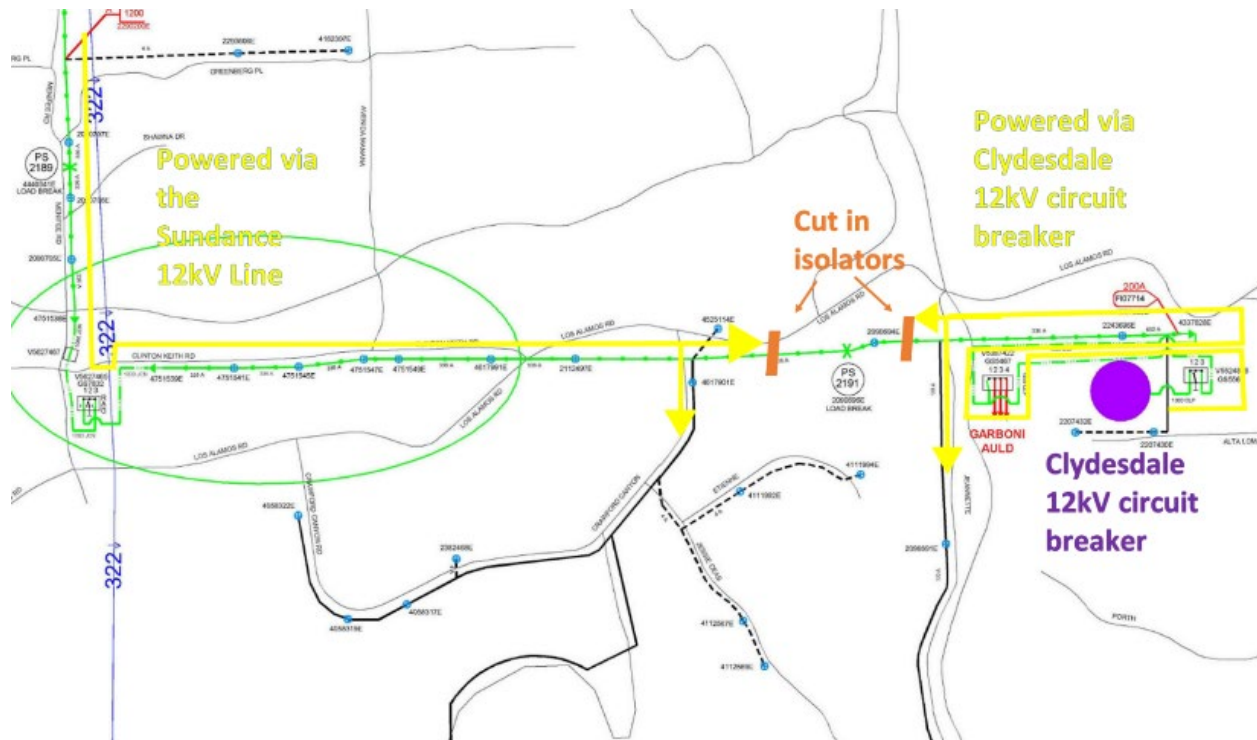
Figure 13: Clydesdale circuit. PS 2191's isolation via the cut in isolators

and inspectors from determining the condition of the switch.⁷¹ Opening PS 2191 was in fact tampering with evidence, especially because the Clydesdale 12 kV circuit was already de-energized and preserving PS 2191 in the closed position did not pose any danger to property or to the public. Furthermore, PS 2191 was the focal point of fire investigator's inspection for fire origin and cause, and subsequently was removed and retained as evidence by CAL FIRE.

GO 95, Rule 19, and PU Code § 316, require Edison to preserve evidence and to cooperate with Commission staff during incident investigation. Opening PS 2191 hindered investigators' ability to carry out their duties pursuant to PU code 316 because they could not determine the following:
