**INVESTIGATION REPORT  
OF THE DECEMBER 5, 2017 WILDFIRE  
IN SAN BERNARDINO, CALIFORNIA  
INVOLVING SOUTHERN CALIFORNIA EDISON FACILITIES  
THAT CAME TO BE KNOWN AS THE MEYERS FIRE**

**SAFETY AND ENFORCEMENT DIVISION  
ELECTRIC SAFETY AND RELIABILITY BRANCH**

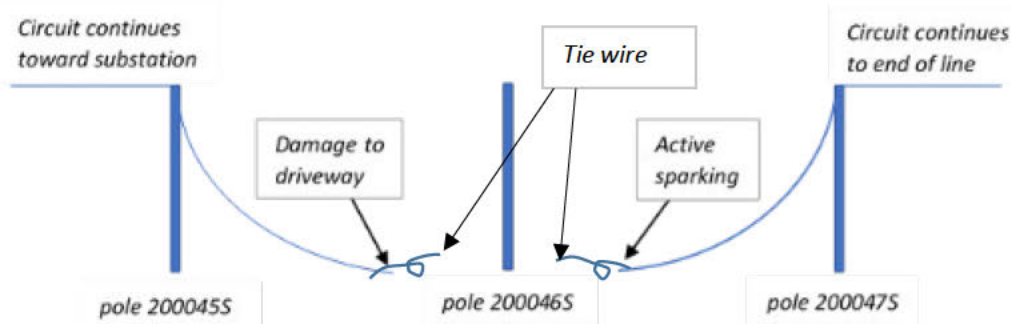
was broken between the two at pole 200046S.<sup>41, 42</sup> The tie wire that had previously secured the conductor to the insulator at the top of pole 200046S was broken and still attached to both ends of the conductor that lay on the ground.<sup>43</sup>

The downed span of conductor attached to pole 200045S, upstream from pole 200046S, landed on the concrete driveway of the residence located at [REDACTED] Meyers Road in San Bernardino. The driveway and the conductor sustained arcing damage from prolonged contact with the downed energized conductor. The troubleman observed that the downed span of conductor attached to pole 200047S, downstream from pole 200046S, was actively sparking on the ground.<sup>44</sup> Figure 6 below illustrates the troubleman's observations of the downed conductor.

Figure 6: Configuration of downed conductor with tie wires attached as described by the responding troubleman upon arrival at the incident location.

After removing the sections of downed and damaged conductor from the Northpark 12 kV circuit, the troubleman completed a Distribution Repair Order calling for the replacement of three (3) spans of the downed 12 kV conductor using the same type of #6 AWG copper wire.<sup>50</sup> Spans that were replaced were from pole 200045S to 200046S, 200046S to 200047S, and 200047S to 2157866E.

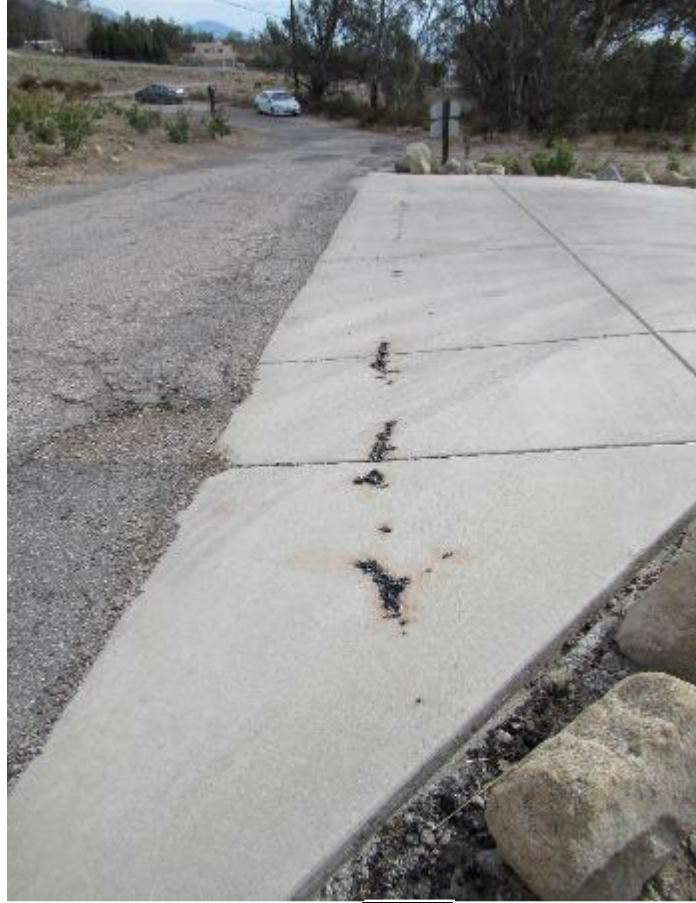
During a site visit on December 22, 2017 with Edison investigators near [REDACTED] Meyers Road in San Bernardino, SED investigators observed arcing damage on the driveway located at [REDACTED] Meyers Rd, as seen in Figure 7. The section of the concrete that was directly beneath the copper wire was burned in a pattern that ran parallel to the wire, consistent with where the downed energized conductor laid until the circuit was de-energized by Edison personnel.

Figure 7: Damaged driveway at [REDACTED] Meyers Road

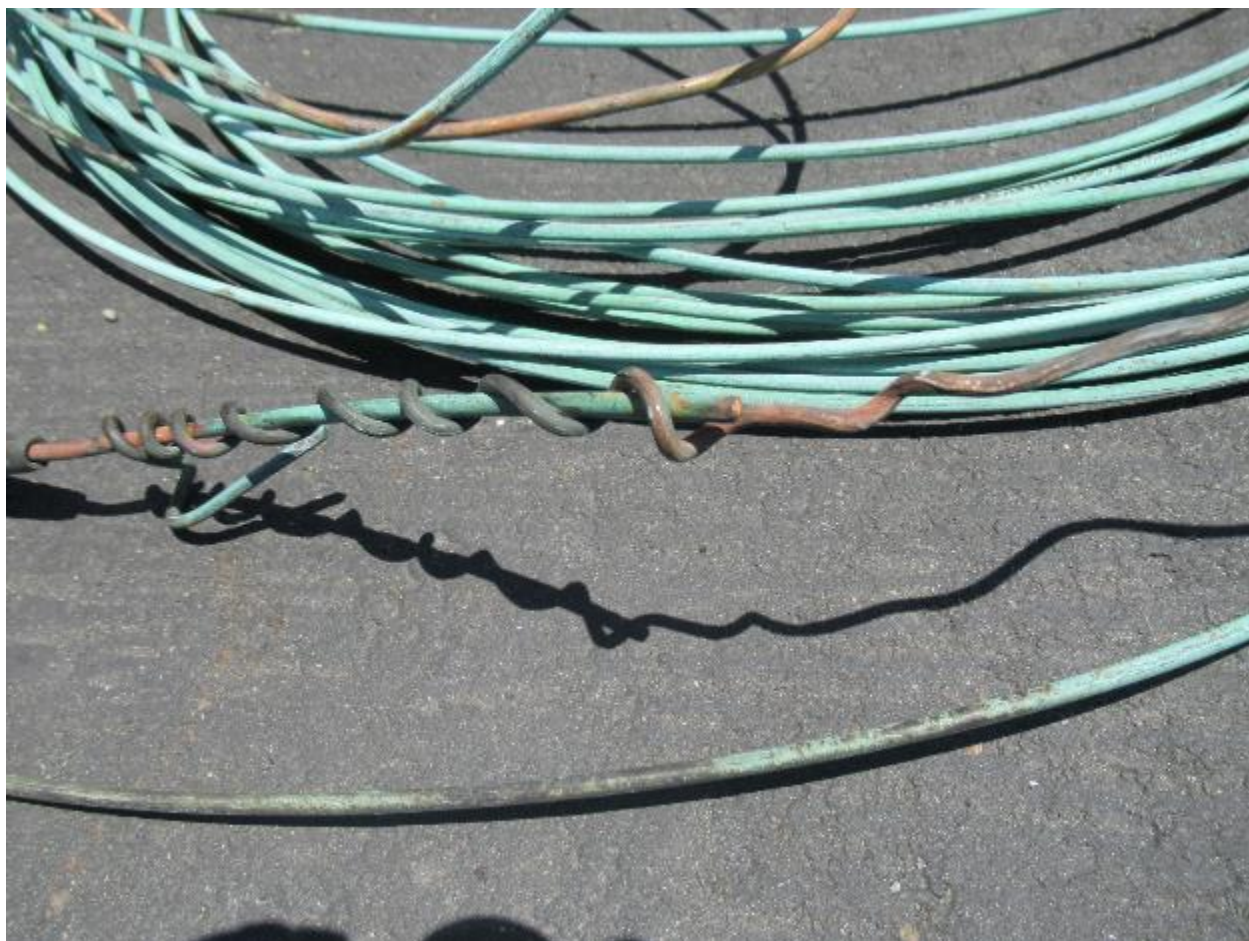
*Figure 8: Conductor 1, with a portion of a tie wire still wrapped around one end.*

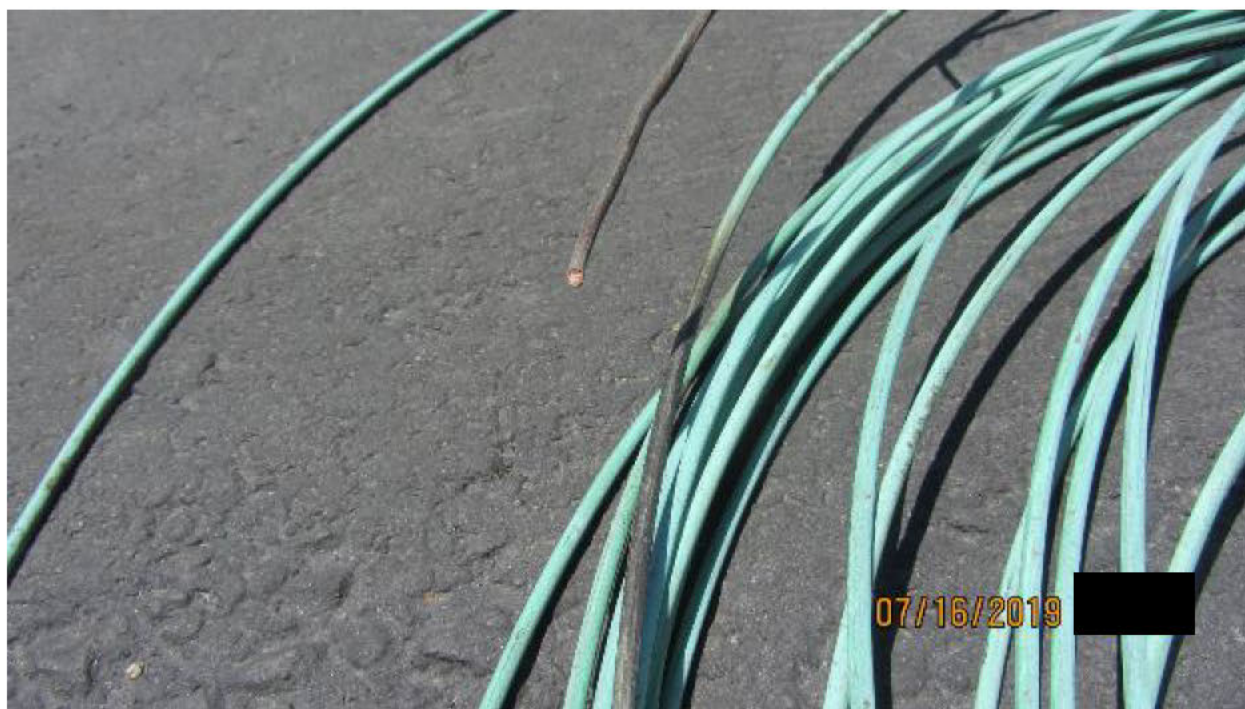
Figure 9: End of the tie wire attached to Conductor 1.

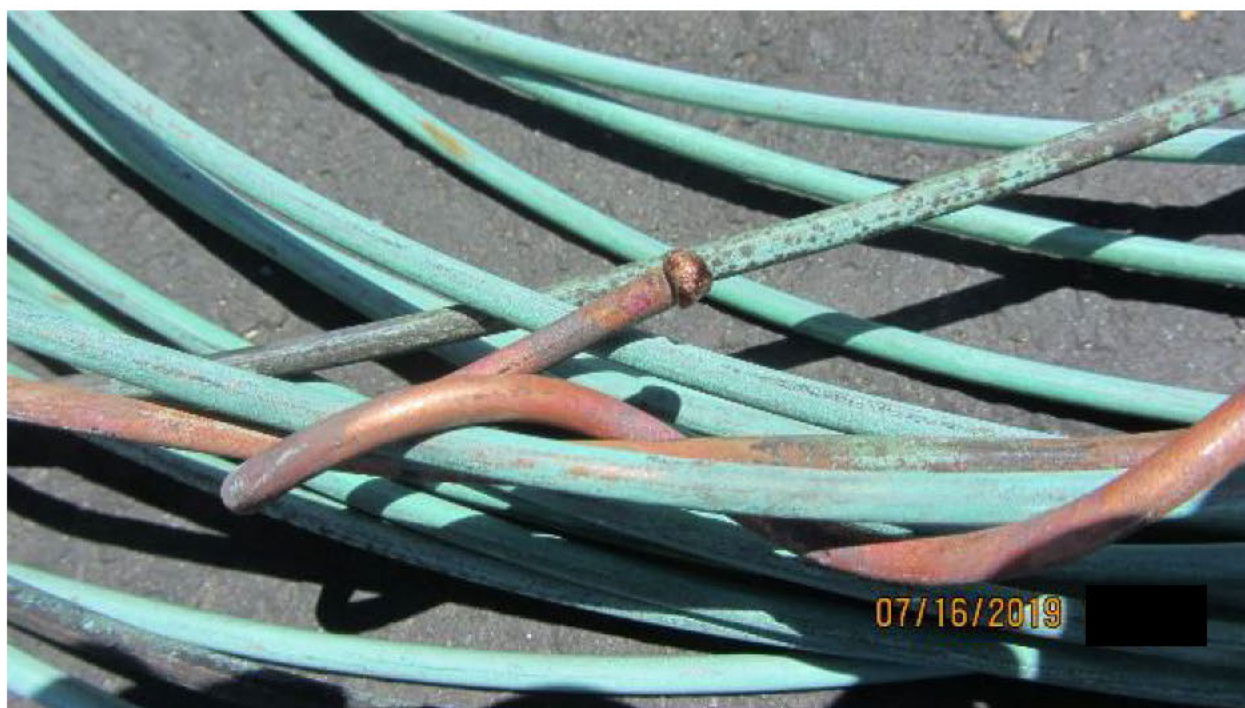
Figure 10: Melted end of Conductor 1.

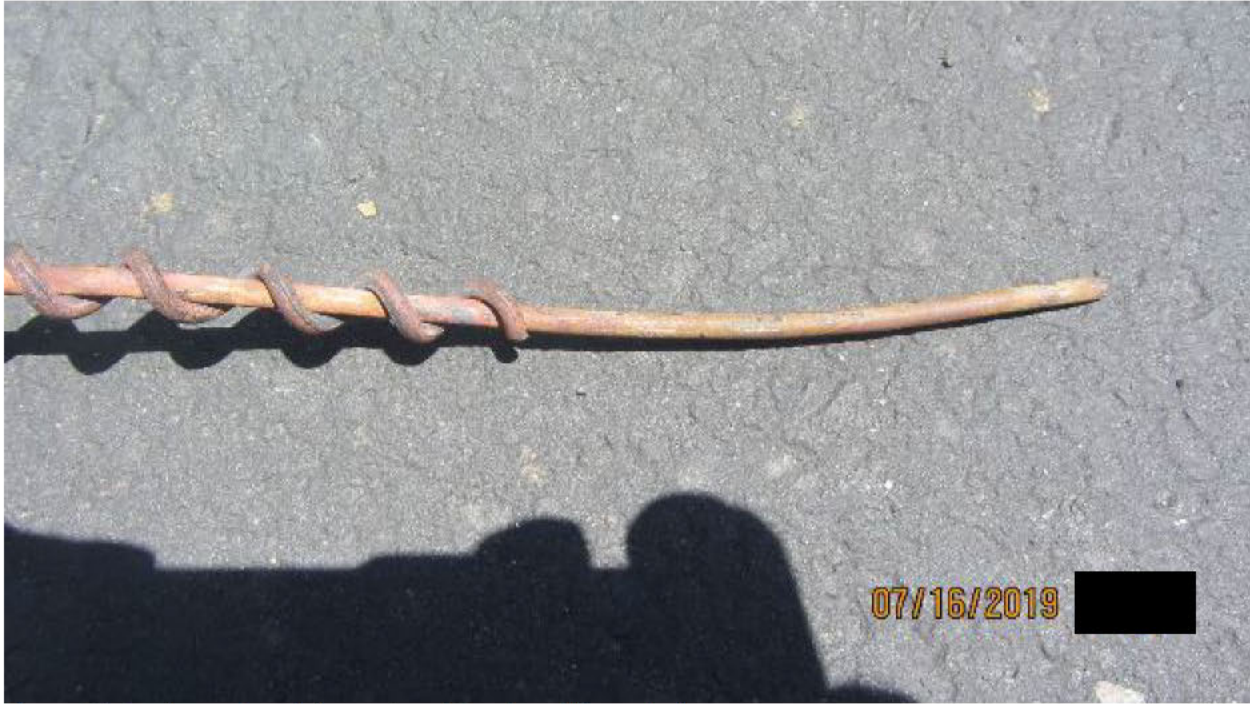
Figure 11: Conductor 2 and the portion of tie wire still attached.

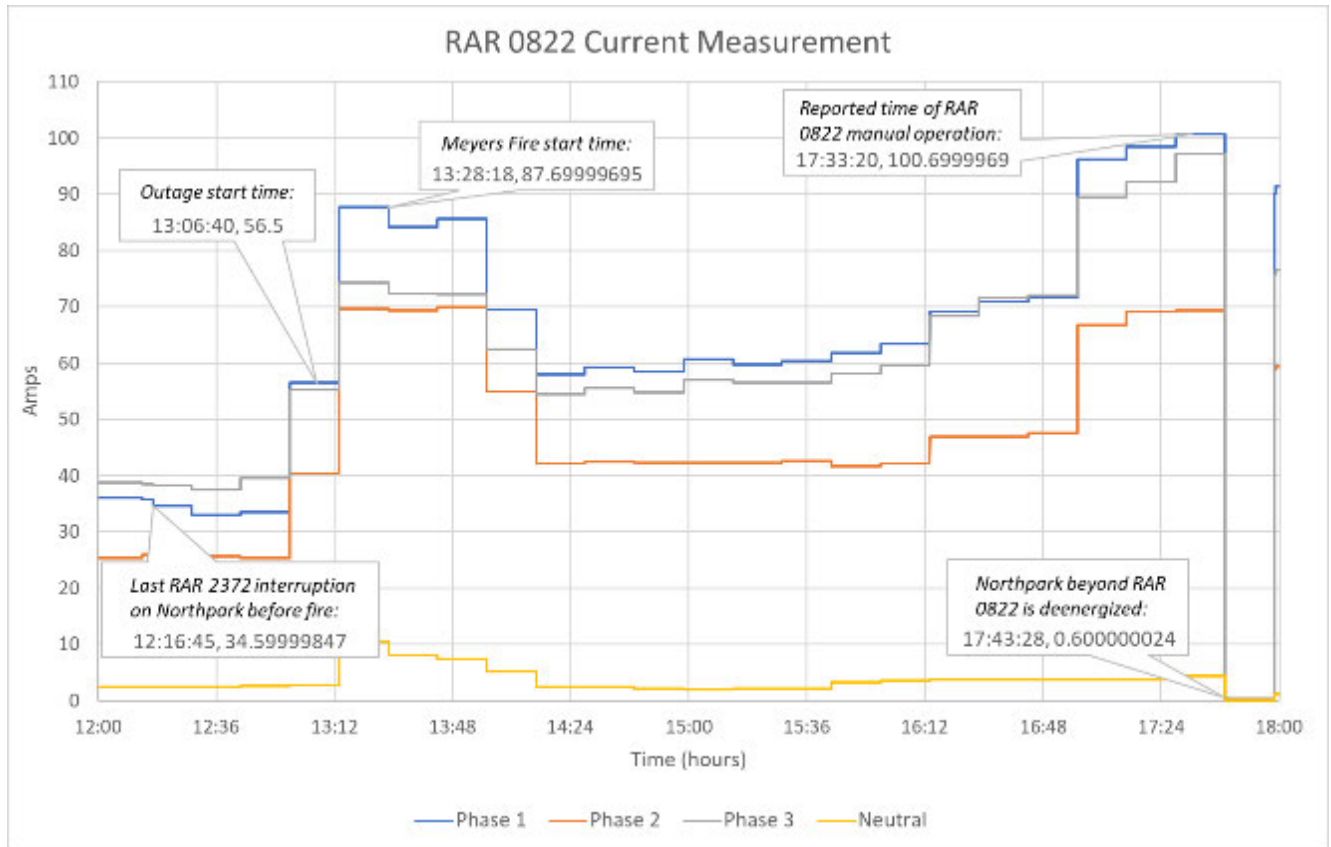
Figure 12: Current measured by RAR 0822 on December 5, 2017 from 1200 hours to 1800 hours.<sup>59</sup>

Edison asserted that the protective scheme of the circuit operated as designed, but did not provide any detail as to why the circuit was not capable of detecting the downed primary wire and de-energizing the circuit.<sup>60</sup> Edison also did not provide any detail as to why an appropriately designed protective scheme allowed for hazardous energized conductors to remain on the ground in an energized state for an undefined period of time.
