**INVESTIGATION REPORT
OF THE DECEMBER 5, 2017 WILDFIRE
IN SANTA CLARITA, CALIFORNIA
INVOLVING SOUTHERN CALIFORNIA EDISON FACILITIES
THAT CAME TO BE KNOWN AS THE RYE FIRE**

**SAFETY AND ENFORCEMENT DIVISION
ELECTRIC SAFETY AND RELIABILITY BRANCH
LOS ANGELES**

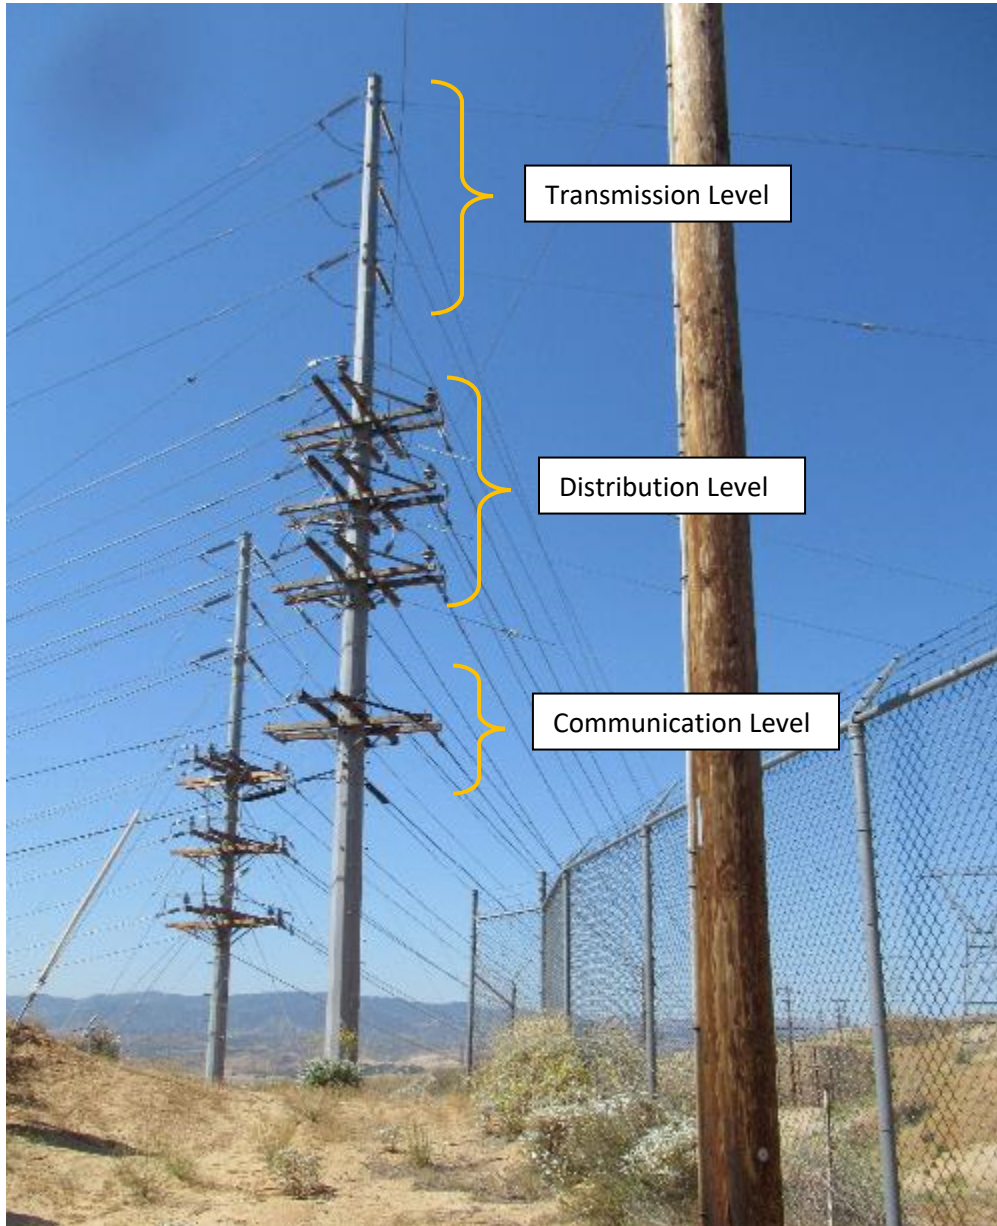
Figure 3: Pole 4389254E

The section of the Nighthawk 16 kV circuit involved in the Rye Fire incident included pole 4389254E, a steel pole supporting three circuits and one communication line. Pole number 4389254E was a 75-foot steel pole with eleven (11) guy wires in total supporting the distribution and transmission level circuits as seen in Figure 3.¹²

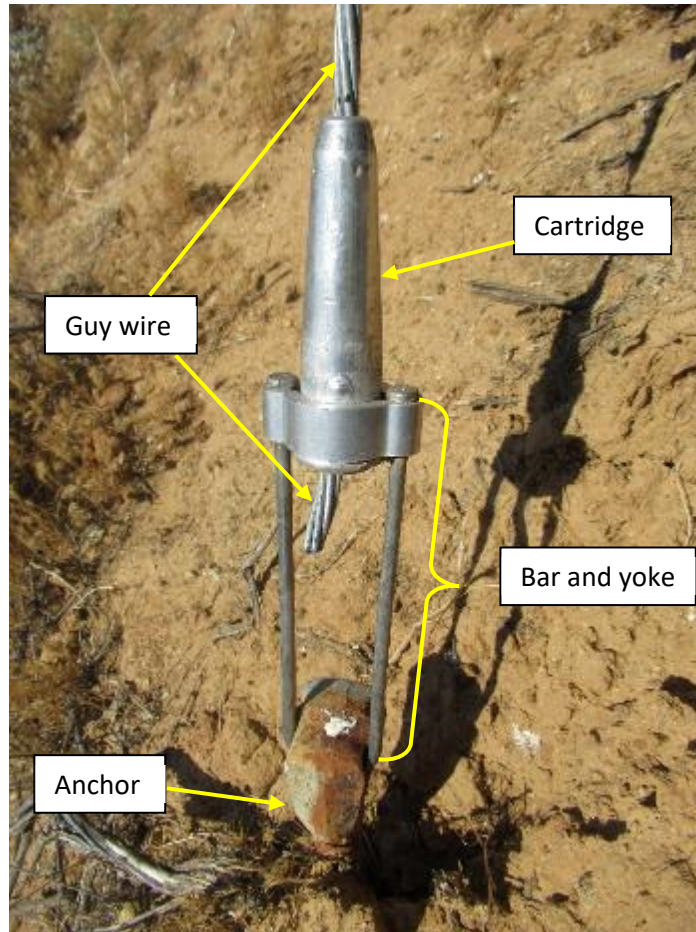
Pole 4389254E, the failed guy wire automatic dead end assembly, and the associated guy wire were all installed in 1999.¹³ The automatic dead end assembly consists of an anchor secured to the ground, a tapered cartridge, and a bar and yoke system that connects the automatic dead end tapered cartridge to the anchor. Figure 4 shows the new automatic dead end assembly which is the same make and model as the previous automatic dead end assembly.

Figure 4: Like-for-like replacement of failed automatic dead end assembly at pole 4389254E.

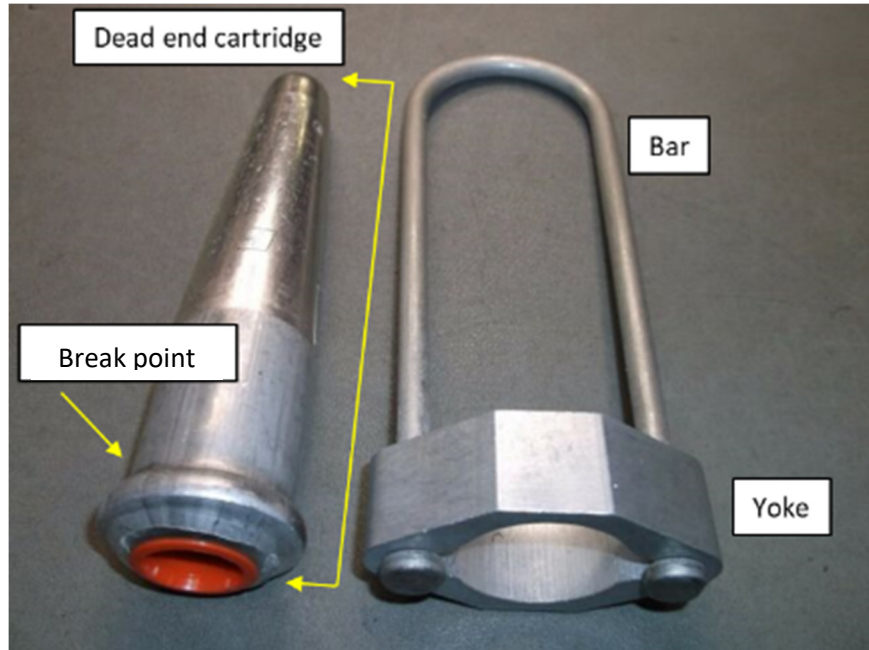
Figure 5: Automatic dead end showing point of failure, not an exact replica of the Edison automatic dead end

SED examined the failed automatic dead end assembly and found that the ring-end section of the tapered cartridge had broken off. This section is normally held in tension against the yoke. The automatic dead end assembly was manufactured by Reliable Power Products.^{14,15} The automatic dead-end assembly was rated to support a maximum tensile force of 10,350 pounds.¹⁶ The guy wire associated with the failed dead end was a 3/8 inch stranded zinc-coated steel wire and was rated to support a maximum tensile force of 15,400 pounds.^{17,18} Edison installed the guy wire to support 6,839 pounds of tension on pole 4389254E.¹⁹ LACFD collected the guy wire as evidence. Edison stated that it was unable to provide the manufacturer of the stranded guy wire because it had not examined the guy wire.²⁰

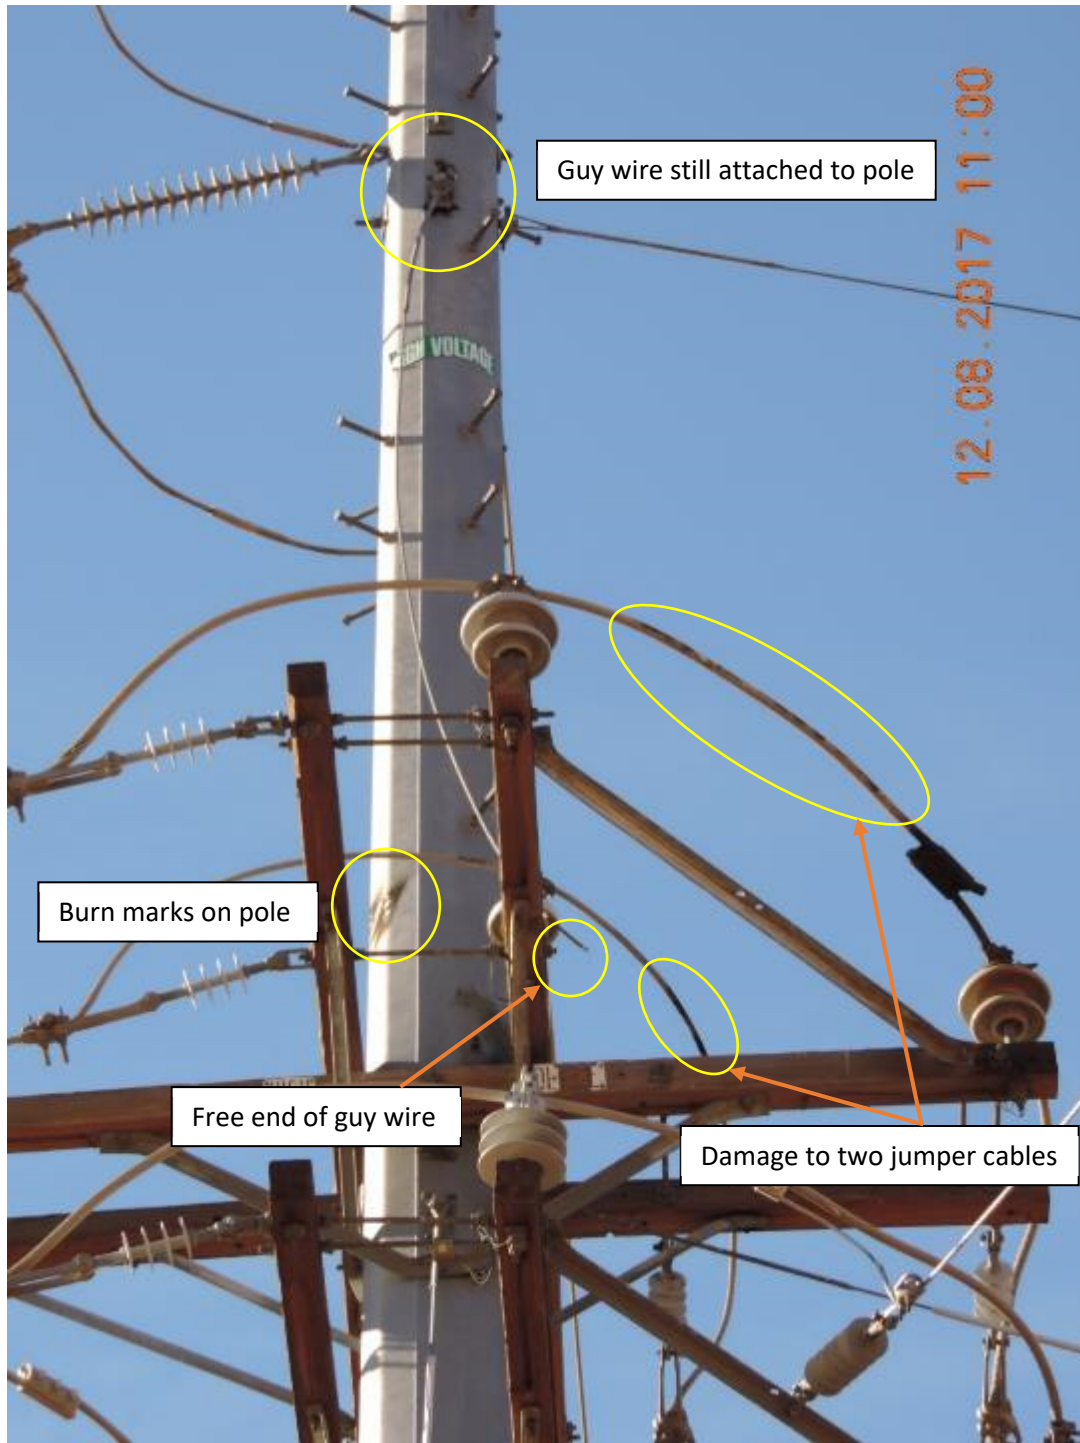
During a site visit to Rye Canyon Loop on December 8, 2017, SED investigators observed that two jumper wires on the distribution level of pole 4389254E exhibited burn marks, as did a portion of the steel pole directly above the jumper cables. An approximately 12-foot portion of a guy wire was still attached to pole 4389254E at the transmission level and was hanging down to the distribution level and was resting on a crossarm. The broken end of the guy wire showed signs of burning. LACFD had already collected and removed the remaining approximately 20-foot portion of the guy wire that Edison initially found on the ground from the incident location. Edison collected the bar and yoke component of the anchor rod that supported the failed guy support. The preserved evidence in Edison's possession is being held in Edison's Rosemead office.³³

Figure 6: Pole 4389254E before evidence was removed.

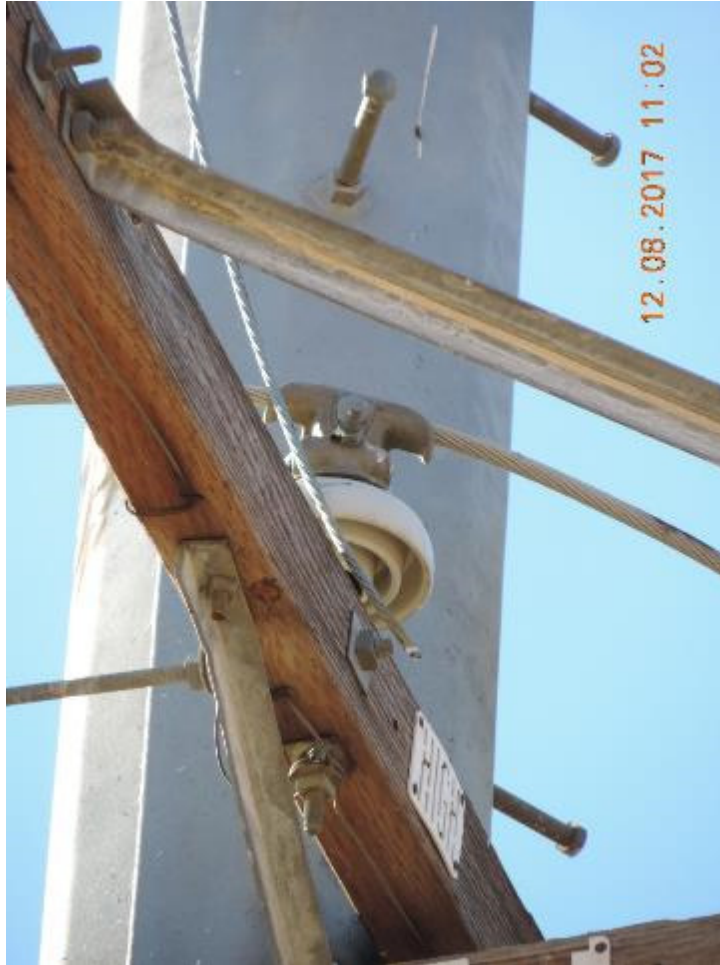
Figure 7: Free end of guy wire resting on a distribution level crossarm before evidence was removed

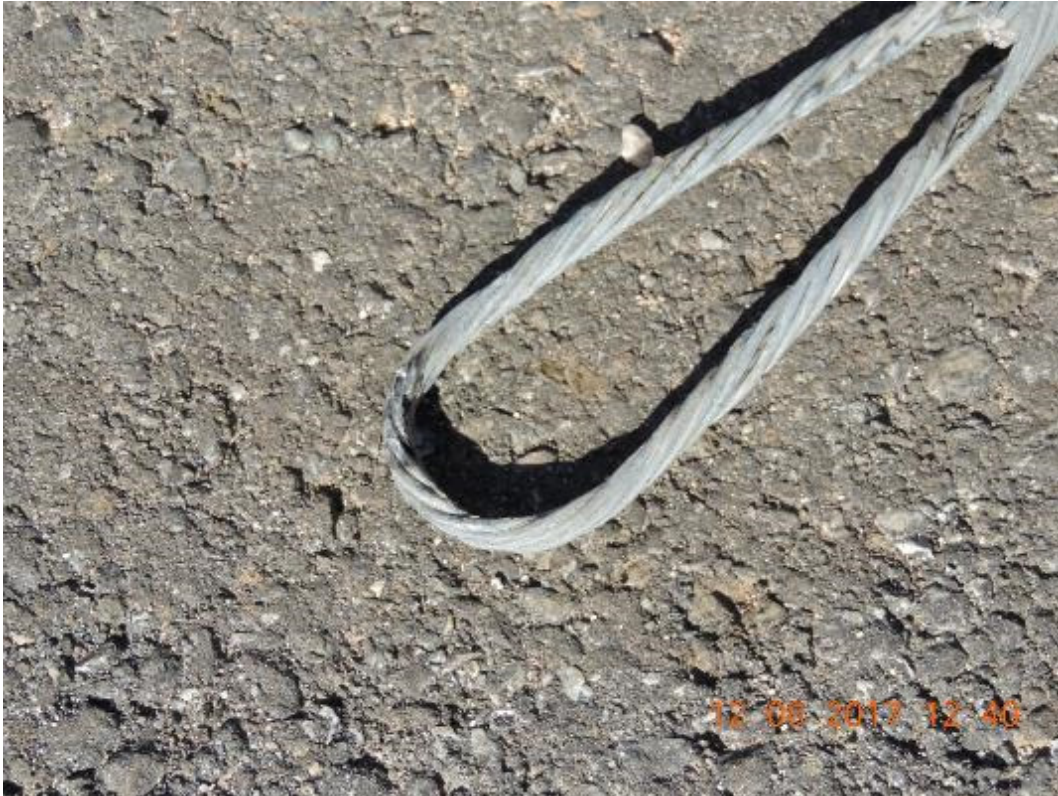
SED investigators examined the guy wire sections collected by LACFD. The approximately 12-foot section of the guy wire exhibited multiple burn marks along the length of the wire. The free end of the guy wire that LACFD found resting on a distribution level crossarm is depicted above in Figure 7. The end of the guy wire exhibited burn marks and loss of material.

Figure 8: Loop on the approximately 12-foot section of guy wire found hanging from pole 4389254E

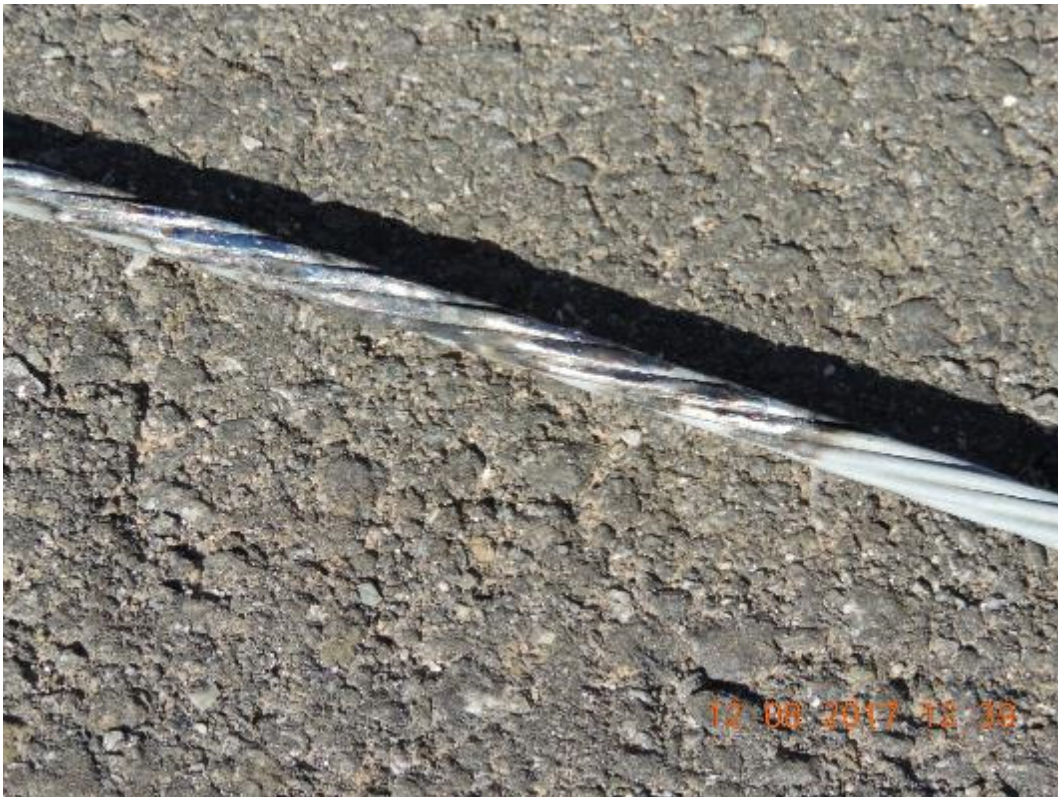
Figure 9: Damage along the approximately 12-foot section of guy wire.

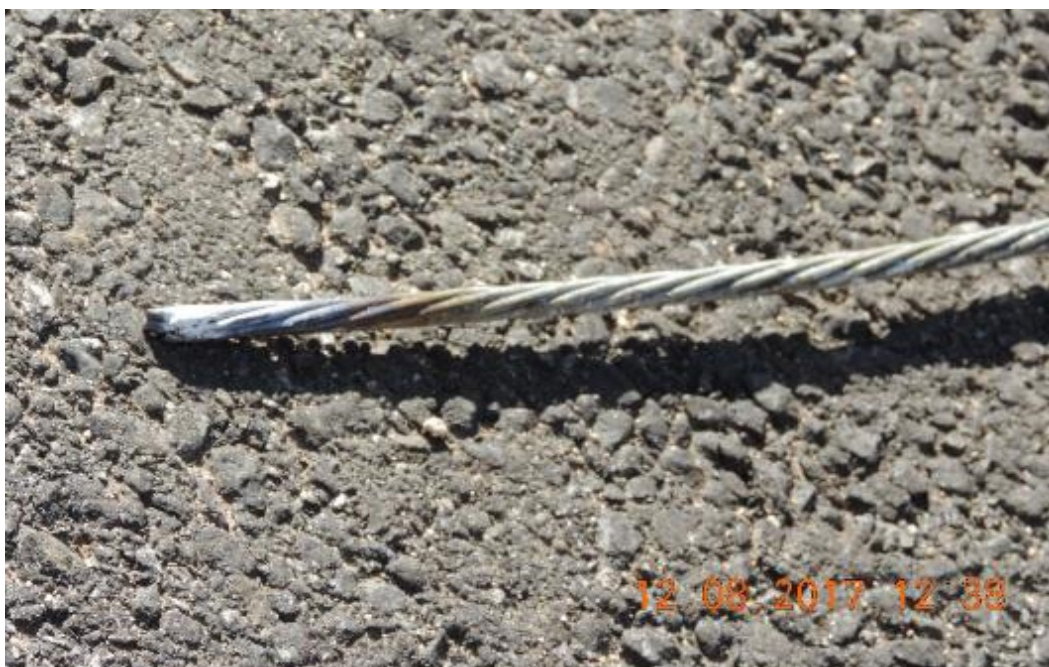
Figure 10: Free end of the approximately 12-foot section of the guy wire found hanging from pole 4389254E

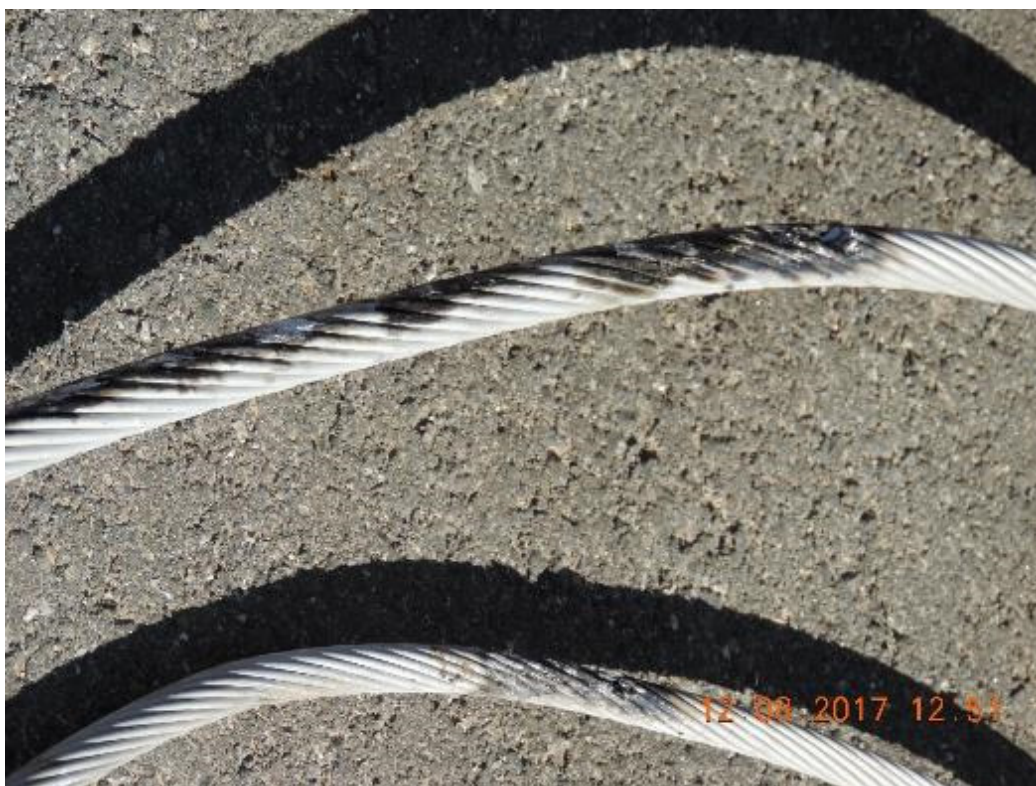
The two jumper lines that LACFD collected exhibited similar burn marks. These are depicted in Figure 11. Figure 12 depicts one example of the melting and loss of material observed on both wires, indicative of arcing due to contact.

Figure 11: Two jumper wires from pole 4389254E exhibit burns and loss of material.

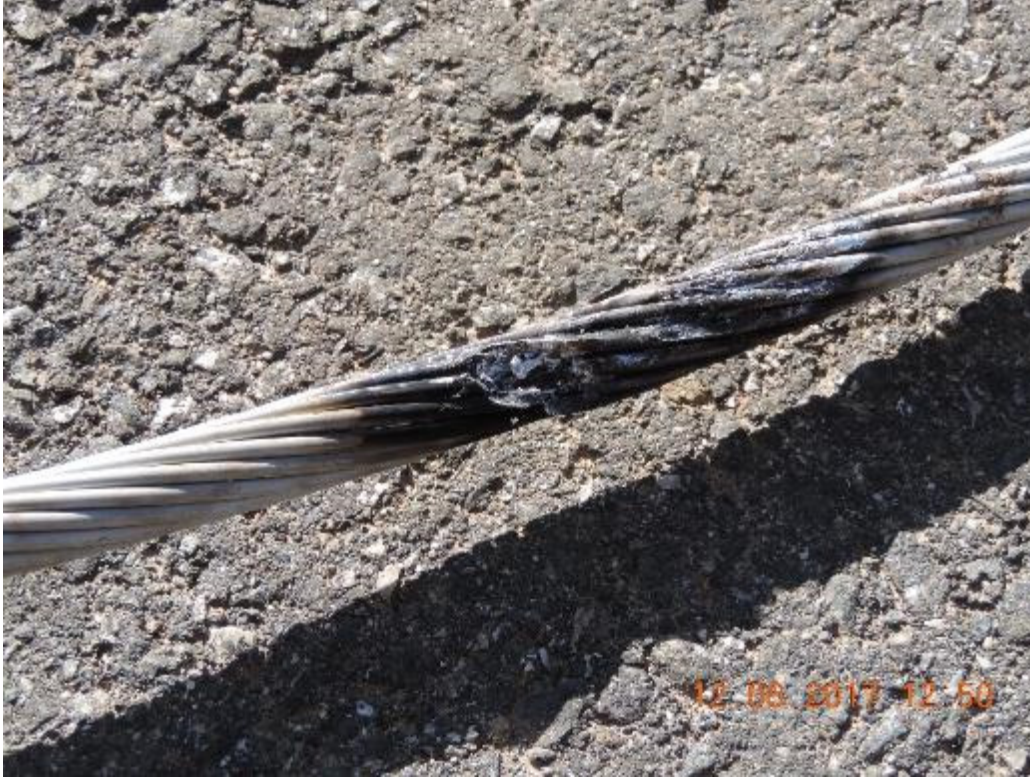
Figure 12: Loss of material on a jumper wire from pole 4389254E.

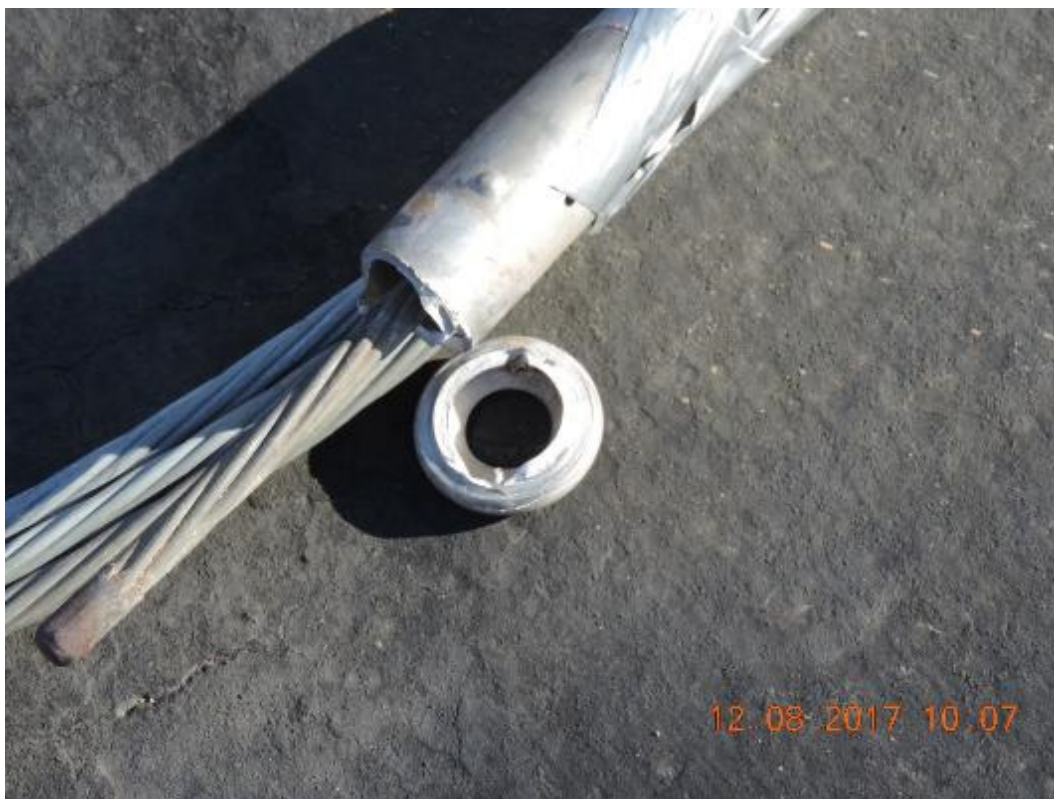
SED investigators also examined the approximately 20-foot portion of the guy wire that Edison removed from the incident location on December 6, 2017. One side of the automatic dead-end tapered cartridge was fastened to one end of the guy wire with tape. The ring-end portion of the broken automatic dead-end tapered cartridge that Edison found next to the pole is shown positioned on the wire in Figure 13 as it was configured in service.

Figure 13: Both pieces of the broken dead end assembly

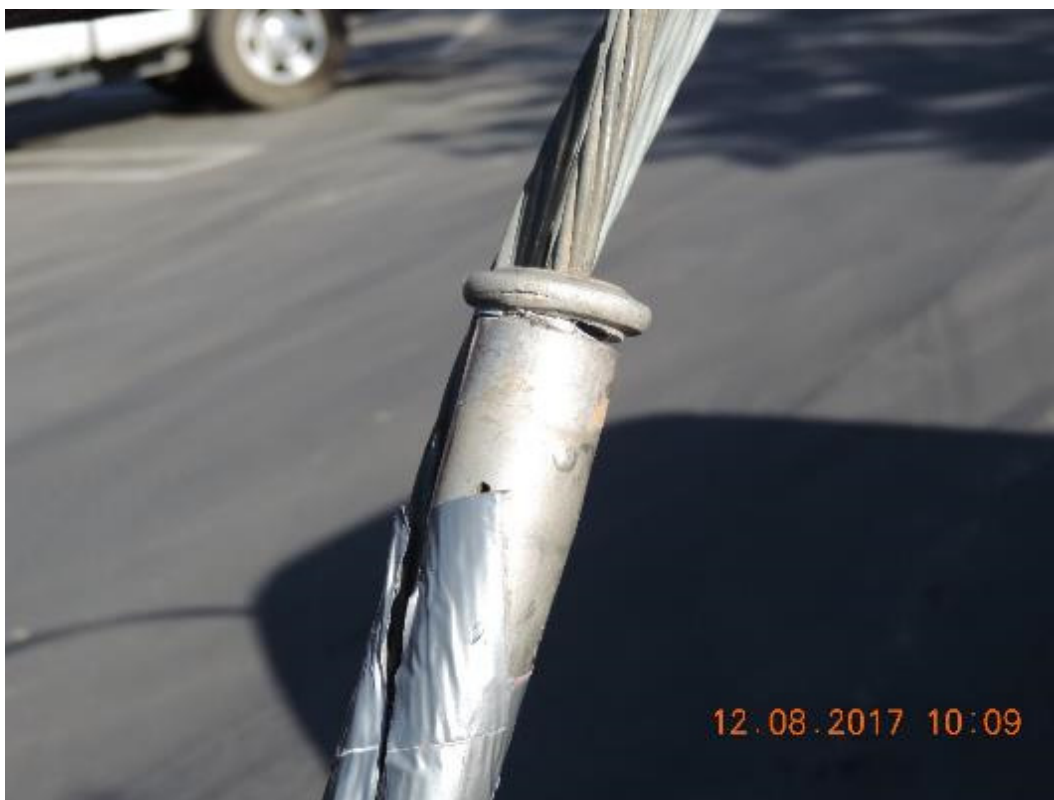
Figure 14: In-service configuration of the two pieces of the broken dead end support.

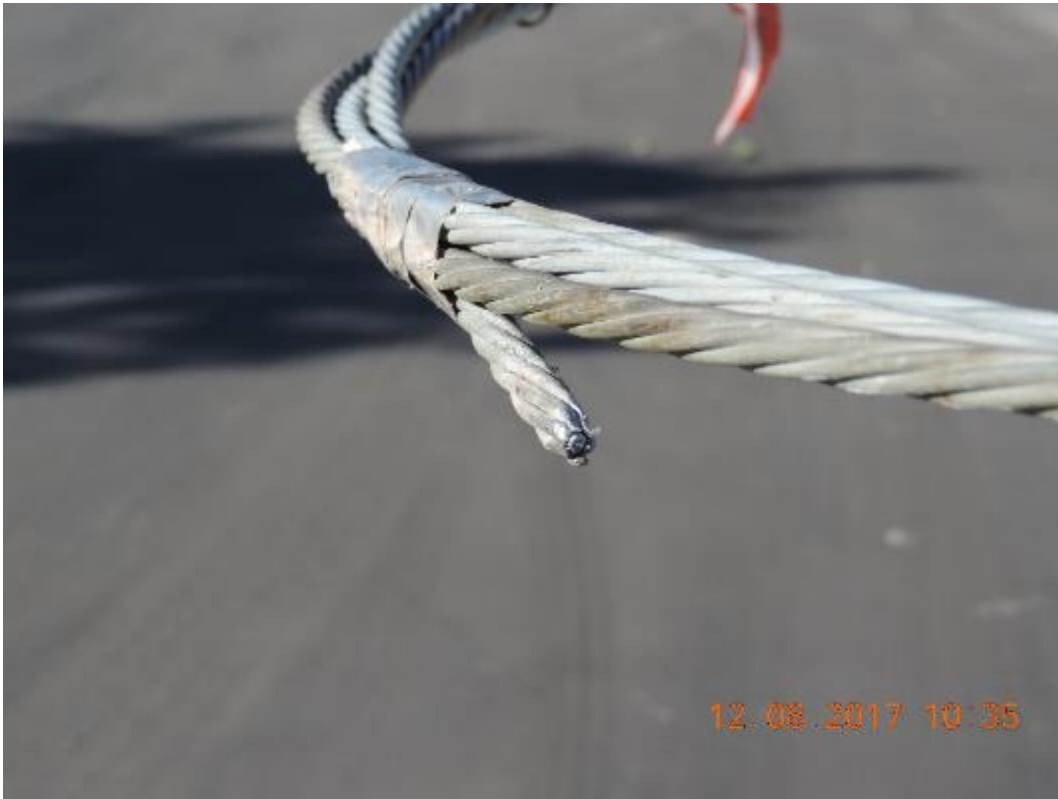
Figure 15: Broken end of 20-foot portion of guy wire
