**INVESTIGATION REPORT
OF THE DECEMBER 5, 2017 WILDFIRE
IN SANTA CLARITA, CALIFORNIA
INVOLVING SOUTHERN CALIFORNIA EDISON FACILITIES
THAT CAME TO BE KNOWN AS THE RYE FIRE**

**SAFETY AND ENFORCEMENT DIVISION
ELECTRIC SAFETY AND RELIABILITY BRANCH
LOS ANGELES**

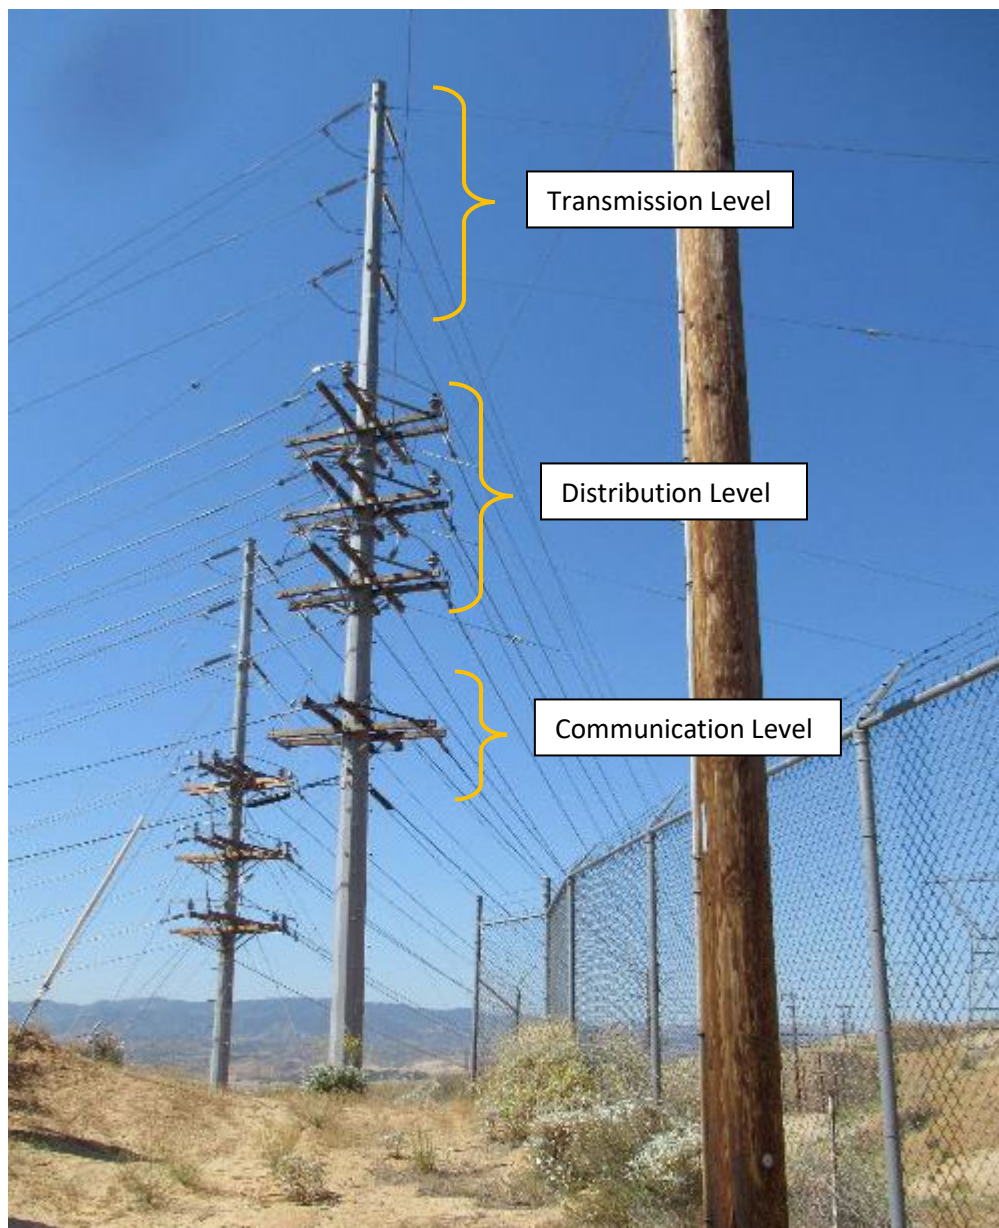
The section of the Nighthawk 16 kV circuit involved in the Rye Fire incident included pole 4389254E, a steel pole supporting three circuits and one communication line. Pole number 4389254E was a 75-foot steel pole with eleven (11) guy wires in total supporting the distribution and transmission level circuits as seen in Figure 3.¹²

Figure 3: Pole 4389254E

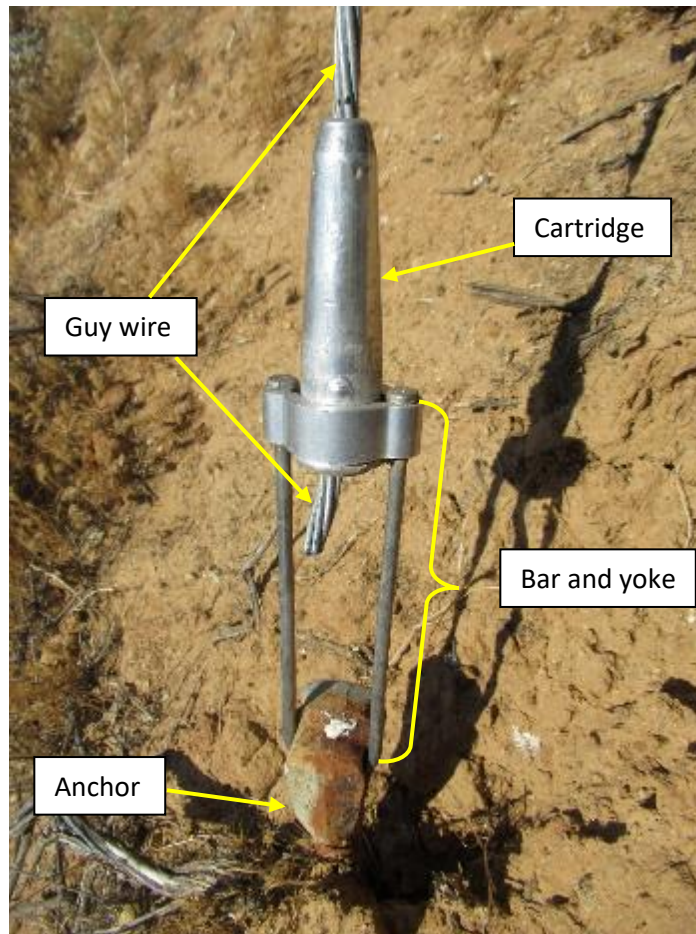
Pole 4389254E, the failed guy wire automatic dead end assembly, and the associated guy wire were all installed in 1999.¹³ The automatic dead end assembly consists of an anchor secured to the ground, a tapered cartridge, and a bar and yoke system that connects the automatic dead end tapered cartridge to the anchor. Figure 4 shows the new automatic dead end assembly which is the same make and model as the previous automatic dead end assembly.

Figure 4: Like-for-like replacement of failed automatic dead end assembly at pole 4389254E.

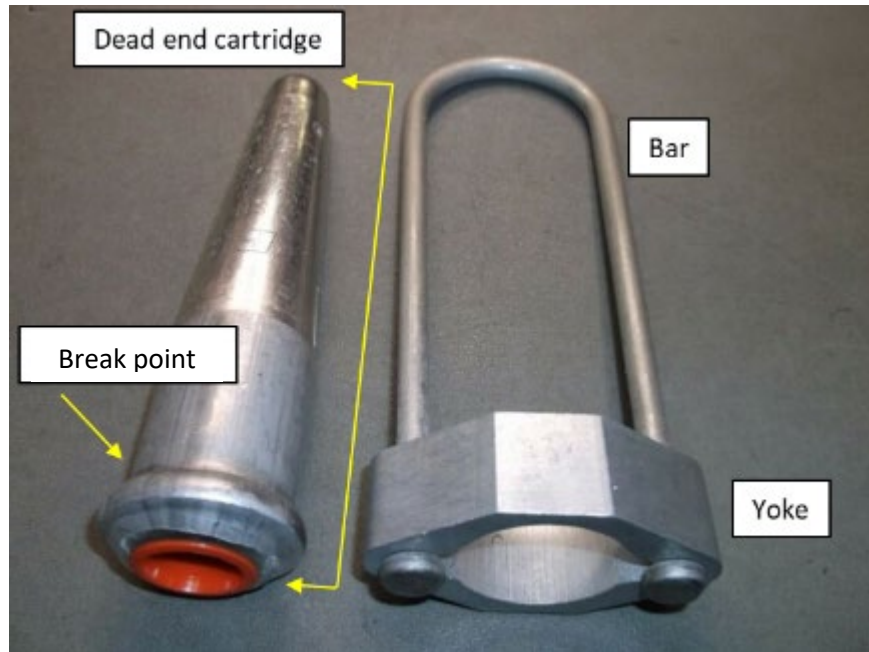
Figure 5: Automatic dead end showing point of failure, not an exact replica of the Edison automatic dead end

SED examined the failed automatic dead end assembly and found that the ring-end section of the tapered cartridge had broken off. This section is normally held in tension against the yoke. The automatic dead end assembly was manufactured by Reliable Power Products.^{14,15} The automatic dead-end assembly was rated to support a maximum tensile force of 10,350 pounds.¹⁶ The guy wire associated with the failed dead end was a 3/8 inch stranded zinc-coated steel wire and was rated to support a maximum tensile force of 15,400 pounds.^{17,18} Edison installed the guy wire to support 6,839 pounds of tension on pole 4389254E.¹⁹ LACFD collected the guy wire as evidence. Edison stated that it was unable to provide the manufacturer of the stranded guy wire because it had not examined the guy wire.²⁰

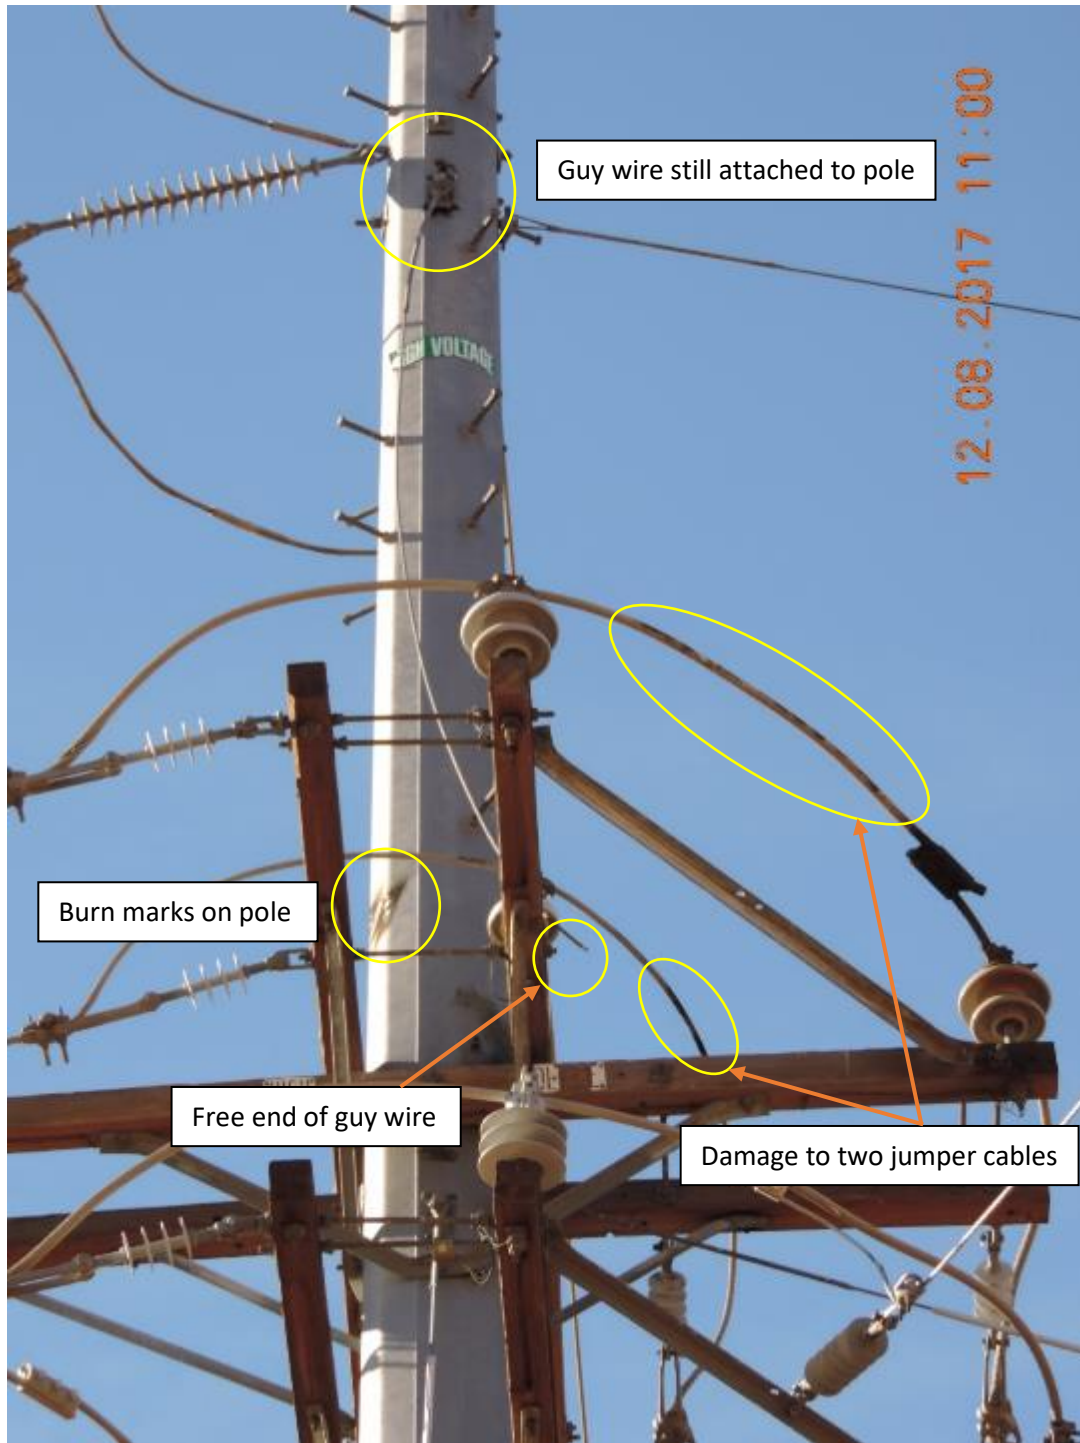
During a site visit to Rye Canyon Loop on December 8, 2017, SED investigators observed that two jumper wires on the distribution level of pole 4389254E exhibited burn marks, as did a portion of the steel pole directly above the jumper cables. An approximately 12-foot portion of a guy wire was still attached to pole 4389254E at the transmission level and was hanging down to the distribution level and was resting on a crossarm. The broken end of the guy wire showed signs of burning. LACFD had already collected and removed the remaining approximately 20-foot portion of the guy wire that Edison initially found on the ground from the incident location. Edison collected the bar and yoke component of the anchor rod that supported the failed guy support. The preserved evidence in Edison's possession is being held in Edison's Rosemead office.³³

Figure 6: Pole 4389254E before evidence was removed.

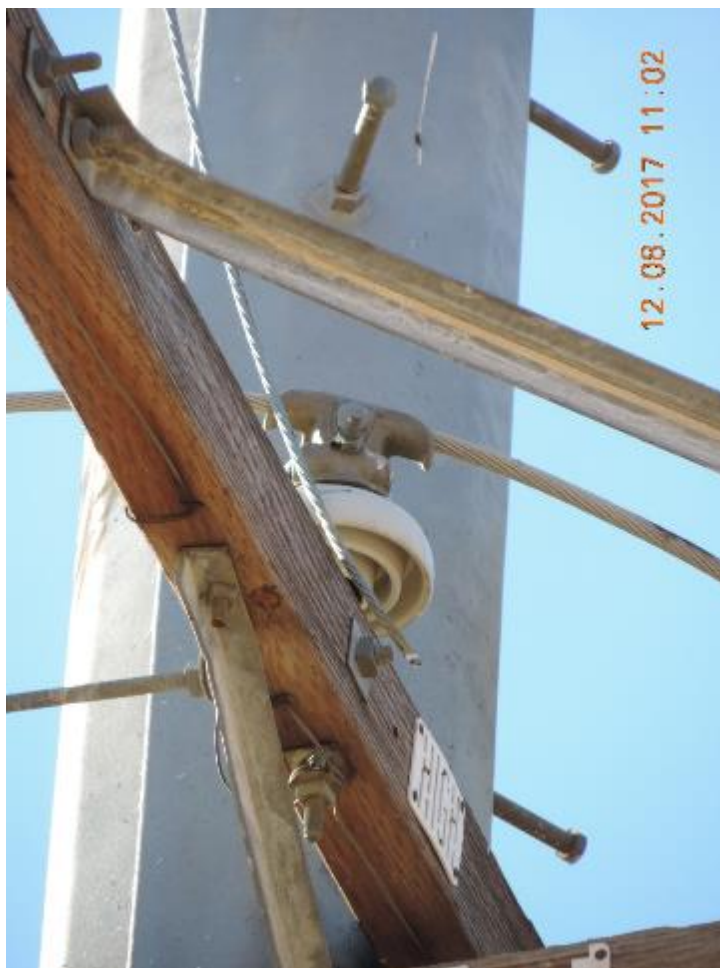
Figure 7: Free end of guy wire resting on a distribution level crossarm before evidence was removed

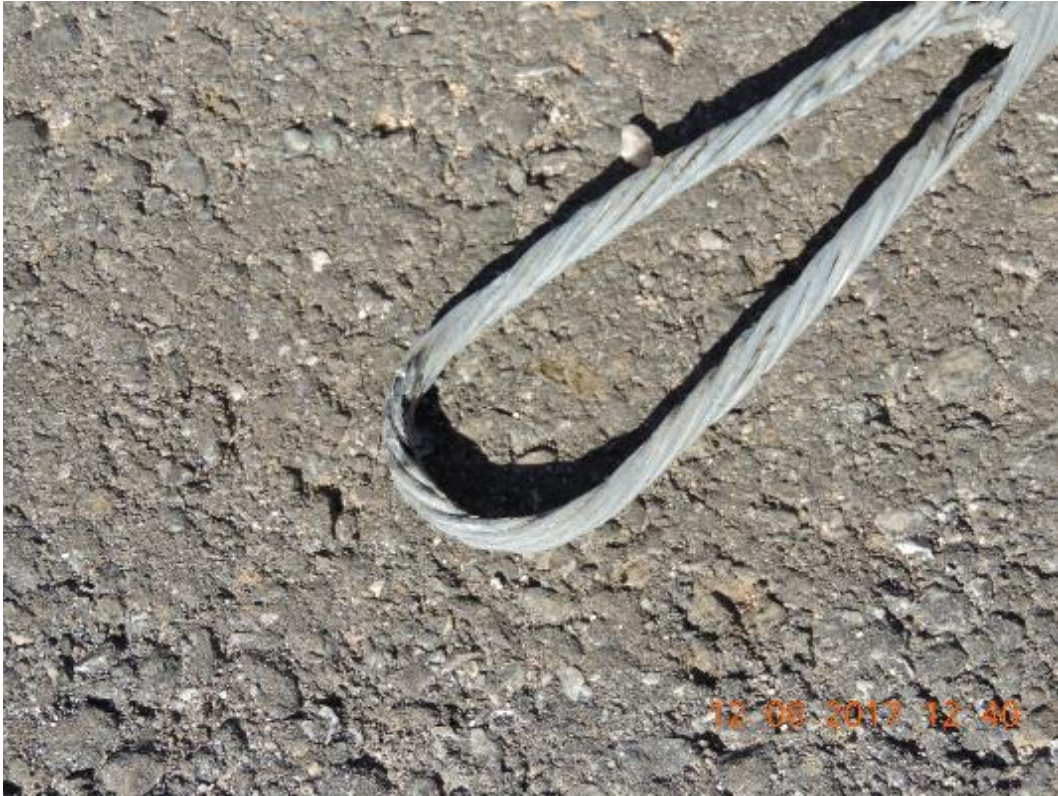
SED investigators examined the guy wire sections collected by LACFD. The approximately 12-foot section of the guy wire exhibited multiple burn marks along the length of the wire. The free end of the guy wire that LACFD found resting on a distribution level crossarm is depicted above in Figure 7. The end of the guy wire exhibited burn marks and loss of material.

Figure 8: Loop on the approximately 12-foot section of guy wire found hanging from pole 4389254E

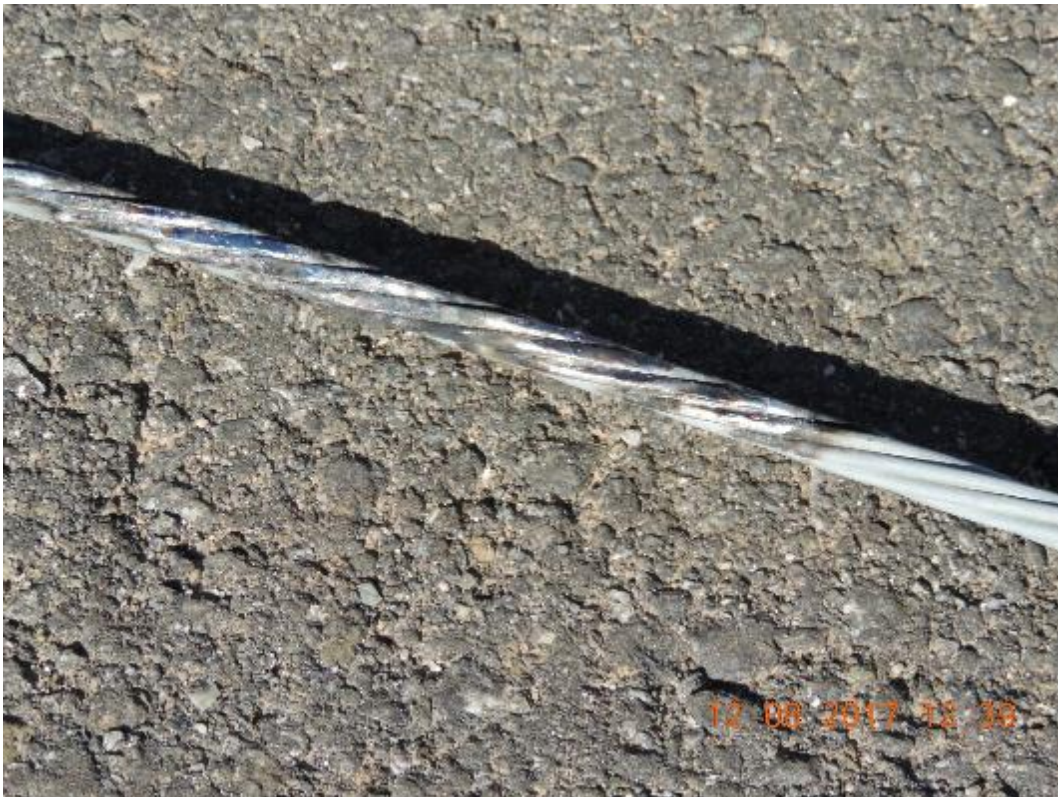
Figure 9: Damage along the approximately 12-foot section of guy wire.

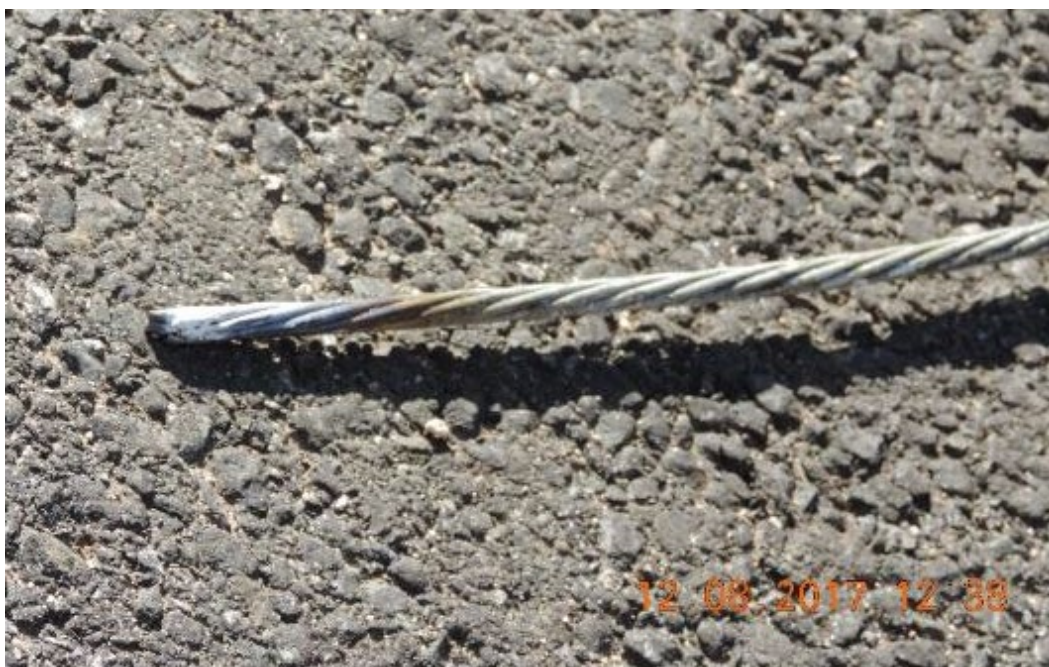
Figure 10: Free end of the approximately 12-foot section of the guy wire found hanging from pole 4389254E

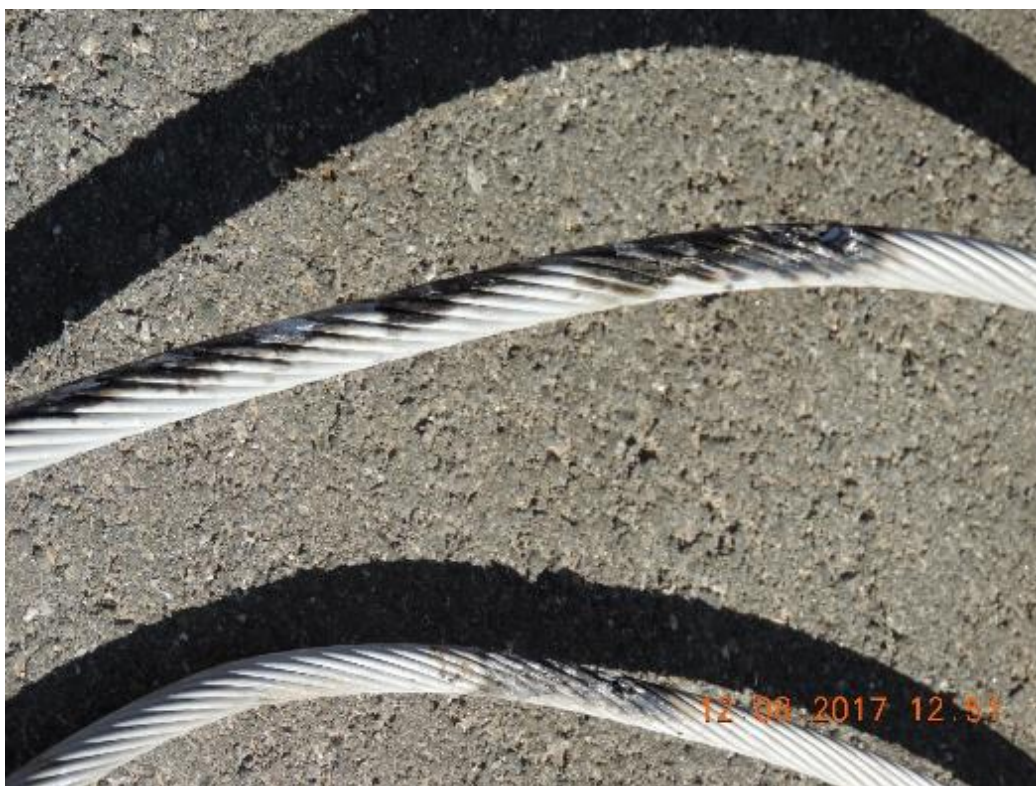
The two jumper lines that LACFD collected exhibited similar burn marks. These are depicted in Figure 11. Figure 12 depicts one example of the melting and loss of material observed on both wires, indicative of arcing due to contact.

Figure 11: Two jumper wires from pole 4389254E exhibit burns and loss of material.

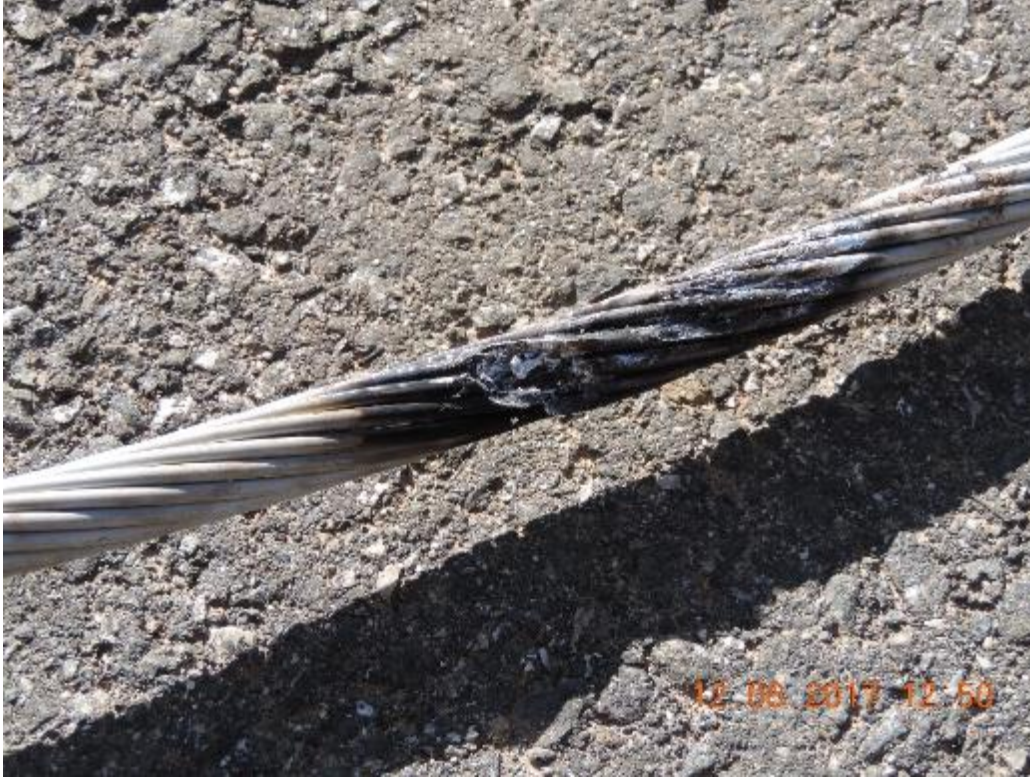
Figure 12: Loss of material on a jumper wire from pole 4389254E.

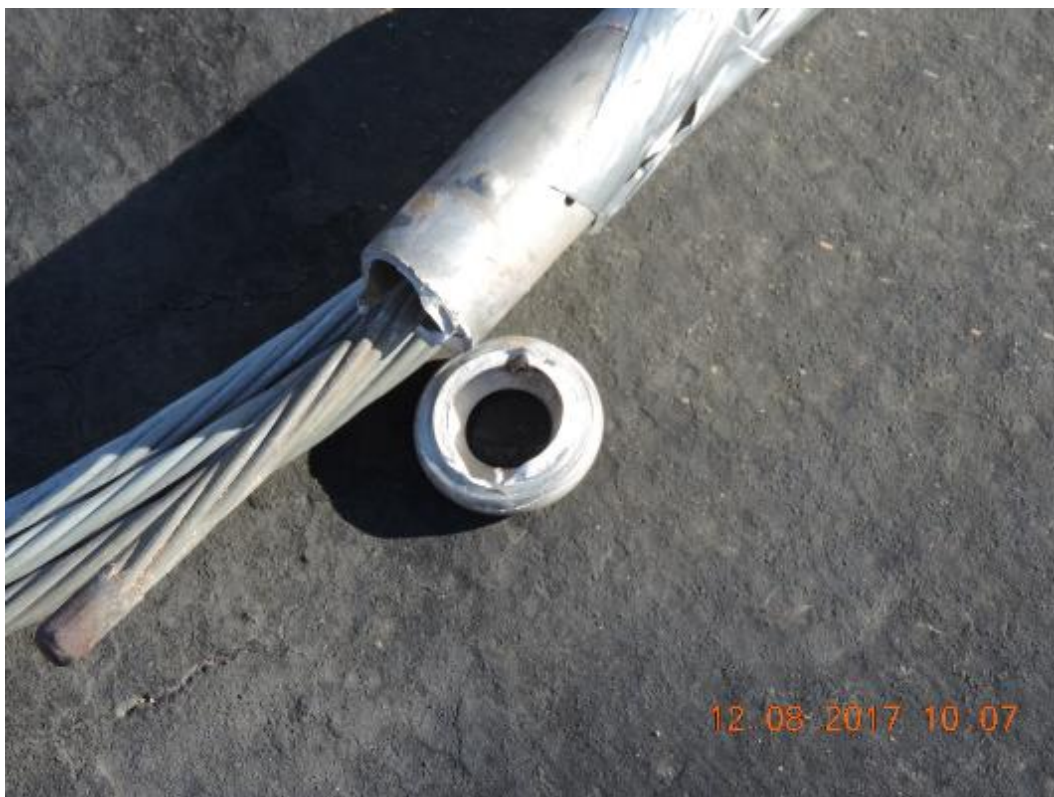
SED investigators also examined the approximately 20-foot portion of the guy wire that Edison removed from the incident location on December 6, 2017. One side of the automatic dead-end tapered cartridge was fastened to one end of the guy wire with tape. The ring-end portion of the broken automatic dead-end tapered cartridge that Edison found next to the pole is shown positioned on the wire in Figure 13 as it was configured in service.

Figure 13: Both pieces of the broken dead end assembly

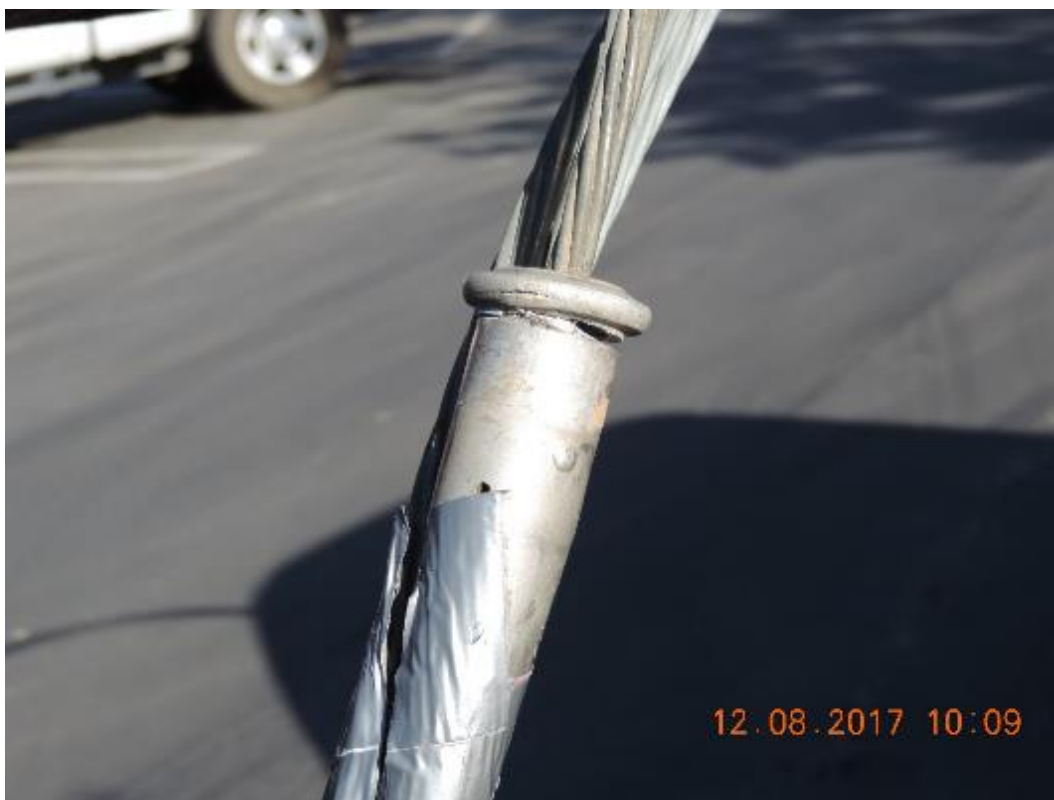
Figure 14: In-service configuration of the two pieces of the broken dead end support.

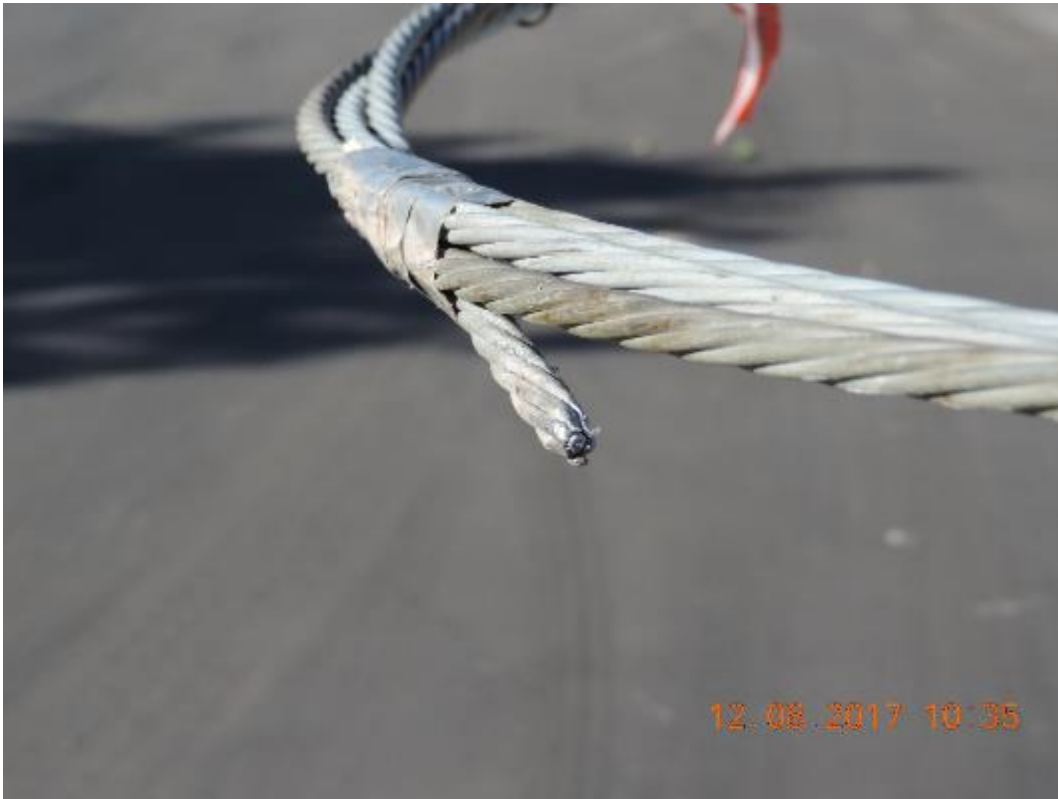
Figure 15: Broken end of 20-foot portion of guy wire
