**INVESTIGATION REPORT
OF THE DECEMBER 4, 2017 WILDFIRE
IN SANTA PAULA, CALIFORNIA
INVOLVING SOUTHERN CALIFORNIA EDISON FACILITIES
THAT CAME TO BE KNOWN AS THE THOMAS FIRE**

**SAFETY AND ENFORCEMENT DIVISION
ELECTRIC SAFETY AND RELIABILITY BRANCH
LOS ANGELES**

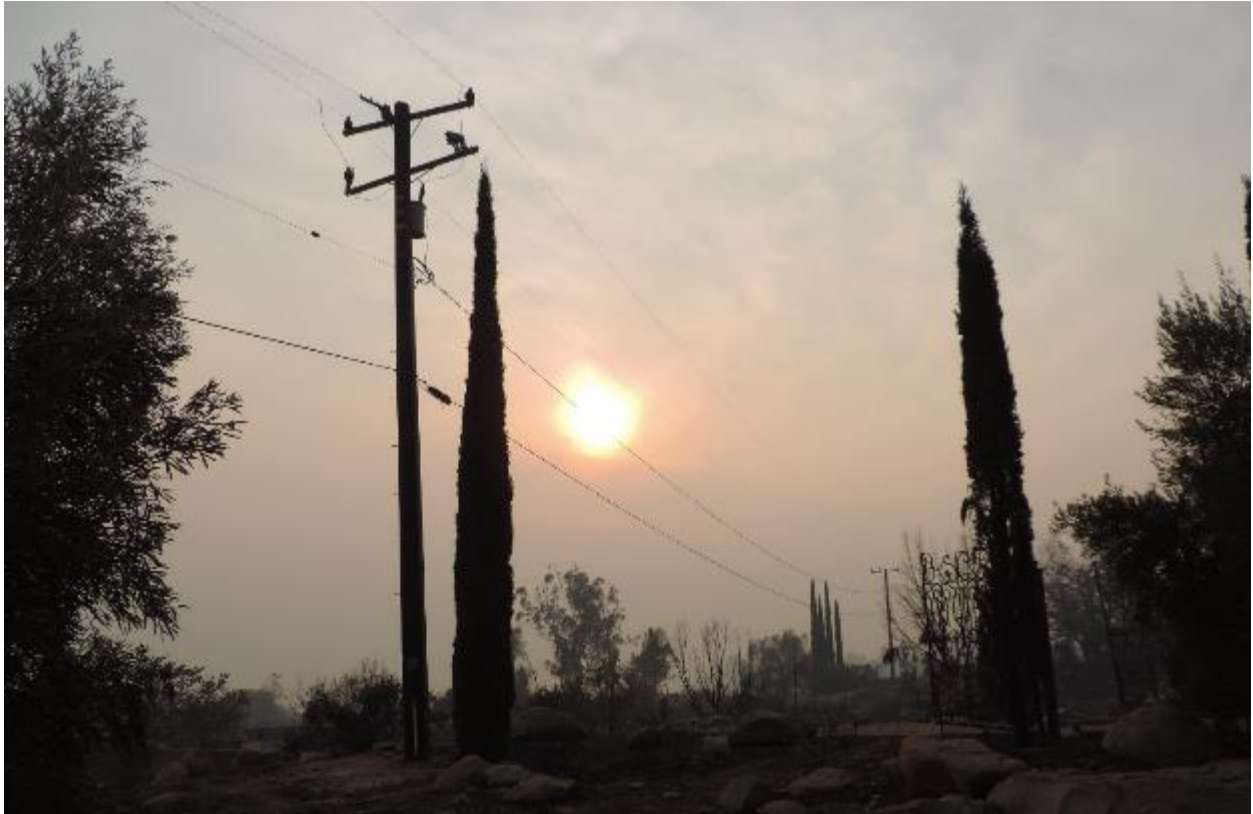
Site photos depict the Koenigstein ignition site, pole 729566E, and pole 729565E. The primary conductor failed towards the 729566E side of the span and remained attached on the 729565E side.

Figure 2: SED photo Koenigstein site, 729566E at the fore, 729565E at the rear.

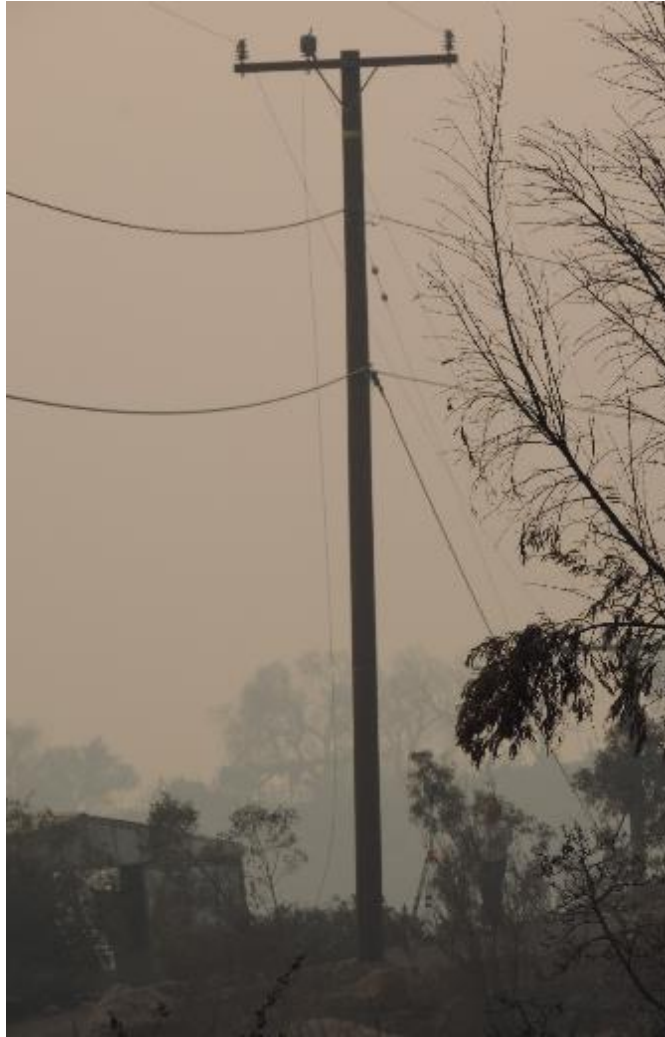
Upon surveying the Koenigstein site, SED investigators observed one end of the center conductor laying on the ground between poles numbered 729565E and 729566E. Multiple points along the conductor were frayed out but remained unbroken, commonly referred to as bird caging. Sections of the conductor were also blackened or charred. It was not apparent whether the discoloration on the conductor was due to an electrical event that occurred on the circuit or due to the fire. The bird caging, damaged conductor end, faults noted on the circuit (as described earlier in this report), and witness statements are all consistent with a failed conductor leading to a ground fault, fire, and circuit interruption on Edison's Castro 16 kV circuit downstream of RAR 0179.

Figure 3: SED photo of Koenigstein site, 729565E with center primary conductor laying on the ground.

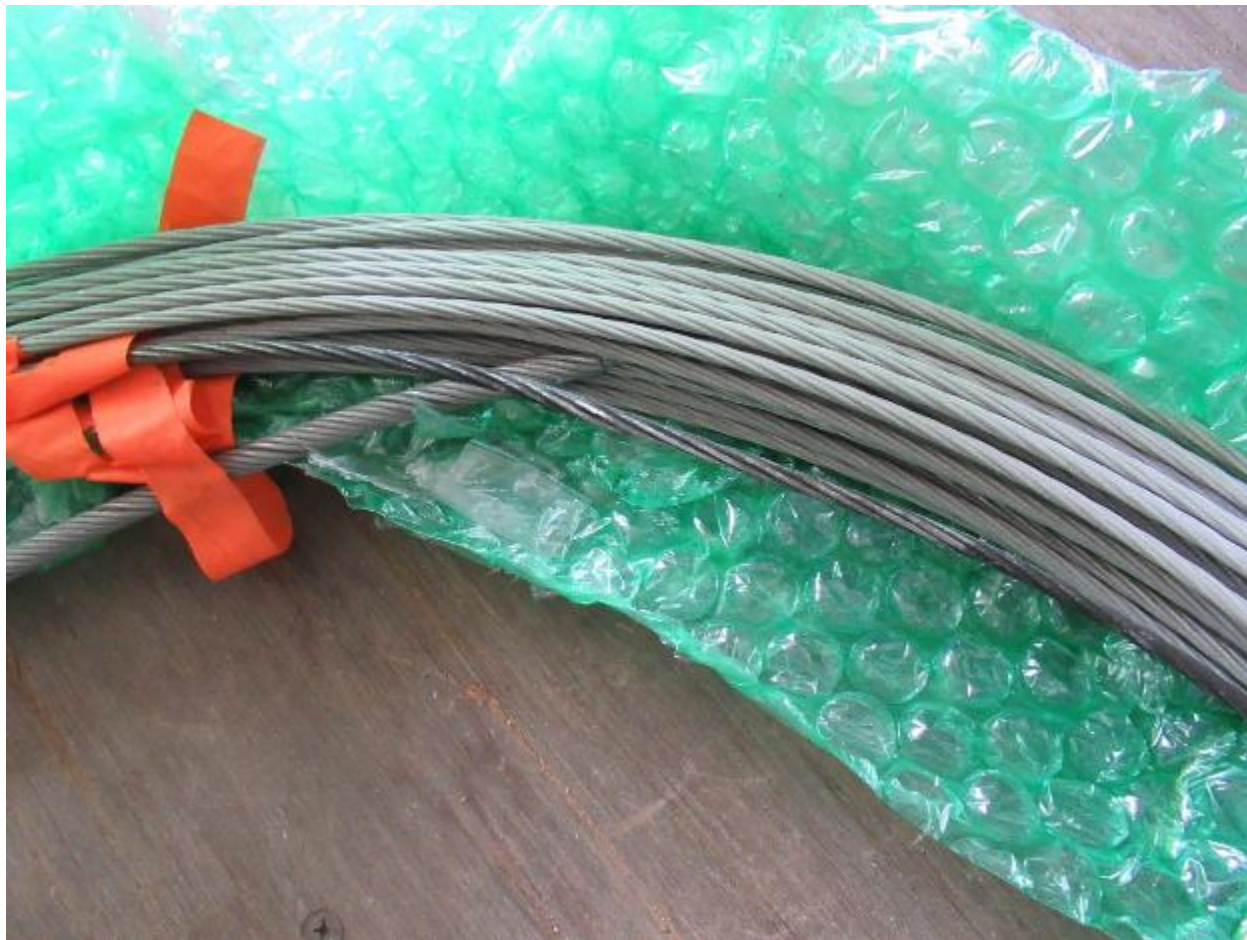
Figure 13: SED photo of February 2017 Anlauf Canyon evidence examination, damage on the east conductor between poles numbered 1025341E and 3002114E.

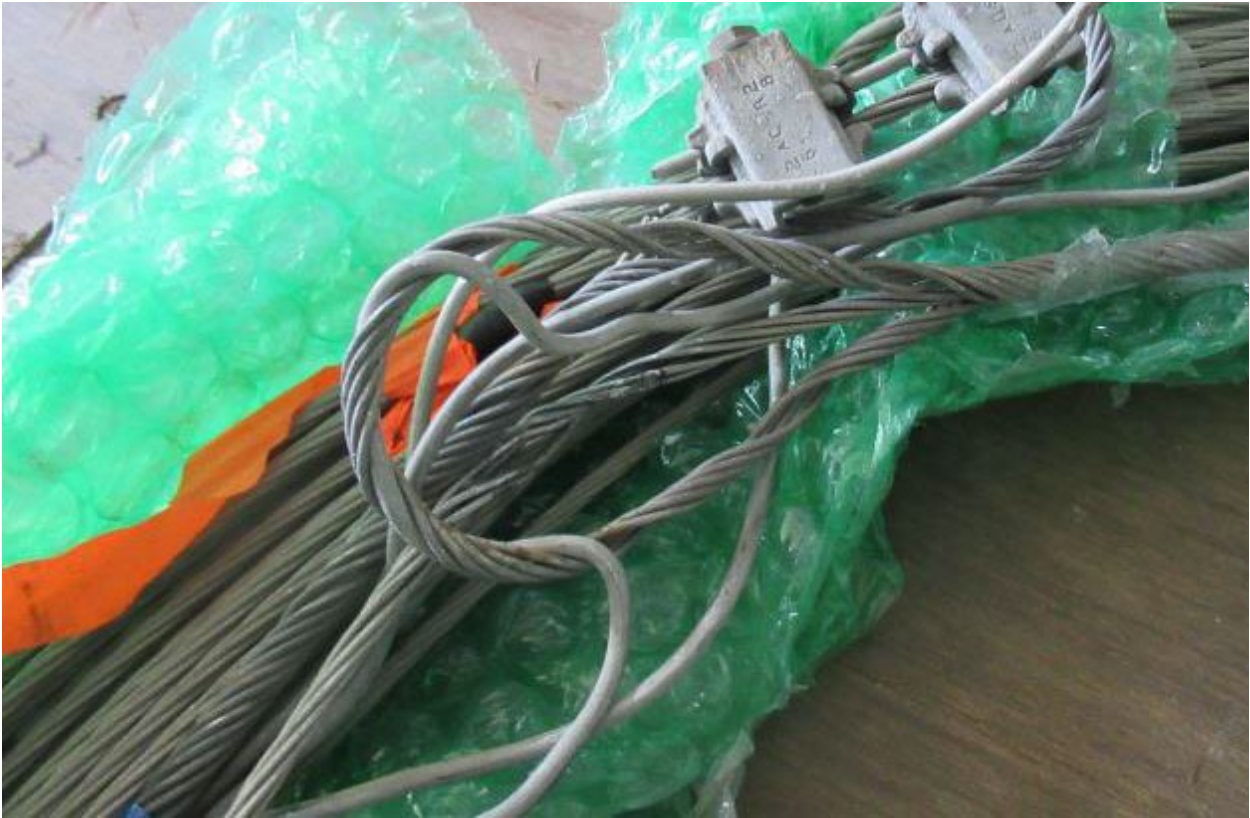
Figure 14: SED photo of February 2017 Anlauf Canyon evidence examination, arc marks and bird-caging on the east conductor between poles numbered 1025341E and 3002114E.

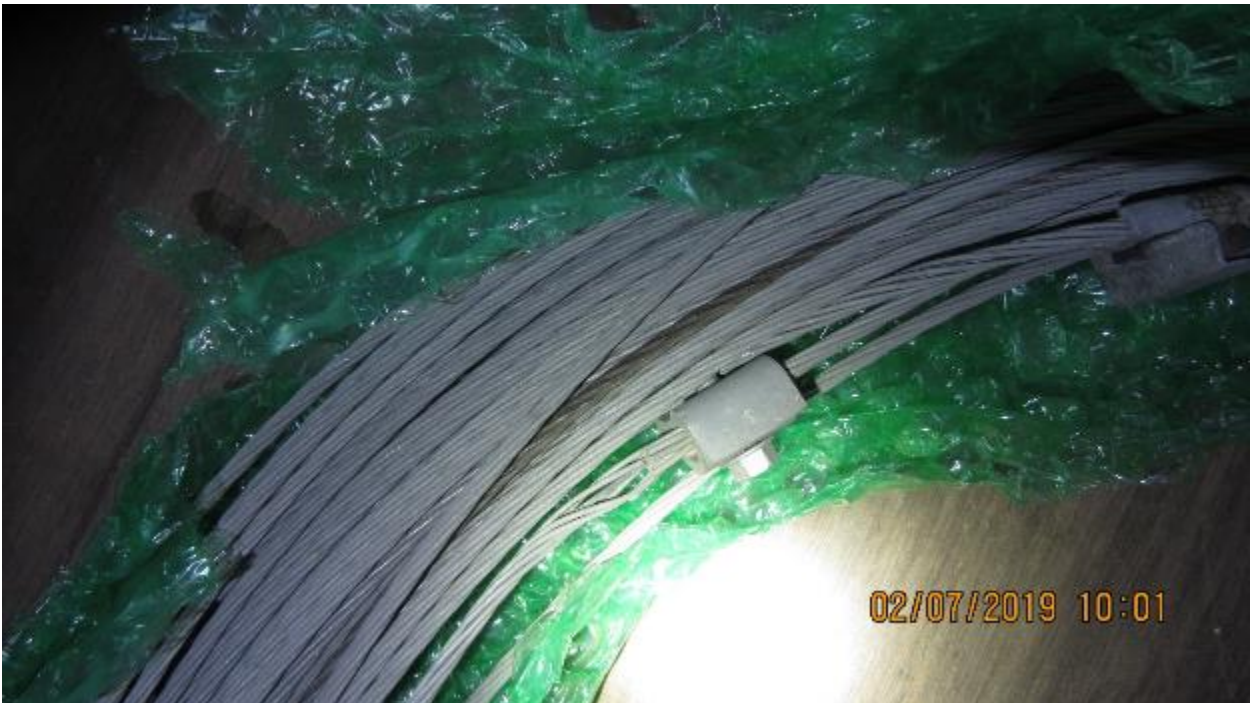
Figure 15: SED photo of February 2017 Anlauf Canyon evidence examination, burn marks and broken strands on center conductor between poles numbered 1025341E and 3002114E.
