**INVESTIGATION REPORT  
OF THE DECEMBER 4, 2017 WILDFIRE  
IN SANTA PAULA, CALIFORNIA  
INVOLVING SOUTHERN CALIFORNIA EDISON FACILITIES  
THAT CAME TO BE KNOWN AS THE THOMAS FIRE**

**SAFETY AND ENFORCEMENT DIVISION  
ELECTRIC SAFETY AND RELIABILITY BRANCH  
LOS ANGELES**

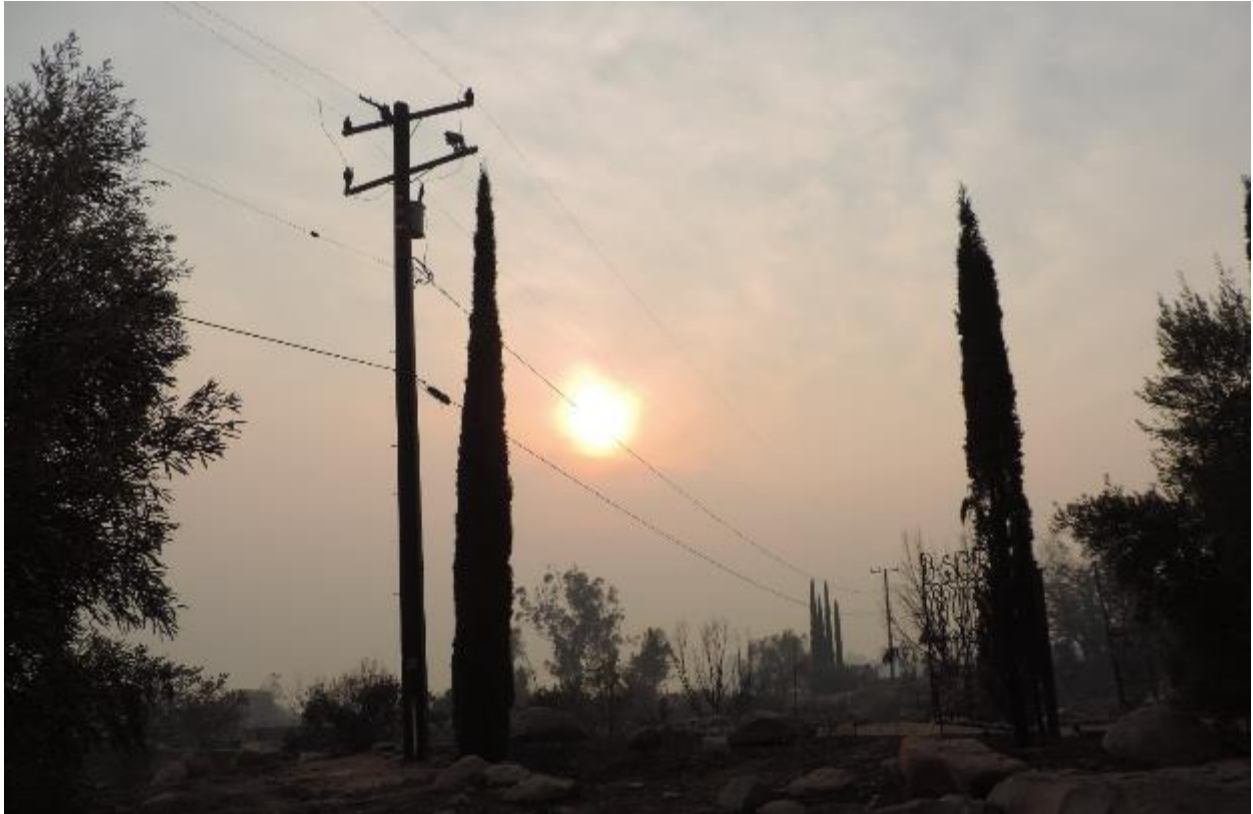
Site photos depict the Koenigstein ignition site, pole 729566E, and pole 729565E. The primary conductor failed towards the 729566E side of the span and remained attached on the 729565E side.

*Figure 2: SED photo Koenigstein site, 729566E at the fore, 729565E at the rear.*

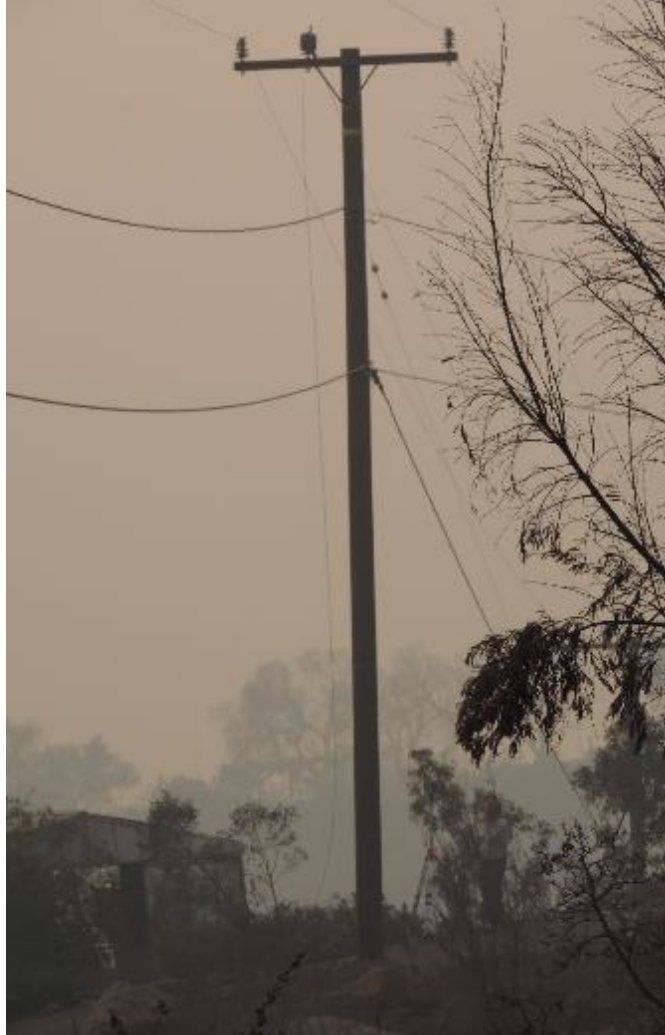
Upon surveying the Koenigstein site, SED investigators observed one end of the center conductor laying on the ground between poles numbered 729565E and 729566E. Multiple points along the conductor were frayed out but remained unbroken, commonly referred to as bird caging. Sections of the conductor were also blackened or charred. It was not apparent whether the discoloration on the conductor was due to an electrical event that occurred on the circuit or due to the fire. The bird caging, damaged conductor end, faults noted on the circuit (as described earlier in this report), and witness statements are all consistent with a failed conductor leading to a ground fault, fire, and circuit interruption on Edison's Castro 16 kV circuit downstream of RAR 0179.

*Figure 3: SED photo of Koenigstein site, 729565E with center primary conductor laying on the ground.*

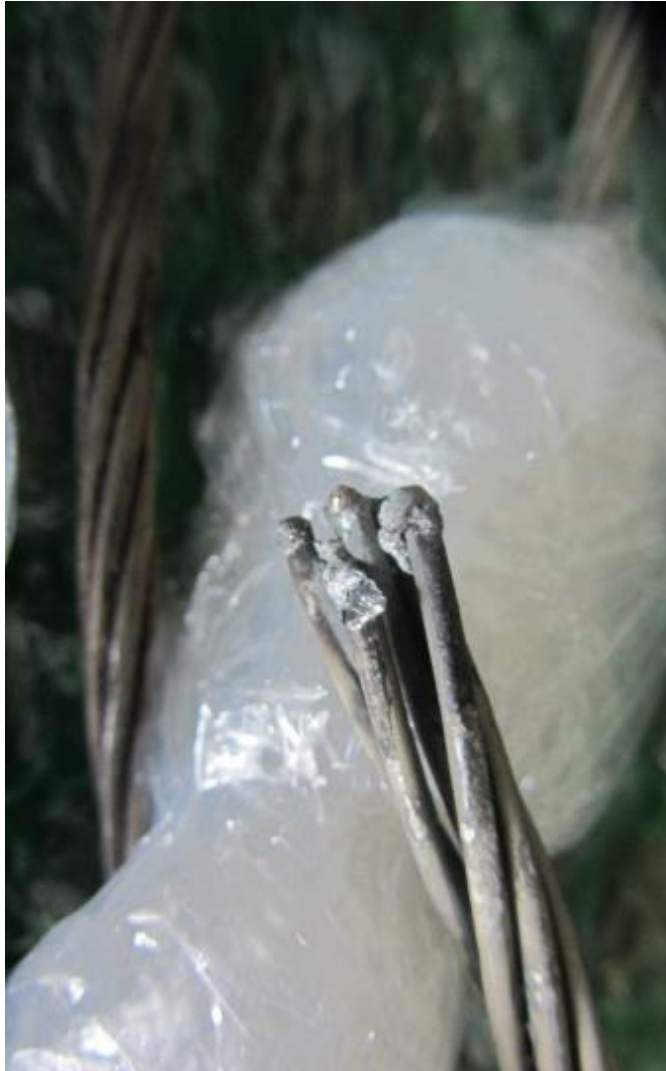
CAL FIRE removed and stored as evidence both ends of the center conductor running between poles numbered 729565E and 729566E. Depicted below in Figure 4 is one end of the failed conductor which appears charred, melted, and is missing material, thereby not appearing as a complete continuous conductor. The other end of the failed conductor shown in Figure 5, is hidden by multiple wraps of black electrical tape. At the time of SED's inspection of the failed conductor, CAL FIRE did not allow SED to remove the electrical tape and examine the other end of the failed conductor. If, at a later date, CAL FIRE conducts a controlled viewing of the end of the conductor covered in electrical tape, then SED investigators will document findings in an updated version of this report.

*Figure 4: SED photo of Koenigstein evidence, one end of failed conductor.*

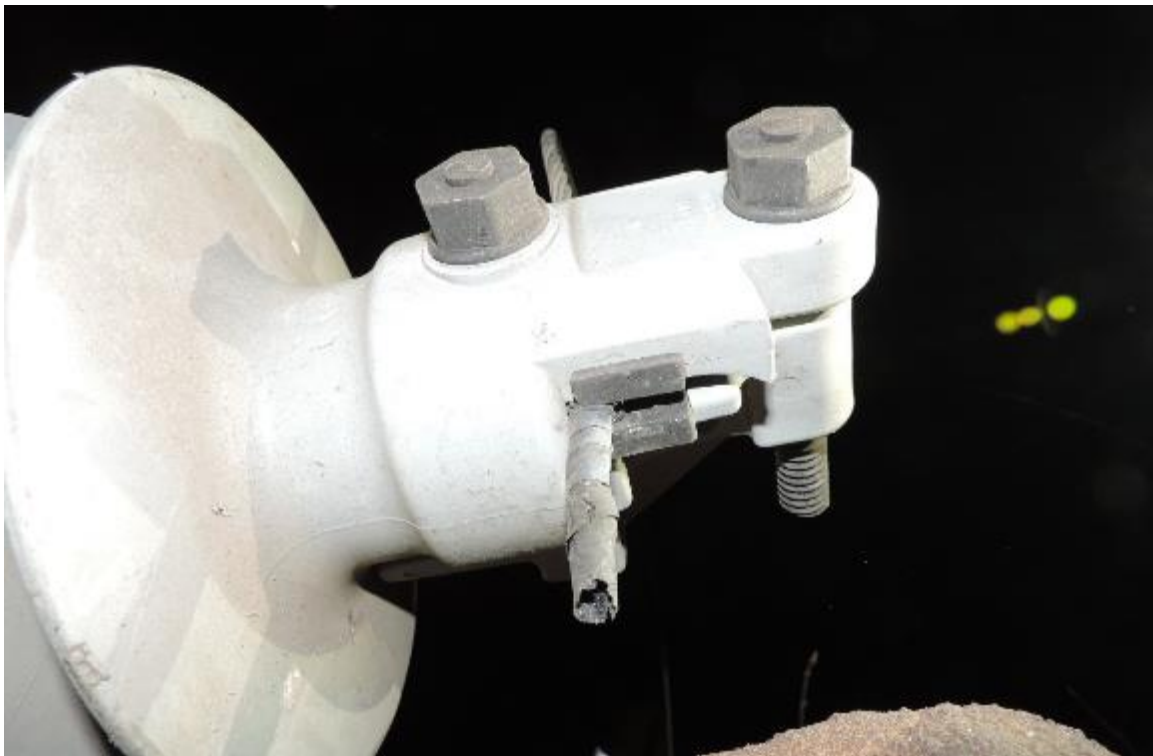
*Figure 5: SED photo of Koenigstein evidence, other end of failed conductor (covered with electrical tape) still attached in the vise of the insulator mounted to 729566E*

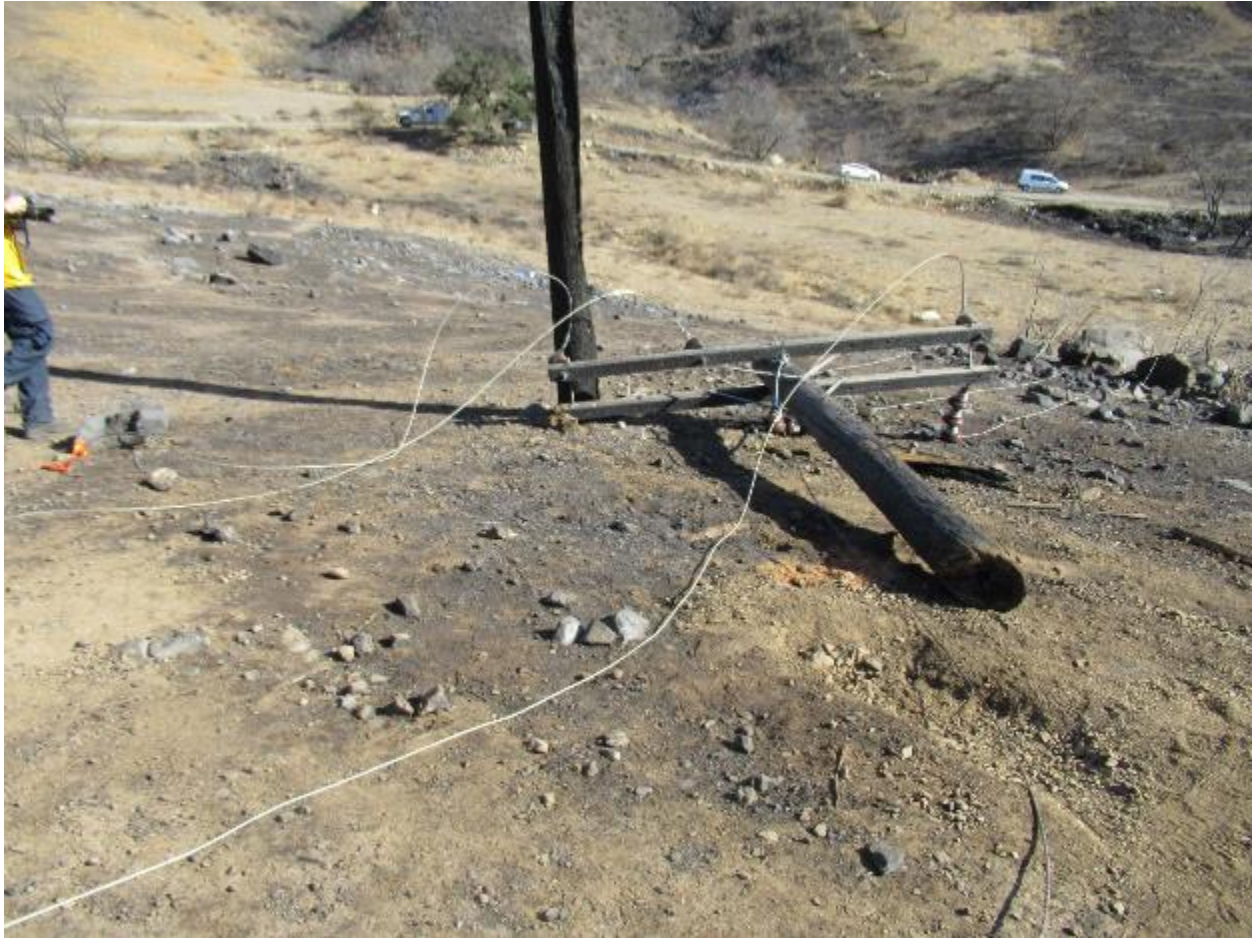
*Figure 7: SED photo of Anlauf Canyon site, the top of pole 1202085E removed by Edison.*

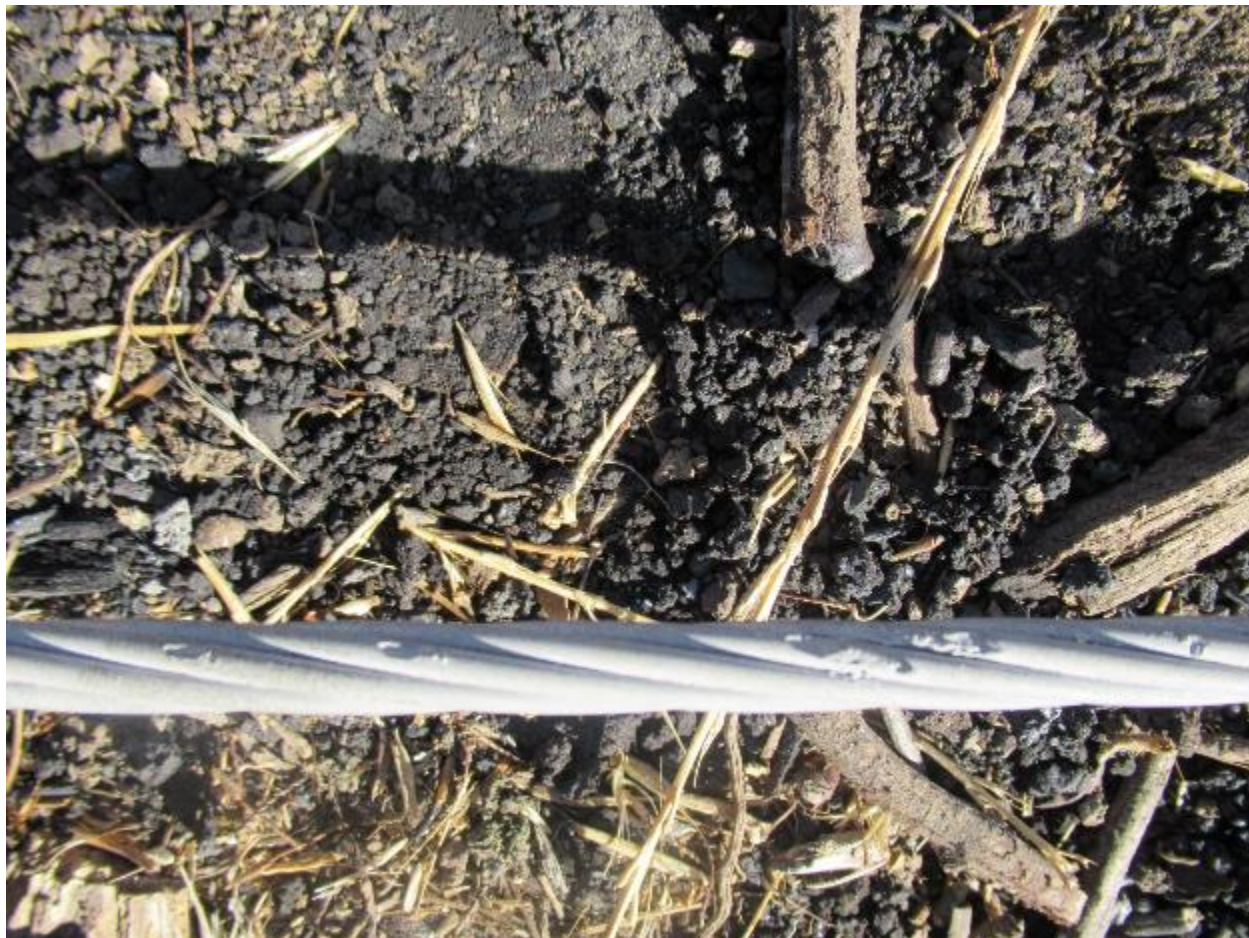
SED observed damage on the east and center conductors including burn marks, arc marks, and loss of material referred to as “pitting” as shown in the figures below. Pitting is an indicator that wire-slap has occurred; however, SED was unable to determine how recently these pitting marks were made. SED examined these same conductors at CAL FIRE’s Fresno facility on February 7, 2017, and found further evidence of damage, including broken strands and bird caging. However, CAL FIRE denied SED’s request to unravel the conductors to examine them more closely. Because SED could not unravel the conductors, SED was unable to take measurements to estimate the location of the damage on the conductors and review the relative locations of the observed damage along the conductors, which would have been useful to confirm whether the damage corresponded in location to similar damage on the adjacent conductor. Corresponding damage would support the conclusion that two or more conductors had made contact.

*Figure 10: SED photo of Anlauf Canyon site, pitting on the east conductor between poles numbered 3002114E and 1202085E.*

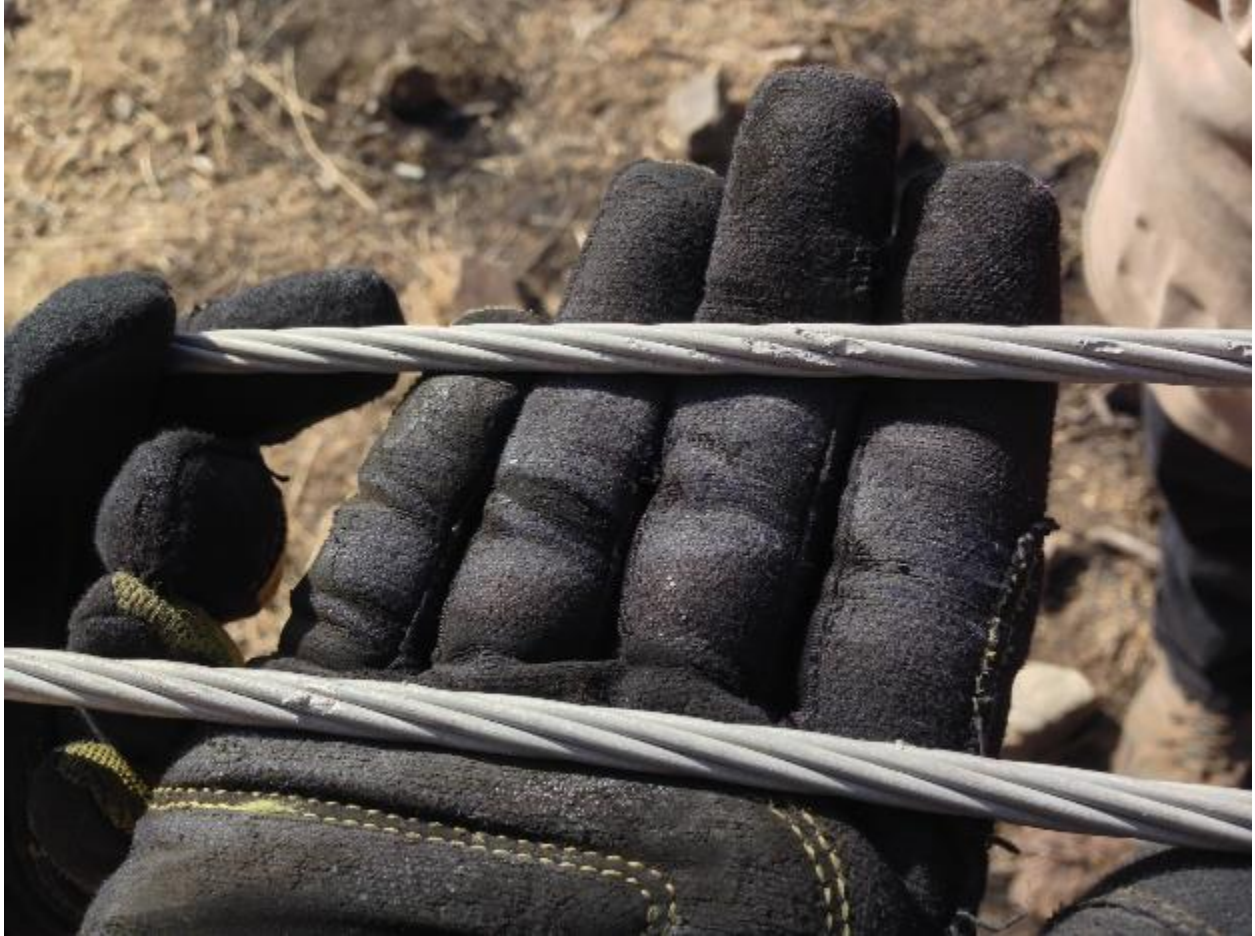
*Figure 11: Edison photograph depicting damage on two unidentified adjacent conductors between poles numbered 1025341E and 3002114E.<sup>62</sup>*

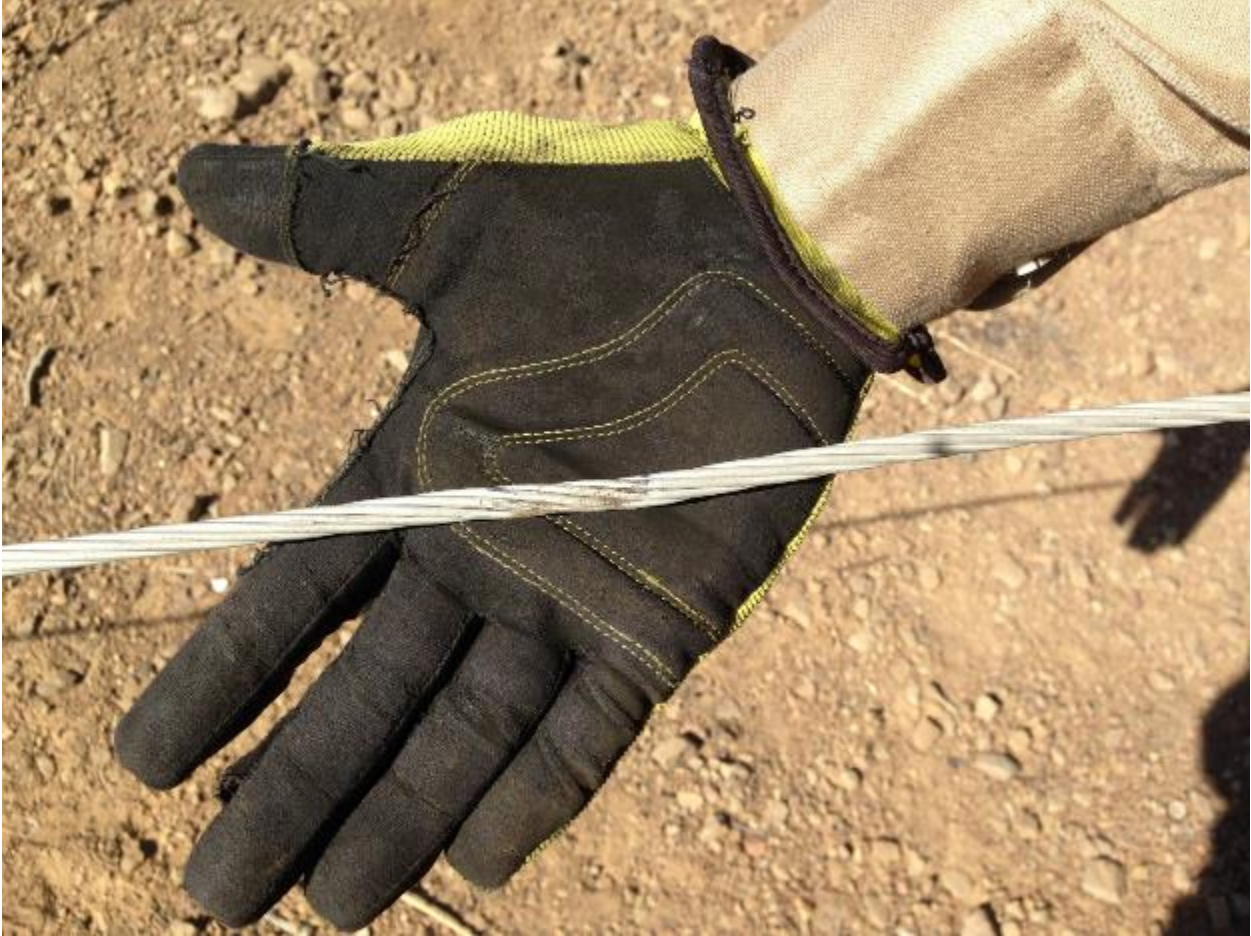
*Figure 12: Edison photograph depicting damage on the center conductor between poles numbered 1025341E and 1202085E.*<sup>63</sup>

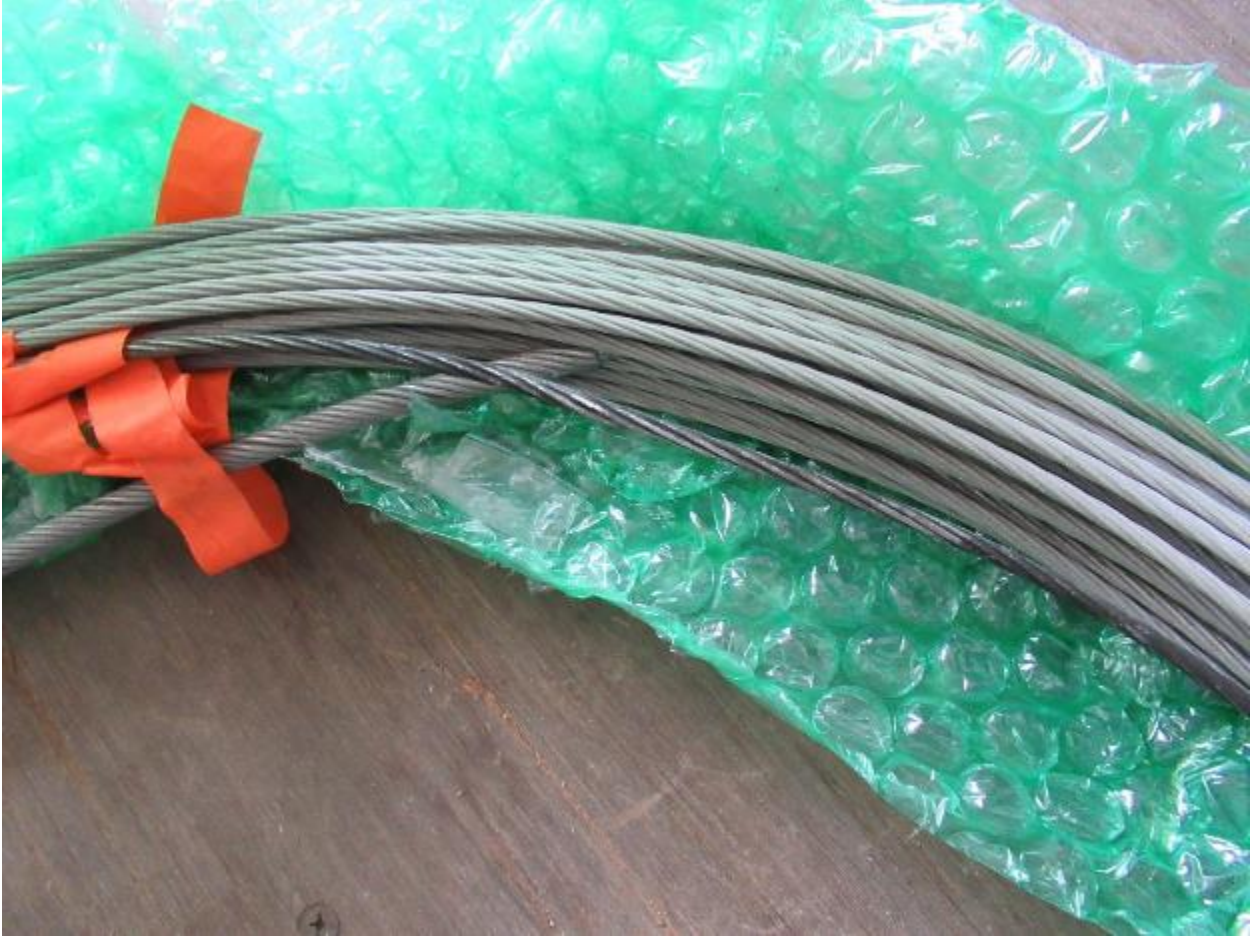
*Figure 13: SED photo of February 2017 Anlauf Canyon evidence examination, damage on the east conductor between poles numbered 1025341E and 3002114E.*

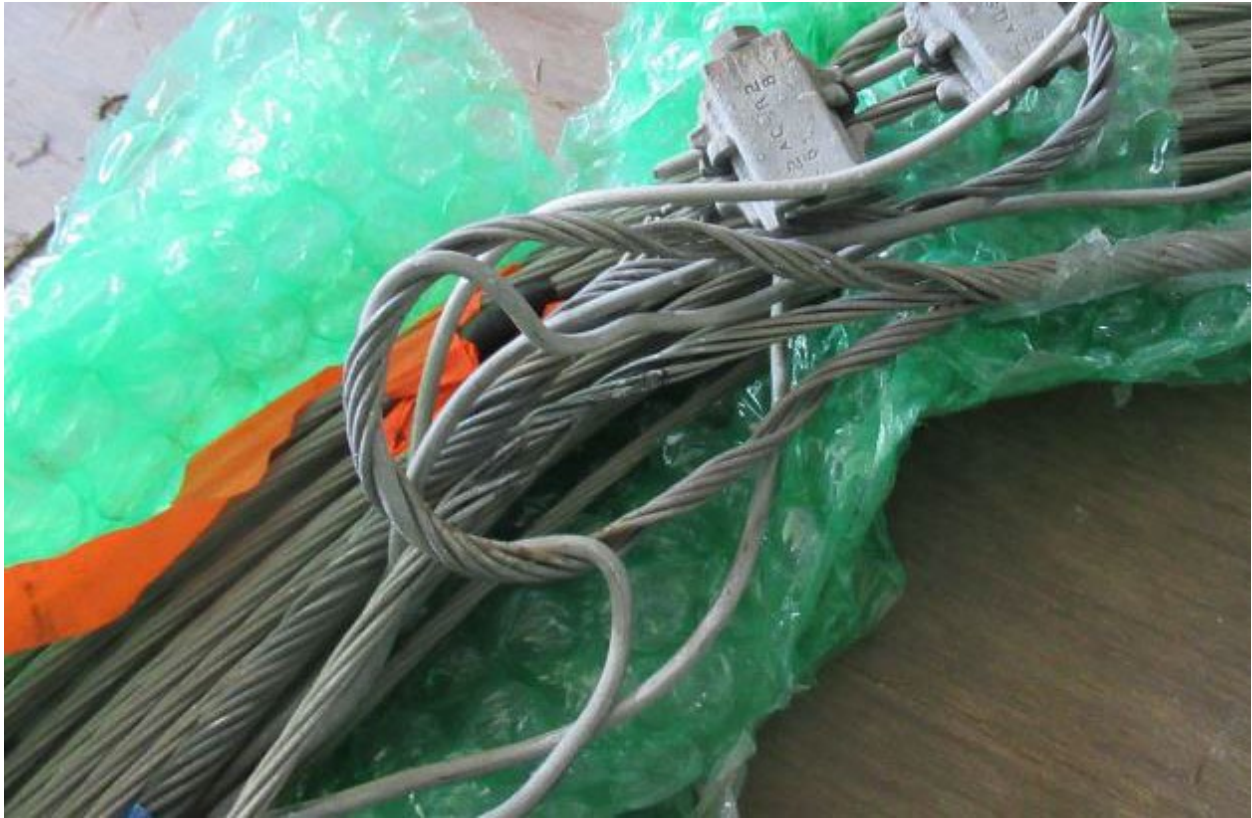
Figure 14: SED photo of February 2017 Anlauf Canyon evidence examination, arc marks and bird-caging on the east conductor between poles numbered 1025341E and 3002114E.
