INVESTIGATION REPORT OF THE WOOLSEY FIRE

**SAFETY AND ENFORCEMENT DIVISION
ELECTRIC SAFETY AND RELIABILITY BRANCH
LOS ANGELES**

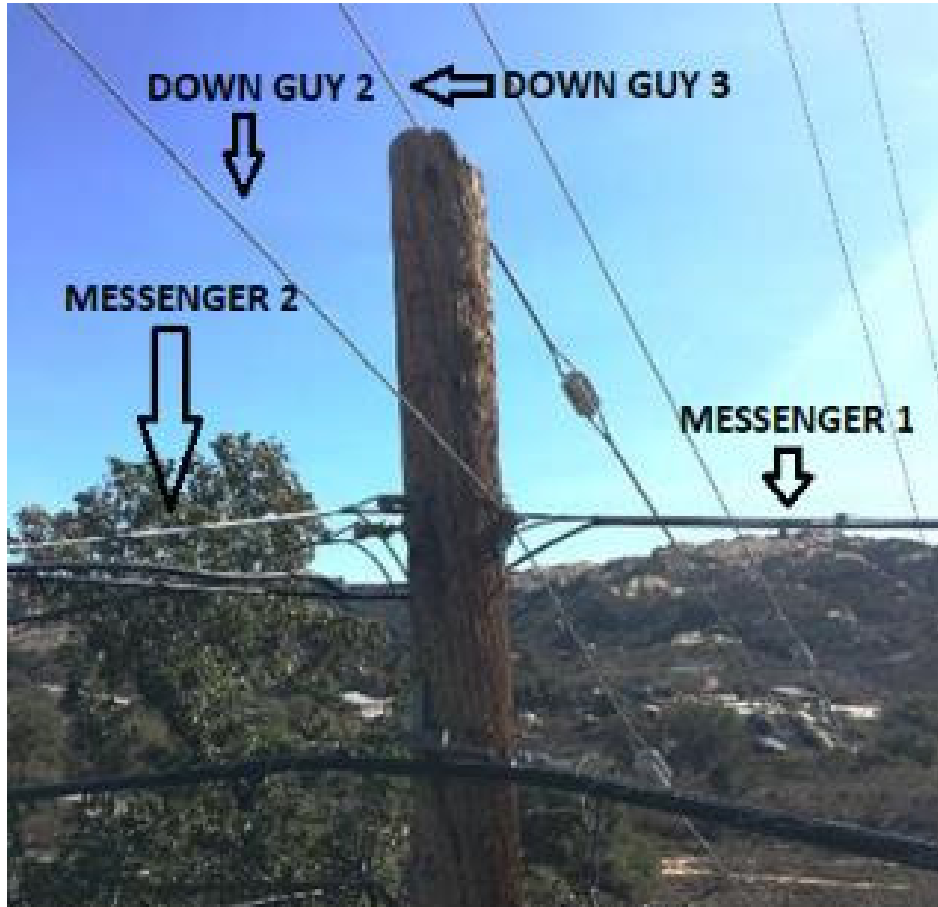
The Stubbed Pole supported communications conductors that ran to the north, east, and west. The communications conductors running east and west from the pole each had their own messenger wires which were connected together via a “through bolt”, a bolt that penetrated all the way through the pole horizontally. One of the northbound communications conductors also had a messenger wire (Messenger Wire 3, which was wrapped around the base of the Steel Pole), but this messenger wire was not electrically linked to the other two messenger wires on the Stubbed Pole. Messenger Wire 1 ran to the west, and Messenger Wire 2 ran to the east toward Site 1. Although the east-and-westbound messenger wires were separate and distinct, they were electrically connected by the through bolt they had in common. One of the loose down guy wires on the Steel Pole was in contact with Messenger Wire 1 at the time the incident occurred. See Figure 5.

Figure 5: The Stubbed Pole as viewed from the northwest. Note the loose down guy in contact with Messenger Wire 1.⁸

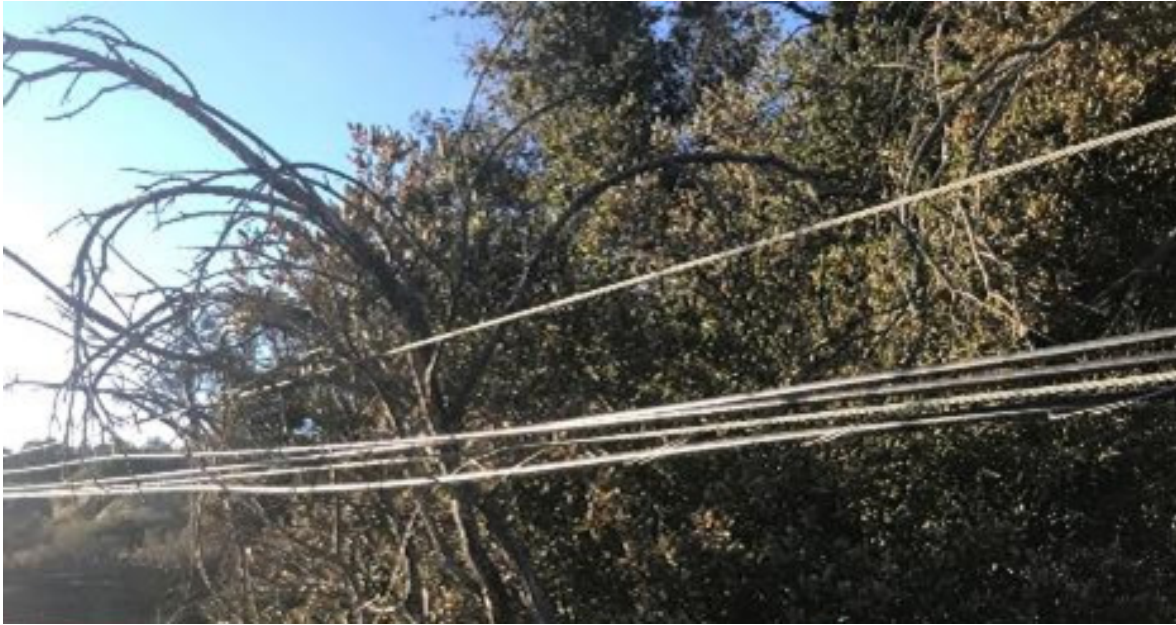
Figure 7: Overgrown tree branches pressing the ECS communications conductor into the third-party communications conductor at Site 1. The communications conductors separated from their messenger guys when their lashing wires melted during the arcing event.¹⁴

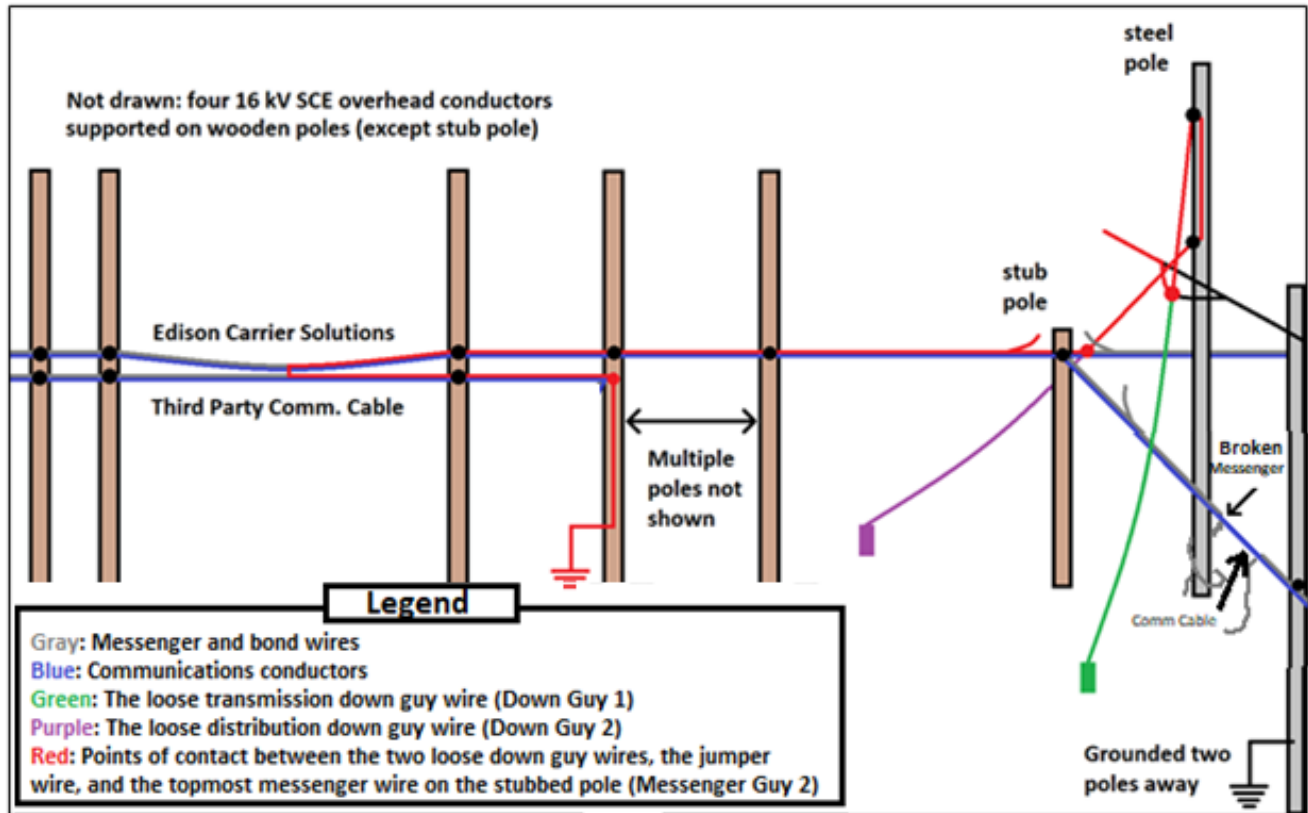
When Down Guy 1 contacted the jumper wire, it became energized, which caused the Steel Pole to become energized as well. As a result, a loose Edison distribution down guy wire (Down Guy 2) attached to the Steel Pole also became energized. Down Guy 2 was also in contact with an ECS messenger wire (Messenger Wire 1) via a steel through-bolt that was supported on the Stubbed Pole. This contact caused Messenger Wires 1 and 2 to become energized along with their respective lashing wires. See Figure 9.

Figure 9: Path of electrical current during the incident. The path of the electric current is represented in red. The loose transmission down guy wire in green made contact with the jumper wire on the Steel Pole, energizing the pole and all its attachments. The loose distribution down guy wire in purple made contact with the messenger wire on the Stubbed Pole. The eastbound messenger wire made contact with the grounded messenger and lashing wires of the third-party communications conductor at Site 1.

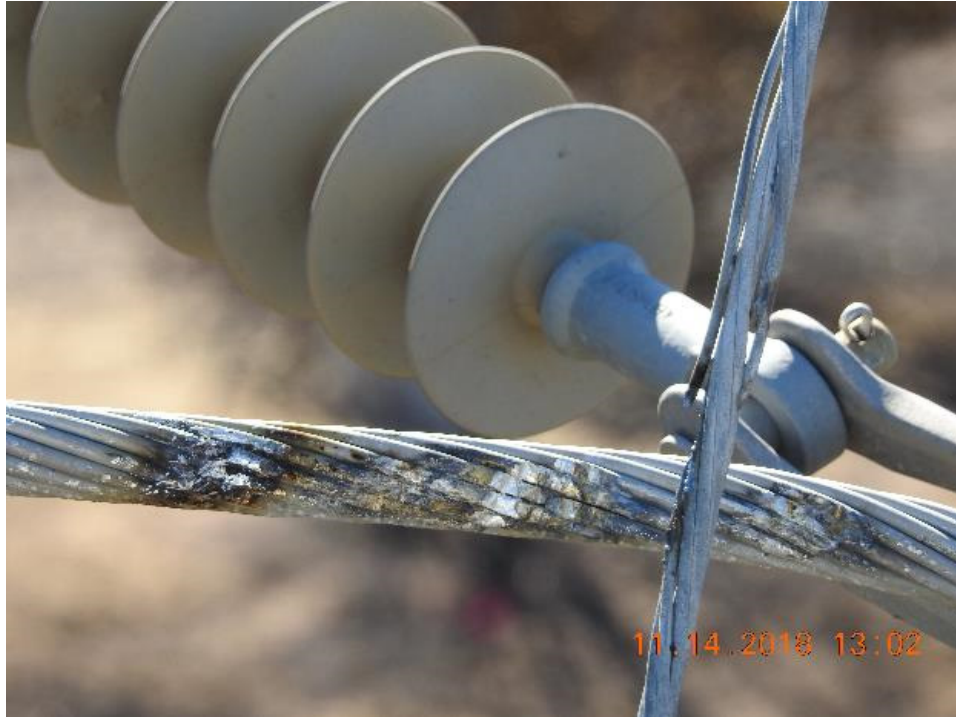
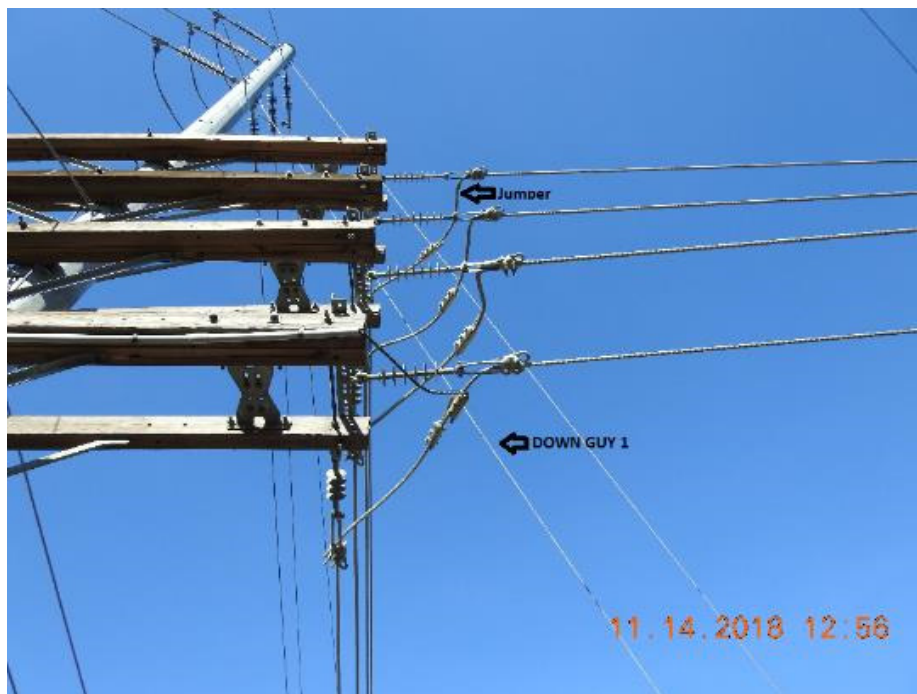
On November 14, 2018, SED Staff visited Site 2. SED Staff observed damage to an Edison transmission down guy wire (Down Guy 1), which was near an Edison 16 kV jumper wire on the east side of the Steel Pole. SED Staff rode an aerial work platform up to the height of the jumper wire and observed damage to the jumper wire and down guy consistent with arcing. Staff measured the radial clearance between the jumper wire and Down Guy 1 and found the clearance to be approximately seven inches. From measurements taken after the incident, Edison also confirmed that the clearance was approximately seven inches.²¹ See Figures 10-14.

Figure 10: Utility staff taking photographs of the down guy and jumper that made contact on the Steel Pole. Contact occurred between the red arrows.²²

Figure 11: A lateral view of Down Guy 1 and the jumper wire taken from an elevated work platform from the northeast.²³

Figure 12: The jumper wire and transmission down guy wire (Down Guy 1) on the Steel Pole. Note the burn marks on the jumper wire and the damage to the down guy wire.²⁴

Figure 13: A detail of the damage to the jumper wire on the Steel Pole and the transmission down guy wire, Down Guy 1.²⁵

Figure 14: The jumper and down guy that made contact as viewed from the base of the Steel Pole.²⁶

Staff observed that Down Guy 1 was loose and had sustained damage consistent with contacting the Edison 16 kV jumper wire. Staff noted that two other Edison down guy wires on the south side of the Steel Pole were also loose. The second loose down guy wire, Down Guy 2, was in contact with Messenger Wire 1 on the Stubbed Pole. The third loose down guy wire, Down Guy 3, was in contact with the top of the Stubbed Pole. Staff observed dark discoloration around the contact point between Down Guy 2 and the ECS through-bolt. See Figures 15-18.

SED Staff measured the clearance between Down Guy 1(or the loose Edison transmission down guy wire on the Steel Pole) and the Edison 16 kV jumper wire supported on pole number 4534353E (at Site 2) and found it to be approximately seven (7) inches. This clearance was measured with the guy wire at rest (no wind or outside forces that may cause the guy wire to move in any direction). Since the guy wire was less than the minimum mandatory clearance, there was a greater chance for it to make contact with the 16 kV jumper wire due to outside forces, such as wind or any events that may cause the guy wire to move. Edison is in violation of Rule 38 for failing to ensure that Down Guy 1 maintained the minimum required clearance of nine (9) inches from the jumper wire.

Down Guy 1 on pole number 4534353E was loose or not taut, which allowed it to make contact with the 16 kV jumper wire. Edison is in violation of Rule 56.2 for failing to ensure that this down guy wire was maintained taut.

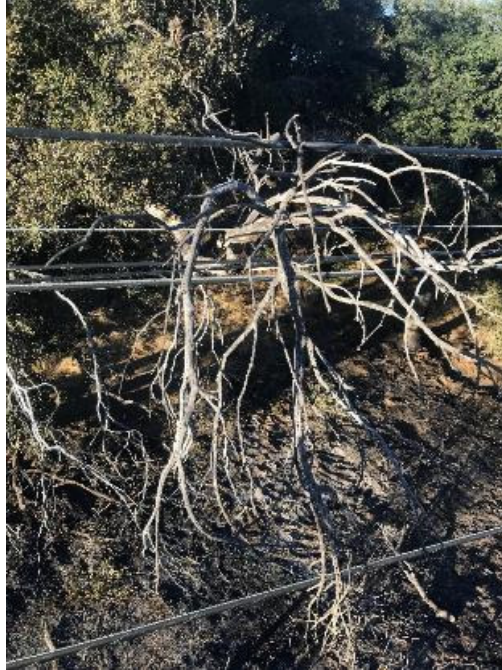
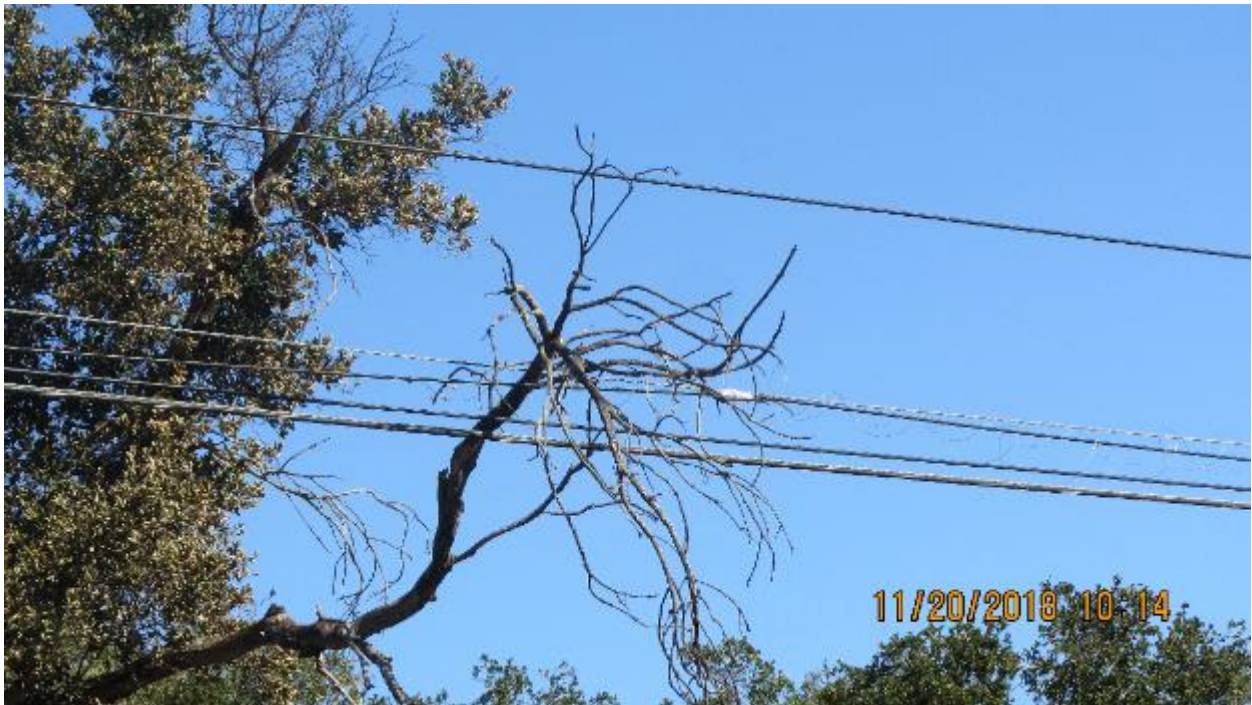
At Site 1, Staff observed tree branches pressing into the communications conductors between poles numbered 4650857E and 4557126E. This caused insufficient clearance between the ECS communications conductor supported on Messenger Wire 2 and a third-party communications conductor on Messenger Wire 4. The lashing wires on both communications conductors were damaged, and the messenger wires had separated from the conductors they supported. See Figures 22-24.

Figure 22: Tree branches pressing the communications facilities together at Site 1. Viewed from the southwest from an elevated position.³³

Figure 23: Another view of the overgrown tree branches pressing the communications facilities together. Viewed from an elevated position in the south.³⁴

Figure 24: One of the branches pressing the communications conductors together at Site 1.³⁵

The ECS communications conductor and the third-party communications conductor supported by poles numbered 4650857E and 4557126E had less than 12 inches of vertical clearance because they were pushed together by vegetation at Site 1. Therefore, Edison is in violation of Rule 38 for failing to ensure that ECS communications conductor No. 06051 maintained a minimum vertical clearance of 12 inches from the third-party communications conductor. This condition most likely existed since at least December of 2015 as shown by photographs taken by VCFD⁴⁹.

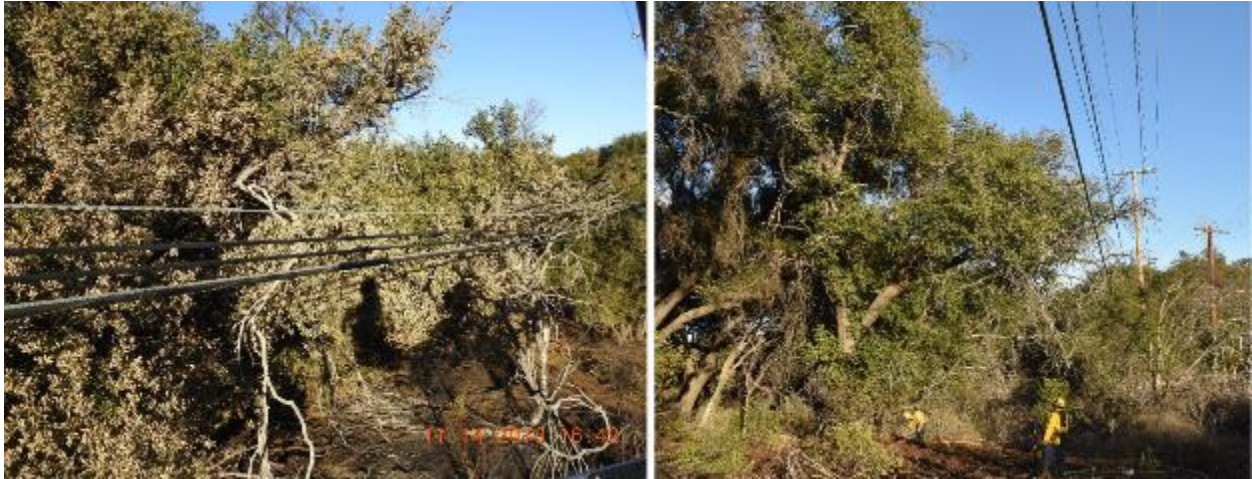
VCFD shared a 2015 fire report with SED that documented a fire that occurred at Site 1 on December 26, 2015.³⁷ VCFD also shared photographs taken on December 26, 2015 that showed overgrown tree branches pushing together the same two communications conductors. CalFire staff reported orally to SED staff that they had found small pieces of lashing wire buried under debris at Site 1 on or around November 14, 2018. It is likely that this 2015 fire occurred in the same manner as the November 8, 2018 fire and that these bits of lashing wire fell there during the 2015 incident. Edison could not provide any evidence of vegetation management taking place between these poles between the dates of November 8, 2008, and November 8, 2018.³⁸ See Figure 26.

Figure 26: On the left are the communications conductors and tree branches as they appeared on November 14, 2018. On the right is a photograph taken by VCFD of the same part of the span in December 2015.³⁹
