PUBLIC UTILITIES COMMISSION 505 VAN NESS AVENUE SAN FRANCISCO, CA 94102-3298

The Safety and Enforcement Division (SED) of the California Public Utilities Commission (Commission) reviewed San Diego Gas and Electric Company's (SDG&E) response letter dated May 13, 2020, addressing one violation identified by SED during its investigation of Department of Transportation (DOT) #1268754 reportable incident that occurred on August 22, 2019

## DOT #1268754 Reportable Incident G20190822-2888 August 22, 2019

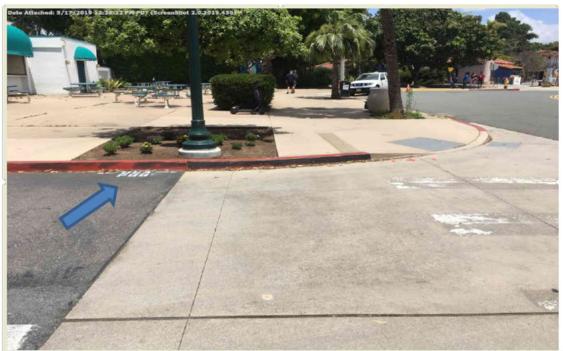
**Image 3:** Picture taken on Old Globe Way facing North at intersection of Village Place on May 17, 2019 during mark out. PGB USA mark stenciled to left of light post. This picture is for Naton Engineering's USA Ticket #A1912341234, which is approximately 300 feet from incident area.

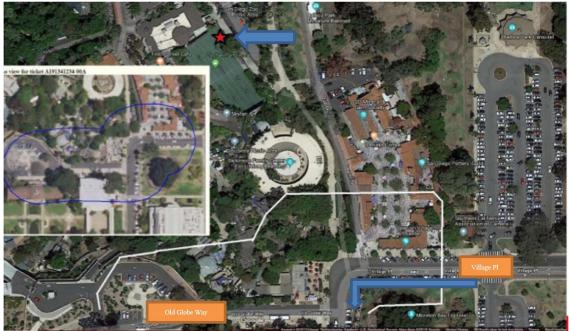
**Image 4:** Depicts area covered by Naton Engineering's USA Ticket #A1912341234 which notes work location: Old Globe Way Intersection: Village Pl. (the boxed area) The Red Star is the approximate damage location, about 300 feet north from boxed area.

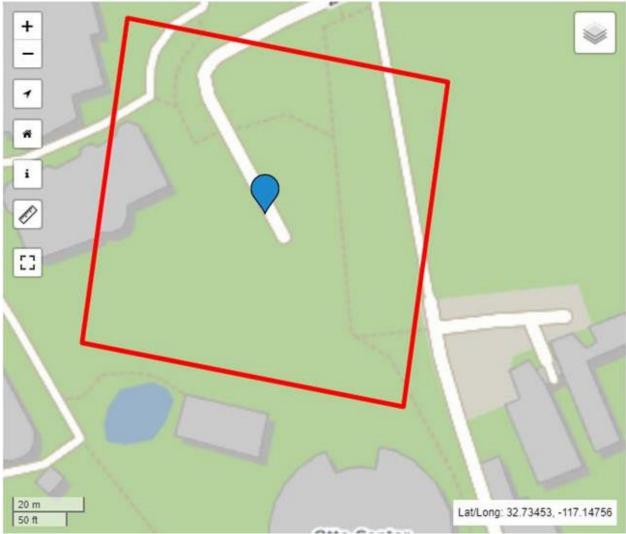
**Image 6:** Depicts area covered by PBG's expired USA Ticket #A191060668. Damage occurred in this area.

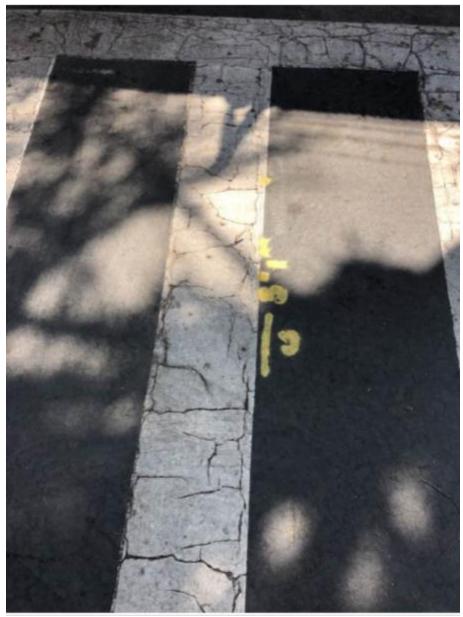
**Image 7:** Marks in area described on expired USA Ticket #A191060668 believed to be provided by Cable, Pipe and Leak locating employees.

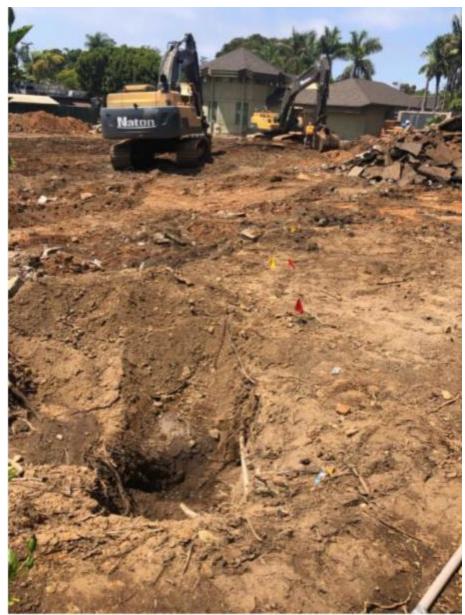
**Image 8:** Flags in area described on expired USA Ticket #A191060668 labeled Cable, Pipe and Leak.

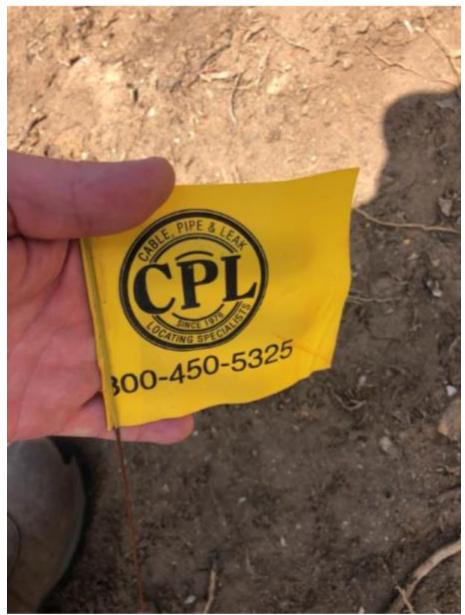
Image 9: Close up of Cable, Pipe and Leak Flag.

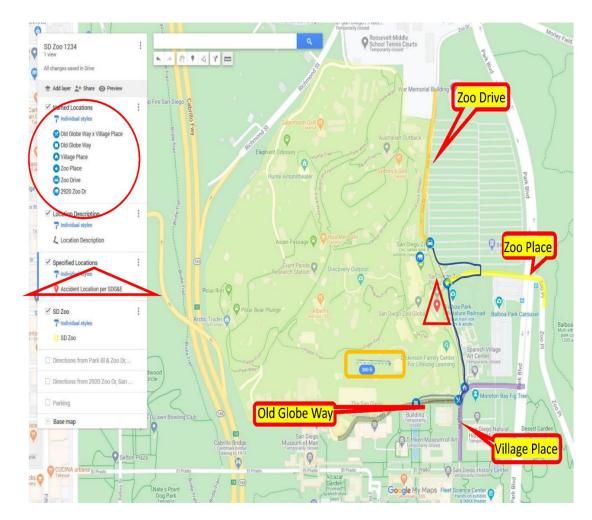
Village Place is highlighted in light purple, Old Globe Way is highlighted in light black, Zoo Place is highlighted in light yellow, Zoo Drive is highlighted in orange. The Location Description is traced by the line in light black (boundaries) and in blue (roads) and links together at named locations per the Location Description. The accident location is indicated by the red point and red triangle. This information can be found on the legend on the left, indicating the excavation area as described in the narrative of USA Ticket #191341234.

According to the Locator's Supervisor (Brad Renfrow), the Locator located and field marked SDG&E's facilities in the vicinity of Old Globe Way and Village Place, but he did not locate and field mark SDG&E's facilities located within the San Diego Zoo at a described in the USA Ticket #191341234. In addition, the supervisor stated that the Locator did not contact the excavator for any additional information. Furthermore, SDG&E's investigation stated that the incident site was "not delineated" by the excavator.

SED investigation found that the Locator failed to locate and field mark all SDG&E's facilities within the San Diego Zoo at **Contract Contract**. In addition, SED investigation found that the Locator failed to follow SDG&E's Gas Standard G8123 to contact the excavator to verify and to obtain a clear description of the excavation area location.
