PUBLIC UTILITIES COMMISSION

G20231216-3638-DOT Initial #1395201

DOT Incident Investigation #1395201
03/29/2024

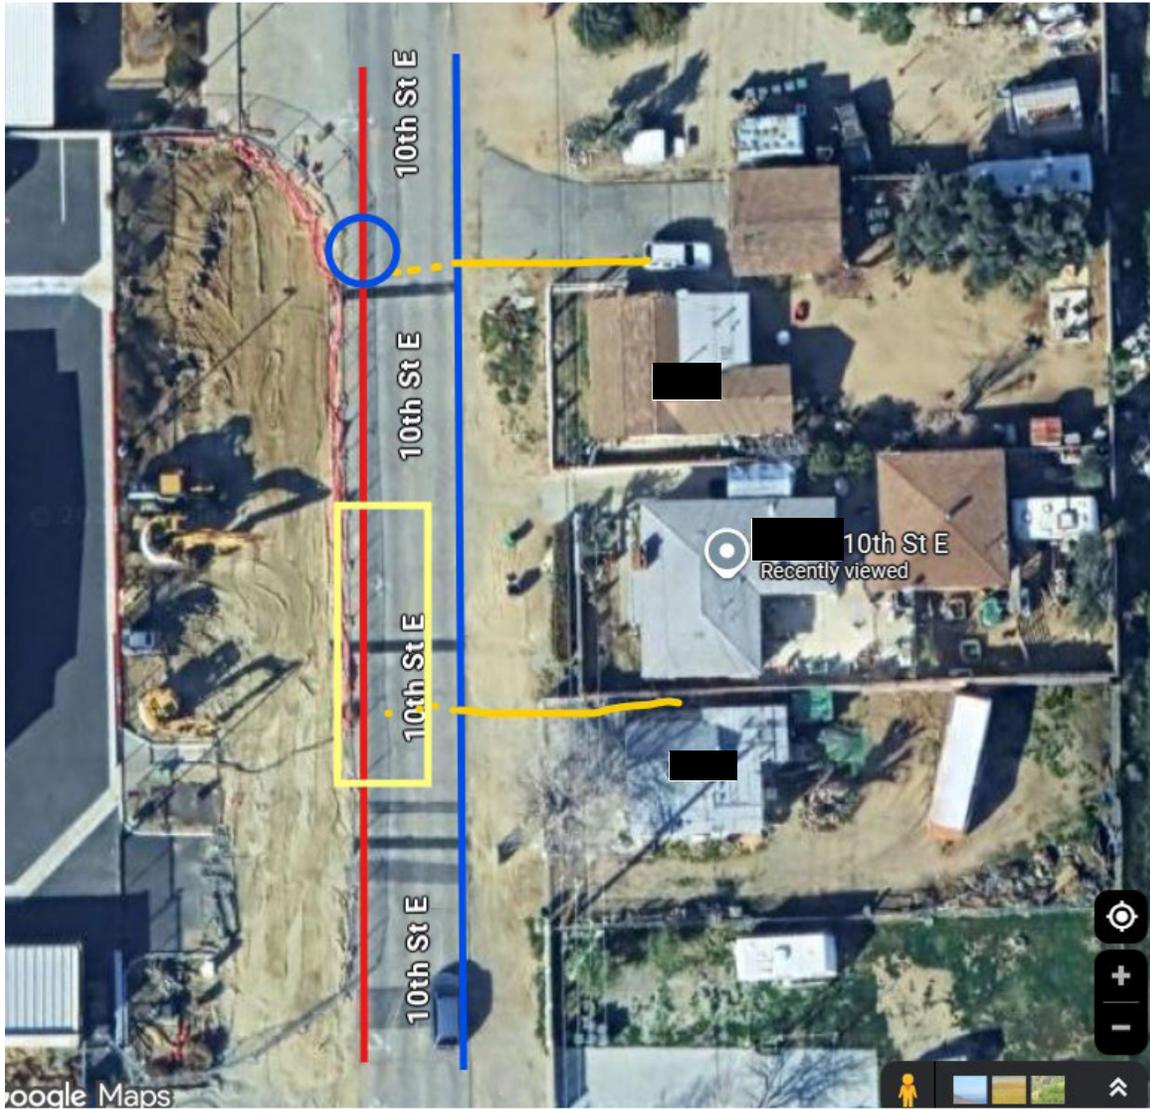
The active 1-inch service stub was struck by Patriot near [REDACTED] 10th St E, Palmdale (yellow rectangle)

However, the SoCalGas GIS map shows a “ST” service stub (blue circle) near [REDACTED] 10th St E, Palmdale, close to where (orange) service line connected to old (red) main and connects to new (blue line) main.
