**2015 Audit of**  
***LOS ESTEROS CRITICAL***  
***ENERGY FACILITY***  
**DECEMBER 2015**

**STAFF REPORT**

**PREPARED BY THE ELECTRIC SAFETY  
AND RELIABILITY BRANCH OF THE SAFETY AND  
ENFORCEMENT DIVISION**

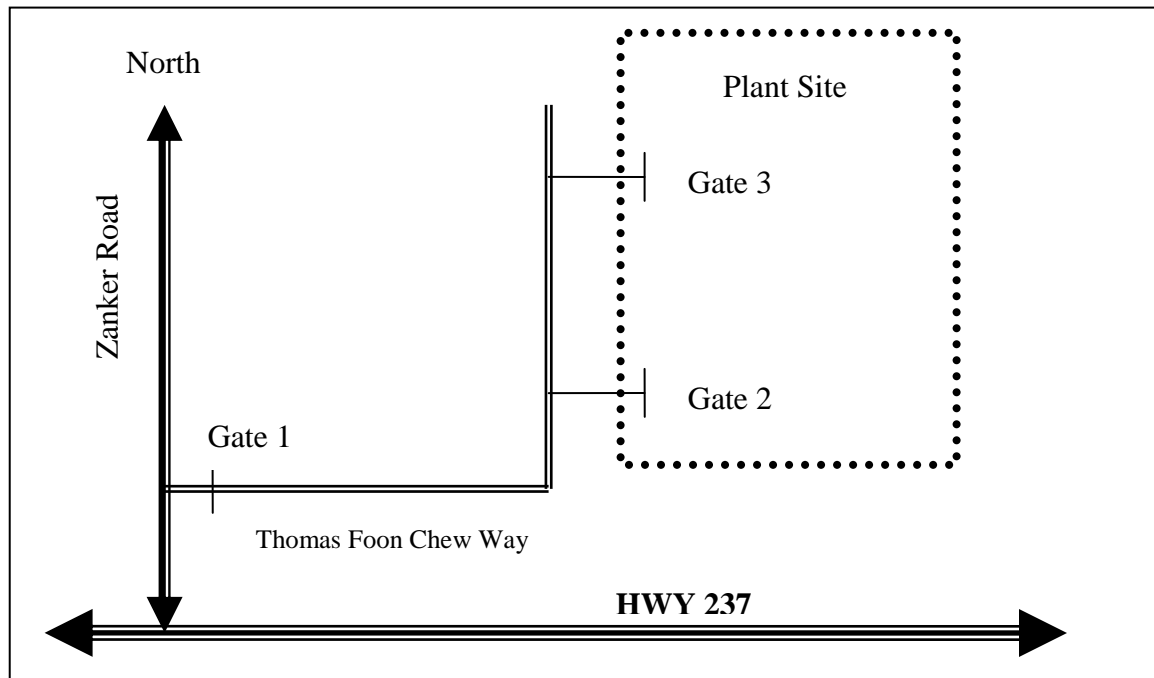
Figure 1: Schematic of the plant’s entry road and main gates (not-to-scale).

The street sign “**Thomas Foon Chew Way**” was missing at the intersection of Zanker Road, where the plant shares its entrance with PG&E and Silicon Valley Power. This entrance has a security gate controlled by the plant’s operator. Vehicles must travel approximately half a mile past this security gate to arrive at the plant’s two entries. One entry has a remote controlled security gate and the other has a manually locked security gate (See Figure 1). It was not apparent to visitors which gate is the correct entryway.

In response, the plant posted a street sign and a company sign at Gate 1. The plant also posted a directional sign at Gate 2 to direct visitors to Gate 3, which is the plant’s main entrance. No further corrective action is required at this time.

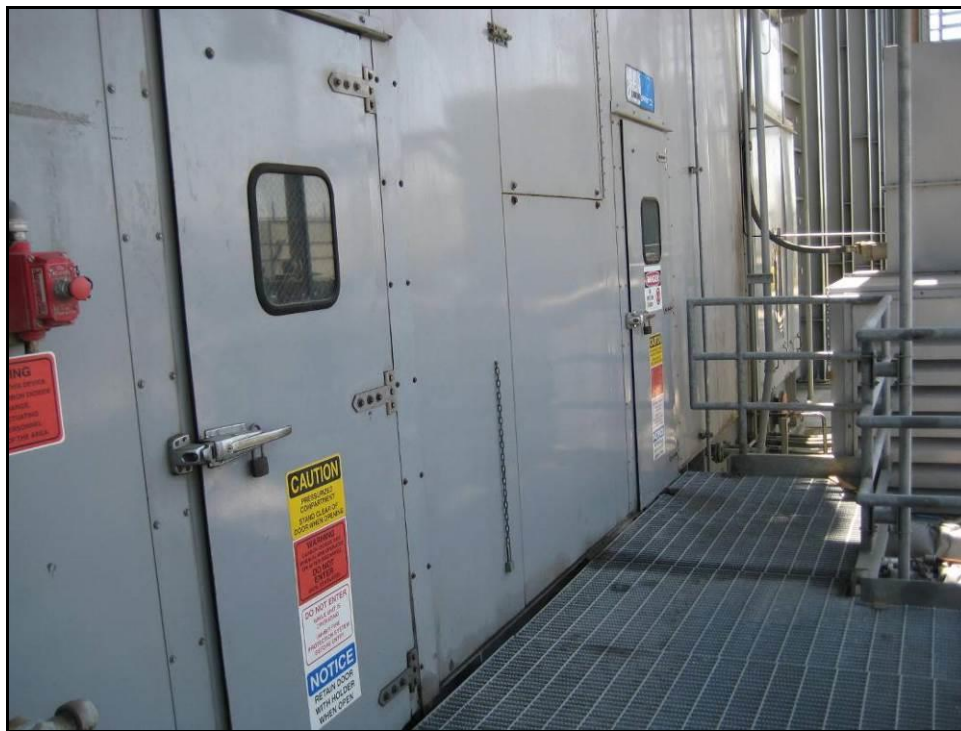
The plant failed to post warning signs on the gas turbine compartments to prevent worker’s entrapment, a violation of Operation Standard<sup>7</sup>.

Unauthorized entry into these compartments may entrap personnel because its doors are virtually locked shut by the differential atmospheric air pressure created by the compartments ventilation fan. While these compartments do not meet the definition of a confined space and are not listed in the plant’s Confined Space Procedure<sup>8</sup>, the plant should mitigate the entrapment hazard because of its licensing agreement with the California Energy Commission.

Photo 1: Turbine compartment lacked a warning sign.

In response, the plant stated and Auditor confirmed that it has an on-site entry procedure<sup>9</sup> that requires plant personnel to obtain authorized signature before entering the compartment. Auditor recommended and the plant posted a warning sign on the compartment door to require a completed form with authorized signature before entry. No further corrective action is required at this time.

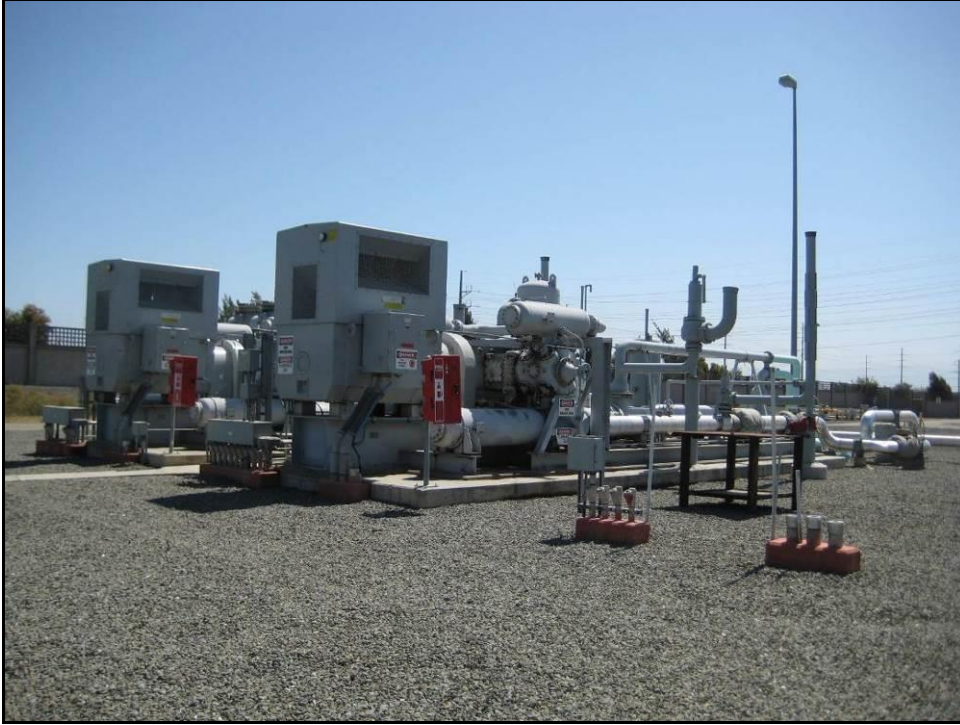
The plant failed to detect and repair gas leaks at the fuel gas compressors, a violation of Operation Standards<sup>13</sup>. During a walkdown, Auditor noticed a strong odor of natural gas at the fuel gas compressors, indicating a leak in the system. The plant compresses natural gas to about 600 psi for the gas turbines to operate. Natural gas is highly flammable. At the right concentrations, the gas can ignite and explode. The plant should survey all pipefittings regularly to detect and repair any gas leaks.

Photo 2: Fuel gas compressors at the gas yard.

In response, the plant explained that operators frequently use a gas detector during their daily rounds to detect leaks. The leak in-questioned was minor and outside of the gas's explosive range, and poses no safety risks. Further, the plant uses a technology called "optical gas imaging" where the plant scans and takes thermal images of gas lines and valves to look for leaks. If a leak occurs, it causes a temperature difference that can be detected by thermal imaging. The plant conducts this test every two years and uses the results to trend and schedule preventive repairs. No further corrective action is required at this time.

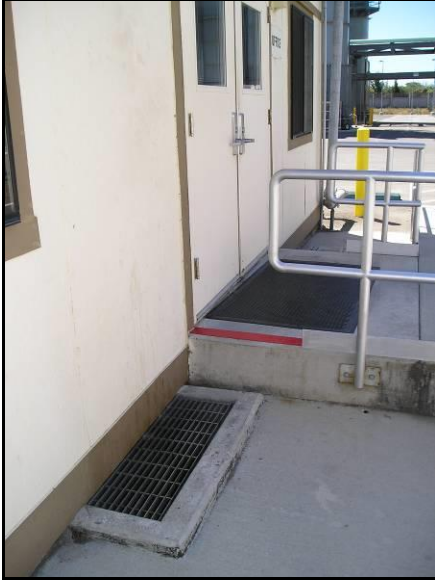
The plant failed to mitigate a trip hazard at a frequently used ramp, a violation of Operation Standard<sup>14</sup>. Auditor noticed workers utilized a handrail gap as a shortcut to enter a building. However, the gap was not meant to be an entry. It was too narrow, the step was too high, and an abutting storm drain posed a trip hazard.

Photo 3: Trip hazard at a building ramp.

In response, the plant abated the hazard by reconfiguring the ramp. The plant bridged the handrail gap and added a side entry for better access. Further, the plant thickened the concrete pad to reduce the steps' height. No further corrective action is required at this time.

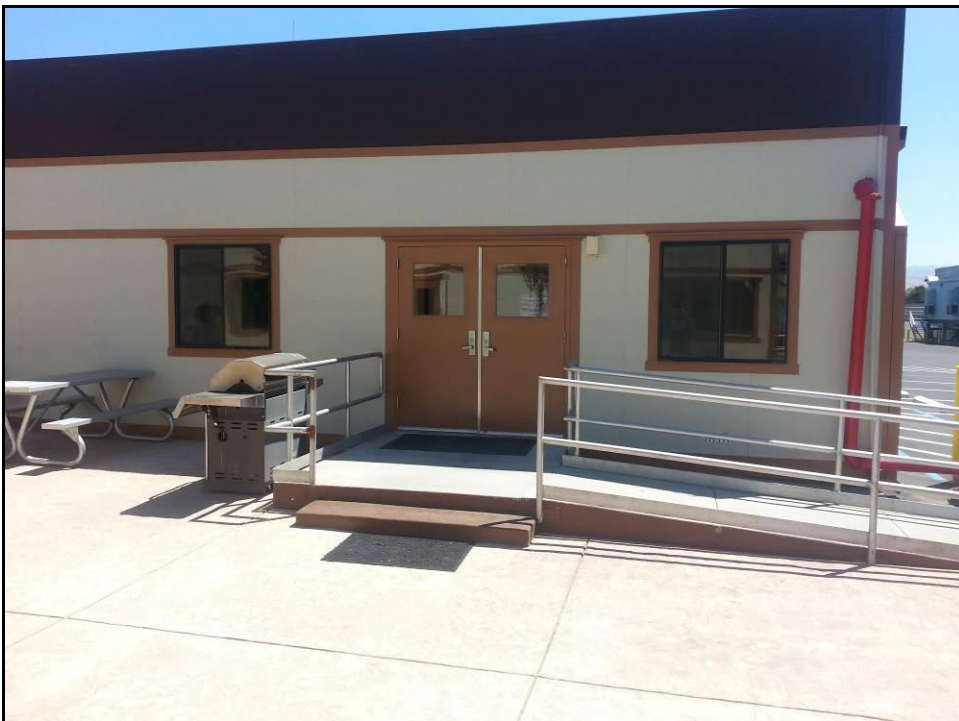
Photo 4: Reconfigured ramp to mitigate trip hazards.

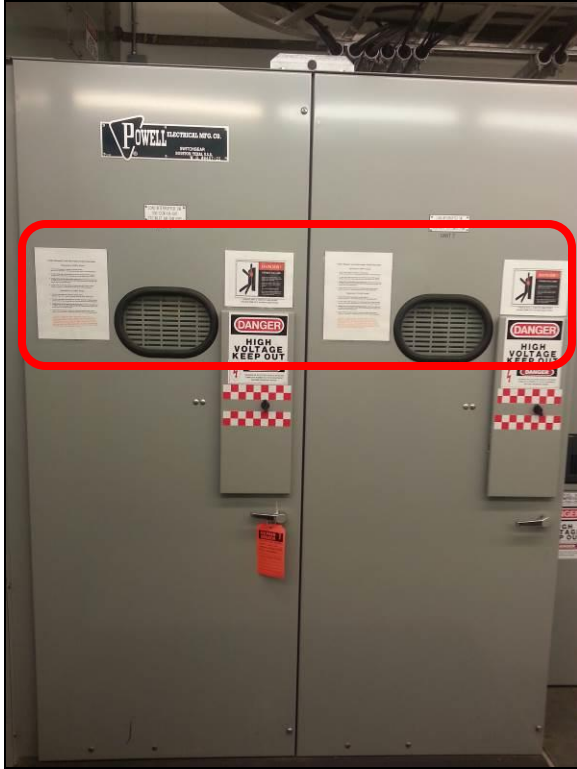
The plant lacked proper operating procedure for an air switch, which resulted in a worker’s injury in April 2009, a violation of Operation Standard<sup>15</sup>.

Photo 5: Operating procedure and warning signs posted on an air switch.

In response, the plant analyzed the root cause and implemented the following corrective actions:

- Developed a detailed operating procedure
- Posted the procedure and added warning signs on the switch
- Briefed workers on the switch’s hazard
- Informed Calpine’s fleets of this hazard

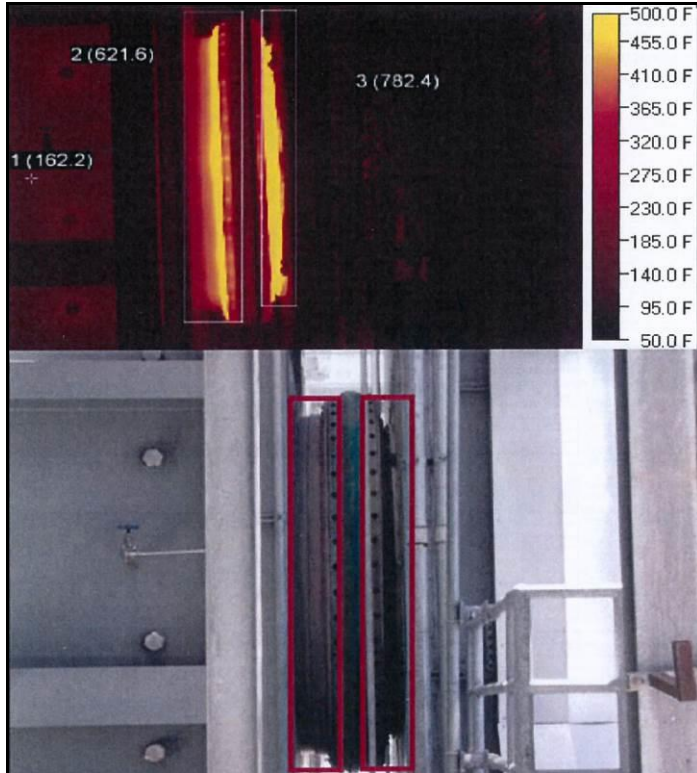
The plant fails to repair hotspots, a violation of Operation Standards<sup>33</sup>. Auditor reviewed a thermography inspection report<sup>34</sup> and noted hotspots at the gas turbines’ exhaust cylinders<sup>35</sup>. Thermal images showed the cylinder registered a temperature well above 500°F.

Figure 2: Thermal image of a gas turbine exhaust cylinder.

Aside from affecting reliability, hotspots also present a burn risk hazard for workers.<sup>36</sup> The plant must take corrective action to repair hotspots.

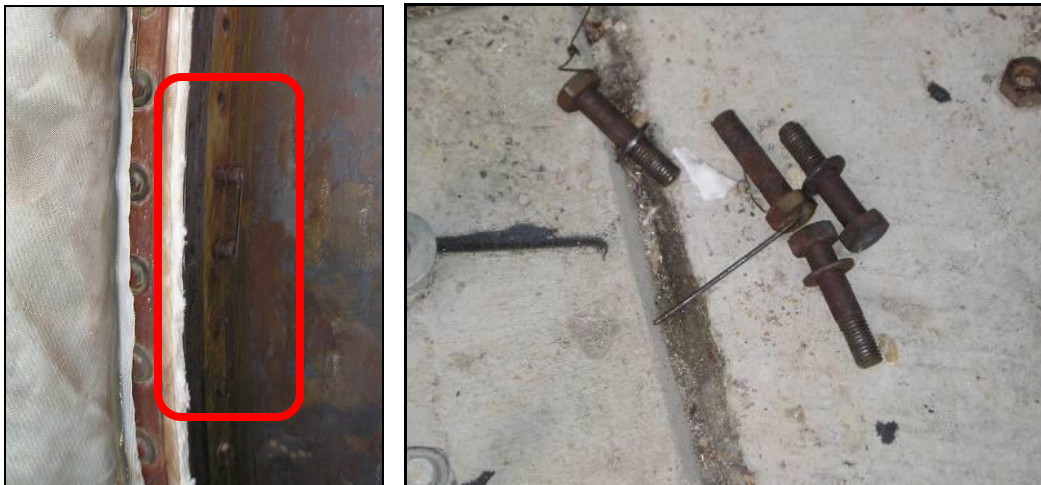
Exhaust cylinders have had a failure history that resulted in outages at Calpine's Metcalf Energy Center. In March 2007, connector bolts failed on Unit 1's cylinder.

Photo 6: Connector bolts failed at Metcalf's Unit 1. *Source: March 22, 2007 File Photo*

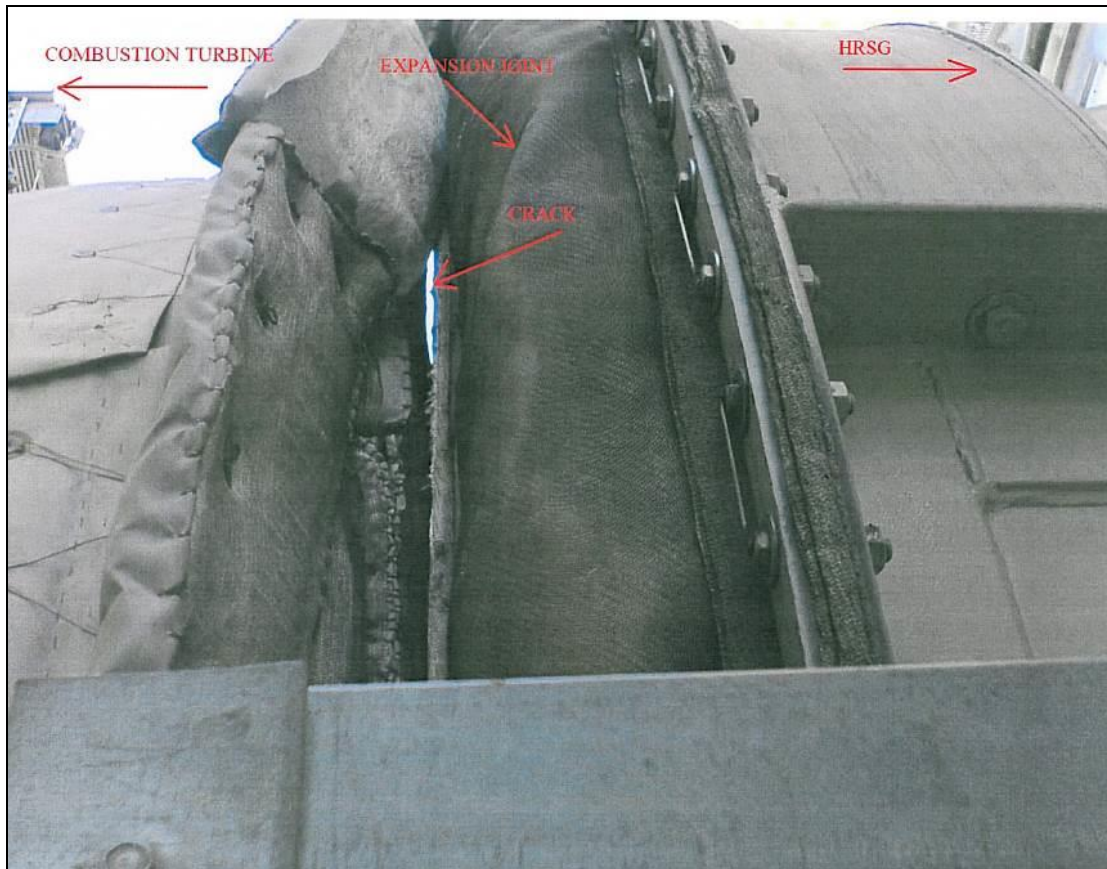
Three months later in June 2007, Unit 2's cylinder also failed. This resulted in a forced outage that lasted more than a week.

Photo 7: Unit 2's cylinder split opened at flange. *Source: Calpine*

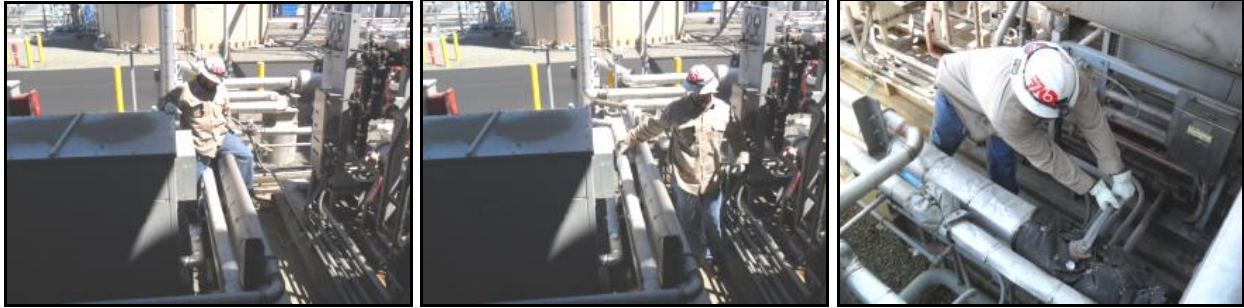
Plant procedure exposes workers to safety hazards, a violation of Operation Standard<sup>37</sup>. Auditor noticed that, per plant procedure, operator has to climb on pipes and lean over a safety guardrail in order to shut off valves before they can access a restricted area. Operators have already damaged pipe insulation on the pipes over which they must climb in order to access a shutoff valve. Operator also has to lean over a guardrail in order to shutoff a CO<sub>2</sub> valve. The plant should implement engineering control to mitigate this hazard.

Photo 8: Operator maneuvered pipes and conduits in order to access a shutoff valve.

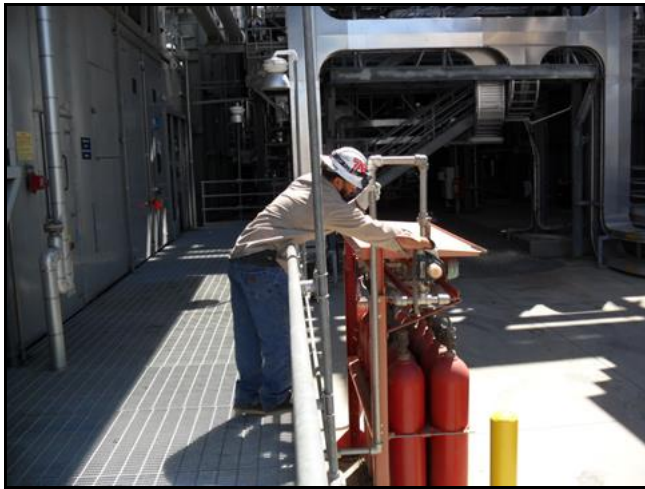
Photo 9: Operator leaned over a guardrail to shutoff a CO<sub>2</sub> valve.

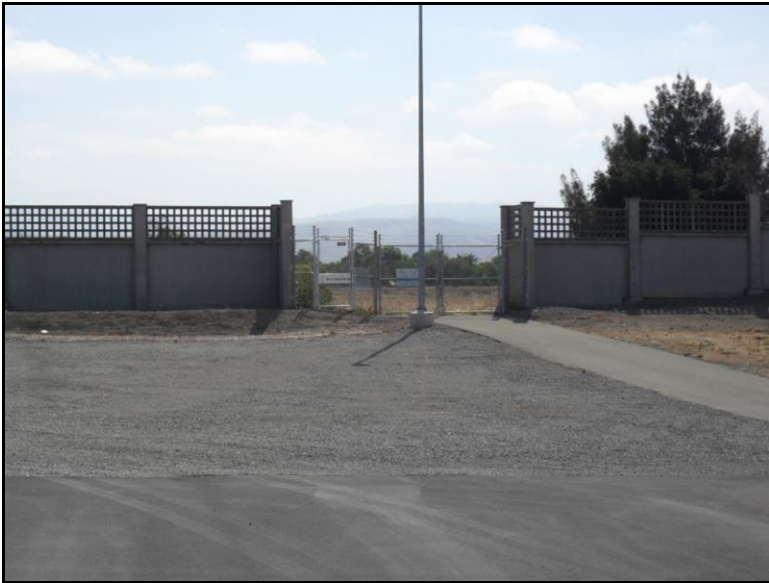
- The gate cameras malfunction periodically and are unreliable
- The security fence is not monitored
- The perimeter fence lacks barbed wire
- The outer perimeter fence lacks “No Trespassing” signs
- The entry gate lacks a “Prohibited Items” sign as required by the “Physical Security Plan”
- The plant lacks an effective procedure to minimize multiple personnel passing through a security checkpoint on a single pass
- The south perimeter fence has excessive vegetation obscuring the view and provides an intrusion path

Photo 10: Perimeter walls are not monitored and lack barbed wire to deter intruders.

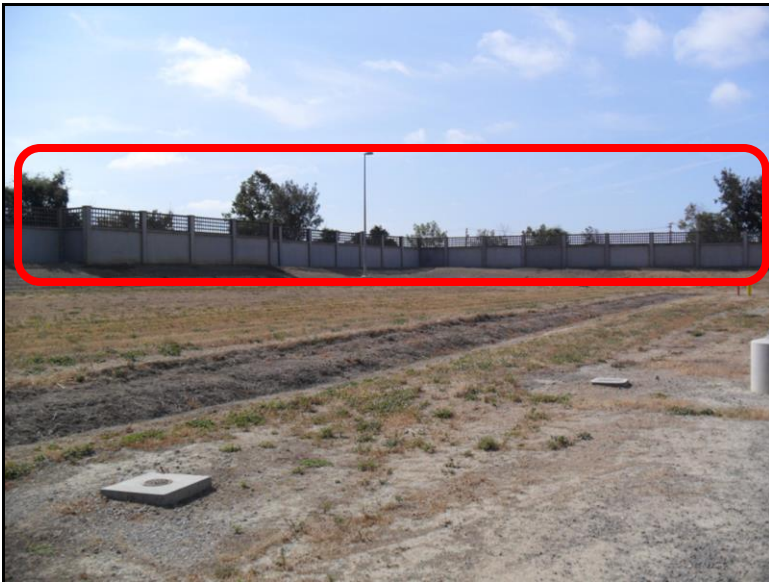
Photo 11: South perimeter wall has excessive vegetation providing an intrusion path.

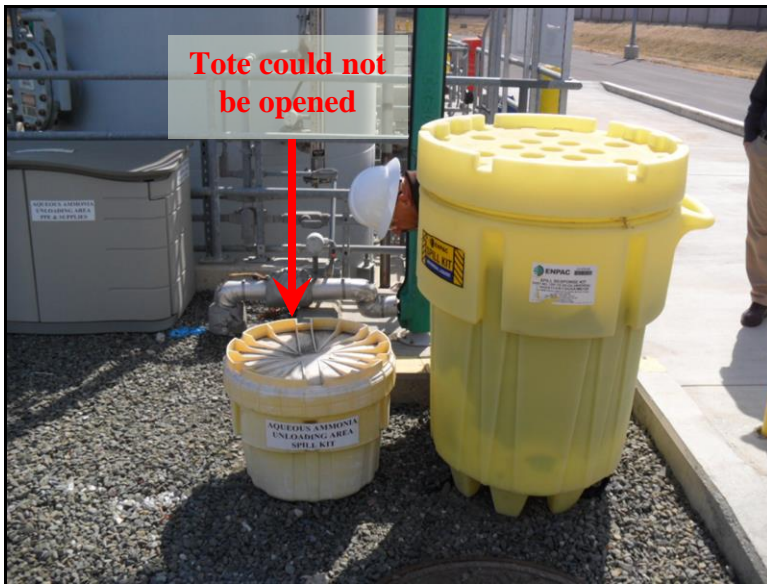
The plant lacks inventory control and condition assessment of its Spill Prevention Control and Countermeasure (SPCC) kits, a violation of Operation Standard<sup>40</sup>. The plant has spill kits throughout the facility to mitigate hazmat spills. However, Auditor found the contents of those kits to be inconsistent. Moreover, the absorbency capacity of each kit is not apparent. Auditor found no evidence that the plant checks the inventory of spill kits regularly and restocks them as needed. Auditor noted that workers used the kits for minor drips and leaks without replenishing them. This defeats the purpose of a kit. Further, the plant does not assess the condition of the spill kits. In at least one occasion, worker was unable to open the container lid of a kit.

Photo 12: Spill kits at the ammonia storage tank.
