## PUBLIC UTILITIES COMMISSION

GA2021-06PE

SUBJECT: Audit of Palomar Energy Center

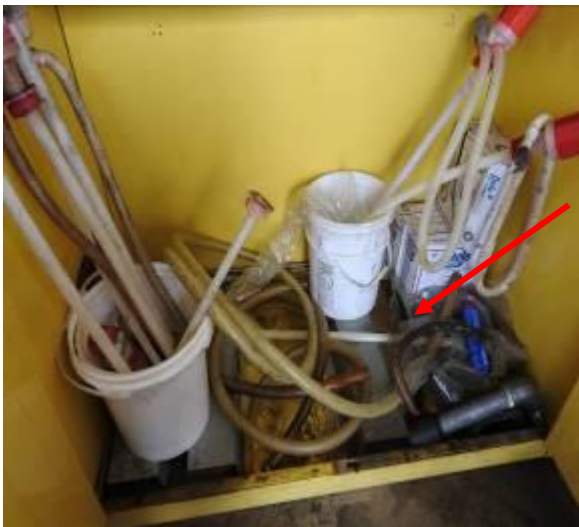
ESRB Staff observed loose pipes and empty buckets kept inside the chemical storage cabinet. Wooden blocks and chemical drum holders were kept at the entrance which can result in a tripping hazard. A piece of equipment used for the cooling tower was kept inside the chemical storage area. As per NFPA 30: Flammable and Combustible Liquids Code - the chemical storage area is solely for the storage of hazardous chemicals. The equipment should be kept in the warehouse or other places.

*Loose pipes, empty buckets kept inside the chemical cabinet*

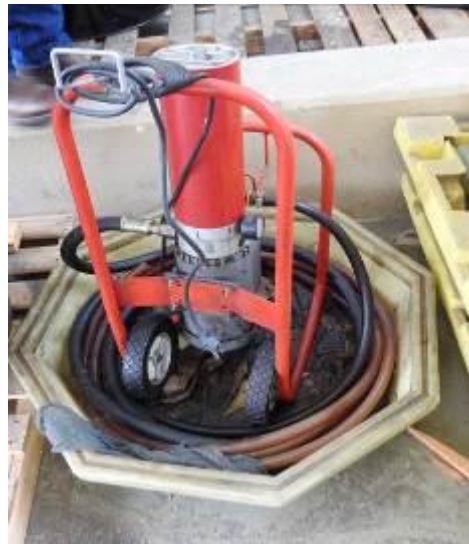
*Equipment kept inside chemical storage area*

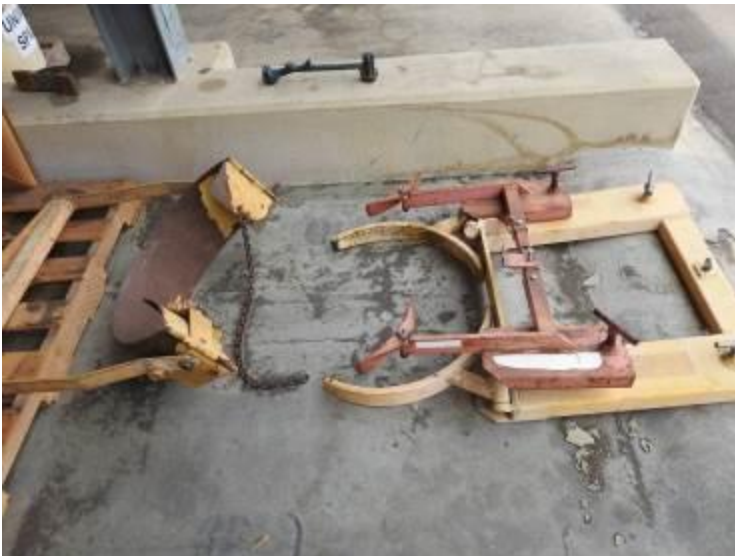
*Chemical drum holders at the entrance of the chemical storage room*

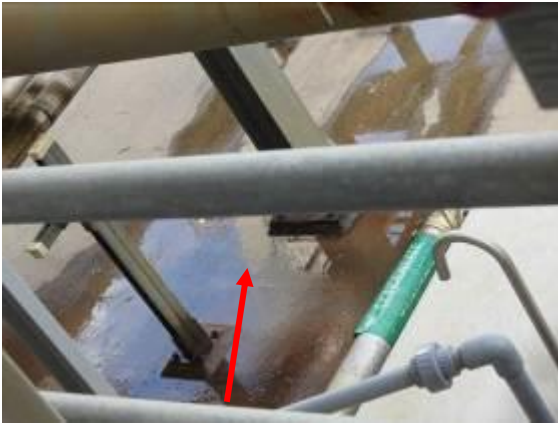
ESRB Staff observed leakage of the condenser vacuum pump, which is a slipping hazard. The staff also observed leakage from the condenser water-box vent valve which was not documented or addressed by the plant.

*Standing Water*

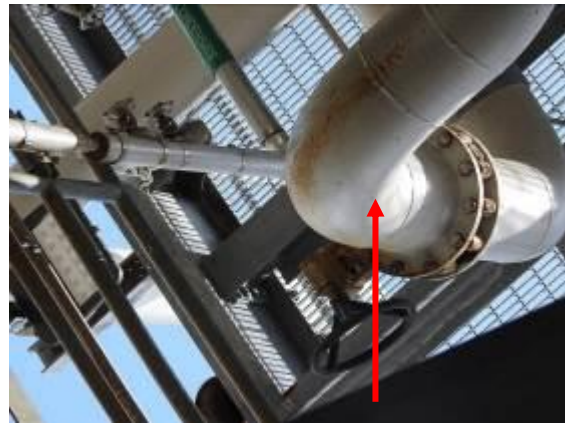
*Leaking condenser water-box vent valve*

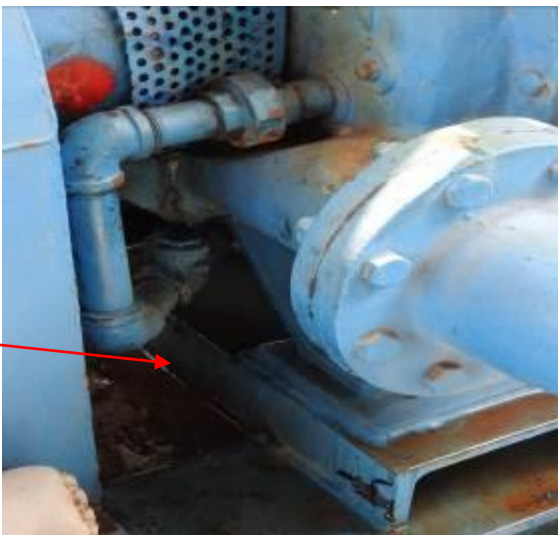
*Leakage from vacuum pump*

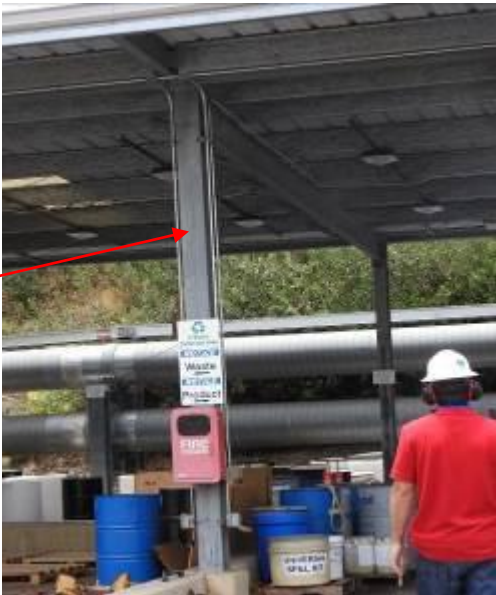
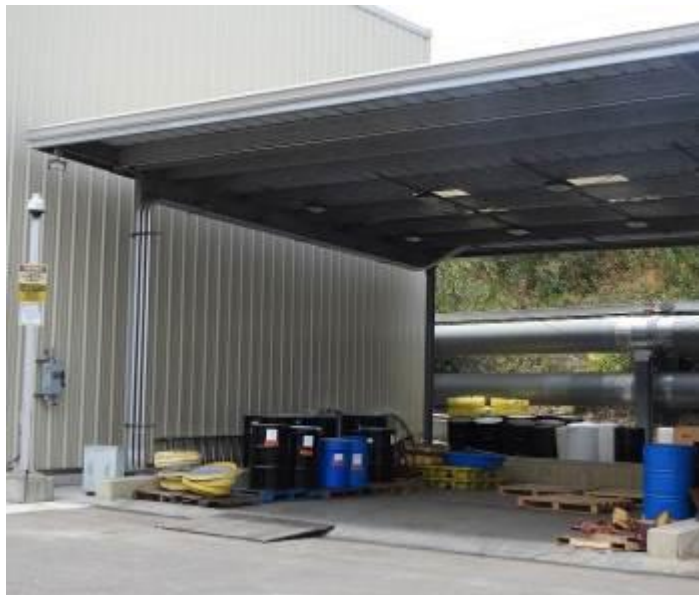
ESRB Staff observed the chemical storage shed lacks proper NFPA sign. (i.e., the fire diamond sign.)

No NFPA signage on the hazardous material storage shed

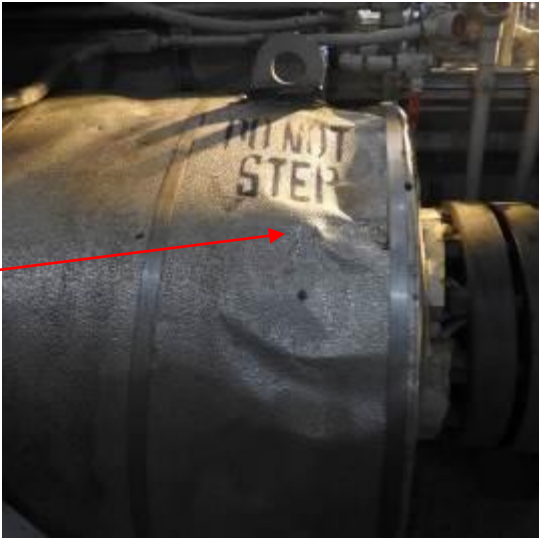
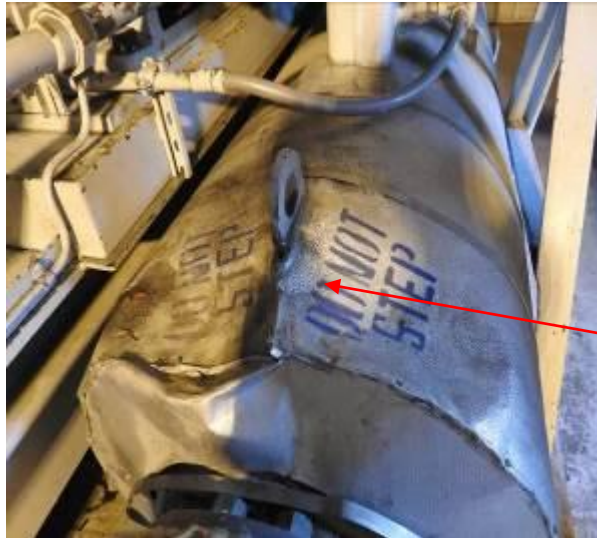
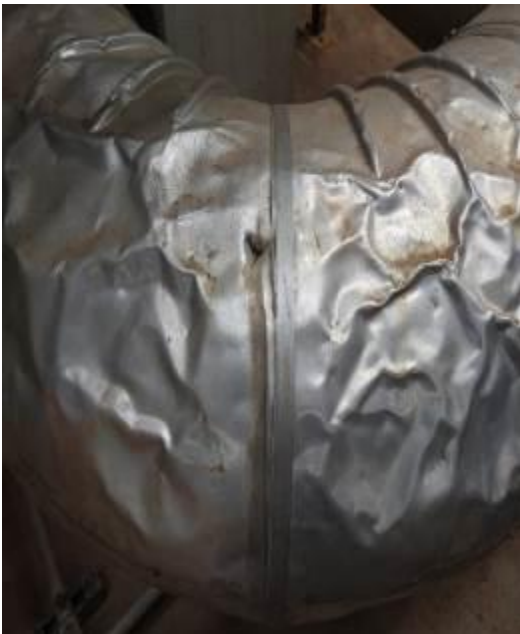
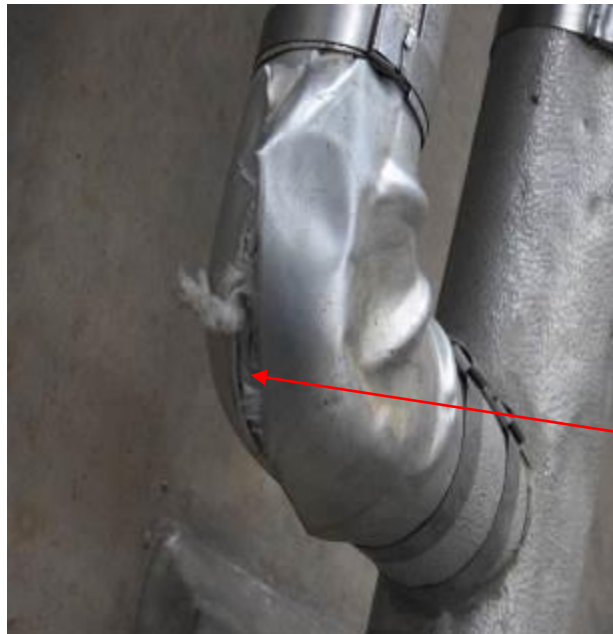
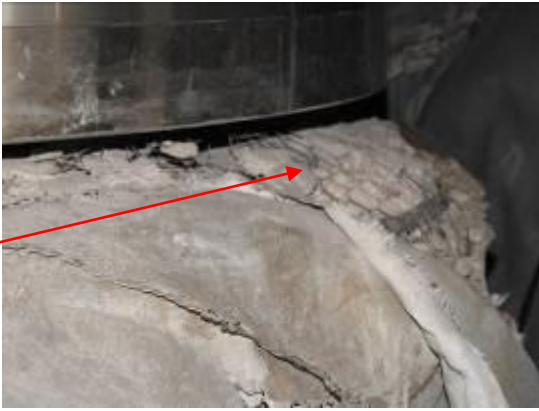
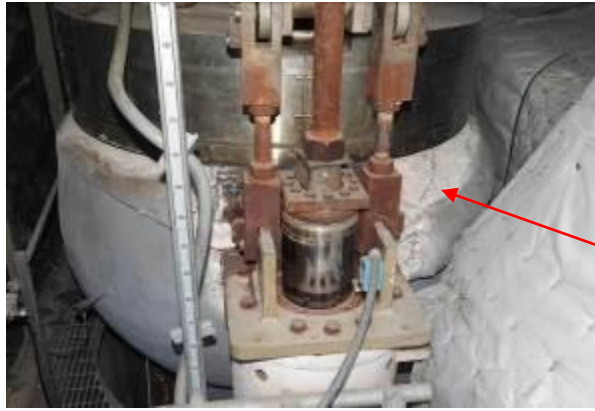
ESRB Staff observed several areas in the plant where damaged insulation is evident. The plant personnel had stepped on the insulation despite having a ‘Do Not Step’ sign. Insulation and cowlings on IP Steam Turbine Combined Reheat and Intercept Valve # 1 and # 2 were damaged.

*Damaged insulation and cowlings in the IP Steam Turbine Combined Reheat and Intercept Valve*

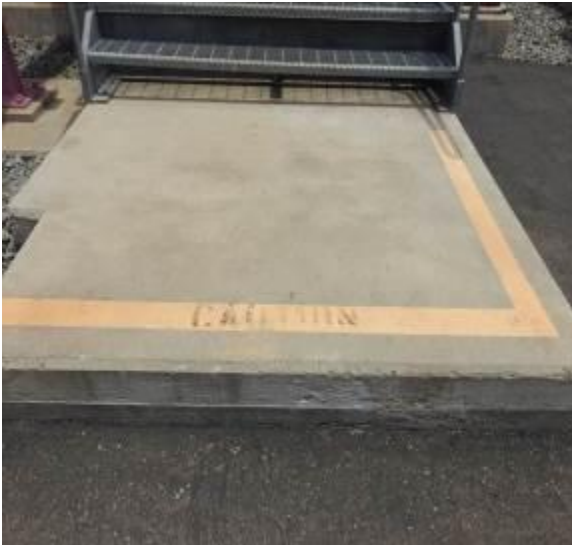
ESRB Staff observed several safety labels and signs that were damaged beyond recognition. These signs are important for the safety of the employees, and they make them aware of the surroundings and any potential safety hazard. For example- confined space sign indicates the danger and requires special permit to enter the confined space.

*Caution sign for the step are worn out*

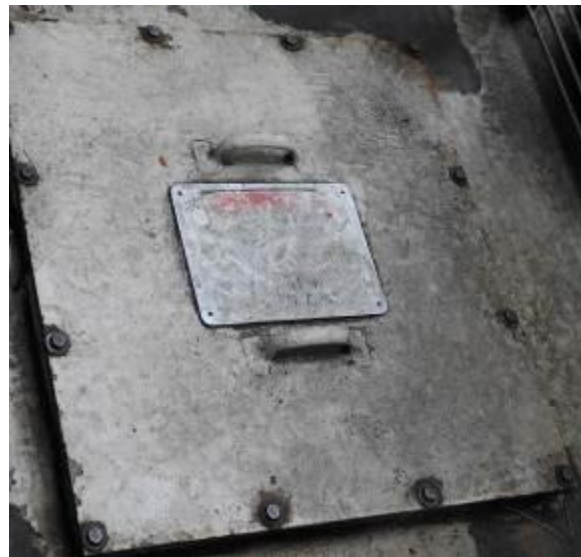
*Faded confined space warning sign*

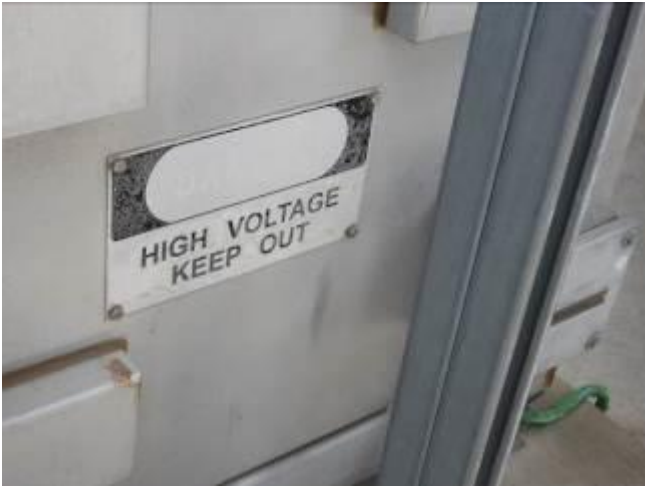
*Faded Danger sign for High Voltage*

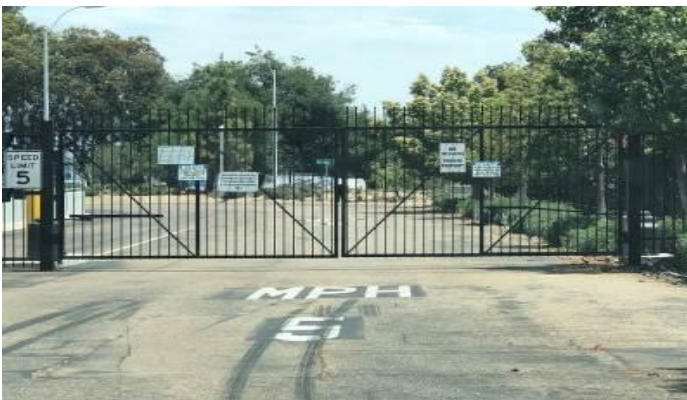
ESRB observed that the Plant’s main gate did not have a National Fire Protection Association (NFPA) 704 warning placard. The Plant stockpiles and uses hazardous chemicals as part of its normal operation. NFPA 704 is a standard system for identifying hazards of materials for emergency response. The posting of an NFPA placard on the main gate is a common industry practice so first responders can quickly and easily identify the risks posed by a facility’s hazardous materials. This helps emergency personnel to determine what safety gear and precautions to use and how best to respond in emergencies.

*Missing NFPA Placard on the main gate.*

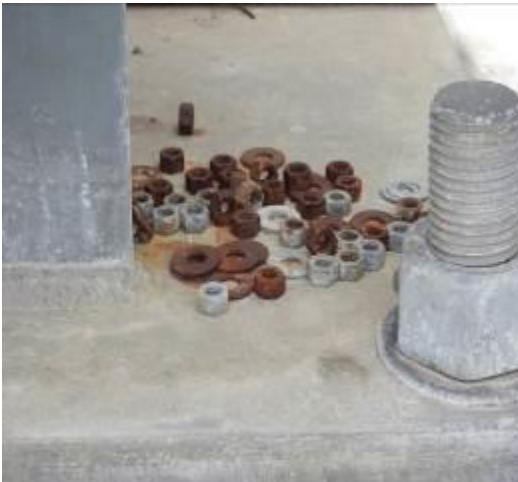
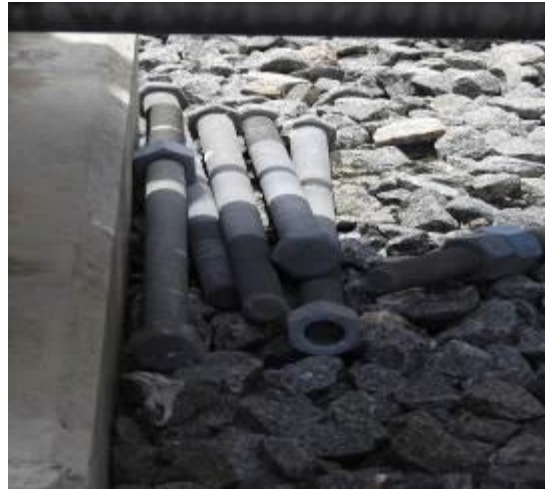
ESRB staff observed poor housekeeping around the plant. Abandoned nuts and bolts were found near the cooling tower. Hoses were kept on the ground which could be a tripping hazard and abandoned insulation covers were found in several areas of the plant.

*Abandoned nuts and bolts near cooling tower area*

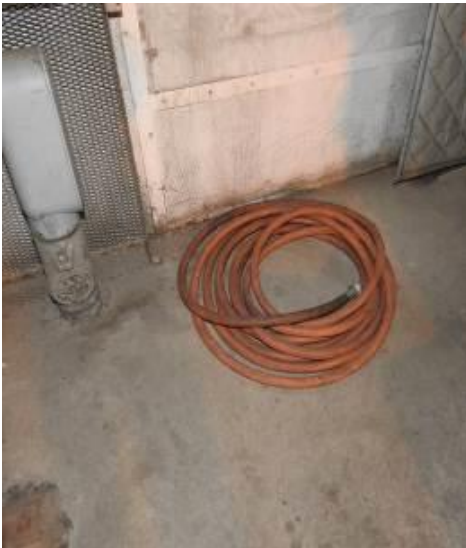
*Hoses on the ground*

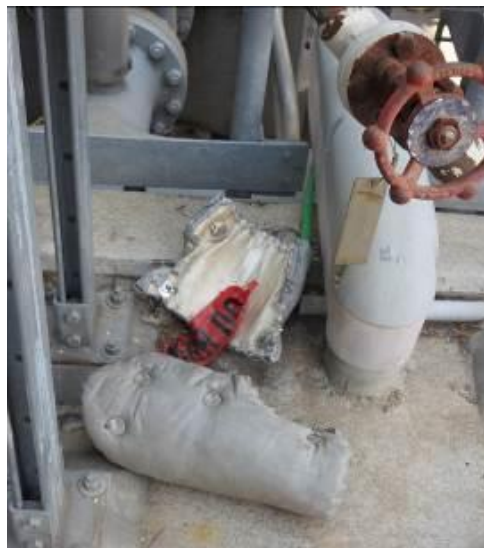
*Abandoned insulation cover*

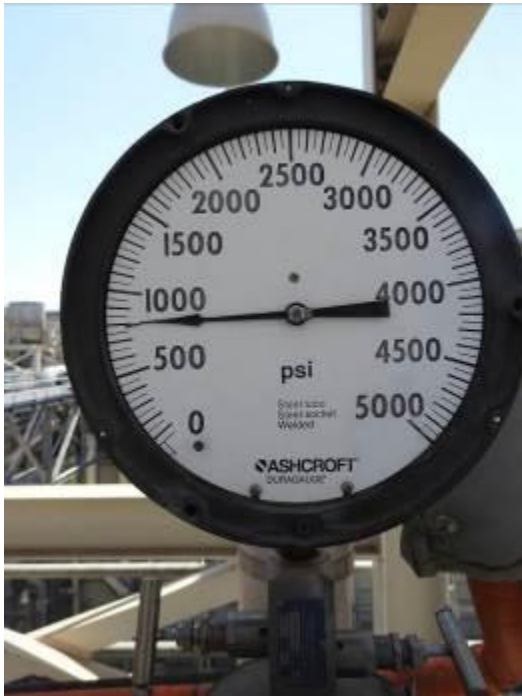
ESRB staff observed two defective pressure gauges. One had water deposition inside resulting from a broken seal and the other was missing a glass cover. Defective pressure gauges can result in erroneous pressure readings.

*Pressure gauge missing the glass cover*

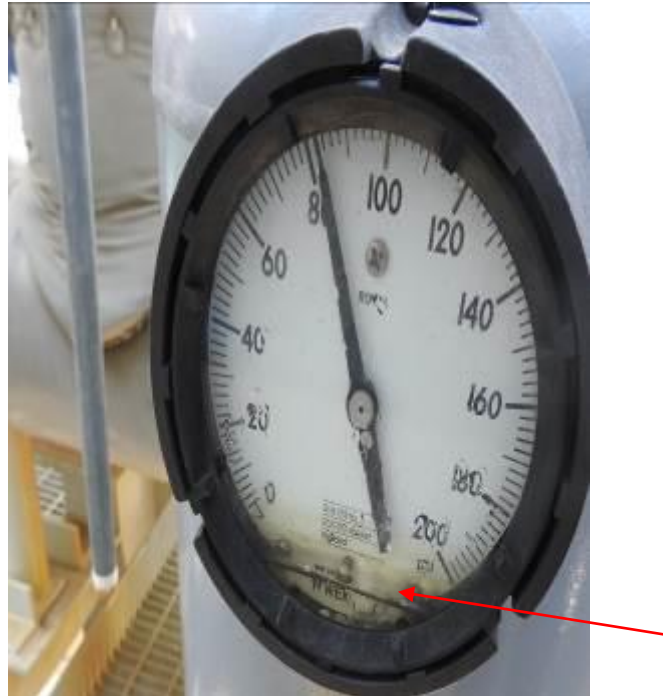
*Water deposition inside the Pressure gauge*
