# **FINAL REPORT ON THE AUDIT OF THE DELTA ENERGY CENTER POWER PLANT**

**CONDUCTED UNDER GENERAL ORDER 167  
TO DETERMINE COMPLIANCE WITH  
OPERATION, MAINTENANCE, AND LOGBOOK STANDARDS**

May 29, 2009

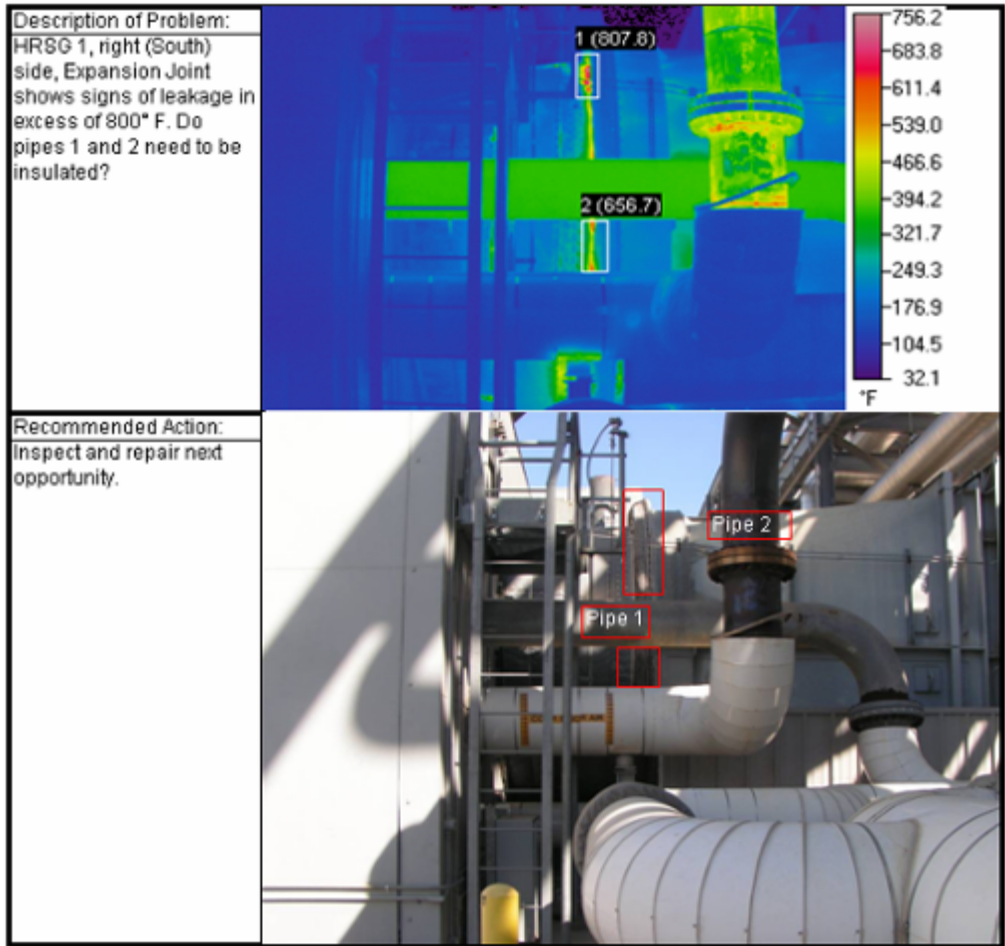
The plant deferred repairs of hot spots in the HRSG, a violation of Operation and Maintenance Standards.<sup>4</sup> Hotspots on the HRSG expose plant staff to burn hazards, reduce thermal efficiency and may lead to equipment damage that affects reliability.

Photo 1: Thermal image of Unit 1's expansion joint.

Further, plant staff identified several severe hotspots during an infrared scan in September 2006.<sup>6</sup> Staff recommended repair in the next immediate outage. However at the time of the audit, which was six months after the recommendation, the plant still had not repaired the hotspots.

The plant repaired most of the hotspots, but left two hotspots untouched because insulation could cause overheating and failure of fasteners. The manufacturer of the expansion joint (Photo 1), KE-Burgman, recommended against insulating that joint, saying that it functions

at high temperature by design. Insulating the joint would raise temperatures and cause the joint's fasteners to fail. To mitigate burn risks, the plant installed caution signs in the area (Photo 4). The HRSG's manufacturer, Deltek, similarly recommended that the plant maintain at least a 2-inch gap between the stainless steel bellow and the existing pipe insulation (Photo 5). The plant therefore left the gap in place, but did not post signs because the area is difficult to access. The plant did, however, install new piping insulation at other hotspots in the HRSG (Photo 6). Finally, the plant replaced gaskets and insulation to repair a hotspot at the manway door for Duct B (Photo 3).

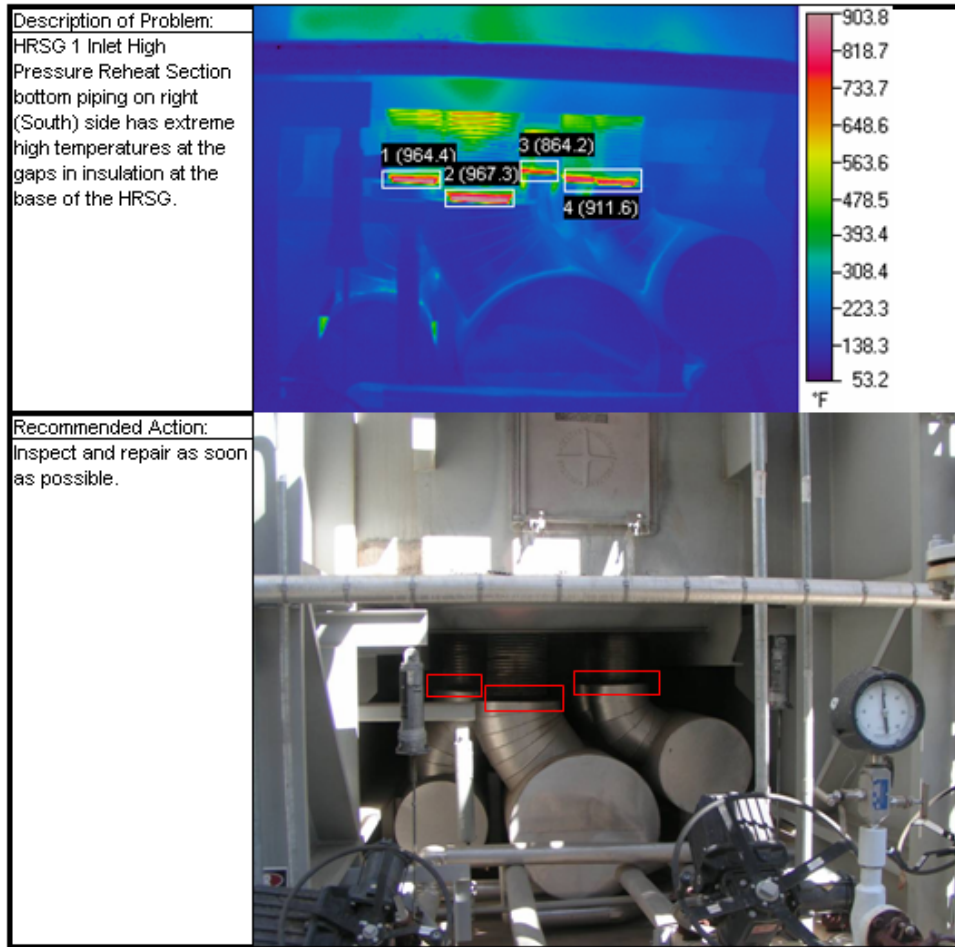
Photo 2: Thermal image of Unit 1's bottom reheater inlets.

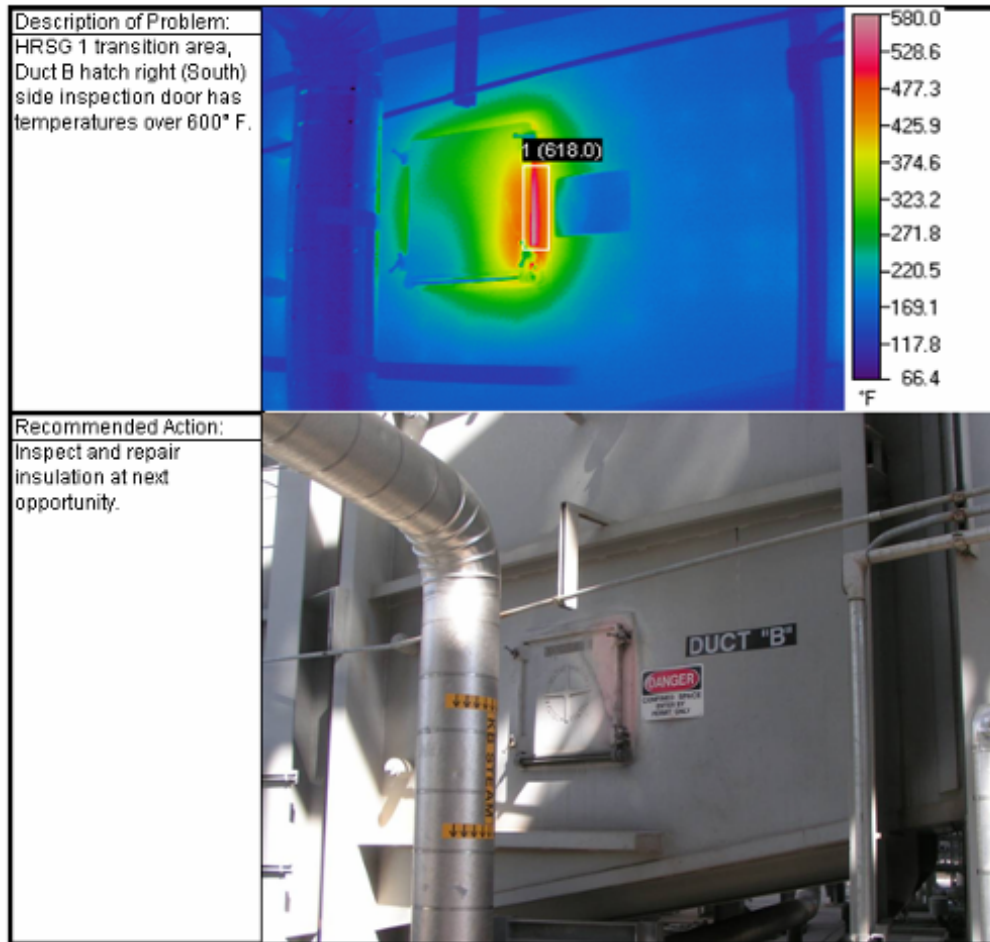
Photo 3: Thermal image of Unit 1's man-way in the transition duct "B".

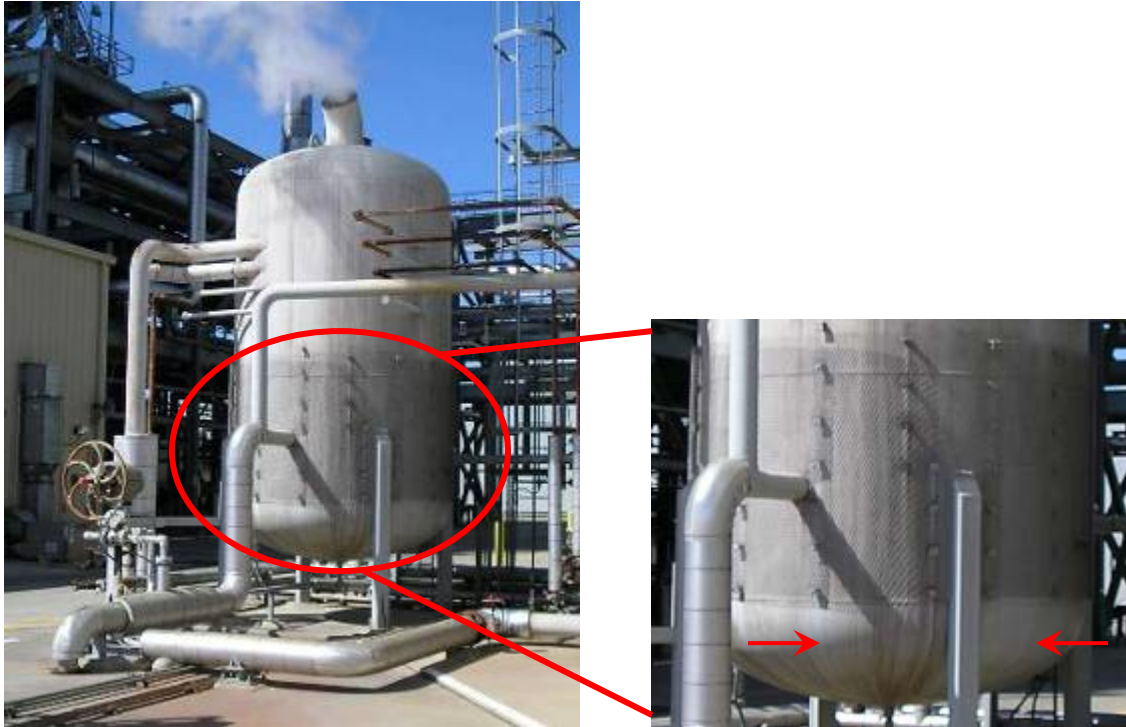
Inadequate barriers on the blow-down tanks expose plant staff to burn hazards, a violation of the Operation and Maintenance Standards.<sup>7</sup> While a mesh wire surrounds the midsection of the tank, the tank’s lower portion lacks a protective barrier and exposes plant staff to burn risks.<sup>8</sup> Further, the tanks are near areas where plant staff walk frequently (See Photo 9).

<sup>8</sup> OSHA – Code of Federal Regulation Title 29 Part 1910 requires hot surfaces within 7 feet of the ground be covered with insulating materials or guarded in manners as to prevent contact.

Photo 9: Blowdown tank's lower portion lacks protective barrier.

The plant added an expanded metal shield to the lower portion of the blowdown tanks to guard against burns (Photo 10).

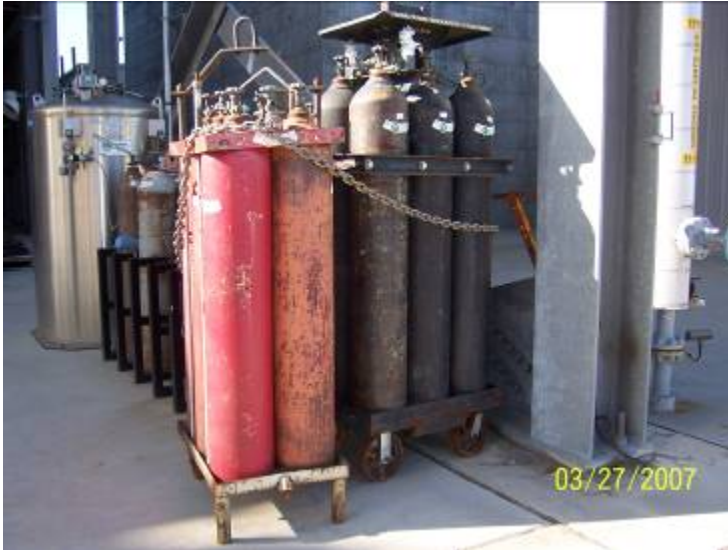
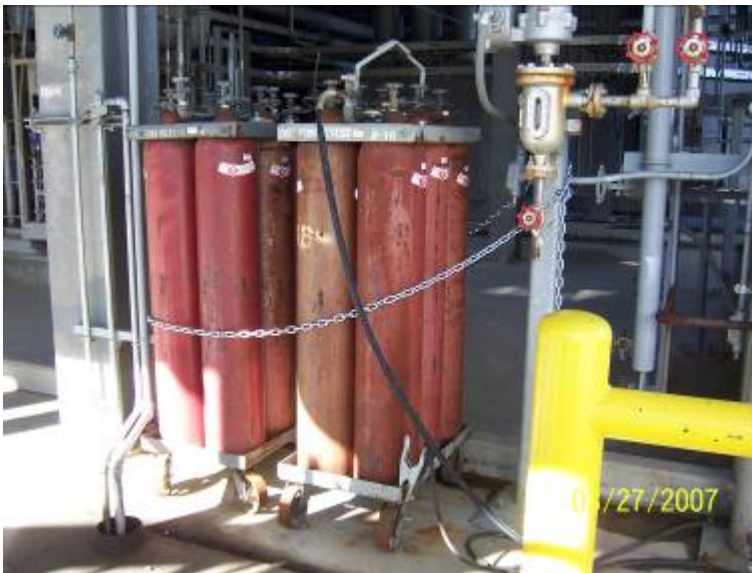
High pressure storage cylinders for hydrogen gas (Photos 11 & 12) are not securely fastened<sup>10</sup> and could be easily tipped over accidentally or during an earthquake, a violation of the Operation Standards.<sup>11</sup>

Earthquakes or collisions could knock over unsecured cylinders and cause serious injuries and/or damage to equipment. Such impacts can shear the regulator valve from an uncapped cylinder, especially if a regulator is attached and unguarded, causing rocking or rapid spinning. Under certain conditions, damaged hydrogen cylinders can become missile-like projectiles.

Photo 11: High pressure hydrogen cylinders are not properly secured.

Photo 12: High pressure hydrogen cylinders are not properly secured.

The plant has replaced cylinder racks and repositioned safety chains (Photos 13, 14 & 15). The plant also reduced its inventory of empty cylinders.

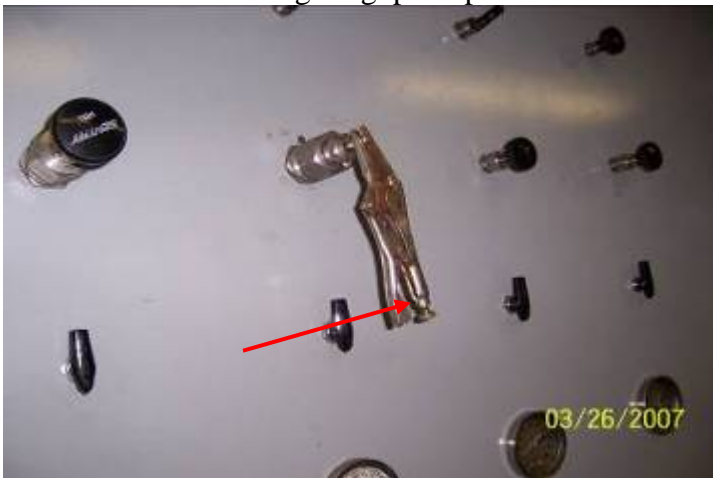
The plant replaced a valve handle (Photo 16) with a vise grip wrench, an awkward arrangement which violates Operation and Maintenance Standards.<sup>12</sup> Located on the chemical sampling panel, the valves isolate and control small streams taken for sampling from the plant's main water and/or steam streams. Use of the vise grip could damage (that is over-torque) the valve, making sampling difficult or impossible, and/or causing leakage of water or steam and thus endangering plant personnel.

Photo 16: A vise grip is used as handle to operate the sample valve.

The plant replaced the valve and wrench with a new valve and handle.

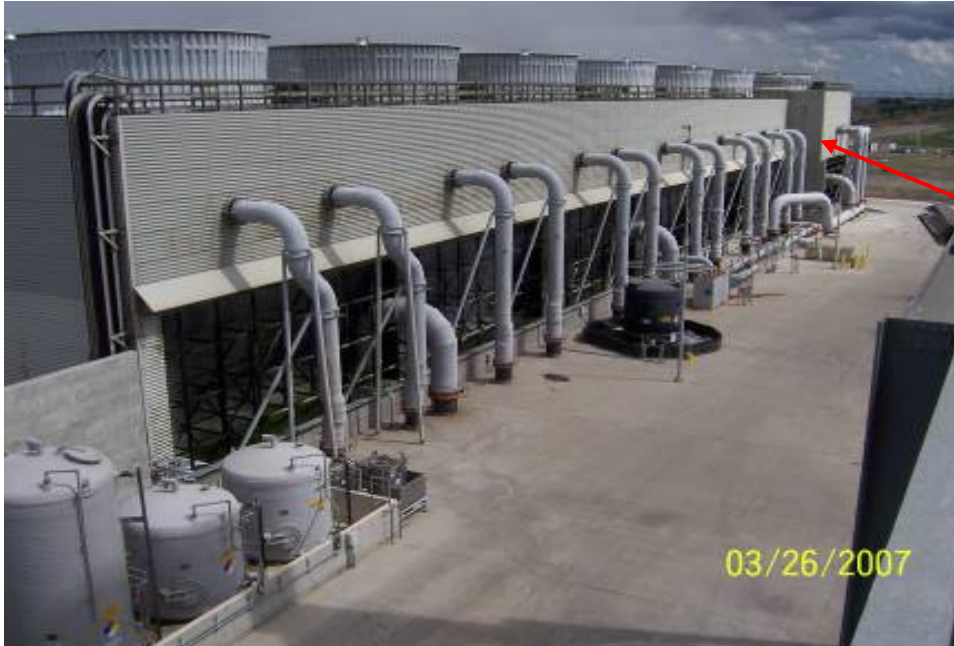
The plant's design drawings for cooling towers fail to show two recently-added cells (Figure 18), a violation of Operation and Maintenance Standards<sup>14</sup>. The plant added two new cells because the original 12 provided insufficient cooling, but never added the new cells to plant drawings. In particular, one design drawing and two of the plant's Piping and Instrumentation Drawings (P&IDs) lack tower numbers 13 and 14, specifically

New cells not reflected on plant P&ID

Photo 18: Cooling Tower drawings do not reflect the addition of two new cells to the cooling tower.

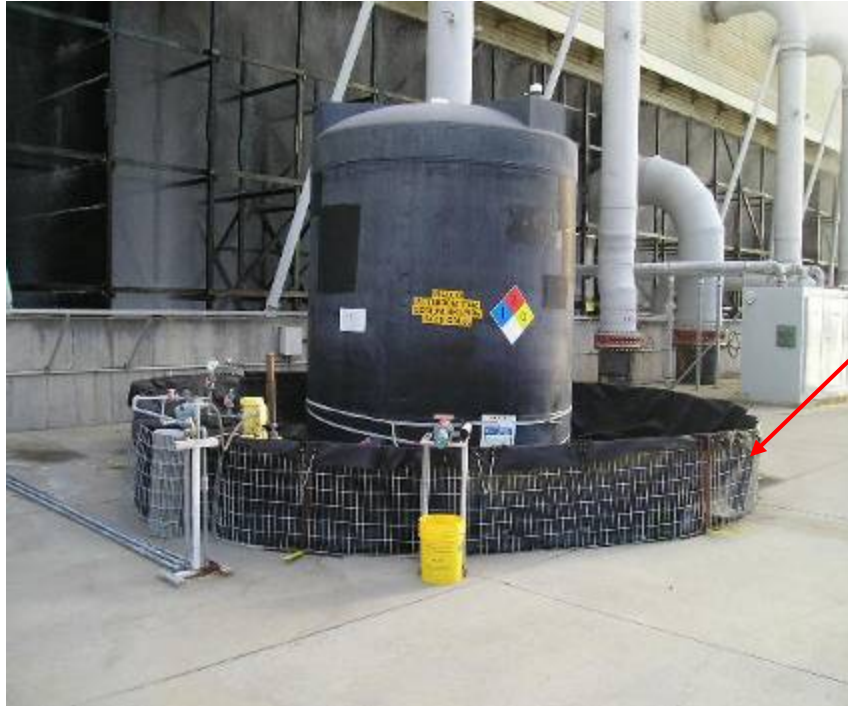
The plant relies on a flimsy plastic tarp, supported by steel mesh, to control spills of sodium bromide, a violation of Operating and Maintenance Standards.<sup>16</sup> The plant adds sodium bromide to cooling water in order to control the growth of bacteria. If touched, ingested, or inhaled, sodium bromide irritates the skin, eyes, and respiratory system; in large quantities it damages the eyes and nervous system. While experimenting with different chemicals and chemical injection systems, the plant installed the tarp (Photo 19) to provide temporary secondary containment,<sup>17</sup> that is, to control spills from the bromide storage tank. The plant permanently adopted the bromide injection system, but never replaced the tarp. The tarp is not acceptable for permanent use because it is located in an open area where passing vehicles, hand carts, or heavy winds can damage it.

Temporary tarp used for secondary containment structure

Photo 19: Temporary sodium bromide chemical injection system.

The plant decided to discontinue use of sodium bromide and to remove the associated chemical injection tank and system. An auditor verified the removal of the tank piping and pumps on Sept. 11, 2008 (Figure 20).

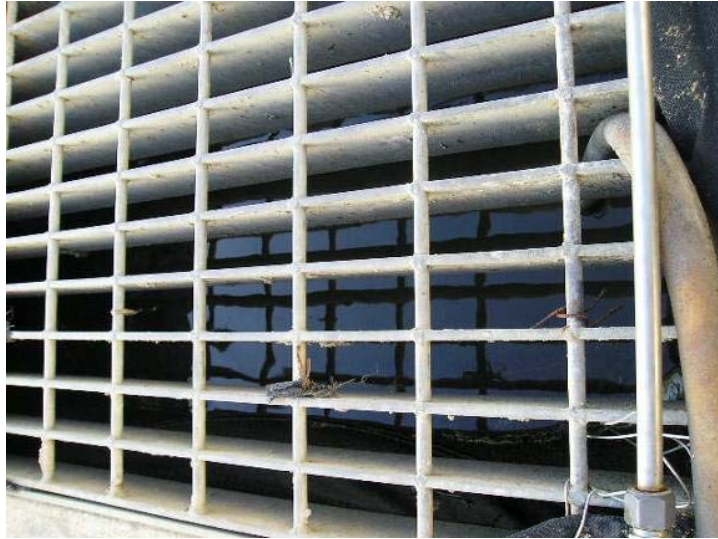
Photo 21: Clogged debris screen in storm drain.

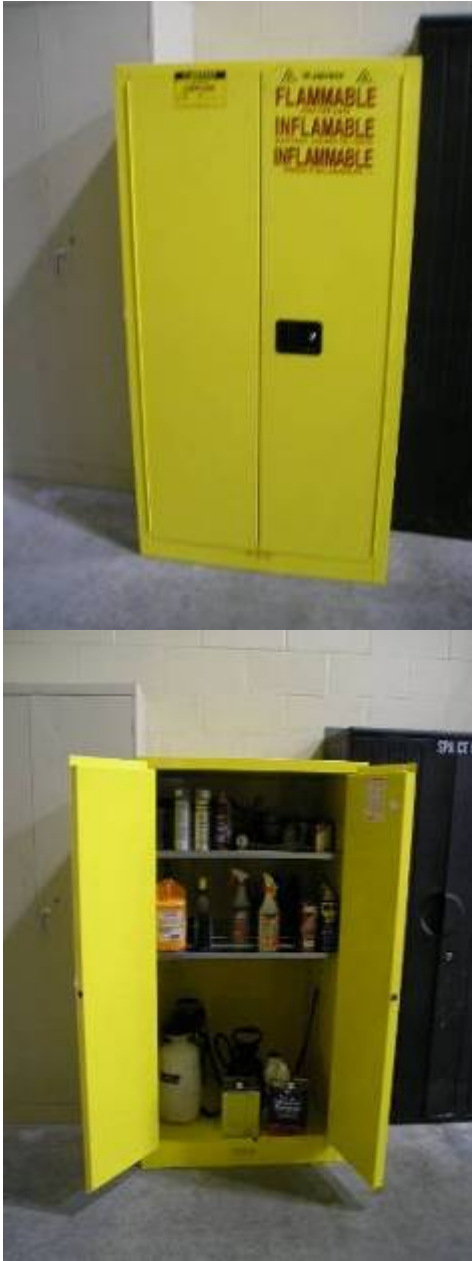
Photo 22: The flammable liquid storage locker does not have an automatic door closer.

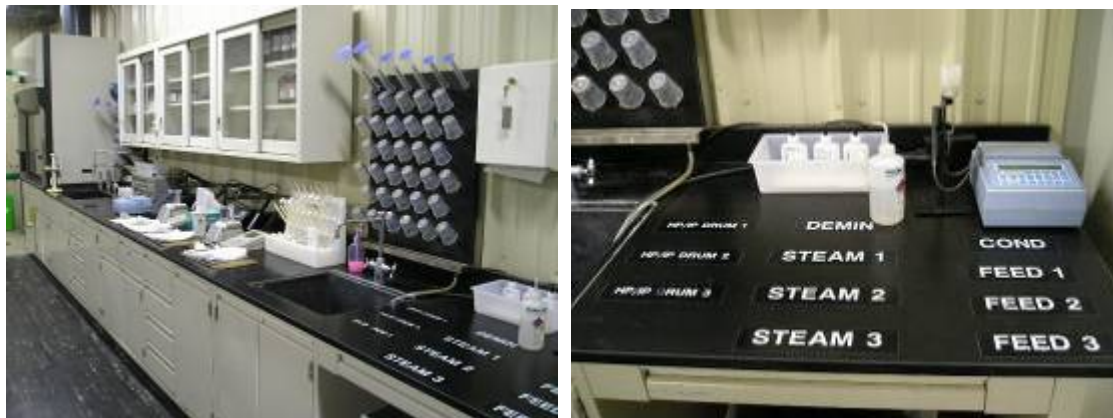
The CPSD Auditor found the water chemistry laboratory to be very well-organized and clean (Photos 23 thru 25).

Photo 23: The chemistry analysis table holds multiple water analysis devices and is well organized.

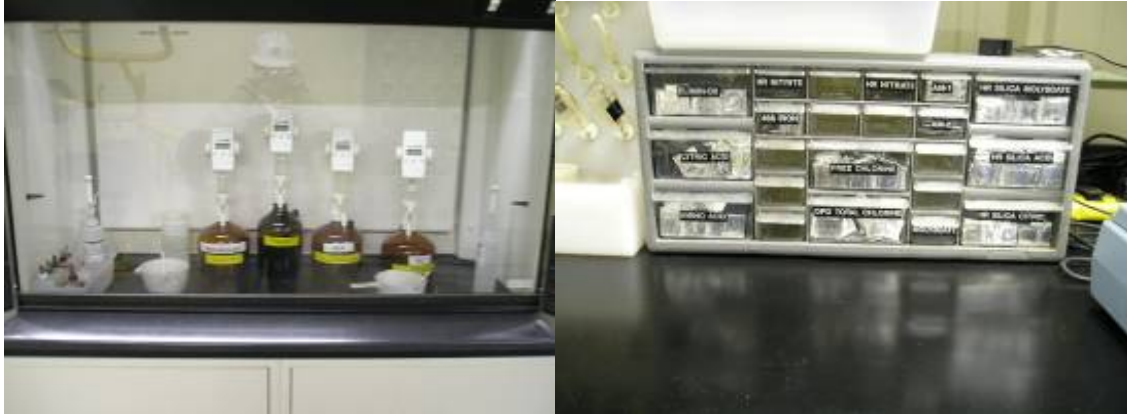
Photo 24: Reagents and corrosive chemicals are properly stored and bench tops are free of clutter.

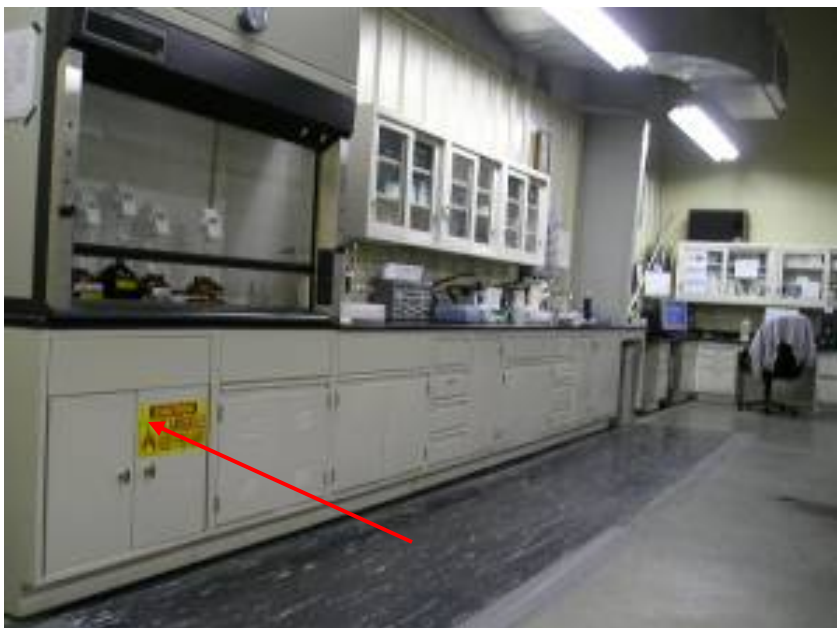
Photo 25: The flammable storage cabinet below the fume hood has self closers.

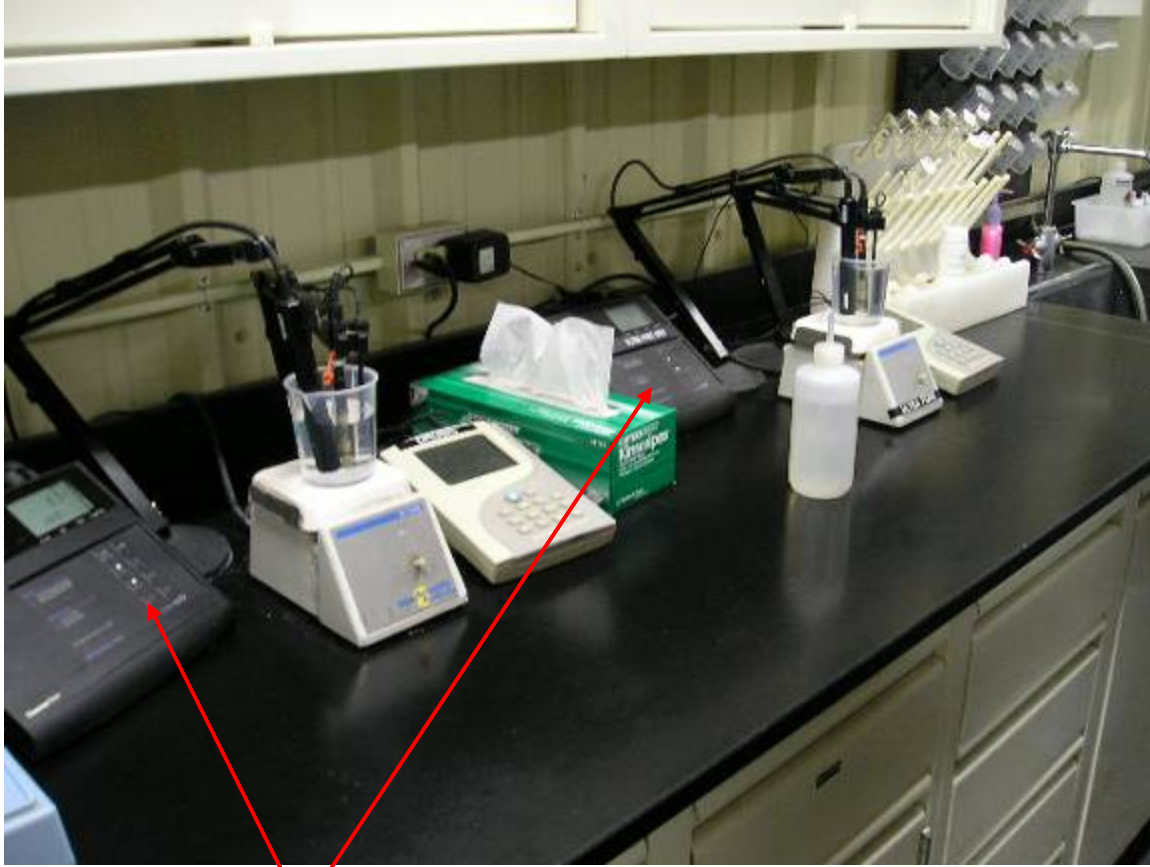
The chemistry lab contains multiples of various kinds of water analysis equipment (Photo 27) which allows staff to double-check measurements and to calibrate one device against another. These pieces of equipment measure water pH, silica, chlorine and iron, among other things.

Photo 27: Multiple water analysis devices can be seen on a clean, well organized lab table.

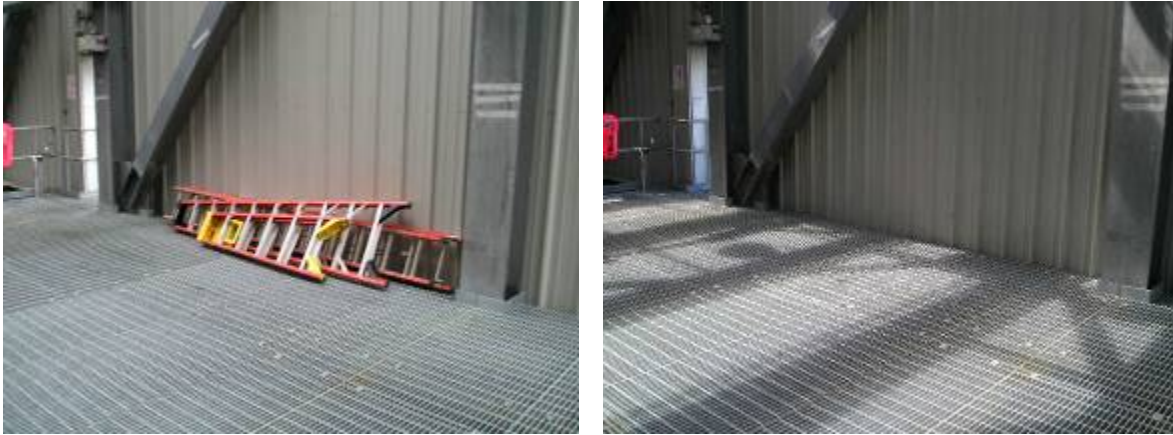
Photo 30: Improperly stored ladders were removed within hours of notification during the Audit.

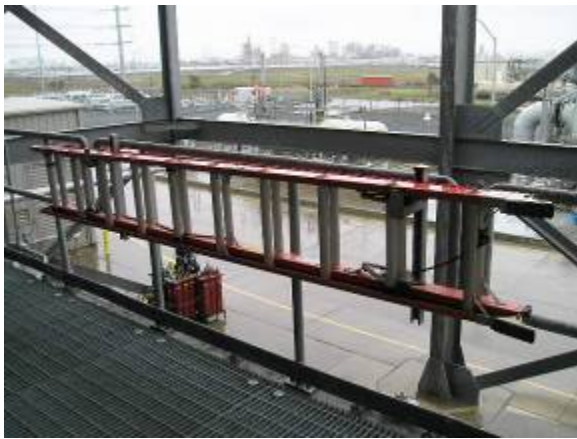
Photo 31: The plant stores ladders on hangers, leaving walkways clear.

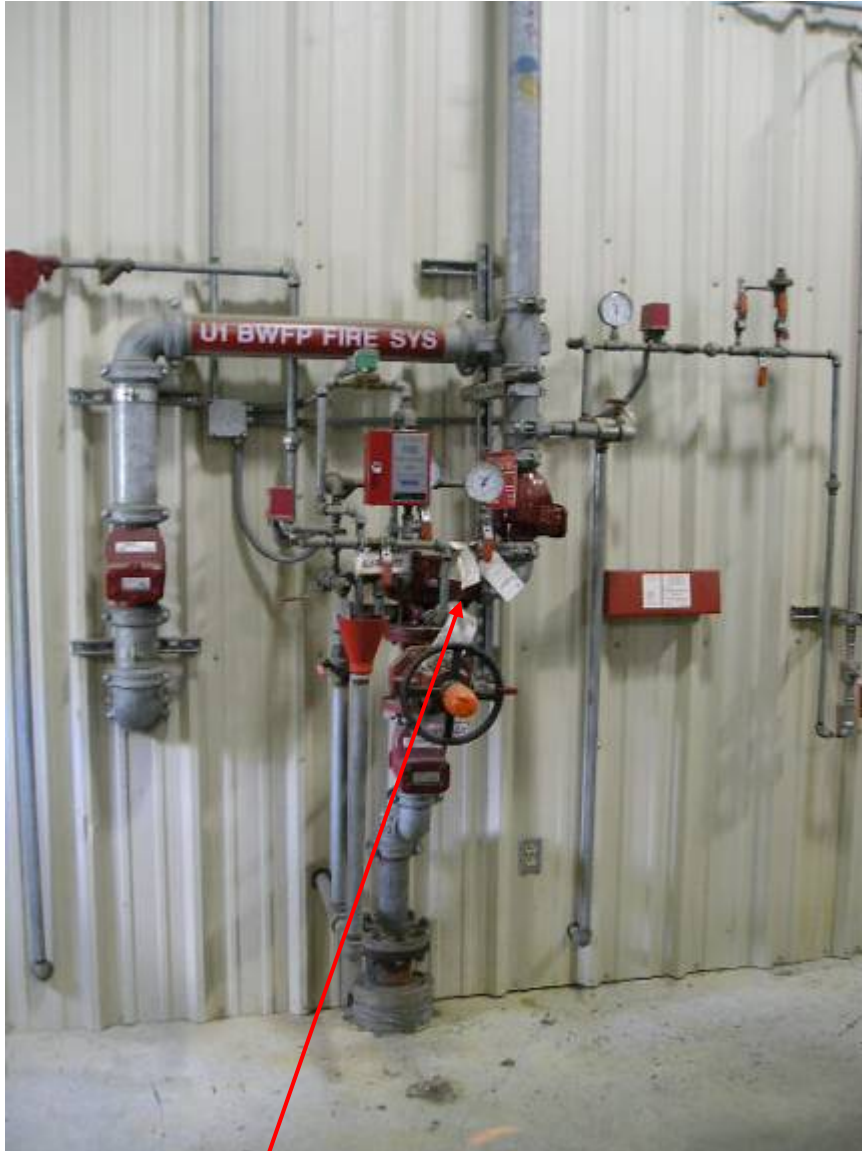
Photo 33: Inspection tags are visible on the boiler feedwater pump fire suppression system.

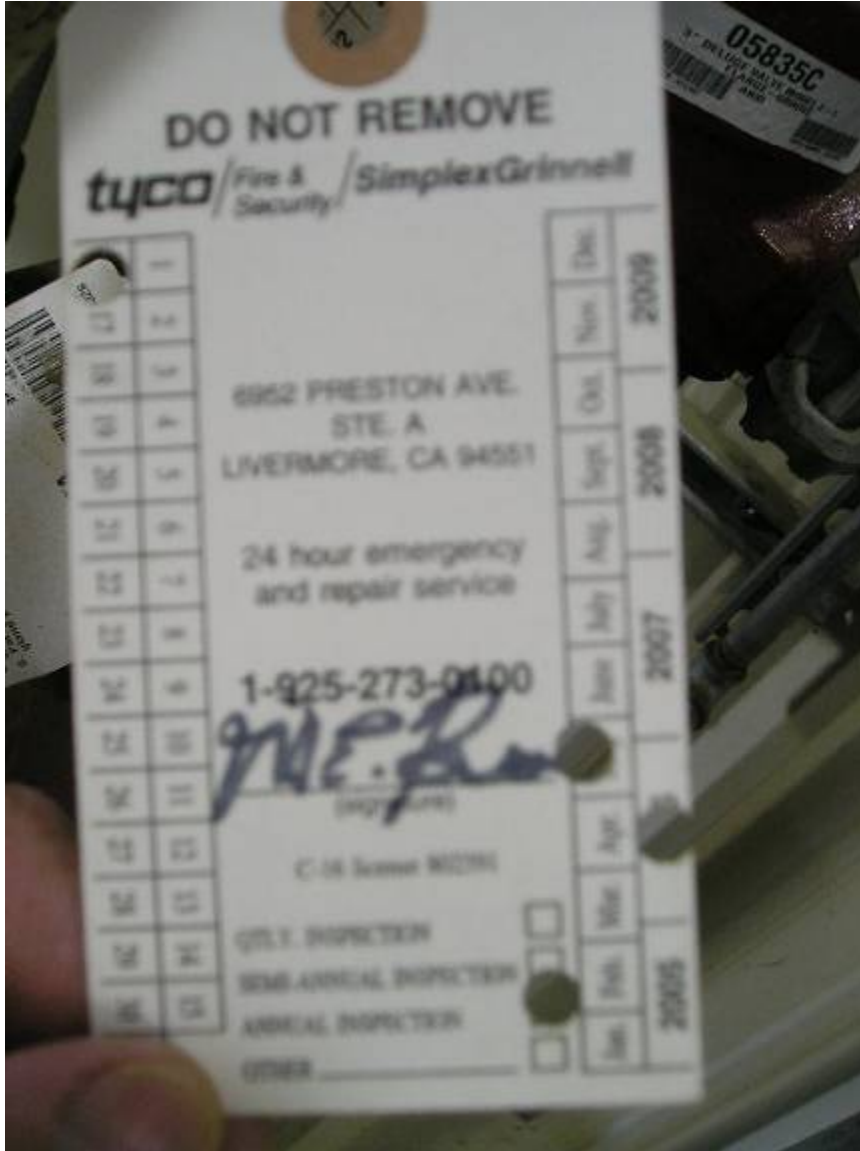
Photo 34: Close-up of the fire suppression system inspection tags show an inspection date of May 2006.

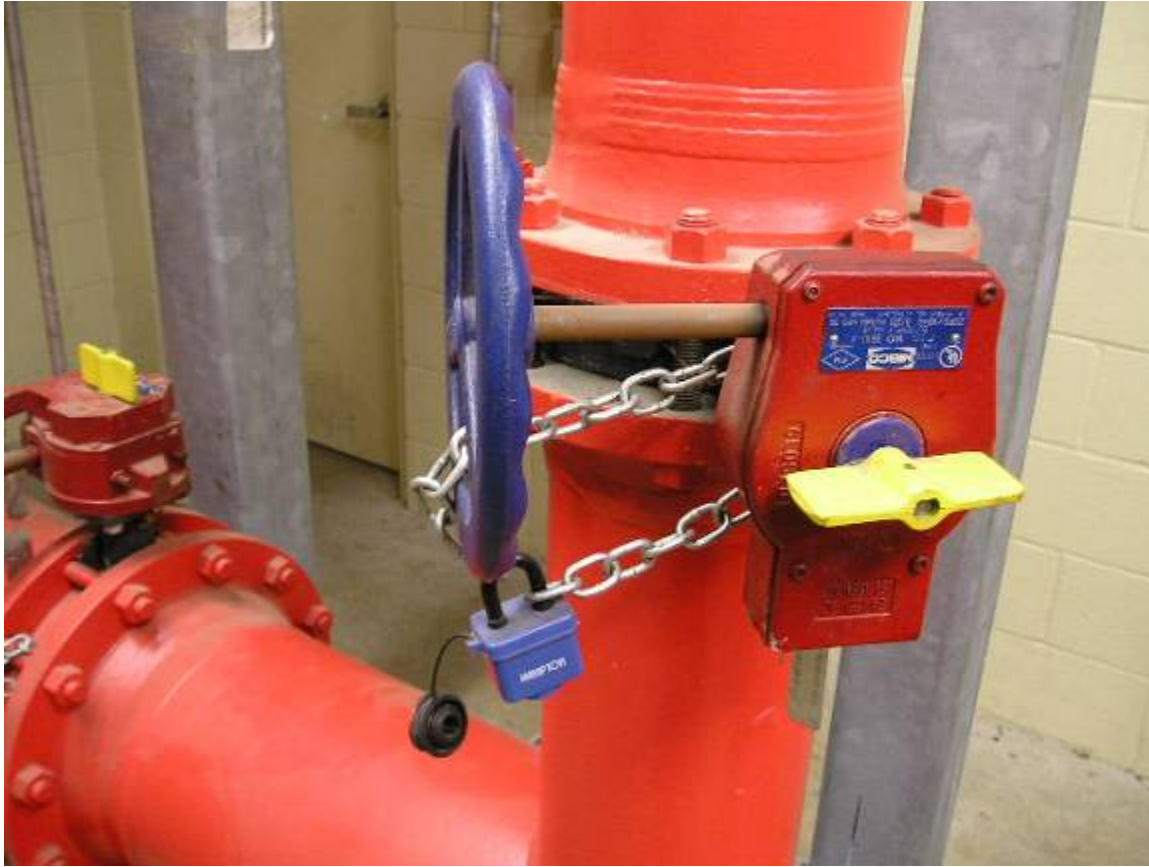
Photo 36: Locks are installed to prevent accidental closure of valves as recommended in the May 2006 inspection.
