**SUBJECT: General Order (GO) 167 Compliance Audit of Russell City Energy Center  
Audit Number GA2019-01RC**

**Audit of the  
Calpine Corporation  
*Russell City Energy Center***

**Audit Number GA2019-01RC**

**STAFF REPORT**

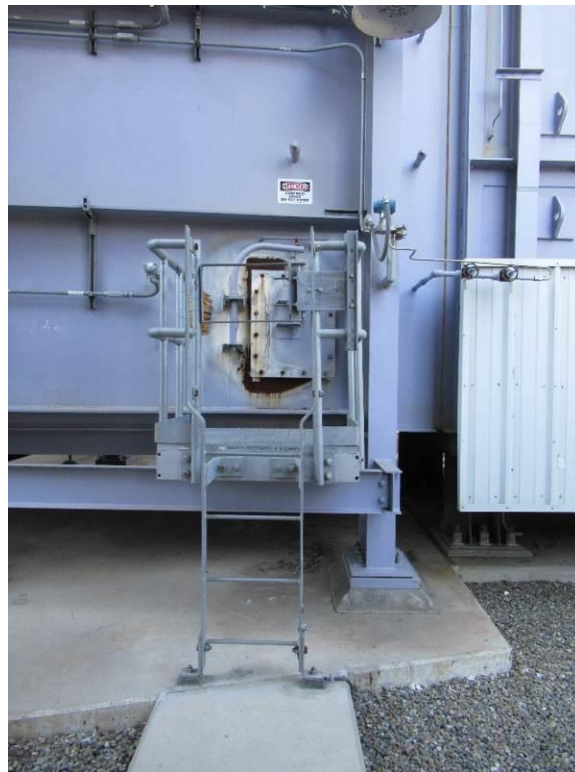
**Finding 2: Manway hatch is severely corroded and presents a burn risk for workers.**

ESRB observed a severely corroded access hatch on Unit 1’s HRSG. The corroded surface and discoloration surrounding the hatch indicate the area has been subject to high heat flux. This presents a burn risk hazard for workers as the hatch is within reach from ground level.<sup>1</sup> The Plant must take corrective action to mitigate the hazard and repair the defect. While ESRB did not observe similar defect on Unit 2, it recommends the Plant to inspect and assess all HRSG manways to identify and prioritize repairs where appropriate.

*Figure 1: Manway hatch is severely corroded and presents a burn risk for workers.*

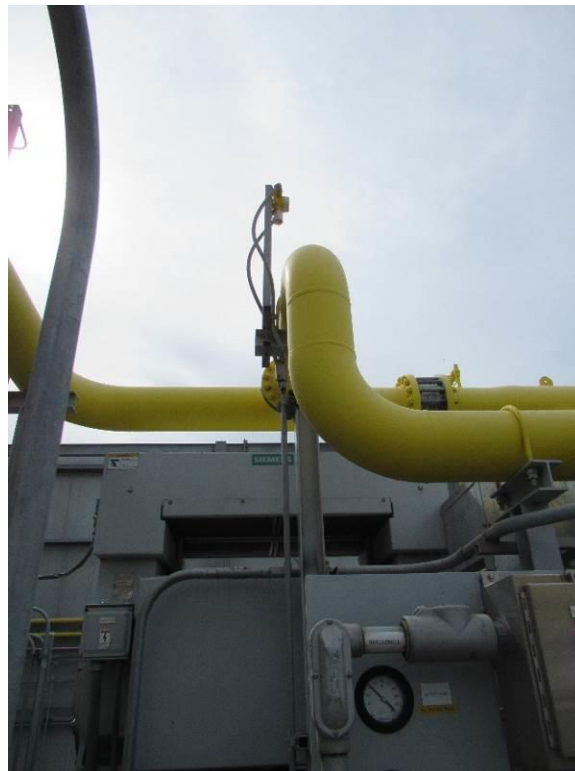
**Finding 3: Methane detectors at the fuel gas compressors are defective.** Due to the methane sensors at the fuel gas compressors being defective, the compartment currently lacks leak detection capability. There're four methane detectors in the compartment, all of which are not

functioning due to a low or no voltage (i.e. sensors are not receiving their power supply in proper voltage in order to function and detect). ESRB noticed that Russell City created a Level 4 (urgent) work order in Maximo on January 24, 2019.<sup>2</sup> However, at the time of the audit (March 2019), the Plant still has not yet repaired the defect. Methane sensors are a part of the fire protection system that detect leakage of natural gas which can accumulate in the compartment and lead to a natural gas explosion. The Plant must repair the detectors as soon as possible.

*Figure 2: Methane detectors at the gas compressors are defective.*

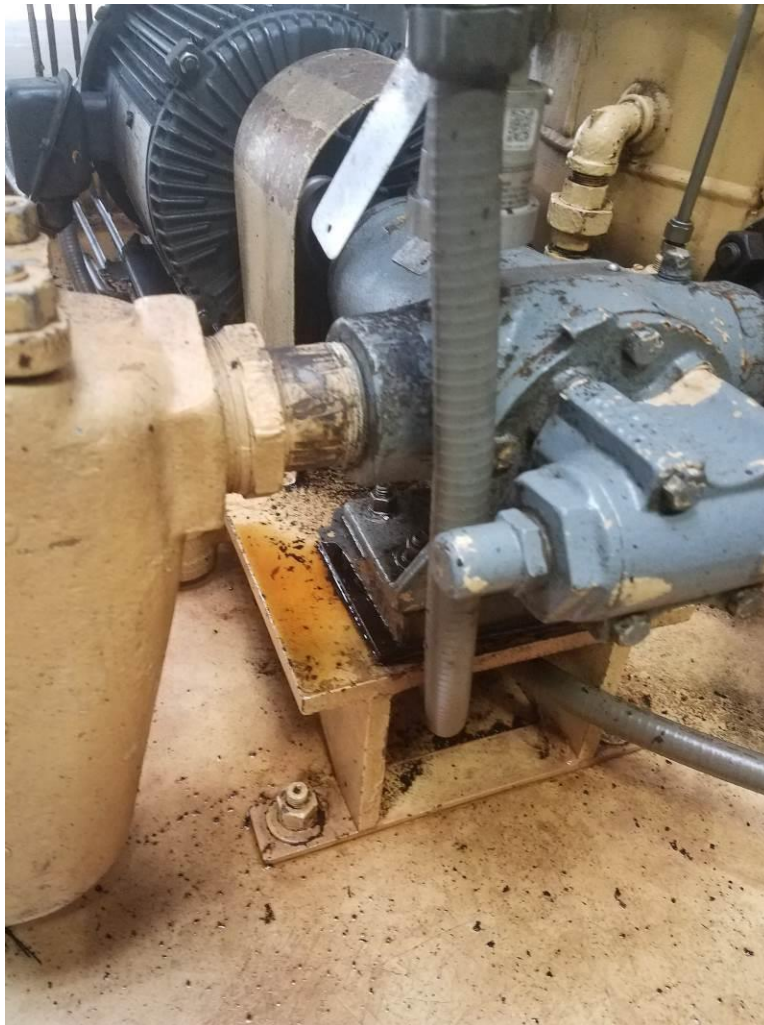
**Finding 4: ESRB observed oil leaks at the steam turbine lube oil pump skid.** The oil appeared to be leaking from the pump seal. Lube oil is flammable and can catch on fire if it contacts hot bearing or other pump surfaces. The Plant had previously created a work order (#26659485) to repair the leak, but the leak persisted. In response, the Plant generated a new work order (#27404664) and assigned it a priority level 3 to repair the defect. The Plant must repair the leak before it gets worse.

*Figure 3: Oil leaks at the steam turbine lube oil pump skid.*

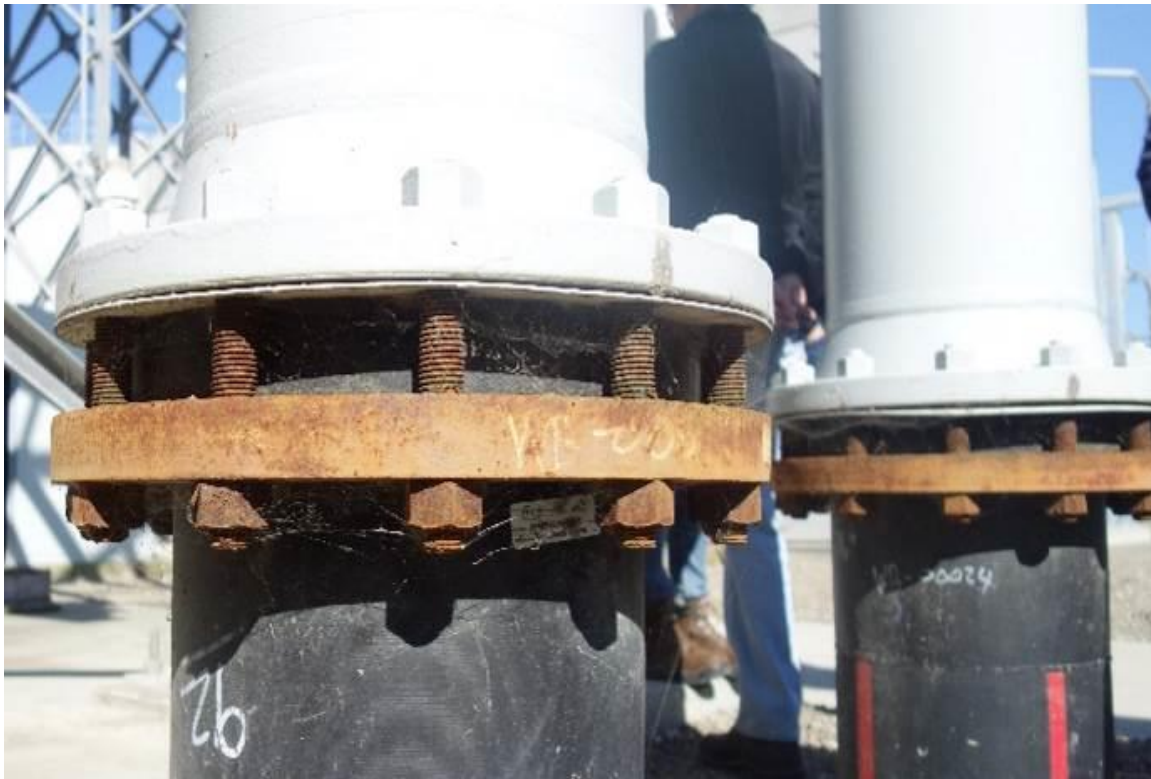
**Finding 5: ESRB observed atmospheric corrosion on piping and pipe flanges**, particularly on the cooling tower risers, and at the zero-liquid discharge (ZLD) crystallizer (See Figures 4 to 9). The Plant plans to clean and repaint the corroded surfaces and is looking into solutions to abate corrosion. As stated in Finding 1, the Plant is located close to the bay and is exposed to moist and corrosive sea air where corrosion is of concern. The Plant must take proper corrective action to address and mitigate atmospheric corrosion on equipment such as increasing the frequency of inspection and re-coating.

*Figure 4. Corroded pipe flange.*

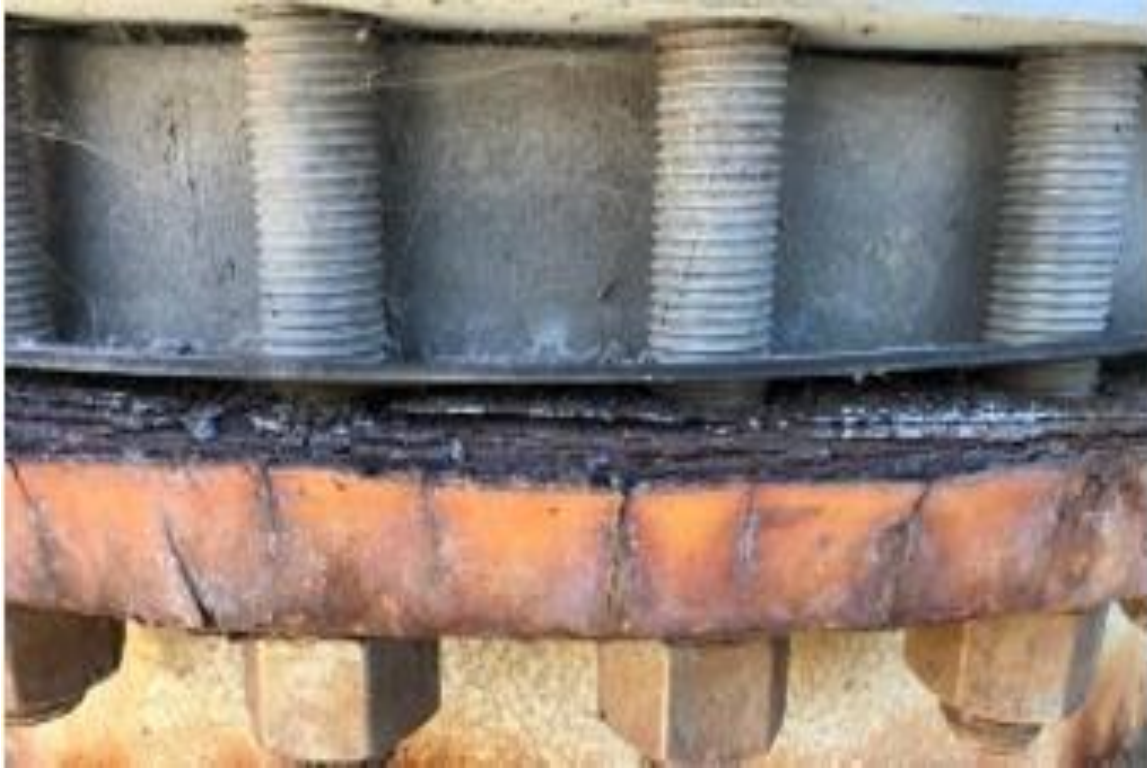
Figure 5. Corroded pipe flange.

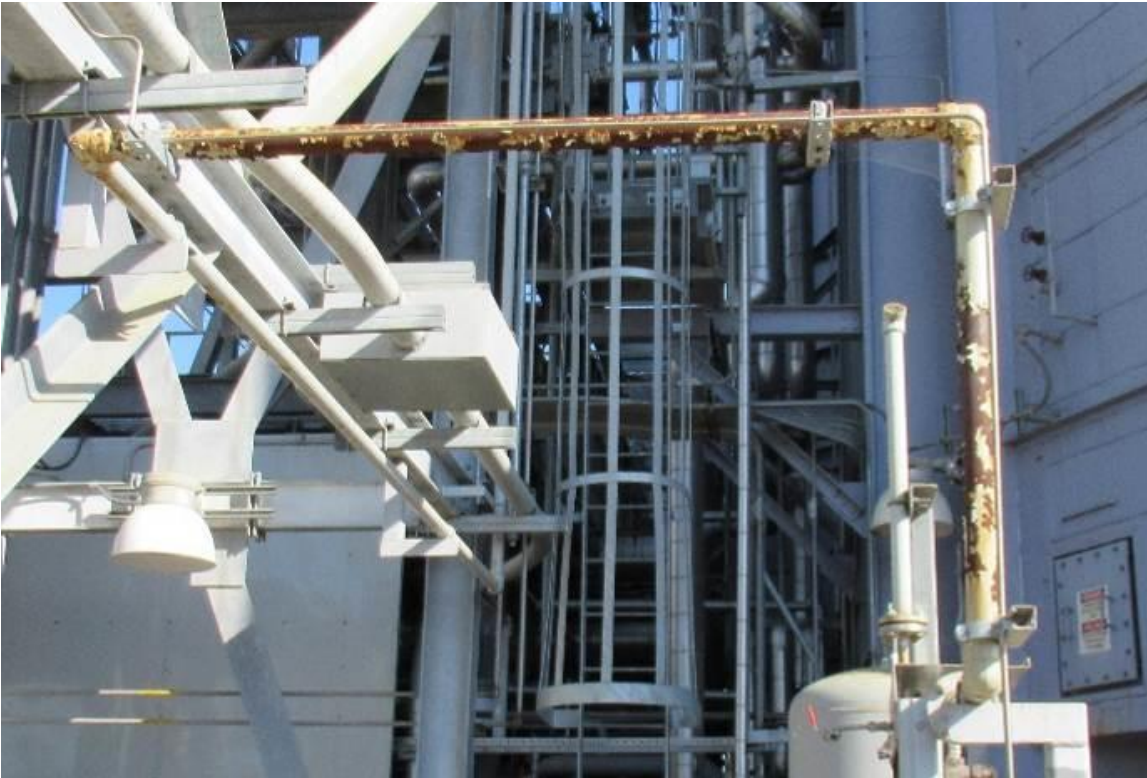
Figure 6. Corroded piping.

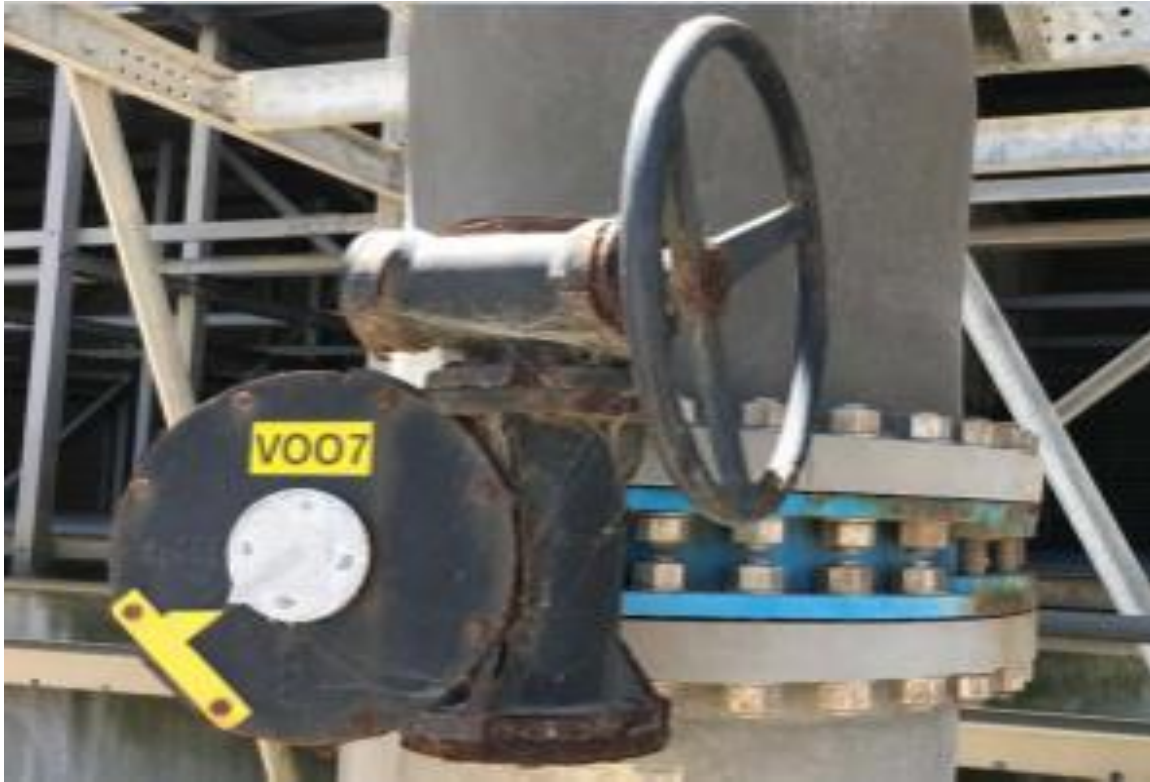
*Figure 7. Corroded riser butterfly valve at the cooling tower.*

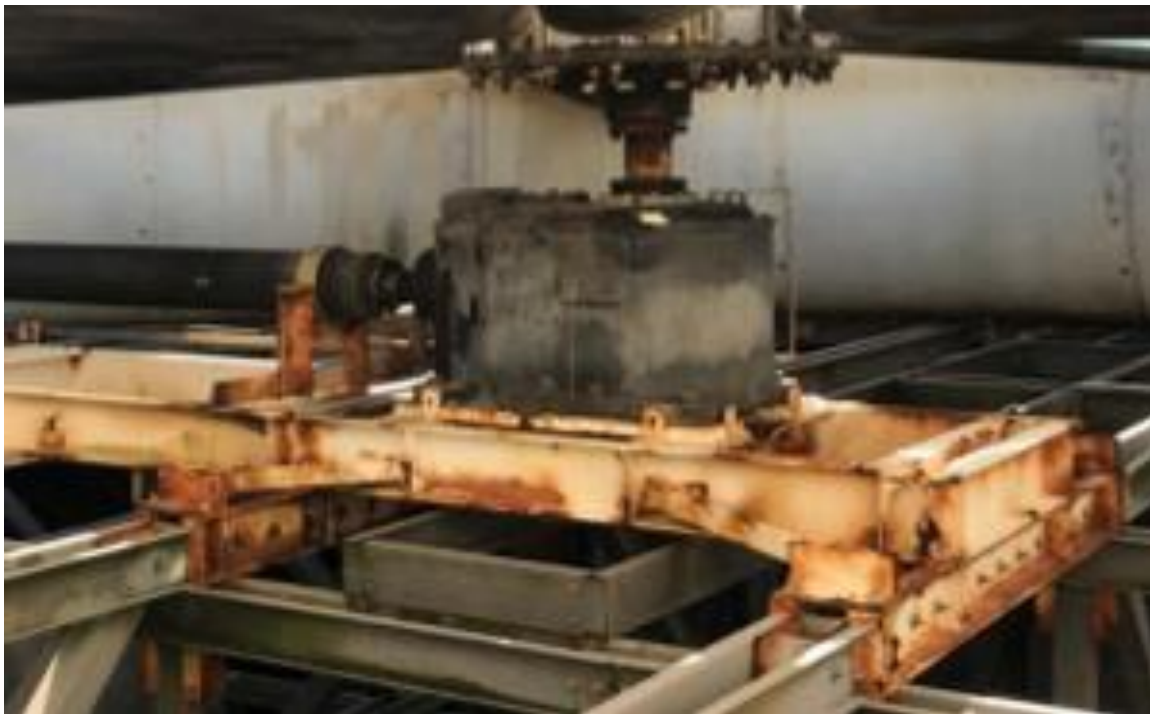
*Figure 8. Corroded support braces.*

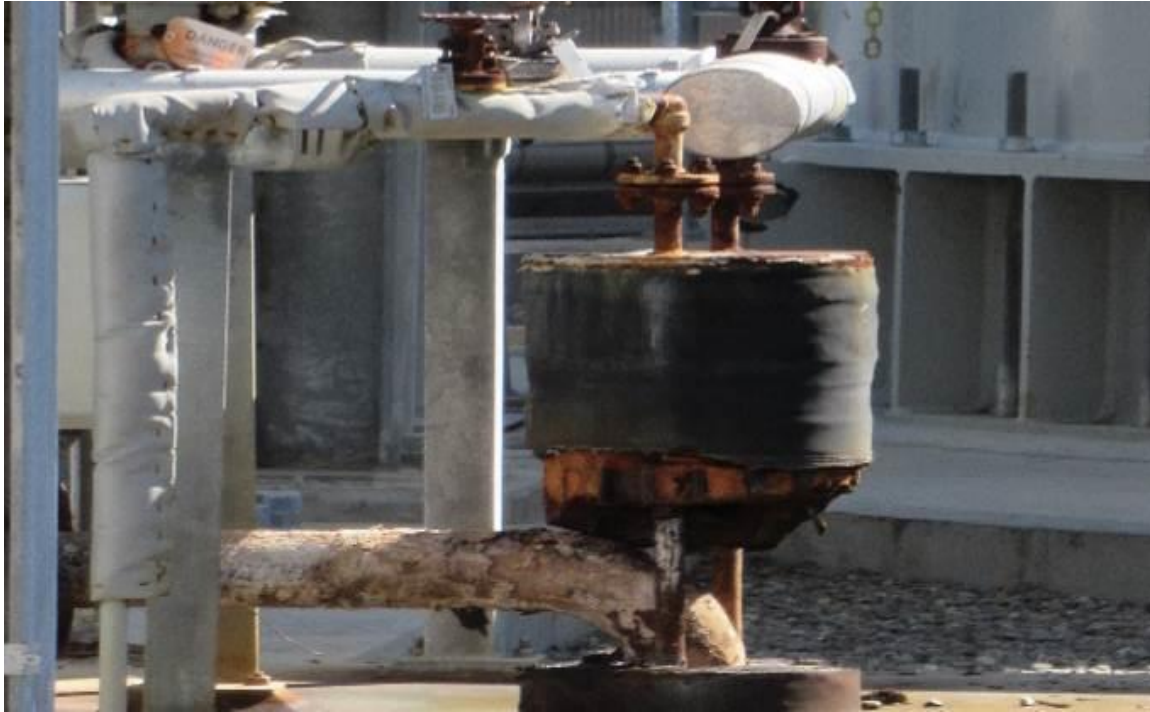
*Figure 9. Corroded equipment at the ZLD.*

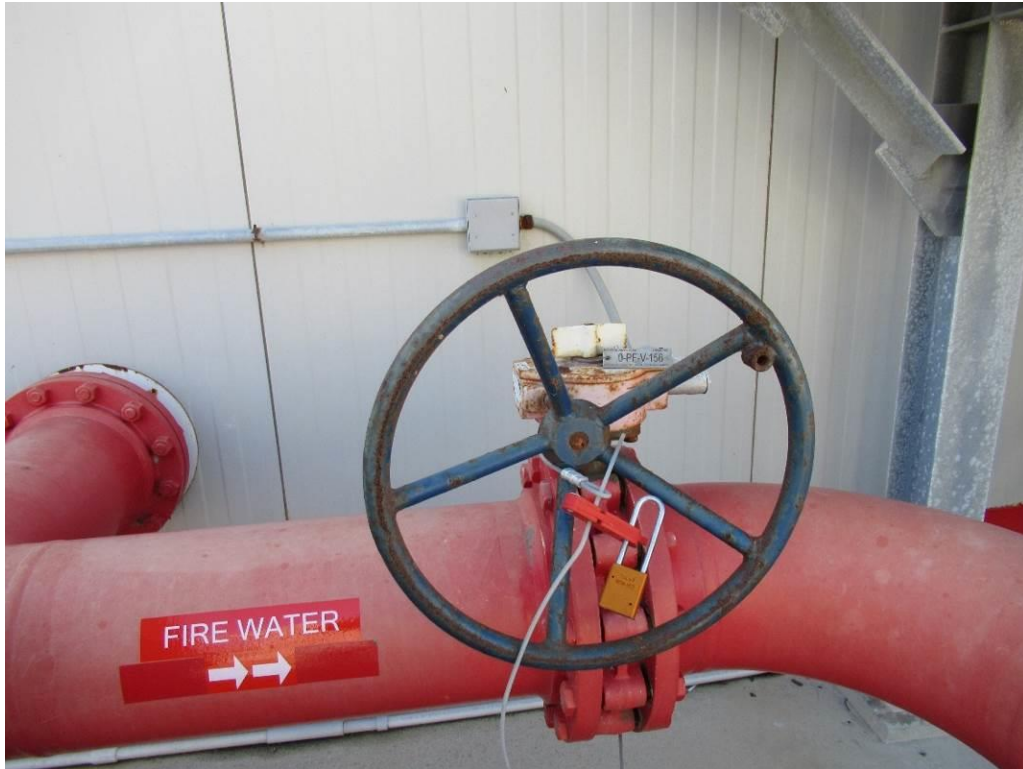
**Finding 7: Tamper switches at two control valves outside the fire pump house are defective.** Per inspection conducted by ORR Protection, two flow control valves next to the fire pump house had defective tamper switches. The Plant confirmed it has not repaired or replaced the switches. While the valves are currently locked open by chain, the tamper switches provide a secondary measure against inadvertent closure of the valves. Water flow to hydrants and sprinklers deluge systems is crucial in the event of a fire. The Plant must repair the defective switches to prevent tampering or accidental closure that would shut off the fire water supply.

Figure 10: Tamper switches at two control valves outside the fire pump house are defective.

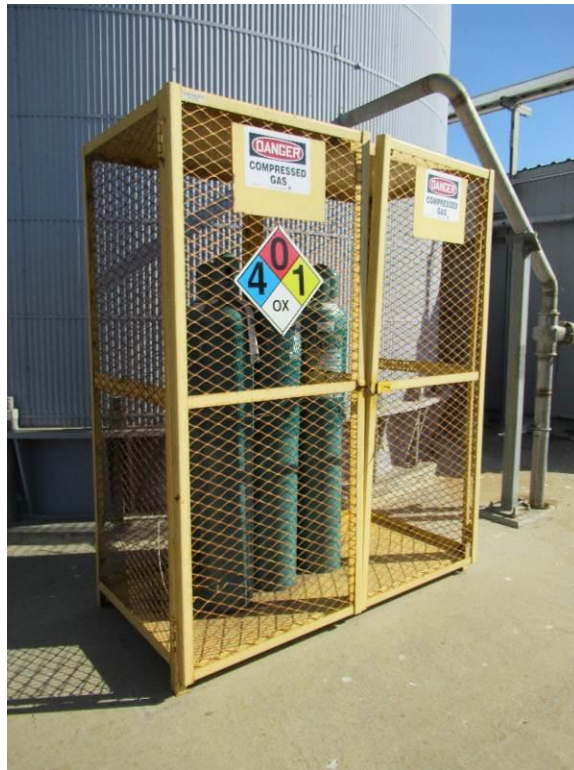
**Finding 10: Compressed gas cylinders are not being secured properly.** ESRB observed improper storage of compressed gas cylinders by the CEMS shack. The high-pressure gas cylinders are loosely held by a single chain with no secondary support, and are otherwise, freestanding. While the Plant stores the tanks inside a metal cage, ESRB observed the cage doors are not secured. General Industry Standard requires compressed gas cylinders to be stored in a manner to prevent hazards by tipping, falling, or rolling.<sup>3</sup> Russell City is located near the Hayward Fault and the area is prone to seismic activities and minor quakes. The Plant must properly secure compressed gas cylinders to prevent tip-overs.

*Figure 11: Compressed gas cylinders are not being secured properly.*

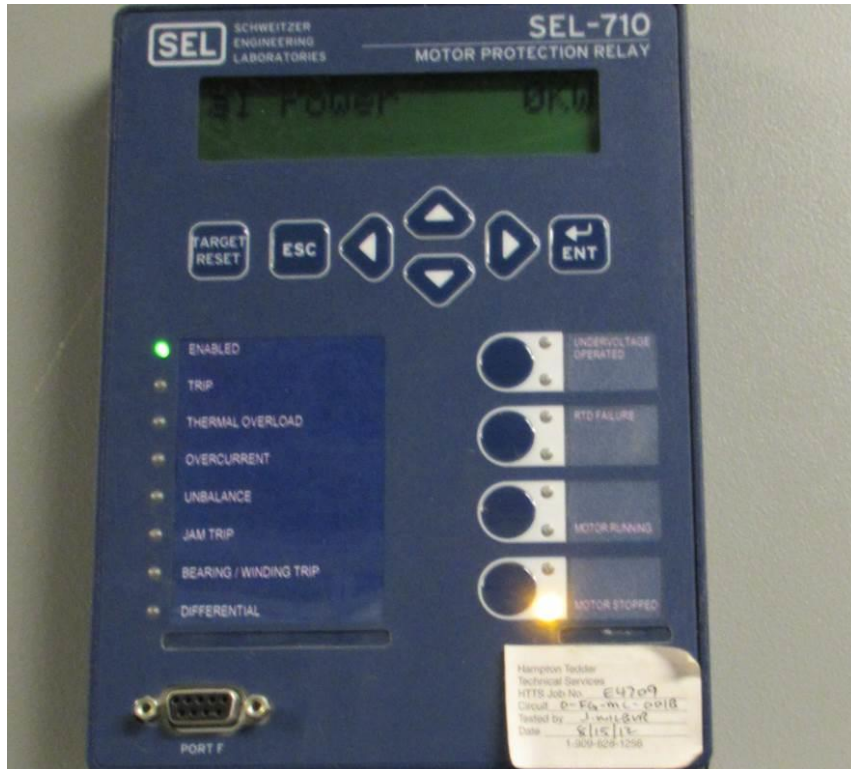
**Finding 11: Calibration stickers are not kept up-to-date.** ESRB observed outdated calibration stickers on breaker relays in the 4160V load center. Similarly, online analyzers in the Sampling Water Analysis Shack also have out-of-date stickers. Outside operators routinely take readings off of these instruments. Without up-to-date stickers, operators may get confused as to whether or not the instrument reading is reliable, which may lead to operational error. While the Plant may track calibrations separately in a database, stickers at the instrument location (point of reading) is an effective and inexpensive way to communicate to the operator regarding the instrument’s calibration status.

Figure 12: Calibration stickers are not kept up-to-date.

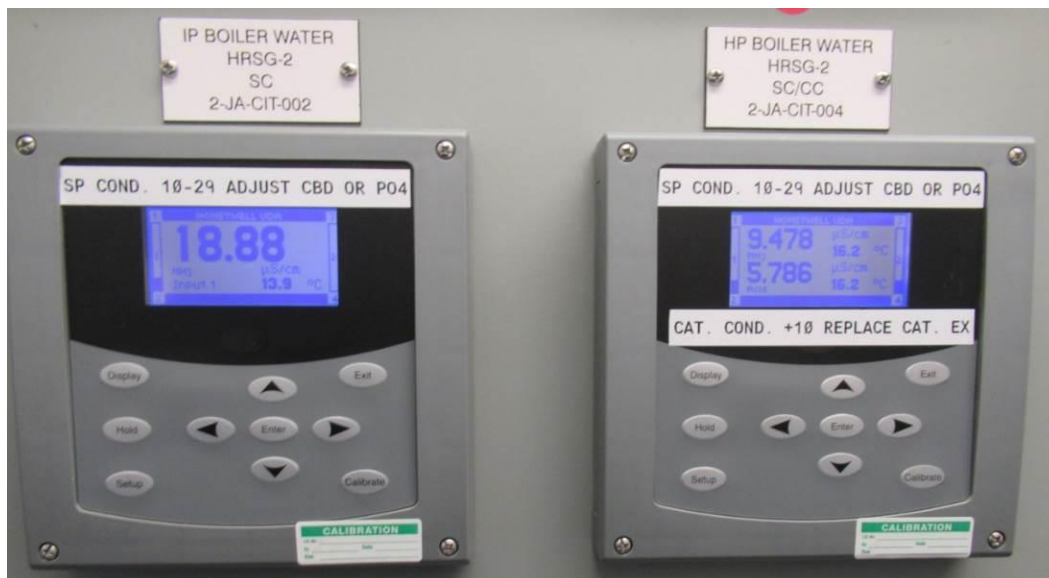
Figure 13: Calibration stickers are not kept up-to-date.

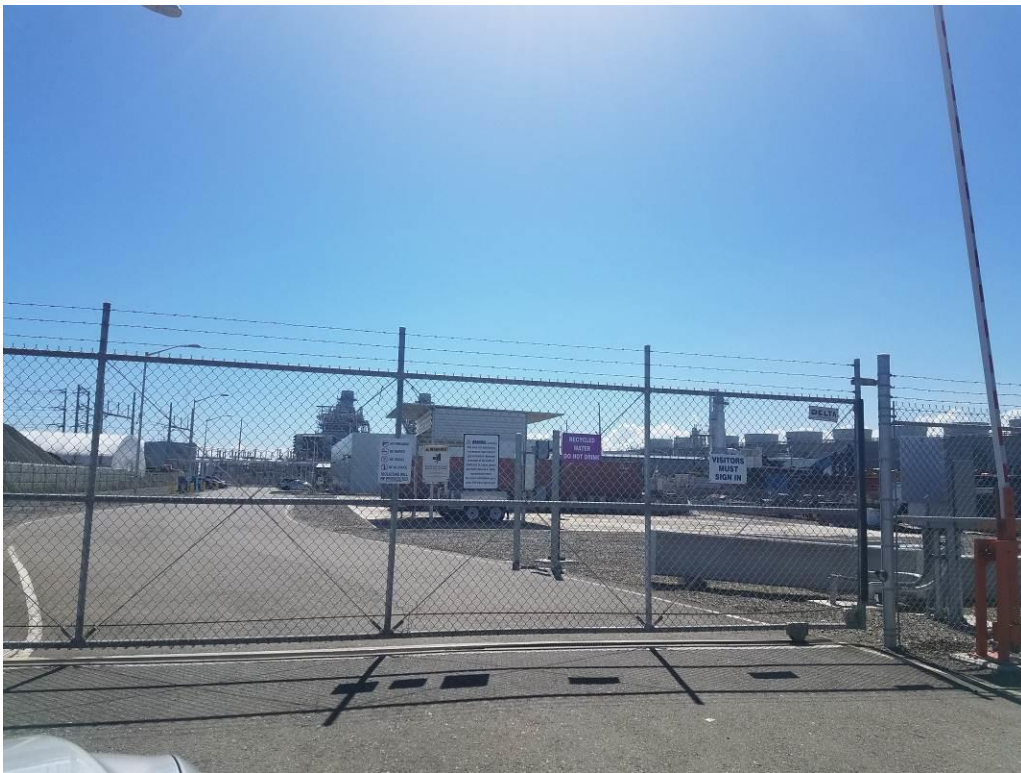
**Finding 12: Missing NFPA Placard on main gate.** ESRB observed that the Plant’s main gate did not have a National Fire Protection Association (NFPA) 704 warning placard. The Plant

stockpiles and uses hazardous chemicals as part of its normal operation, including ammonia for emission controls, sodium hypochlorite, pH adjuster, and oxygen scavenger for feedwater controls. NFPA 704 is a standard system for identifying hazards of materials for emergency response. The posting of an NFPA placard on the main gate is a common industry practice so first responders can quickly and easily identify the risks posed by a facility's hazardous materials. This helps emergency personnel to determine what safety gear and precautions to use and how best to respond in emergency situations. In response, the Plant installed a placard on the main gate. Therefore, the Plant does not need to take further corrective action.

*Figure 14: Missing NFPA Placard on main gate.*

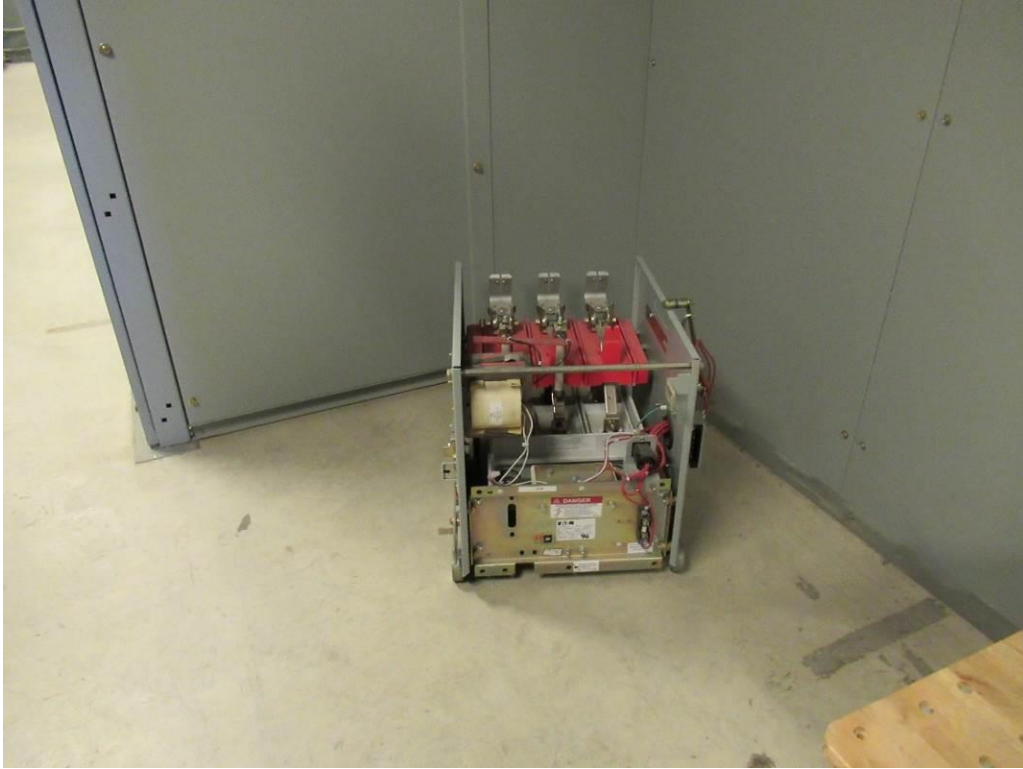
**Finding 14: Improper storage of spare component.** ESRB observed a metal-clad breaker being precariously stored in the 4160V load center. The Plant should store spare components in the warehouse where they’re properly tracked and inventoried. In response, the Plant relocated the spare part back into proper storage in the warehouse. Therefore, the Plant does not need to take further corrective action.

*Figure 15: Improper storage of spare component.*

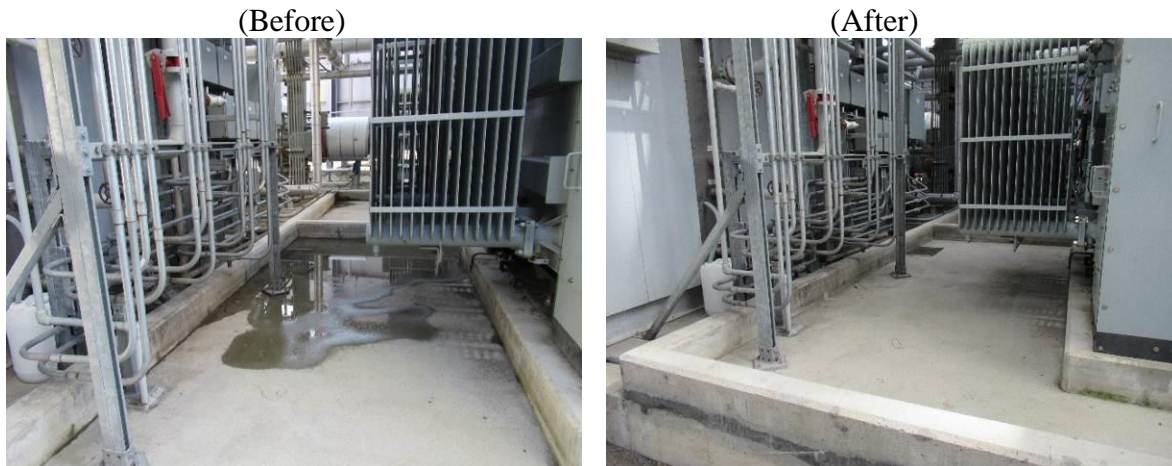
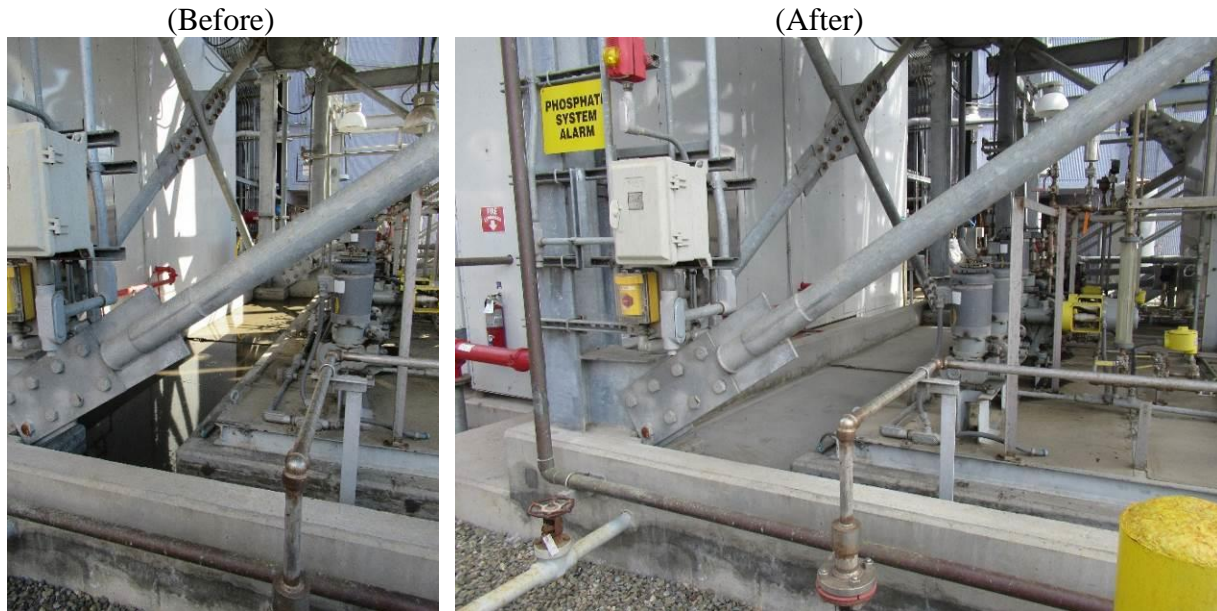
**Observation 1: Water ponding in secondary containments.** ESRB observed water ponding in secondary containments of Unit 1’s station transformer and phosphate storage tank. Due to recent storms, rainwater had accumulated in the containment. In response, the Plant tested the water with pH strips (confirming it was indeed storm water) prior to draining the water out of the containment. Containments are designed to hold certain fixed volume per the equipment in the event of a leak. Allowing water to pond in the containment displaces its design volume and defeats its purpose. While the amount of water in the containment did not appear to significantly lower the catch volume, ESRB nonetheless recommends the Plant to follow good industry practice to drain containments after major storms.

Figure 16: Before and after photos of water ponding in secondary containments.
