PUBLIC UTILITIES COMMISSION

GA2022-04BSS

SUBJECT: Generation Audit of AES Big Sky Substation

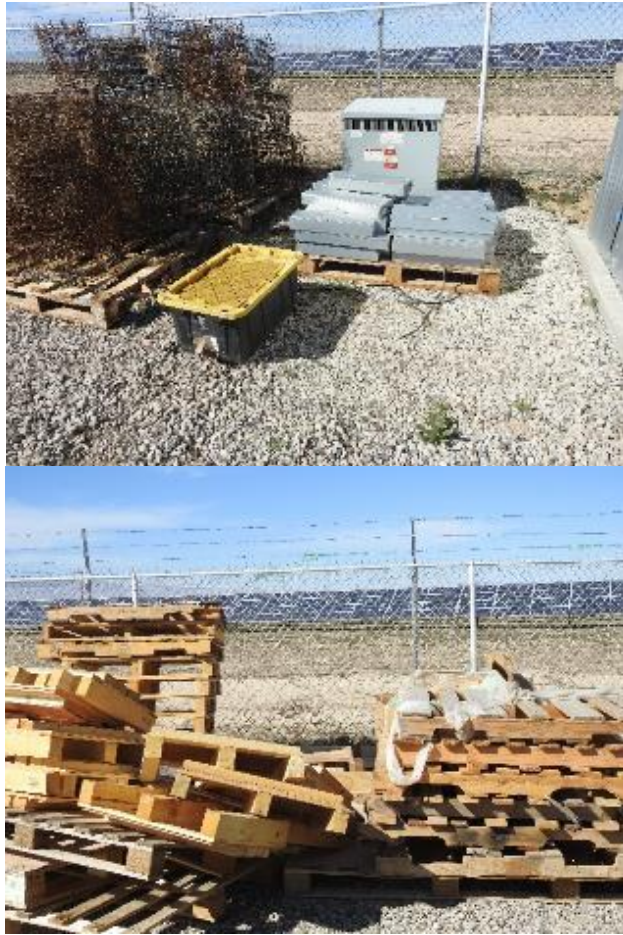
1. Finding: Improper storage of waste and materials.

ESRB staff observed surplus and waste items stored outside the storage area. Items should be properly stored if intended for future use or properly disposed of for environmental and safety reasons.

Figure 1 is of a storage container that contained an unidentified fluid and a pallet supporting electrical components left outside unprotected. Figure 2 is of a photograph of a stack of disarray pallets.

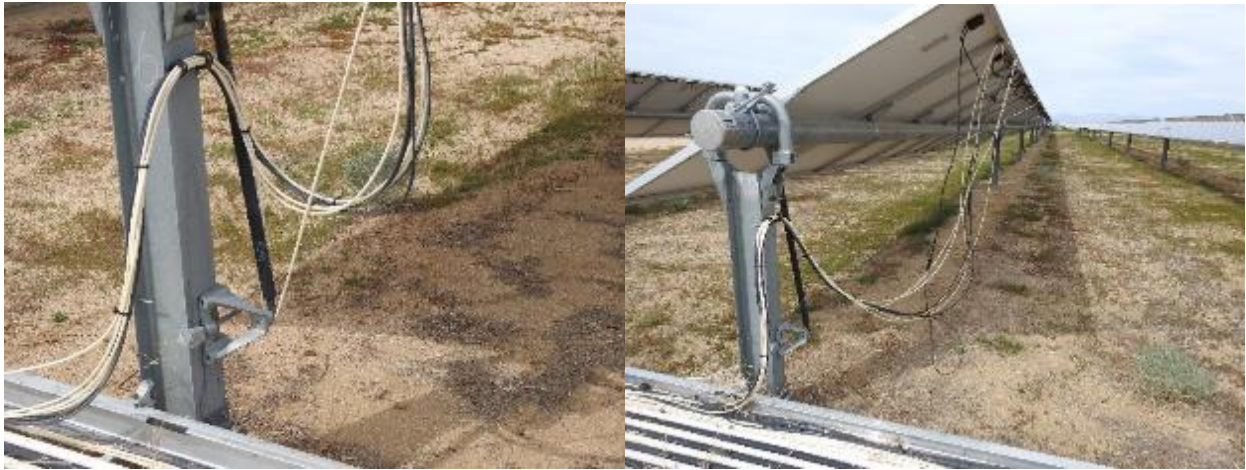
2. Finding: Multiple locations had unsecured cables attached to solar panels.

ESRB staff observed multiple solar panel areas with unsecured cables touching or almost touching the ground. The unsecured cables can be damaged by wildlife or caught in the tracker system as seen in figure 3.

Figures 3 and 4 are photographs of a cable that was caught on the strut of the solar panel structure.

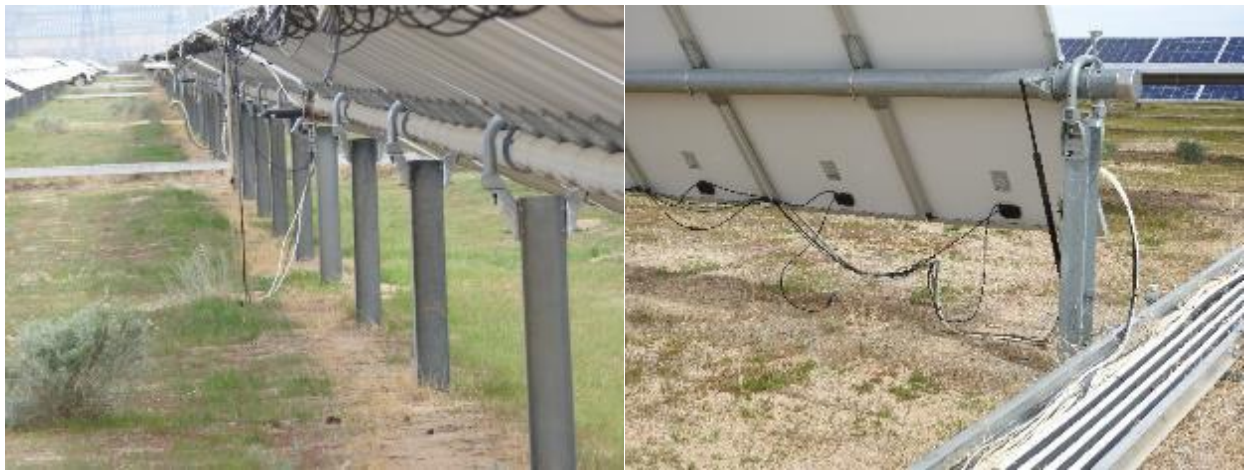
Figures 5 and 6 are displaying cables that have detached from panels and contacting the ground.

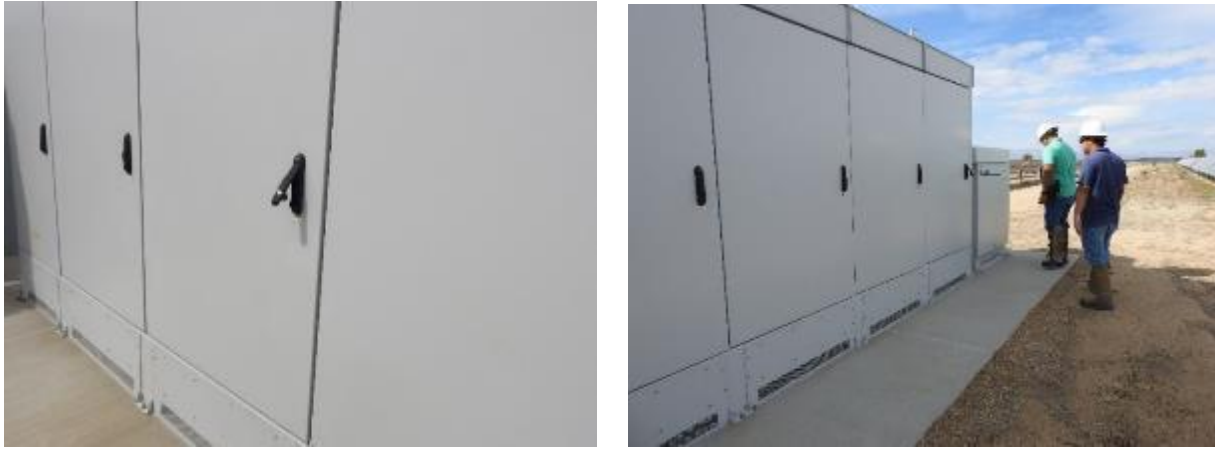
3. Finding: Multiple areas had unlocked inverter cabinets

ERSB staff found multiple inverter cabinets that were unlocked. Unauthorized access from unqualified personnel or members of the public that can lead to death, serious injury, or an interruption of service.

Figures 7 and 8 are photographs of inverter cabinets that were not locked allowing access to the internal components.

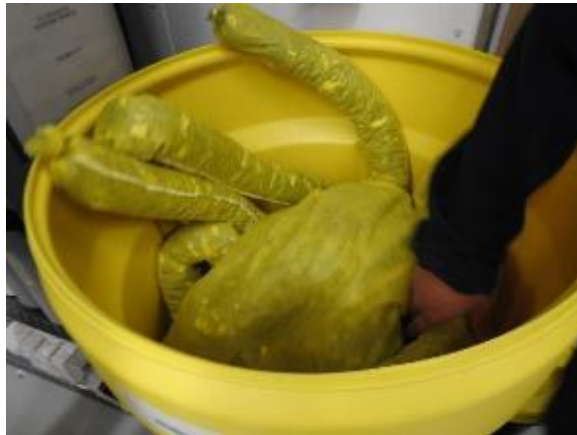
4. Finding: ERSB Staff observed multiple spill kits throughout the solar facilities were missing items.

ESRB staff opened and observed multiple spill kits located throughout the areas that did not have all the items listed on the contained check lists. The lack of spill supplies will result in being unprepared for a spill that can result in injury and environmental hazard.

Figure 9 displays a spill kit that was examined to be incomplete missing multiple items.

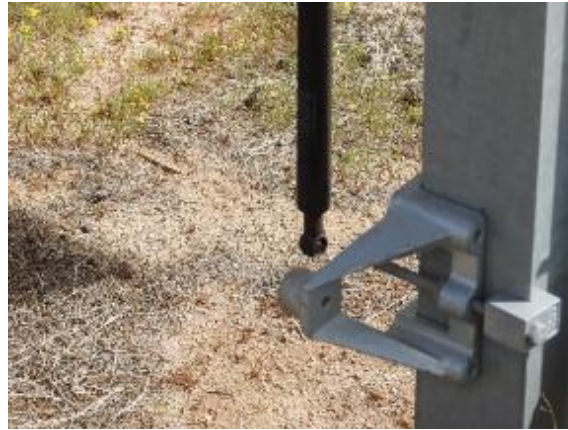
5. Finding: Several solar array struts in multiple locations were damaged and detached

ESRB Staff observed several solar array support struts that were damaged and detached from their connection point. The disconnected strut supports can cause the solar tracking systems to malfunction, leading to inefficiency in the performance of the array of panels.

Figure 10 is displaying an observed detached solar array strut.

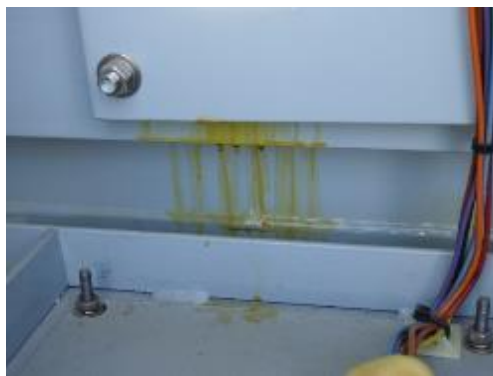
6. Finding: Oil leakage at an inverter panel.

ESRB staff observed a panel located at an inverter that was seeping oil from a panel that is used to observe oil levels of the inverter.

Figure 11 is a photograph of oil that was observed to be leaking at an inverter panel.

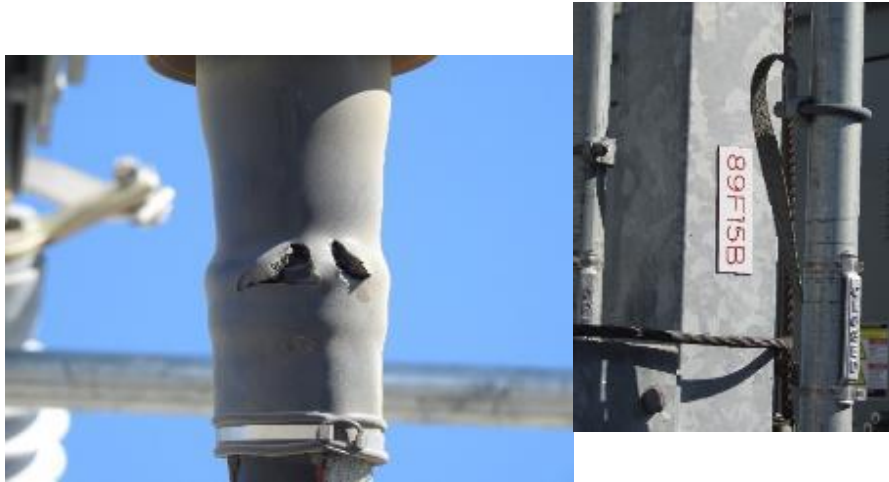
ESRB staff observed a damaged insulator boot for a bus bar attached to an underground conductor. The issue poses a safety risk to maintenance crews or any personnel working on or near the facility.

Figure 12 is a photograph of the damaged insulator boot and Figure 13 is the structure ID of the facility.

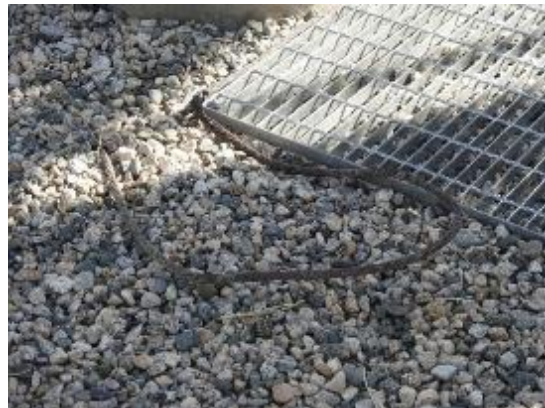
8. Finding: Grounding wires for platform pads protruding out the ground causing tripping hazard.

ESRB staff observed multiple ground wires protruding out of the ground and attached to grounding pads, creating tripping hazards.

Figure 14 is a photograph displaying a ground wire observed by ESRB staff that was protruding creating tripping hazard.
