SUBJECT: Generation Audit of Tranquillity Solar Facility - Audit Number GA2022-05TS

**CPUC AUDIT FINDINGS OF
TRANQUILLITY SOLAR FACILITY
April 18 – 22, 2022**

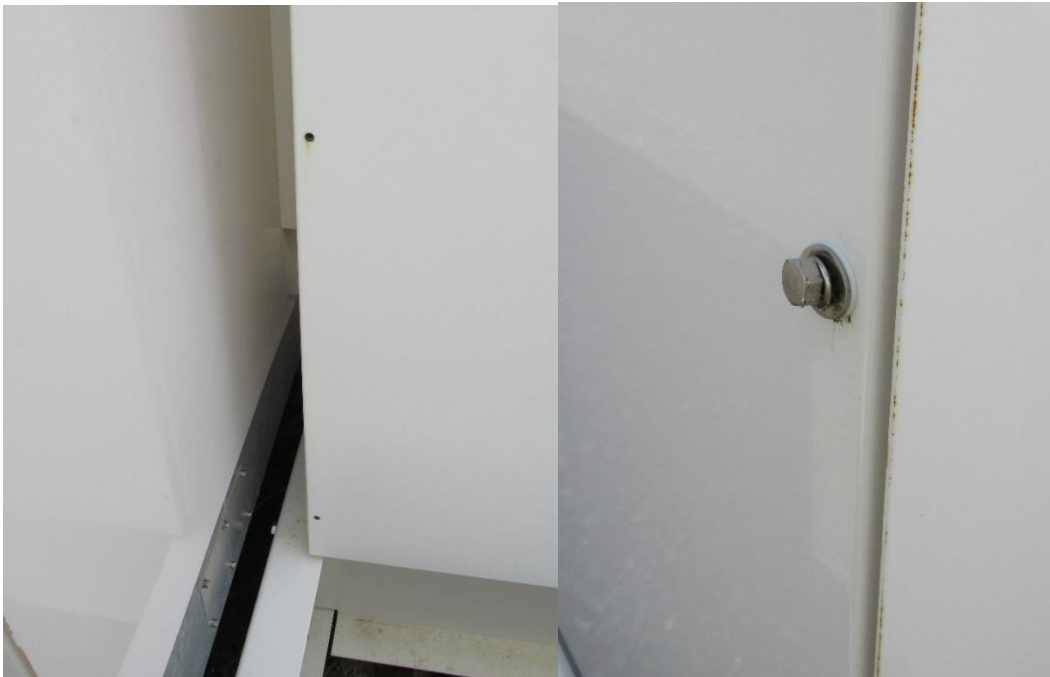
ESRB identified loose and missing fasteners that secure panels on Inverter 41. Missing or loose fasteners reduce the strength of the mechanical connection between the panel to the inverter and may allow panels to separate from the inverter during high vibration or high winds. Inverters must be regularly inspected for any loose or missing hardware and any identified loose or missing hardware must be replaced. Additionally, ESRB identified a loose fastener on the cover for Feeder Breaker 52F1. Fasteners on breaker covers must be regularly inspected. Secure covers are essential for protection of the equipment and personnel.

Figure 1. Missing and loose fasteners on Inverter 41 panels.

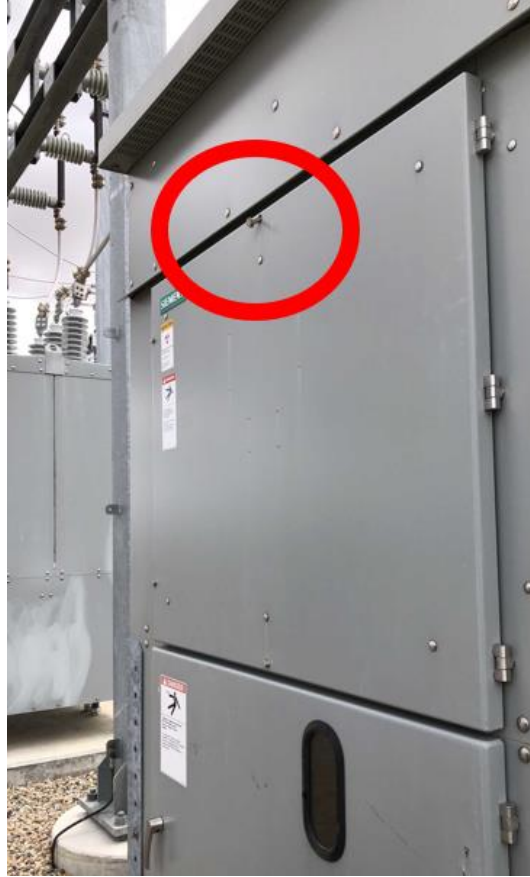
Figure 2. Loose fastener on Feeder Breaker 52F1.

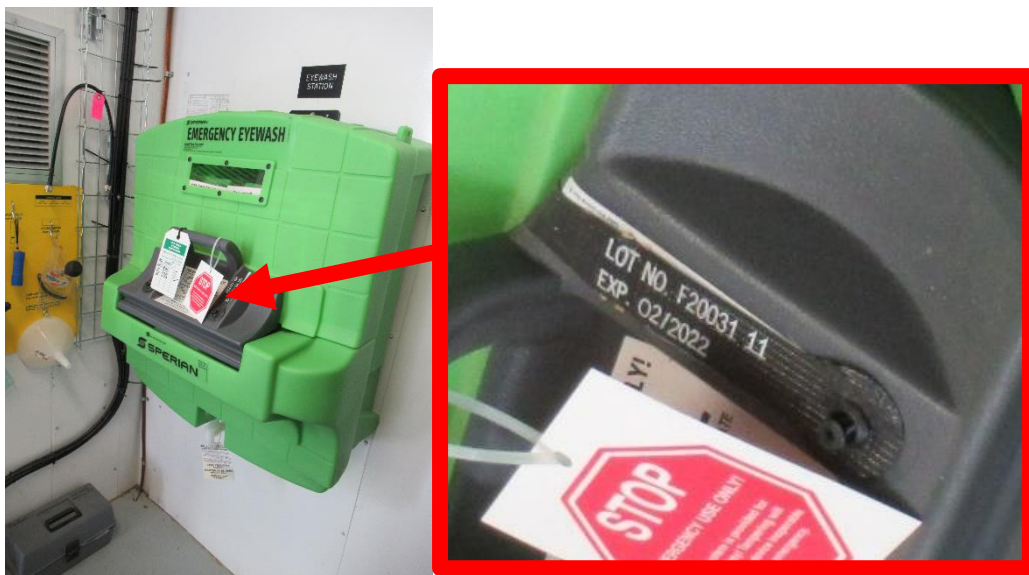
ESRB noted that the eyewash station located next to the DC batteries in the substation control room had expired in February 2022. Expired eyewash solution may lose its effectiveness in the protection against chemical-related eye injuries in the event the eyewash needs to be used. The Plant must replace the expired eyewash station and include all eyewash stations in its routine inspections.

Figure 3. Expired eye wash station in the substation control room.

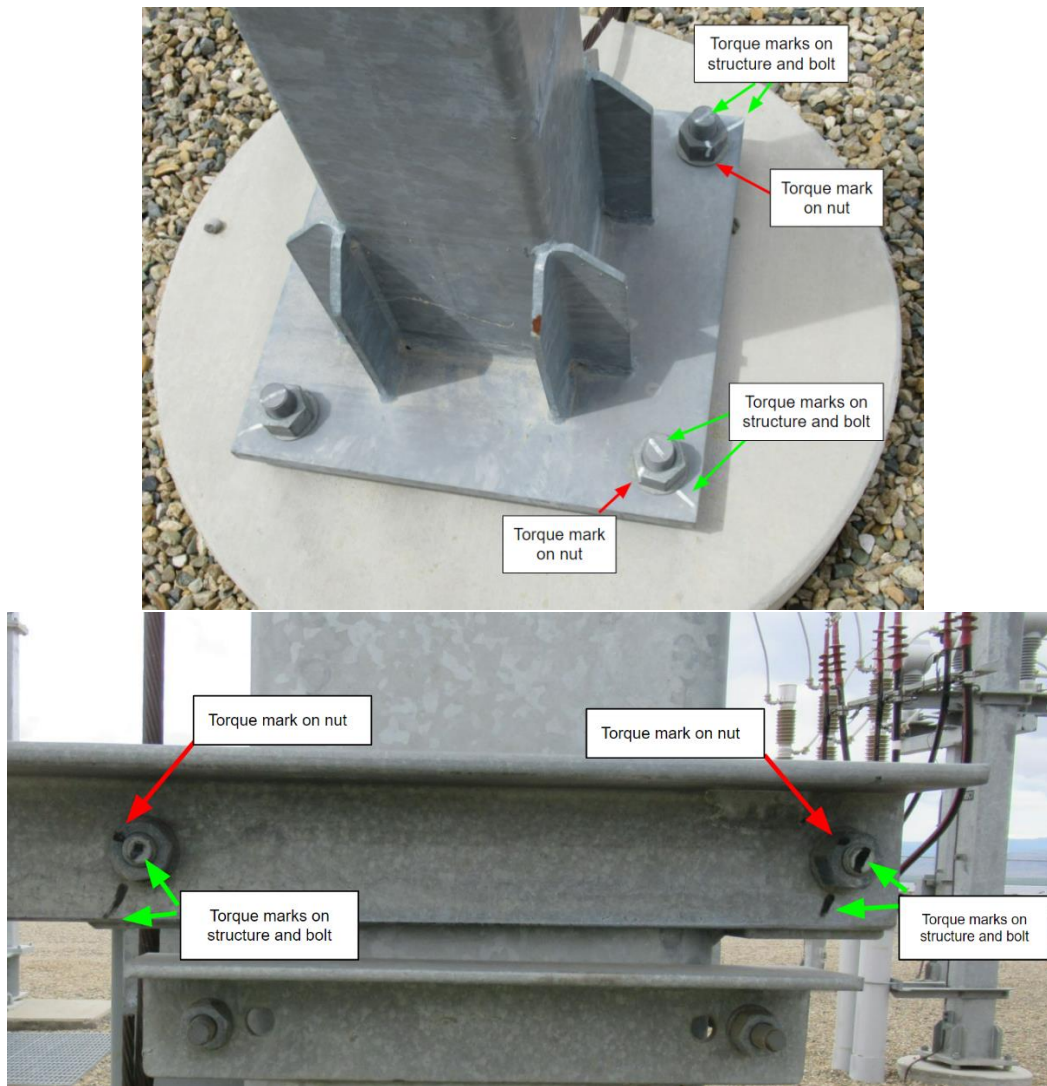
ESRB identified several loose hardware on the substation structures and equipment. Several nuts on the foundation bolts and structures had shifted and were no longer in line with their torque marks. All substation hardware must be properly torqued and regularly maintained to ensure the integrity of structures and equipment.

Figure 4. Foundation nuts (top) and nuts on a bracket (bottom) are not in line with torque marks.

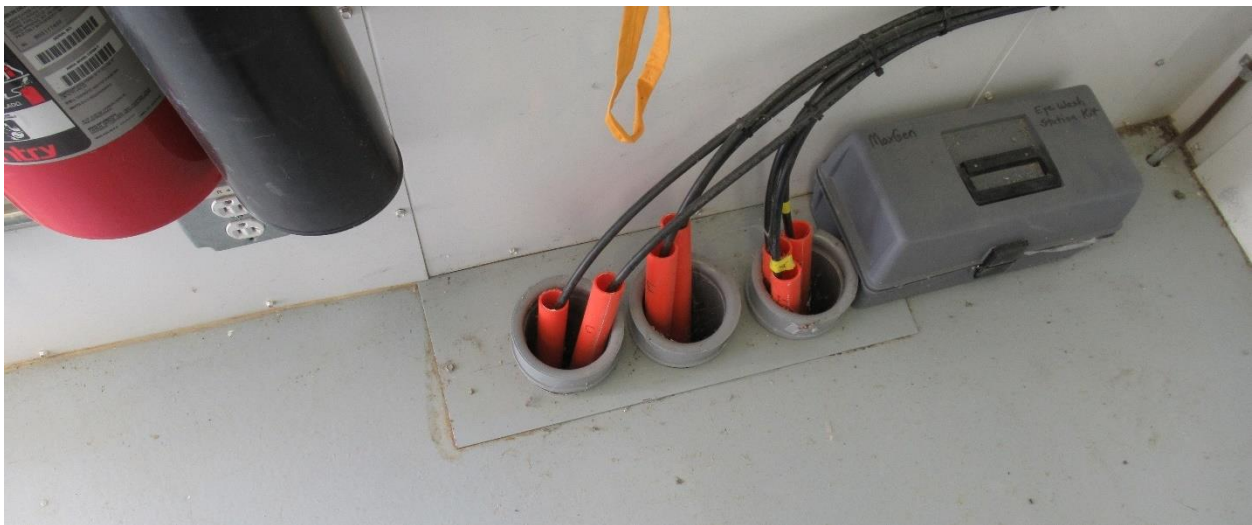
ESRB identified three cable conduits near the eyewash station that penetrated through the bottom of the substation control room that were not sealed or closed off. Cable conduits must be sealed to prevent the potential spread of a fire and unwanted intrusion from things such as water, gases, debris, pests, and animals.

Figure 5. Unsealed cable conduits in the substation control room.

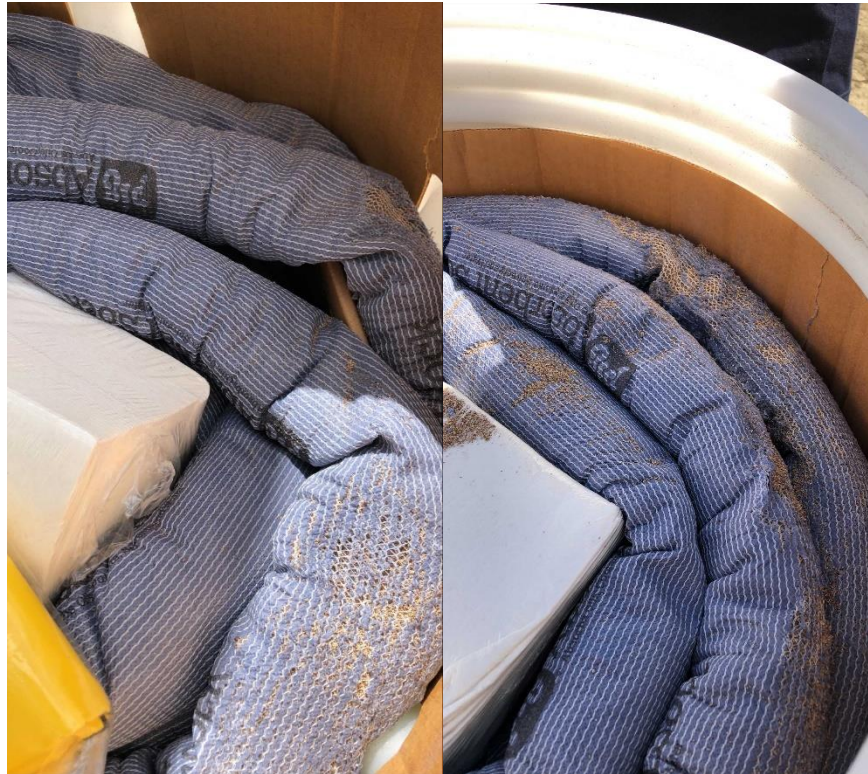
ESRB inspected two spill kits at the Plant and observed that the absorbent socks have become porous, and the inside material had seeped out. To ensure the spill kits are in good working order, the Plant must inspect the condition of their contents, and keep track of the material shelf life and their expected replacement date.

Figure 6. Spill kits adjacent to the Universal Waste Storage Area (left) and at the northwest corner of Block C (right).

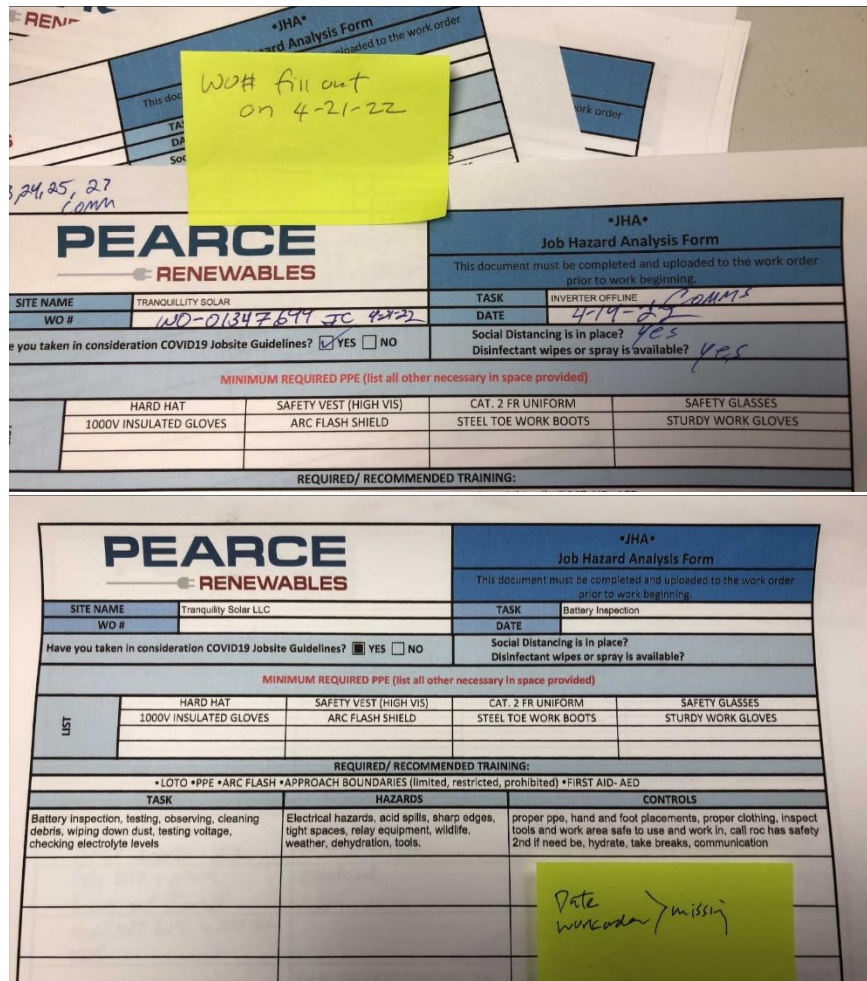
ESRB identified two job hazard analysis forms with missing work order numbers. In the first instance, the technician(s) filled out the JHA for an offline inverter before the work order was created, which the Plant said was not an uncommon practice. The site supervisor completed the form during the CPUC audit, on 4/21/2022, as shown in the first photo below. In the second instance, the technician conducting the battery inspection failed to complete the form. During the CPUC audit, the technician completed the form. The Plant must implement a review process to verify JHA forms are completed prior to closing out work orders.

Figure 9. JHA forms that were incomplete.

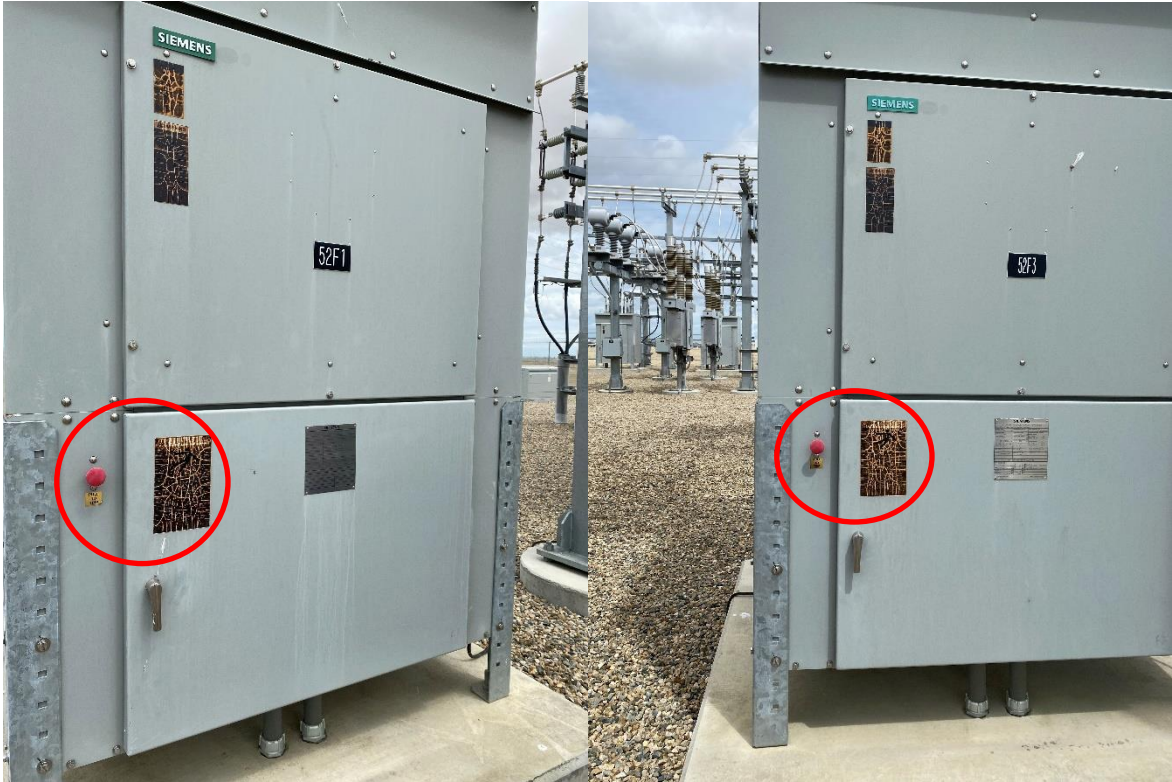
ESRB observed several fading and deteriorating signs (“High Voltage”, “Danger”, “Warning” placards and posted signs). High Voltage, warning, and danger signs help inform employees as well as visitors and contract workers who may be unfamiliar with the nature of the equipment about their inherent dangers.

Figure 10. Fading signs on Circuit Breaker 52F1 (left) and 52F3 (right) in the substation.

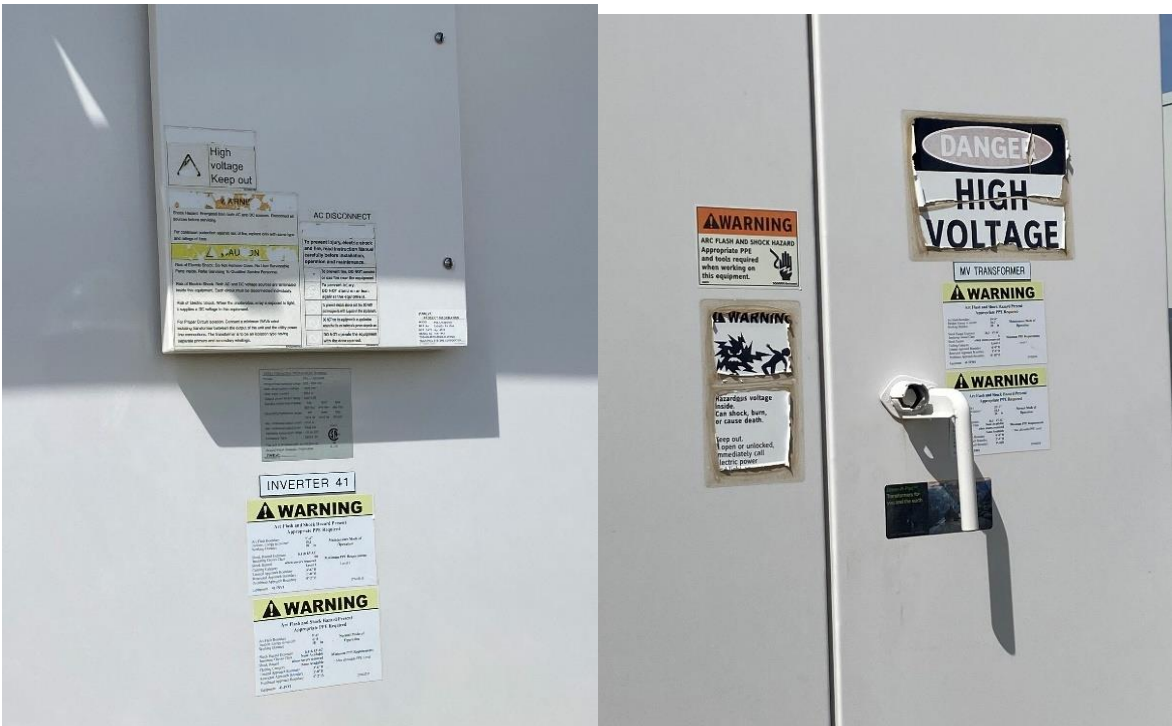
Figure 11. Fading signs on Inverter 41 (left) and fading and peeling signs on the medium voltage transformer (right) for the inverter.

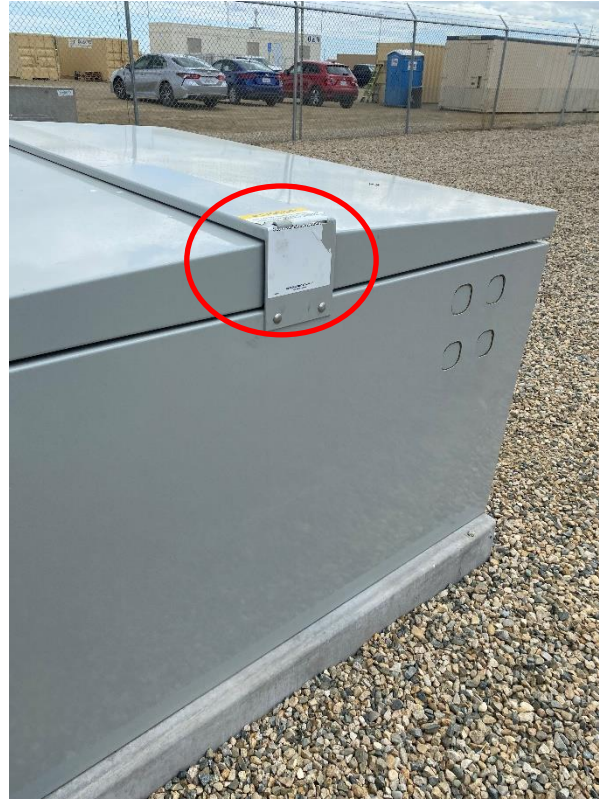
Figure 12. Fading sign on the auxiliary transformer (Aux 52) in the substation.

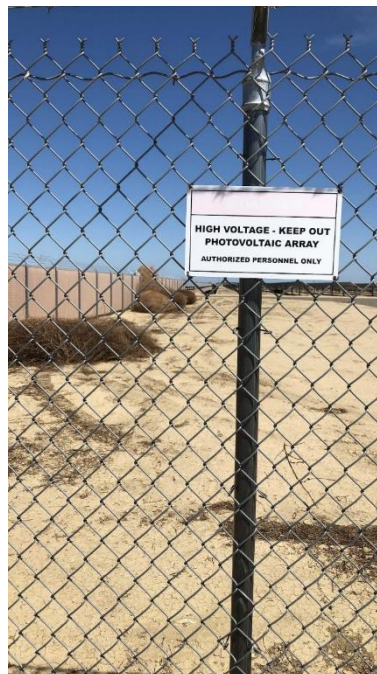
Figure 13. Fading “Danger High Voltage” sign at the B Block, on the south side fence.

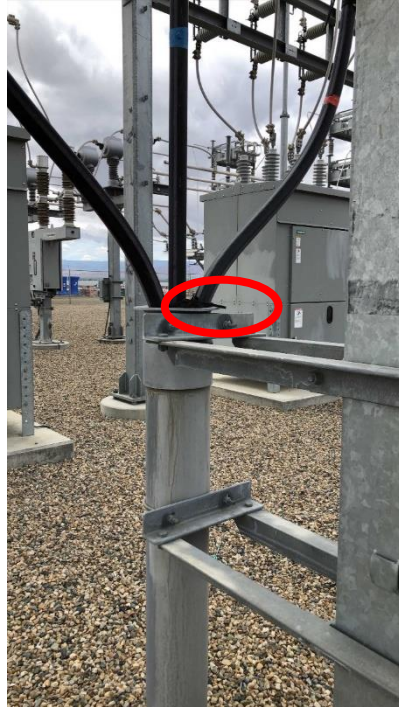
ESRB observed strings and a broken zip tie around conductors in the substation. In addition, ESRB observed an attached foreign object at Generator Step-Up (GSU) Transformer 2. At the time of the audit, the Plant did not have knowledge of what the object was.

Figure 15. Broken zip tie on a feeder conductor on the GSU 1 side.

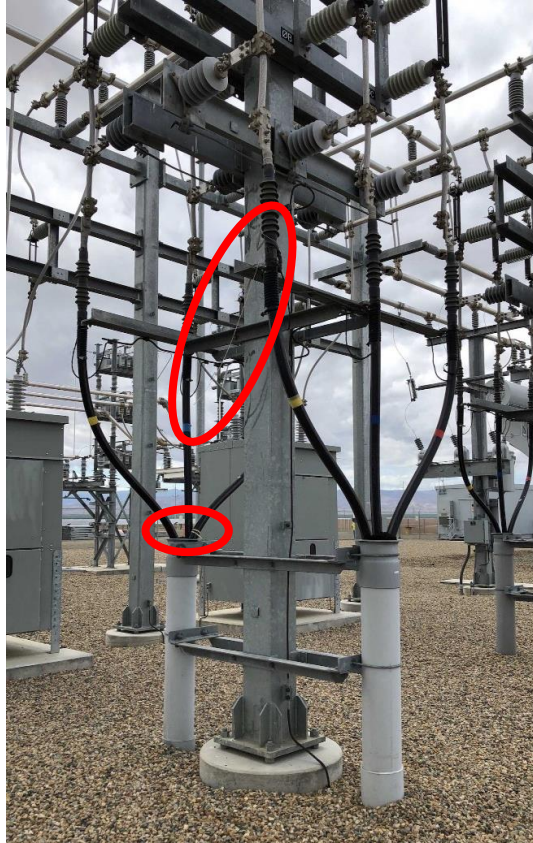
Figure 16. Strings wrapped around feeder conductors on the GSU 1 side.

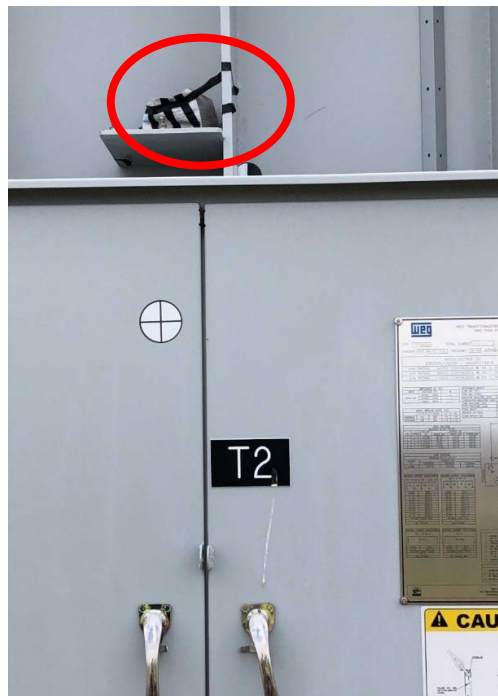
Figure 17. An unidentified foreign object taped to GSU 2.

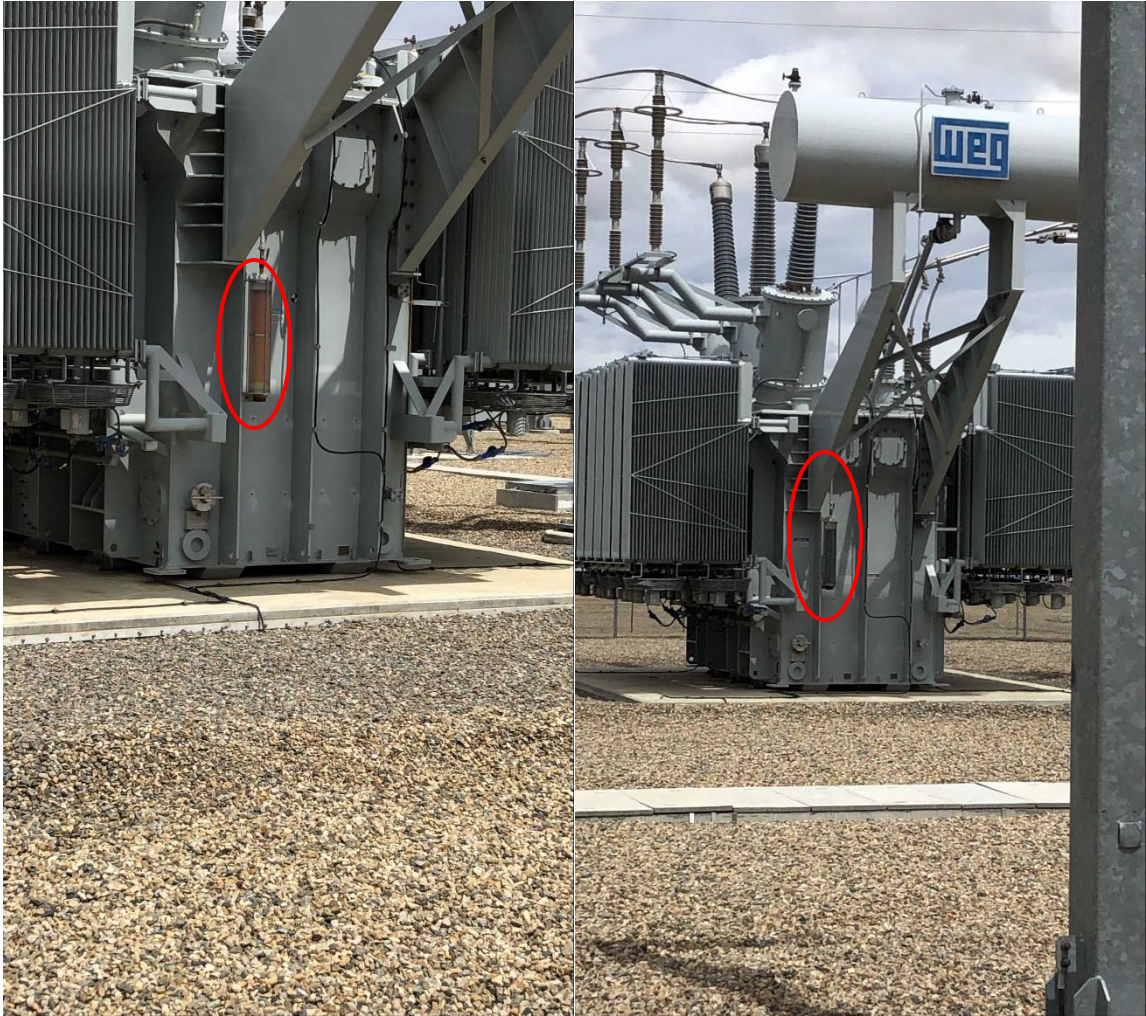
ESRB observed that the desiccant color on GSU 1 was red, but the color on GSU 2 was blue. The red desiccant indicates that it has absorbed moisture and needs to be replaced. The Plant should inspect and/or consult with experts to either monitor or replace the desiccant.

Figure 20. GSU 1 desiccant (left) and GSU 2 desiccant (right).
