CPUC AUDIT FINDINGS OF PANOCHE ENERGY CENTER July 25 – 28, 2022

I. Findings

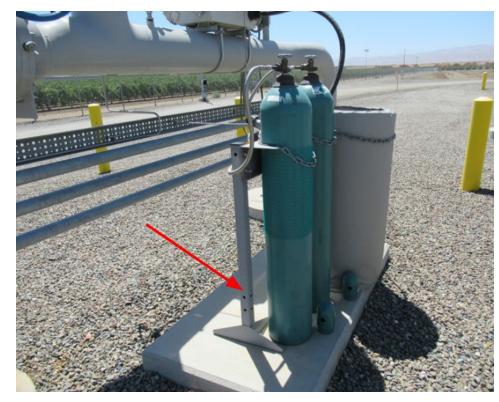
ESRB identified high-pressure cylinders at various locations that lacked an additional restraint on the bottom one-third section of the cylinder. Providing high-pressure gas cylinders with two forms of securement is industry best practice to prevent the cylinder from tipping-over and possibly slipping out of its securement.

1. The two nitrogen cylinders in the gas yard at the gas chromatograph require a second restraint on the bottom third of the cylinder.

Figure 2: Cylinders in the gas yard are not equipped with two forms of securement.

The Plant must install a second restraint for the high-pressure cylinders at the following locations:

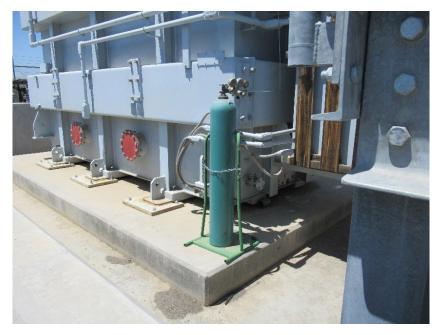
2. The nitrogen cylinder on the spare generator step-up transformer requires a second restraint on the bottom third of the cylinder.

Figure 3: The cylinder on the spare transformer is not equipped with two forms of securement.

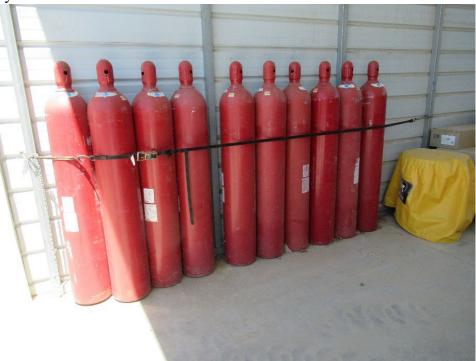
3. The spare CO2 bottles in the storage area require a second restraint on the bottom third of the cylinders.

Figure 4: Cylinders in the storage area are not equipped with two forms of securement.

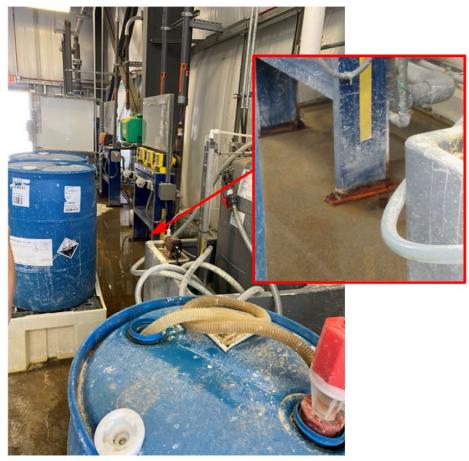
The Enhanced Wastewater System at the Plant has standing water gathering in the corner of the building. The standing water is causing rust and corrosion on metal racks and structural members, which can lead to weaking of the material and metal equipment being used for the Plant's operation. The water also intrudes on walkways, which introduces slip hazards. The Plant shall mitigate the source of this water or install additional drains or diversions to keep water away from walkways and critical equipment.

Figure 5: Standing water accumulating in the Enhanced Wastewater System building.

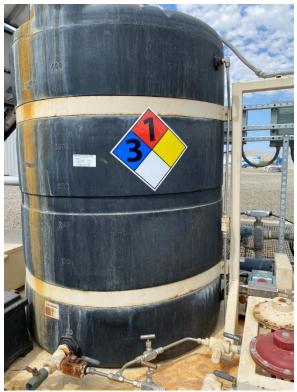
1. The NFPA diamond on the Annulus Fluid tank at Well 4 is missing the yellow reactivity number. The Plant shall inspect any other Annulus Fluid tanks around the Plant's wells to verify that their NFPA diamonds are installed correctly.

<u>Figure 6</u>: The Annulus fluid NFPA diamond at Injection Well 4 is missing its yellow reactivity number.

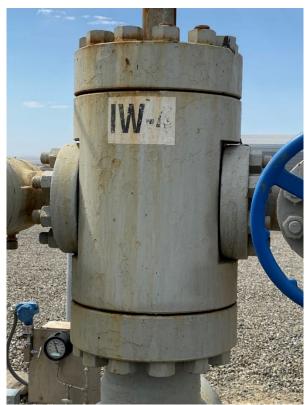
2. The equipment label for Injection Well #4 is faded and illegible.

Figure 7: Injection Well #4 equipment label is faded and illegible.

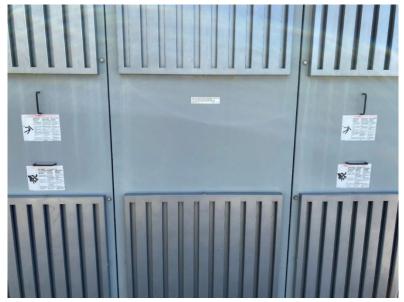
3. The warning signs on the Unit 4 Power Control Module (PCM) transformer are faded.

Figure 8: The PCM transformer near Unit 4 has faded warning signs.

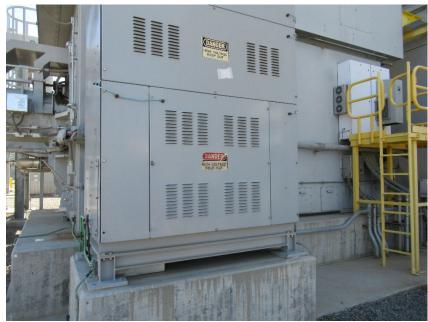
4. The High Voltage signs on the Unit 3 neutral grounding cabinet are faded and damaged.

<u>Figure 9</u>: The neutral ground cabinet near the Unit 3 generator has faded and damaged High Voltage Signs

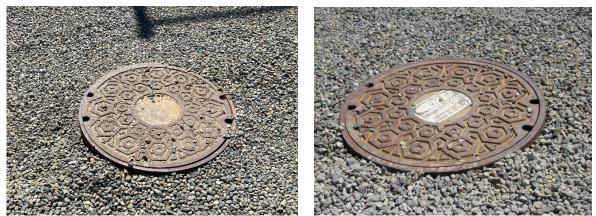
5. The confined space entry sign is missing on the manhole between Unit 2 and Unit 3 and faded on the manhole behind the operations and maintenance (O&M) building.

Figure 10: (Left) Missing confined space sign on the manhole between Unit 2 and Unit 3. (Right) Faded confined space sign on the manhole behind the O&M building.

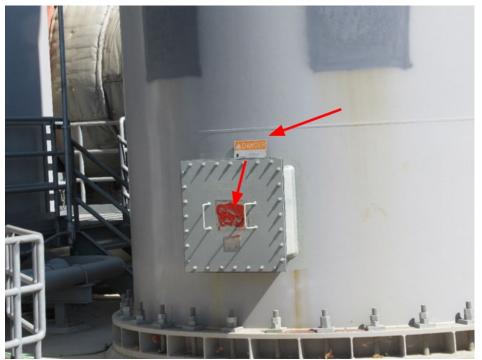
6. The confined space sign on the Unit 3 variable bleed valve (VBV) is not properly secured to its respective confined space entry point.

Figure 11: The VBV at Unit 3 has a detached Confined Space Sign.

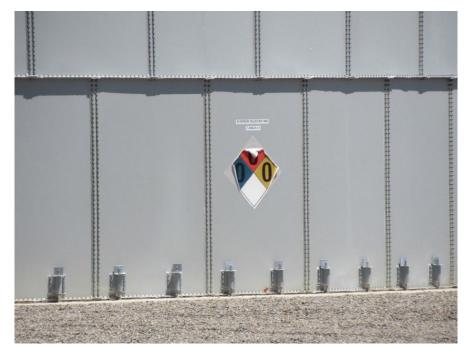
7. The NFPA 704 diamond on the blowdown collection tank is damaged.

Figure 12: Damaged NFPA diamond on the blowdown collection tank.

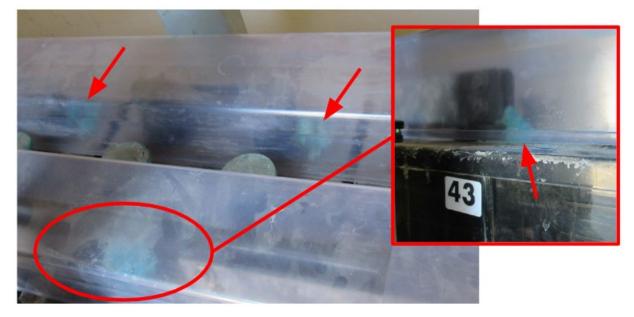
ESRB observed corroded terminals on the backup batteries. These batteries are crucial because they supply backup DC power to protective equipment at the MCC if the plant losses AC power. If left unmaintained, the corrosion could degrade batteries' performance and short-circuit terminal connections. Best practice is to clean up any spilled electrolytic solution after refilling the batteries and to apply a corrosion inhibitor on the terminal contacts to prevent corrosion buildup.

Figure 13: Blue corrosion forming on battery terminals.

The Plant must perform regular battery inspections and correct all identified deficiencies to prevent further degradation of the battery system.

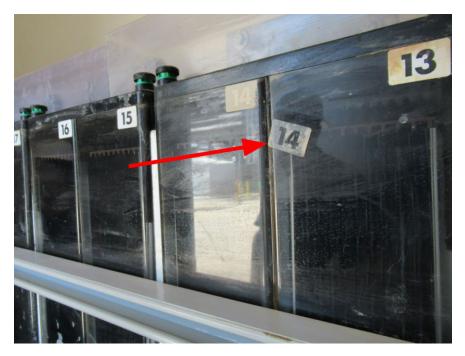
Additionally, ESRB observed fallen battery labels. Proper labeling enables workers to correctly identify specific battery cells for maintenance.

Figure 14: Battery equipment labels are falling off.

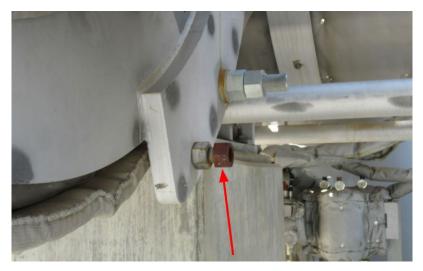
ESRB identified a loose lock nut on the bottom section of the Unit 1 intercooler. Friction locking that utilizes two nuts requires the second outermost nut to be in contact with the bottom jam nut to get the full effect of the mechanical fitting. The outermost nut needs to be tightened down according to its design torque specification. The nut is also rusted. The Plant must tighten the nut and consider replacing it with a new nut.

Figure 15: Lock nut is rusted and loose.

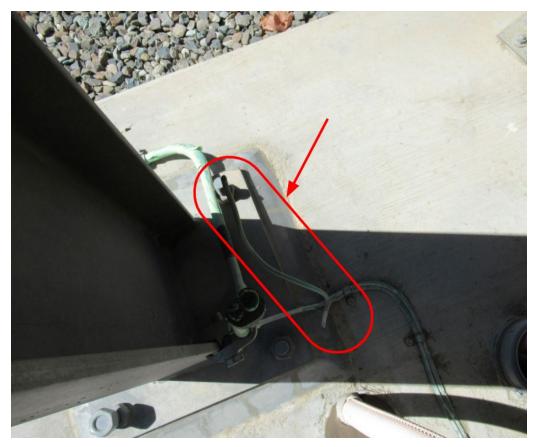
ESRB identified a ground wire outside the Unit 3 PCM that was not bonded to the grounding grid. Grounding and bonding are essential to ensure metallic components are properly grounded in order to protect workers and equipment. The Plant must restore this ground wire to its original design configuration.

Figure 16: Unbonded ground wire on the Unit 3 PCM.

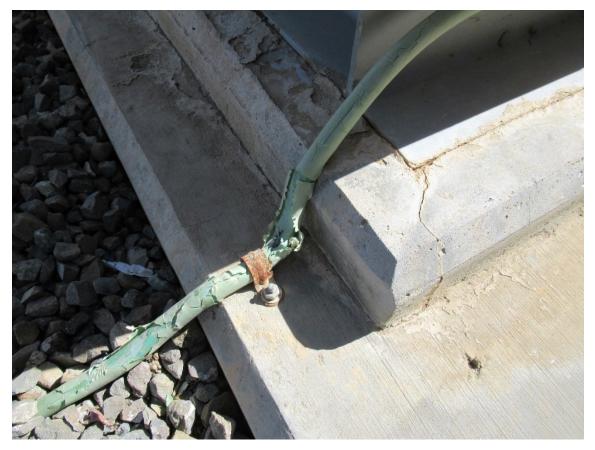
ESRB identified a ground wire at the Unit 4 ammonia injection skid with damaged insulation and exposed conductor. While this is not an imminent safety hazard as ground wires are typically unenergized, the damaged insulation could allow for water intrusion which can further corrode and degrade the conductor, rendering it ineffective. The Plant must repair the damaged insulation.

Figure 17: Ground wire with compromised insulation.

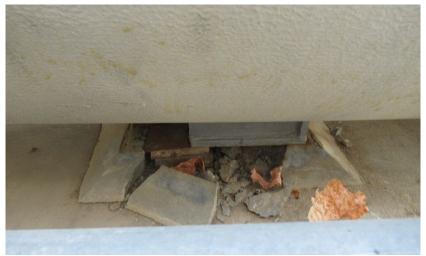
The concrete mastic around the structural supports at the Units 2 and 3 attemperating air fans is degraded and spalling. The Plant must repair the concrete to prevent further deterioration that may compromise the fan's operation and structural integrity.

Figure 18: Spalling concrete on the Unit 2 air fan structural support.

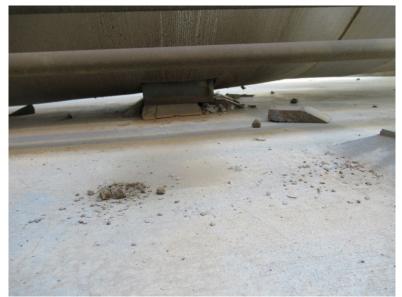
Figure 19: Spalling concrete on the Unit 3 air fan structural support.

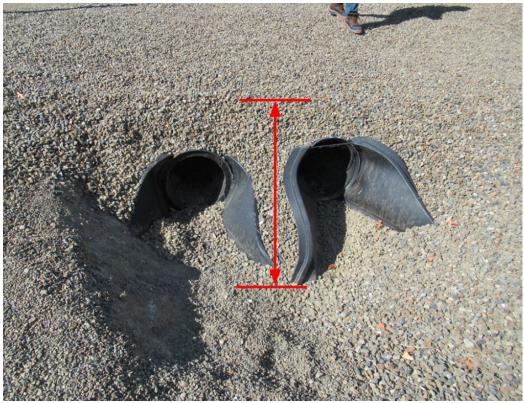
Various storm drains around the Plant have sudden vertical drop offs that blend in with its surrounding gravel terrain. ESRB acknowledges that the Plant has existing safety bollards to prevent vehicles from falling into these drop offs at some locations. However, these bollards are intended for vehicles and are installed more than 15 feet away from the drop-offs. Workers traversing the plant by foot may not be aware of the sudden drop offs. The Plant shall install delineator posts closer to all areas subject to high foot traffic to mitigate the potential fall hazards.

Figure 20: Example of a sudden vertical grade change near a storm drain at Unit 4. The vertical drop blends in with the terrain if standing from the top area of the drain.

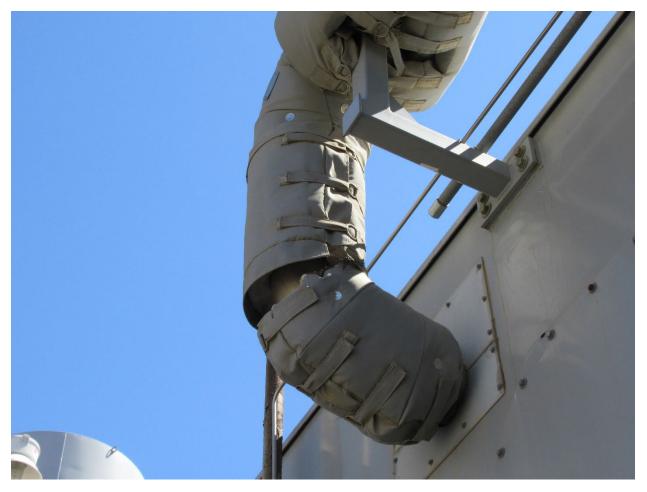
The insulation jacket on the elbow of the Unit 3 anti-icing system has loosened, exposing the underside pipe surface. The anti-icing system prevents ice related internal damage to the combustion turbine on days of low temperature and high humidity. Damaged insulation reduces thermal efficiency of this system. The Plant must repair the insulation and include pipe insulation in its routine inspections.

Figure 21: Insulation on the anti-icing system is coming apart.
