PUBLIC UTILITIES COMMISSION

SUBJECT: General Order (G.O.) 167-B Audit of Oakland Power Plant

Audit Number GA2022-10OAK

CPUC AUDIT FINDINGS OF OAKLAND POWER PLANT July 18 – 22, 2022

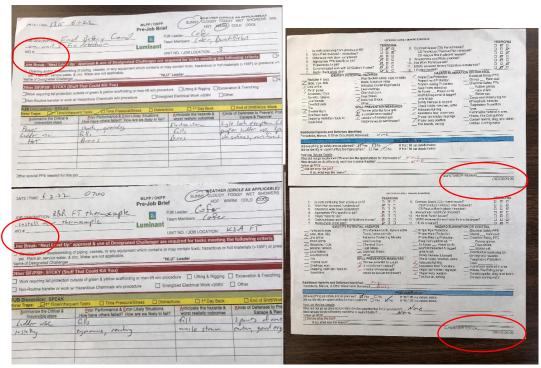
ESRB observed that completed Pre-Job Brief forms with the work order number and the supervisor review were missing. The proper completion of the Pre-Job Brief and the supervisor review are critical for ensuring that the Plant personnel consider hazards associated with each job before starting the work.

Figure 1. Pre-Job Brief forms with work order number and supervisor review missing.

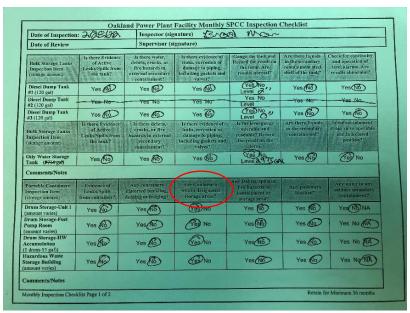
In addition, ESRB observed that the revised Monthly Spill Prevention Control and Countermeasure (SPCC) inspection form was being filled out incorrectly. Sometime between February 2022 and May 2022, one of the questions on the inspection form was changed from "Are Containers within designed storage areas?" to "Are Containers not within designated storage areas?" requiring a different response if the situation has not changed. However, the response was the same.

Figure 2. Monthly SPCC Inspection for February 2022.

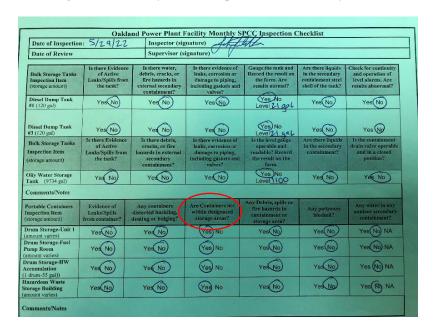
Figure 3. Monthly SPCC Inspection for May 2022When forms are revised, the revision version and/or date should be noted on the forms, and the Plant staff should be notified of the changes, and trained, if necessary, to properly fill out the forms.

The supervisor signature was also missing from the Monthly SPCC Inspection forms.

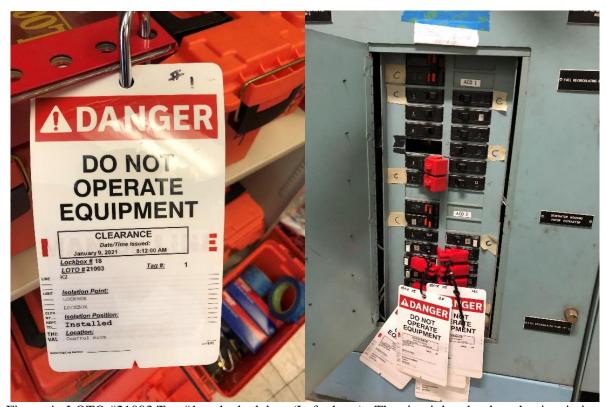
ESRB walked down LOTO #21003 for review and observed that several LOTO tags were missing. Tag numbers 30, 31, 32, 34, 36 and 40 were missing from a circuit breaker box. The photo below shows three of the red lockout devices are missing tags. At least one LOTO was missing the red lockout device itself.

Figure 4. LOTO #21003 Tag #1 at the lock box (Left photo). The circuit breaker box that is missing LOTO tags (Right photo).

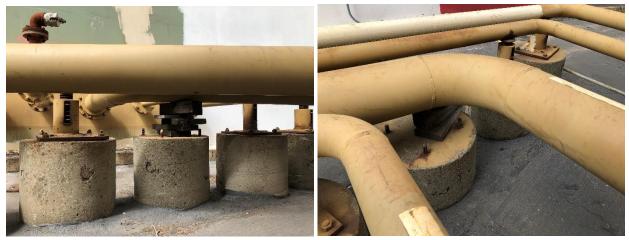
At the fuel tank, ESRB observed two locations where an outgoing pipe is supported by stacks of wood rather than spring-loaded pipe supports as it was originally designed. In addition, ESRB observed fully compressed supports, an indication that they may no longer be providing adequate support. The Plant must have the fuel pipe supports inspected by an expert to assess their condition.

Figure 5. Two locations where the spring-loaded pipe supports have been replaced with stacks of wood.

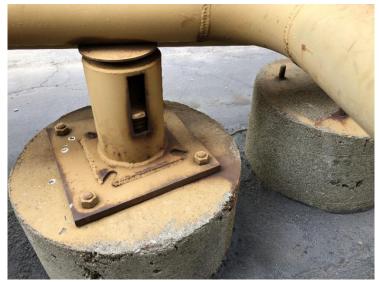
Figure 6. A fully compressed spring-loaded pipe support.

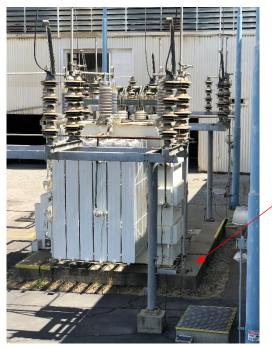
The manually operated air switch at Transforer #9 lacks clear deterrence against unauthorized operation of the air switch. Transformer #9 is the step-up transformer for Unit K3. The air switch is located upstream of the transformer and is used to connect Unit K3 to the grid each time it starts up. The air switch handle is designed with a lockable mechanism, but the Plant does not utilize it. The Plant must put up a clear warning sign or make use of the locking mechanism.

Figure 7. Transformer #9 for Unit K3, with the arrow pointing to the air switch handle.

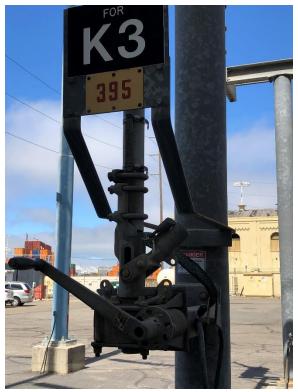
Figure 8. The air switch handle.

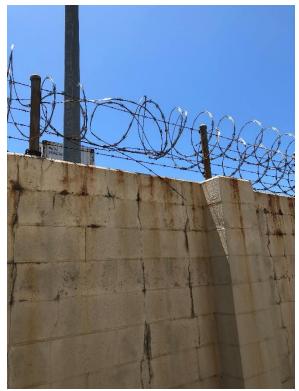
In one section along the western perimeter of the fuel storage area, ESRB observed broken barbed wires. Although intrusion through this area may still be challenging due to the razor wire that loops around the barbed wires, the Plant must repair the broken wires to present strong deterrence against potential intruders.

Figure 9. Broken barb wire along the western perimeter wall.

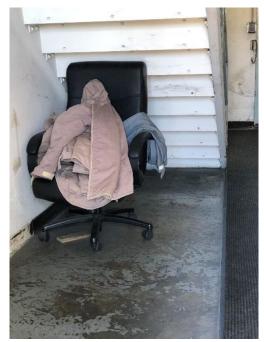
ESRB observed equipment that were not stored in their proper places. The flame resistant (FR) suit used for air switch operation at Transformer #9 was stored on a chair under a stairway. A hand crank was seen on the pedestal at Transformer #7. It appears the hand crank is for the transformer tap changer, which the Plant does not adjust. ESRB also observed trip hazards created by improper placement of items.

Figure 10. The FR suit for air switch operation.

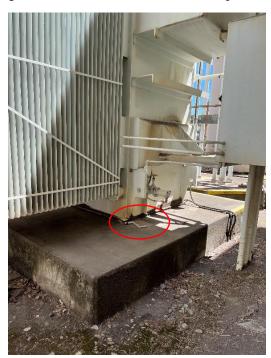
Figure 11. A hand crank on the concrete pedestal at Transformer #7.

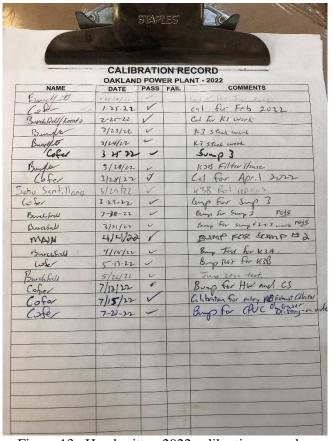
The Plant was unable to find 2021 overspeed test documents. This test is conducted annually. In addition, for the 2018 - 2022 calibration records that ESRB requested prior to the audit, the Plant kept 2018 - 2021 records in Maximo, the computerized maintenance management system, but kept only handwritten records for 2022. To effectively retain records, the Plant must consistently use a secure and reliable method.

Figure 13. Handwritten 2022 calibration records.
