# PG&E Gas Curb Valve Box Leak Analysis

Andres Beltran, Stephen Ramos

January 2021

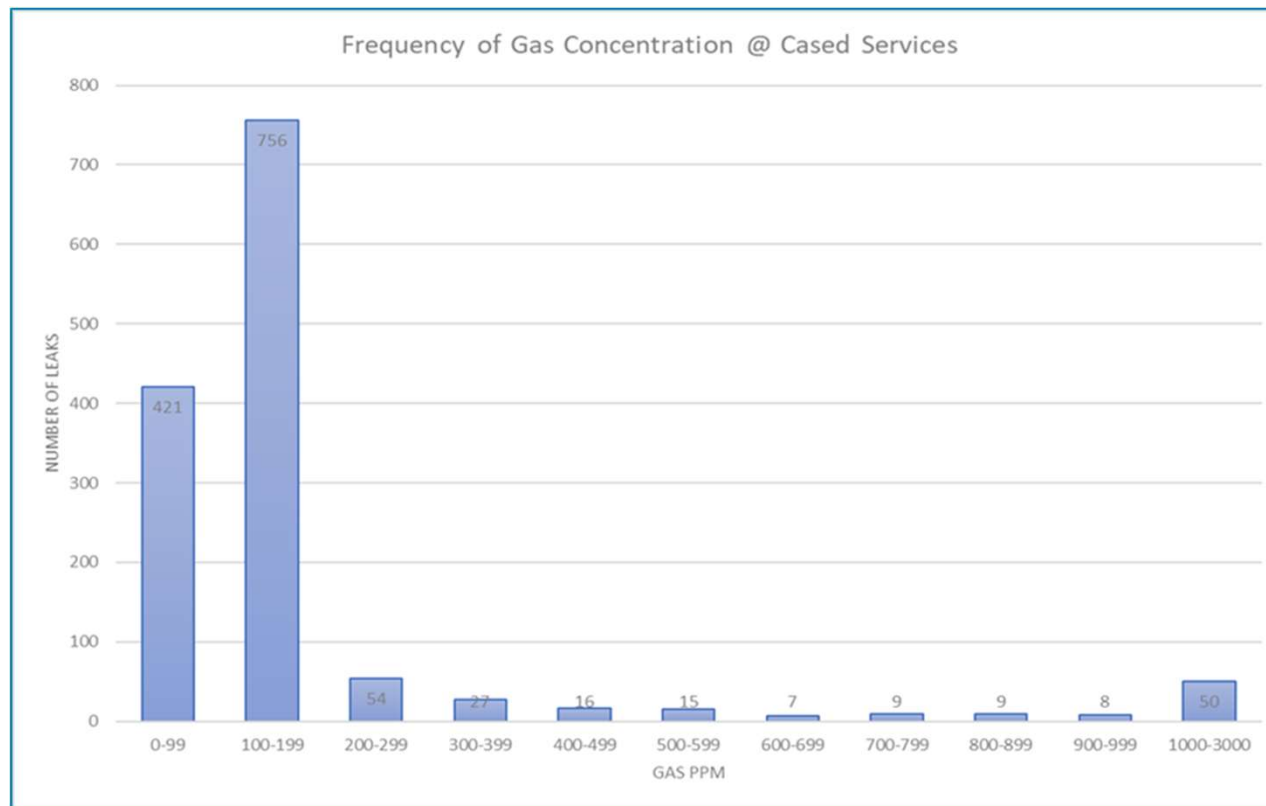
- Submitted **1700** GVB leaks to GIS, **1400** were connected to an incased service line
- Depicted below is the number of leaks at a GVB with an incased service line versus the reported gas concentration

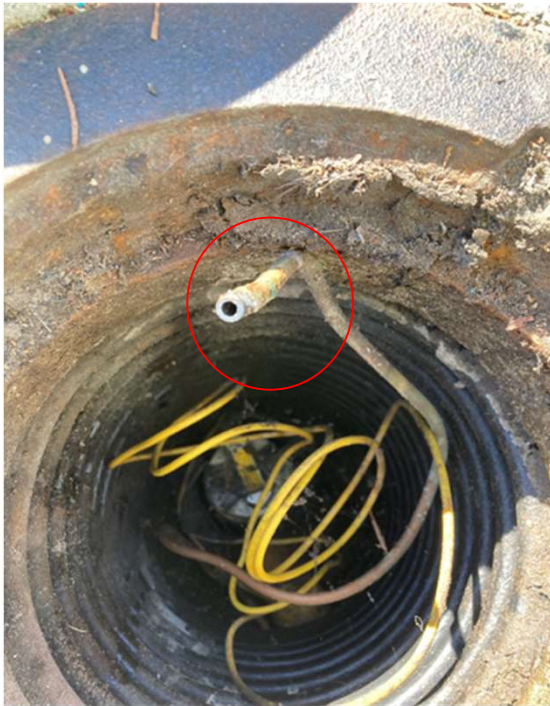
- There appeared to be a correlation between reported low concentration leaks at a GVB having a corresponding service installed in a casing
- A potential source for gas to accumulate in the curve valve box could be a **copper tubing** that **vents methane** from the **service casing** per the **A.90 Standard**

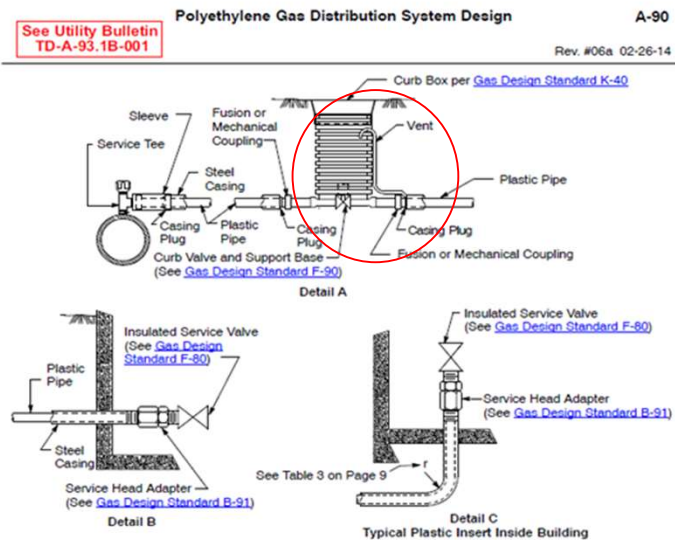
Figure 7  
Typical Plastic Insert Into Basement or Meter Box

3. Use 1/4" copper tubing (Code 012037) or stainless steel tubing as the vent pipe. The vent pipe shall be inserted approximately 6" into the annulus between the casing pipe and plastic pipe. The tubing may be slightly ovalled to fit into the annulus. Care must be used to avoid restricting the carrying capacity of the tubing. Insulate the tubing from the steel casing by wrapping the tubing with tape. Drill a 3/8" hole into the plastic extension of the curb valve box and insert tubing with slight goose neck to prevent dirt from clogging the vent.

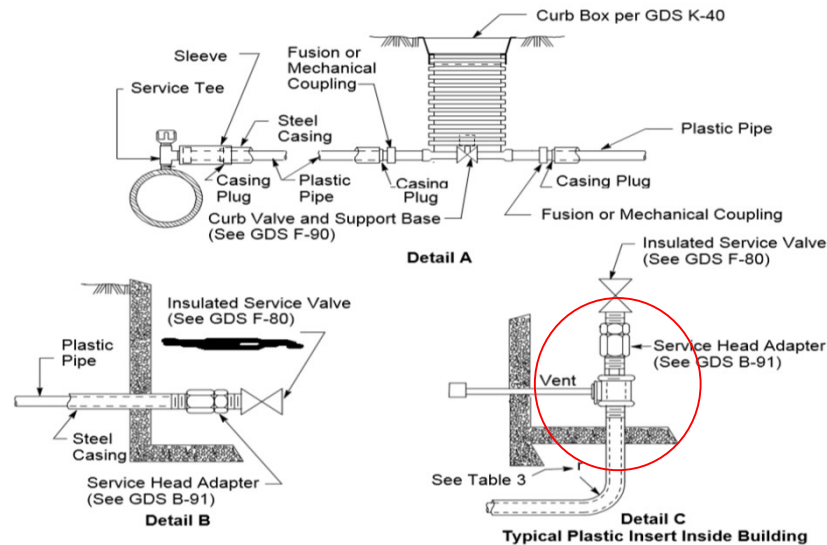
- The A.90 standard allows for **gas to vent from the service casing into the valve box**, however in **2018** the standard was changed and demanded that service casing vent gas at the **service head adapter**
- The A.90 standard was in effect between **1973-2017**; based on that window we calculated the number of GVB boxes that had service casing installed per the original A.90 standard
- Of the **1400 GVBs** with **an incased service line**, **1370** were installed per the original standard

*New A.90 standard where the vent from the casing is to be installed at the service head adapter and no longer at the GVB*

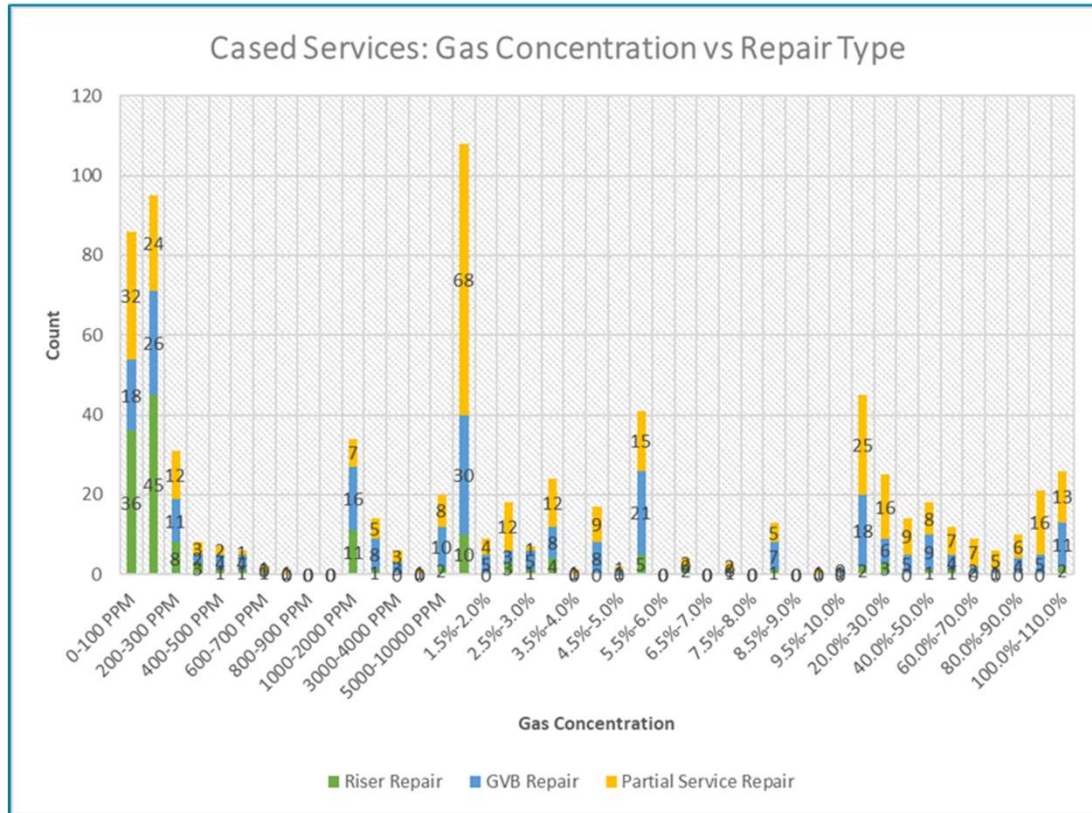
Repairs (cased) 0 - 300 PPM

Repairs (Cased) 0 - 3000 ppm

Repairs (cased) 0.5 - 1.5 % Gas
