**FILSINGER ENERGY**  
P A R T N E R S

**PG&E**  
**INDEPENDENT SAFETY MONITOR STATUS UPDATE**  
**REPORT**

May 15, 2025

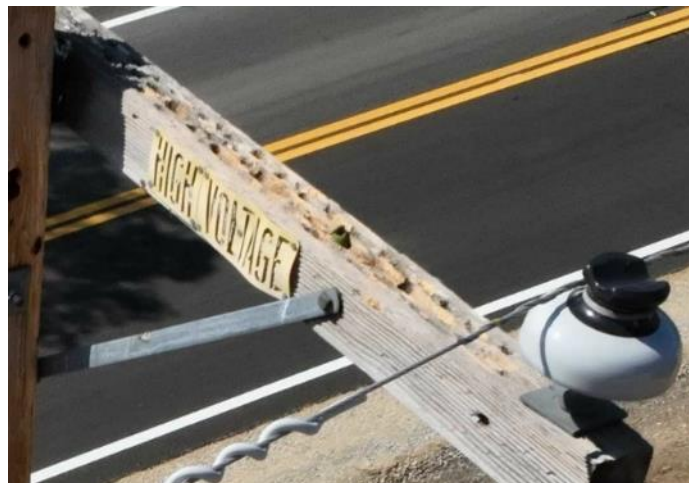
The ISM also noted instances where crossarm integrity issues are not visible from ground inspections, as depicted in Figure 17 below.

*Figure 17: Crossarm integrity issues visible from aerial photos but not visible from the ground.*

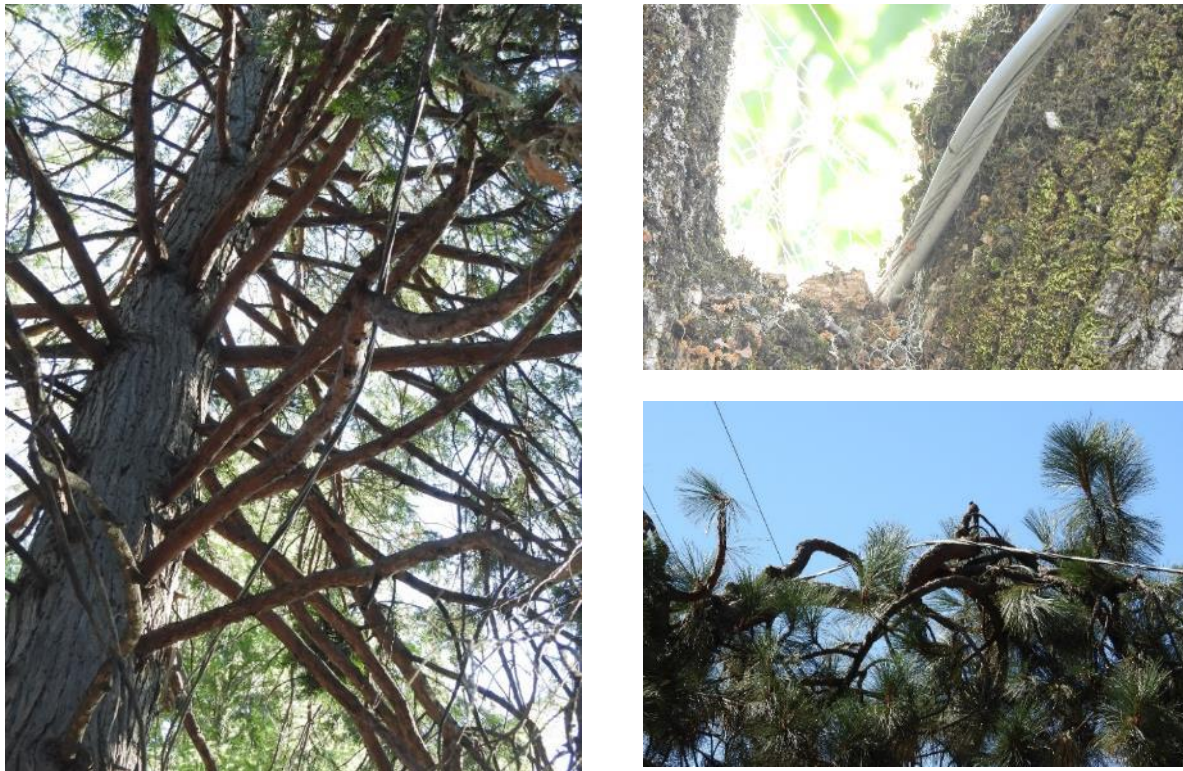
downward, vegetation-related strain ties for the 3<sup>rd</sup> highest finding in 2024 which could come from the limited perspectives of the aerial inspections in detecting such conditions compared to ground-based evaluations. Since service conductors are below the primary conductors, it is difficult to take aerial photos of the service conductor spanning from the pole to the customer. Example photographs of this condition, taken from the ground, are shown in Figure 18 below. Photographs of these conditions were not captured in the PG&E aerial inspection photographs.

Figure 18: Photos of vegetation causing strain or abrasion taken from the ground. Photos of this condition were not captured in PG&E aerial inspection photographs.

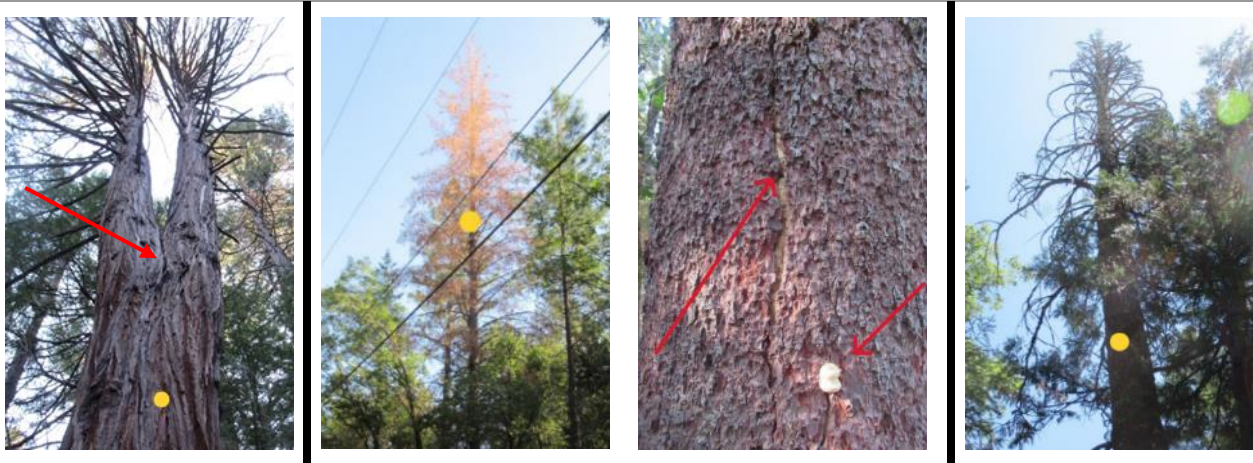
Figure 19: Left: Vertical crack below codominant union. Middle Two Photos: Hazard Tree identified by the ISM during a routine patrol with slipping bark. Right: Hazard Tree identified by the ISM on a routine patrol.

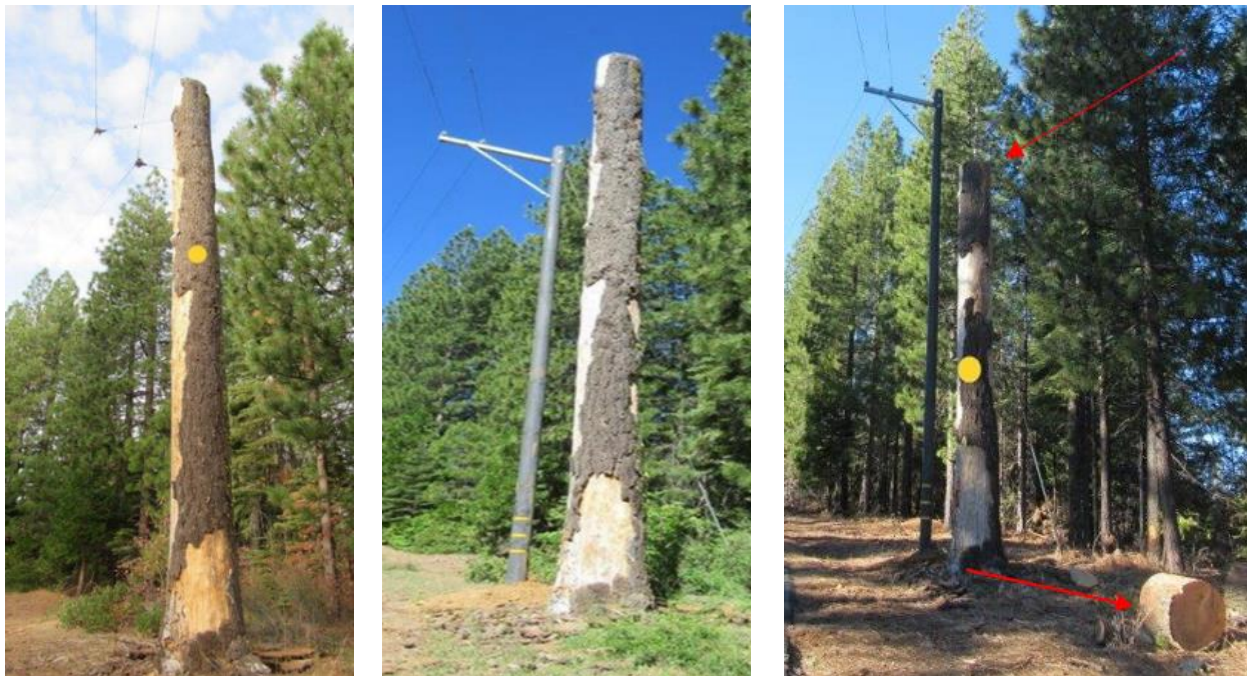
Figure 20: Left: Tree Connect observed November 2023. Middle: Same tree observed July 2024. Right: Same tree observed November 2024.<sup>52</sup>

<sup>52</sup> November 2023 observation: Tree dead and slipping bark with decay in progress. July 2024 observation: Tree connect removed and new pole and guy installed. Dead snag now a Hazard Tree to conductor, pole, and guy wire. November 2024 observation: Dead snag topped below conductor height but still has strike potential to new pole and guy wire.
