FILSINGER ENERGY  
P A R T N E R S

PG&E  
INDEPENDENT SAFETY MONITOR STATUS UPDATE  
REPORT

October 31, 2025

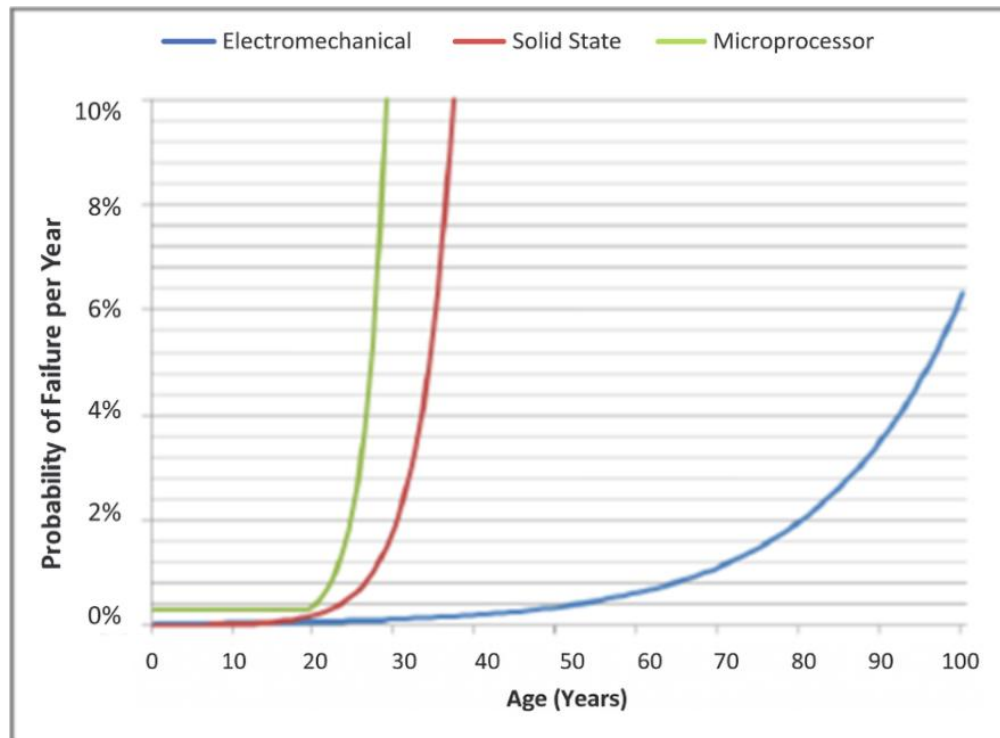
Figure 10: Relay Failure Rates by Age and Type<sup>62</sup>

the useful life for the electro-mechanical relays are 40 years. PG&E also notes that while the vendors of the microprocessor types recommend replacement every 15 years, PG&E's internal sustainability analysis based on simulations and historical data analysis indicates a life span of 20 years. Figure 10 shows the large increase in PG&E's projected probability of failure for the microprocessor and solid-state relays starting in year 20, while the more complex electro-mechanical relays (which do not have the same finite read/write cycle limitations or target power supply life of the microprocessors) have increasing failure rates spread over a longer period of time.

Table 8 shows that at present, approximately 23% of the relays are past their useful life, and with no planned replacements, PG&E projects that 36% of the relays would be at the end of life by 2030.

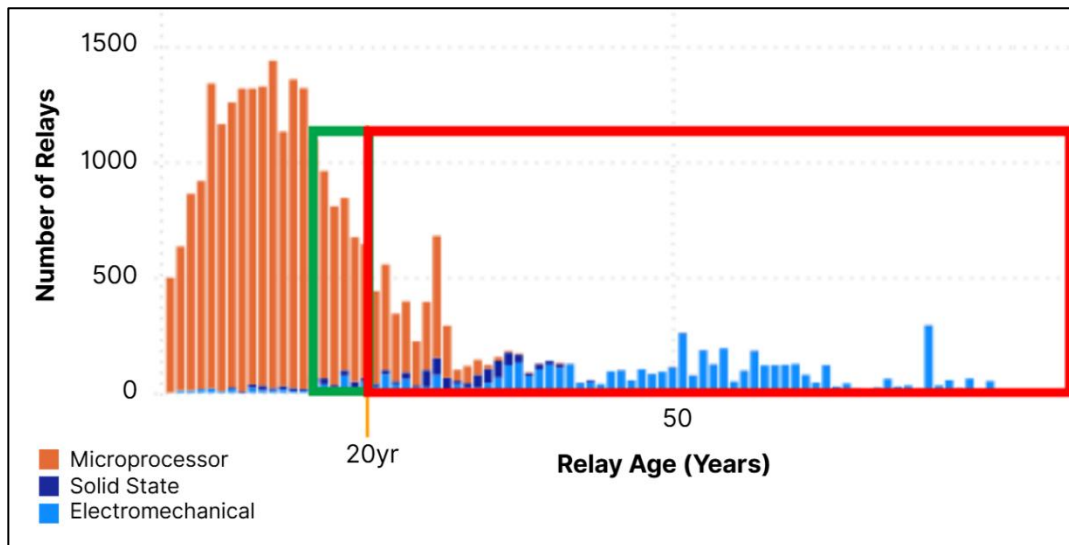
Figure 11: Population of Relays by Age and Type

cover the remaining backlog of relays past their useful life would require an additional \$1.3 billion (represented by the overdue relays in the red box in Figure 11).

Historical funding for the replacement of relays declined in recent years. From 2017 through 2022, funding for relay replacements averaged approximately \$60 million per year. This funding declined to approximately \$40 million in 2023 and 2024, and was set to decline further to \$31 million in 2025, before PG&E recently allocated an additional \$8 million to bring funding back up to the previous year's levels.

With funding below the level needed to proactively replace relays at the end of the useful life, PG&E shifted to a “just-in-time” prioritization of relays, focusing on those deemed to have the highest predicted probability of failure (PoF) and the highest consequence of failure (CoF).<sup>64</sup> Based upon its analysis, PG&E’s system protection group estimated that to replace its Priority 1 relays (66 relays with the highest PoF and the highest CoF) would require \$200 million.<sup>65</sup> This exceeds the \$60 million which the systems protection group indicated it recently secured for its 2026 funding. When questioned by the ISM how these funds would then be allocated, the group indicated that it would start with the highest risk relays within the Priority 1 population.

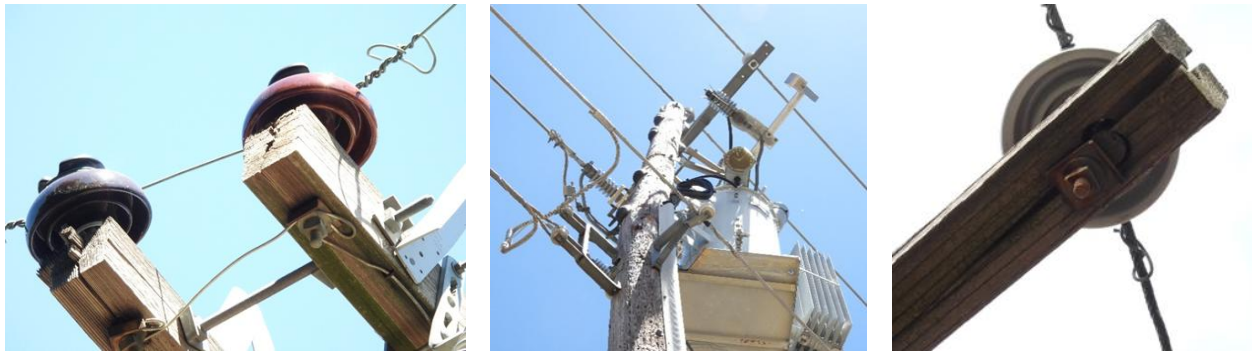
As of June 2025, the ISM began reviewing a dataset containing approximately 7,000 open B tags. Through July 31, 2025, the ISM performed a field review of 102 tags as summarized in Table 10. During the course of the ISM's review, three open B tags were referred to PG&E for additional review - two past due and one current. These open B tags are shown in the photos below. PG&E has since completed the repair of all three B tags.

Figure 12: Representative B-Tag Field Observations (Conductor Strain on Insulators (left); Cracked Pole Below Voltage Regulator (middle); Crossarm Damage at Insulator (right))

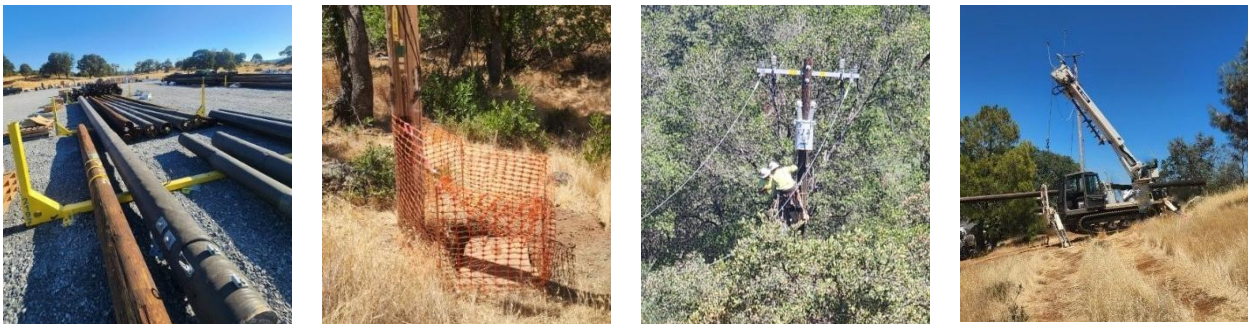
The photographs in Figure 14 below provide a representative overview of the work performed and observed during this site visit.

*Figure 14: Representative Mega Bundle Field Observations*

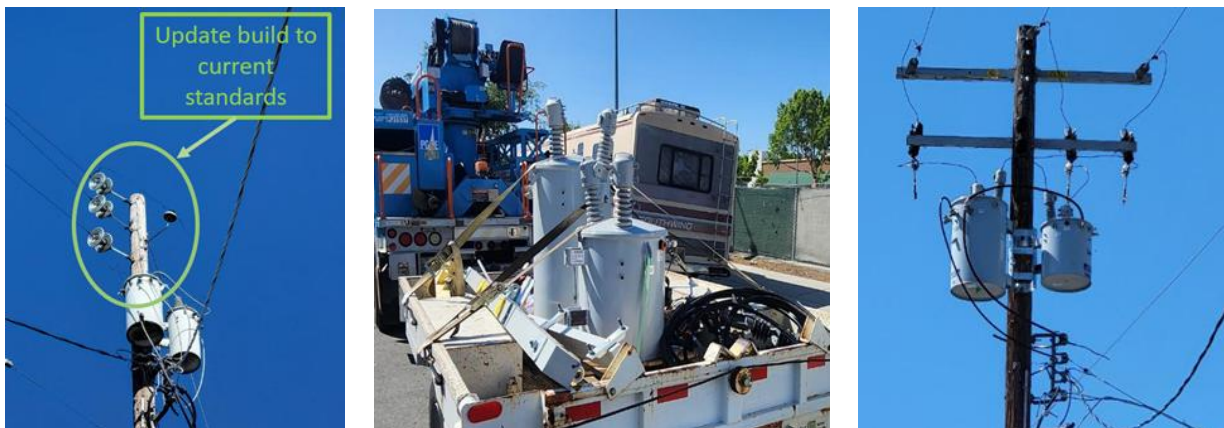
Crews replaced two transformers and added crossarms to conform to PG&E's current construction standards and eliminate vertical dead-end construction. The crews found no visible cause for the outage; however, the troubleman's report indicated a likely bird contact incident. Prior to reconnection, crews field-tested transformer voltage to confirm proper operation. The foreman coordinated with commercial customer electricians to prepare for re-energization, after which the transformers were re-energized by closing the cutouts. The following photographs show the defective transformers and required upgrades, the project loadout, and completed work.

*Figure 15: Representative Routine Maintenance Field Observations (A-Tag, Project Load-Out, and Completed Project)*

After completing the A-Tag repair, the foreman described PG&E's close-out process: 1) Emergency Construction Package forms are completed in hard copy, 2) reviewed and approved by the supervisor, and 3) forwarded to the clerk for entry into SAP and then forwarded to mapping for GIS updates and creation of as-built drawings.

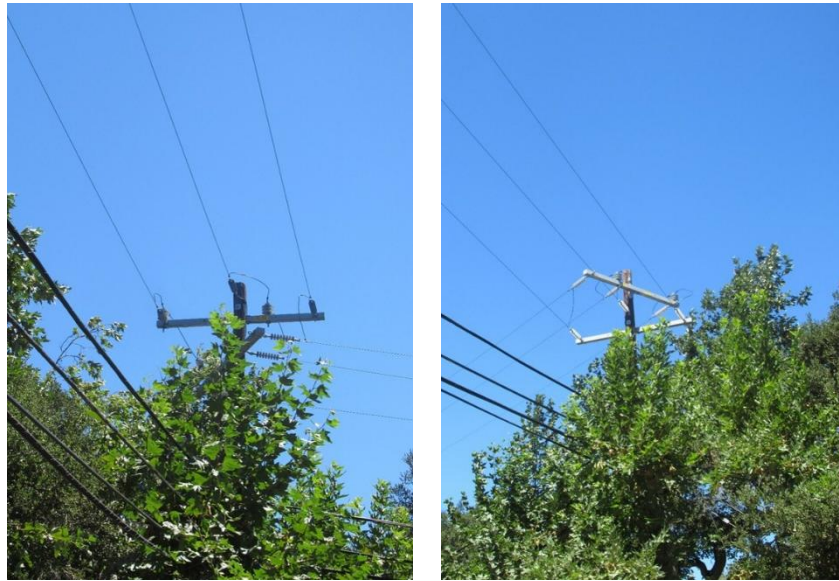
*Figure 19: Representative VMOM Proactive Project Field Observations (Tree Approaching MDR With No Prescription in the System of Record)*

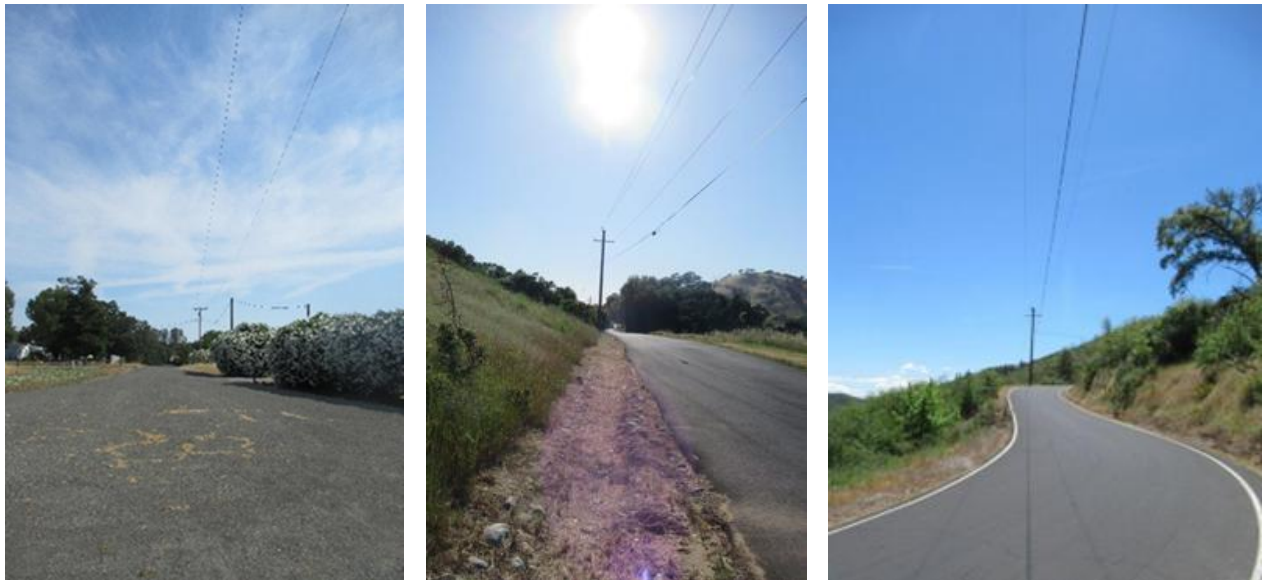
The AOC process developed by the VASA team is supported by PG&E’s WDRM v4. This model incorporates ignition and outage data from 2015 through 2022 and evaluates risk at the CPZ level within HFRA. In 2025, PG&E updated its modeling approach to include areas with high wildfire risk but low tree density, ensuring that sparsely vegetated areas that are still high risk are not overlooked. During the current ISM reporting period, the ISM observed some of these known tree density areas shown in Figure 20 below. AOCs may extend beyond HFRA or HFTD boundaries.

*Figure 20: Representative Field Observations of Areas with High Wildfire Risk but Low Tree Density*

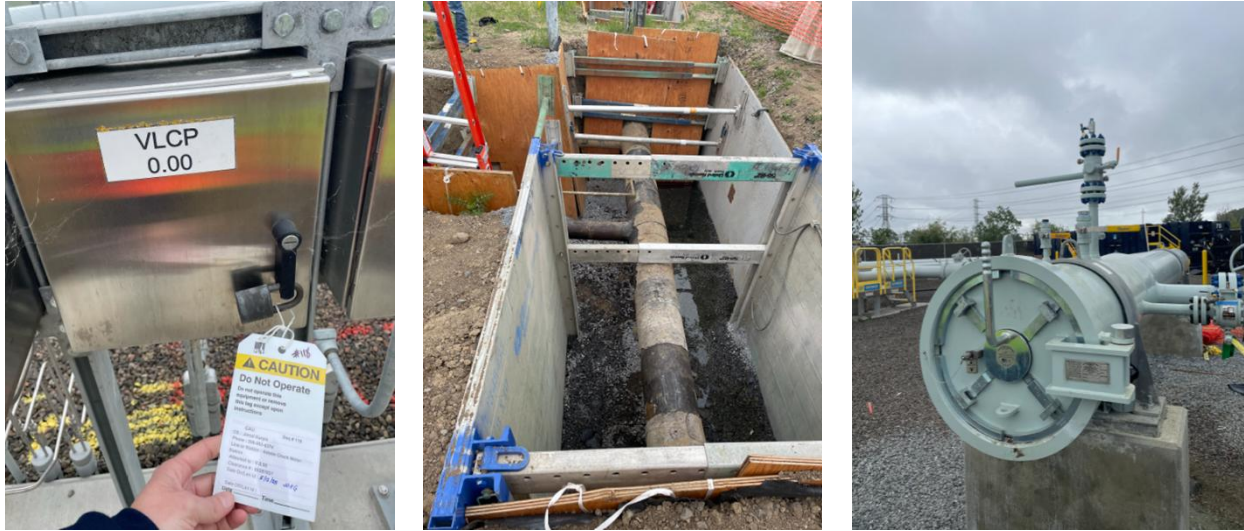
After the "Report On," the clearance team passed project control to the construction team, who completed the project work. Pictures of some of the work completed, including replacement of two pipe tees and installation of a pig launcher can be seen in Figure 26.

Figure 26: Representative Clearance Field Observations (Caution Tag (left), Replacement of Two Pipe Tees (middle), and Installation of a Pig Launcher (right))
