# Root Cause Analyses

## *2017-18 Wildfires*

Root Cause Analyses of the 2017-18 Wildfires found to have been ignited by PG&E & Corrective Action Report

Prepared by: Envista Forensics, Inc. & Subcontractor Witt O'Brien's

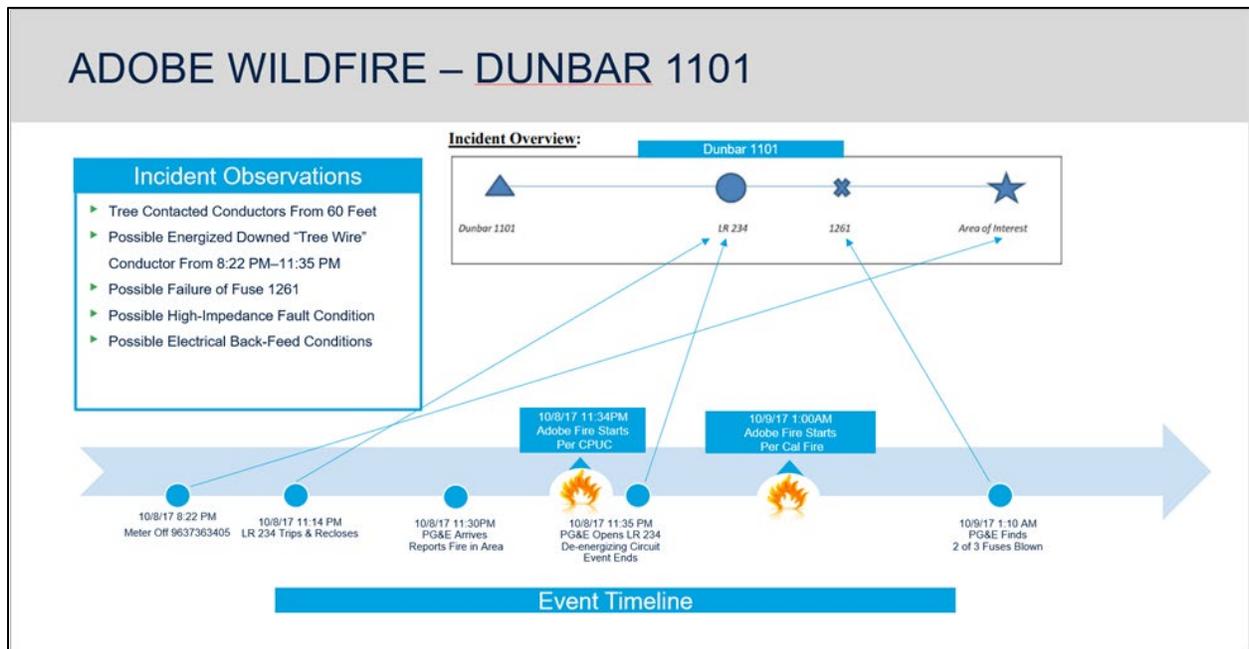
**Figure S1.** Wildfire Circuit Sequencing for Adobe Wildfire Ignition

Without physical evidence, the RCA Team relied on a document-based technical understanding of the PG&E electrical system, including time stamps and other data from PG&E records, all supplemented by the CAL FIRE and CPUC investigative reports. Using this data for each wildfire ignition, the RCA Team reconstructed what happened on each distribution system power line including the protection systems designed to reduce the risk of fires. Through this reconstruction model the RCA Team identified the characteristics of the circuit design, where the protection systems failed to perform and the estimated duration of energized power lines on the ground. In some cases, gaps, or unexplained inconsistencies in the data, increase the uncertainty associated with potential explanations for what caused the fires. A graphical example of this process is provided below for the Adobe Wildfire and explained in more detail in the report. Through this analysis it is estimated that for the Adobe Wildfire, the downed energized conductor was on the ground for at least 193 minutes, far beyond industry standards. In the other wildfire ignitions evaluated the estimates are less, and others are higher.

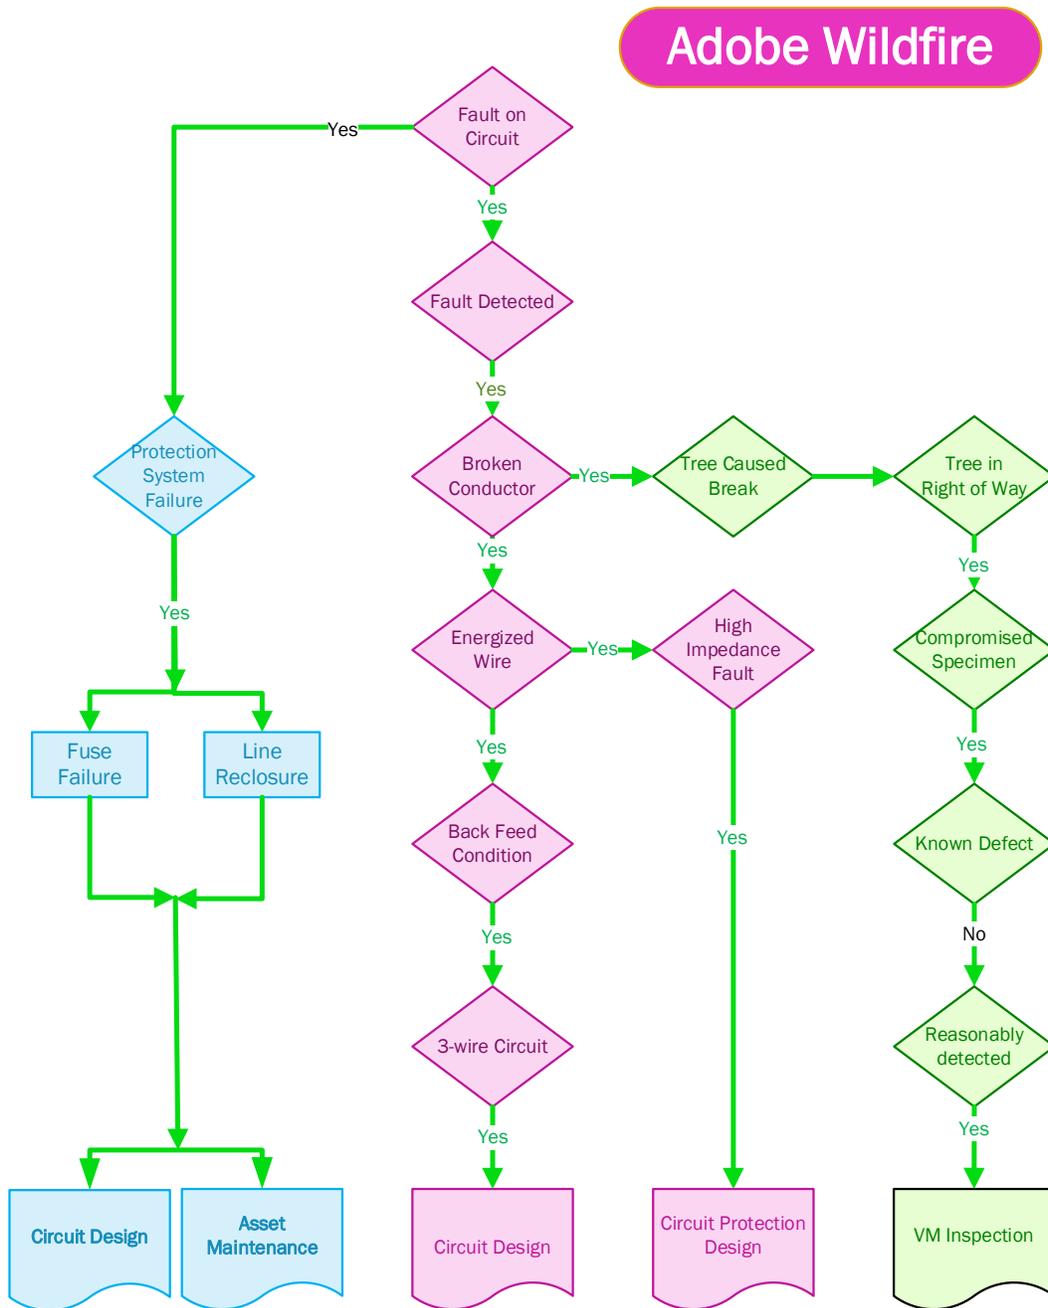
Figure S3. Failure Decision Analysis Flowchart for Adobe Wildfire Ignition

This methodology was applied to the FDA criteria in the database for each wildfire ignition and decision tree flow charts were developed to show the determination of the root causes for each. An example is provided for the Adobe Wildfire. The decision analysis flowchart displays the process of determining the Root Causes; in this case vegetation management inspections, circuit design (in two cases), circuit protection design and asset maintenance.

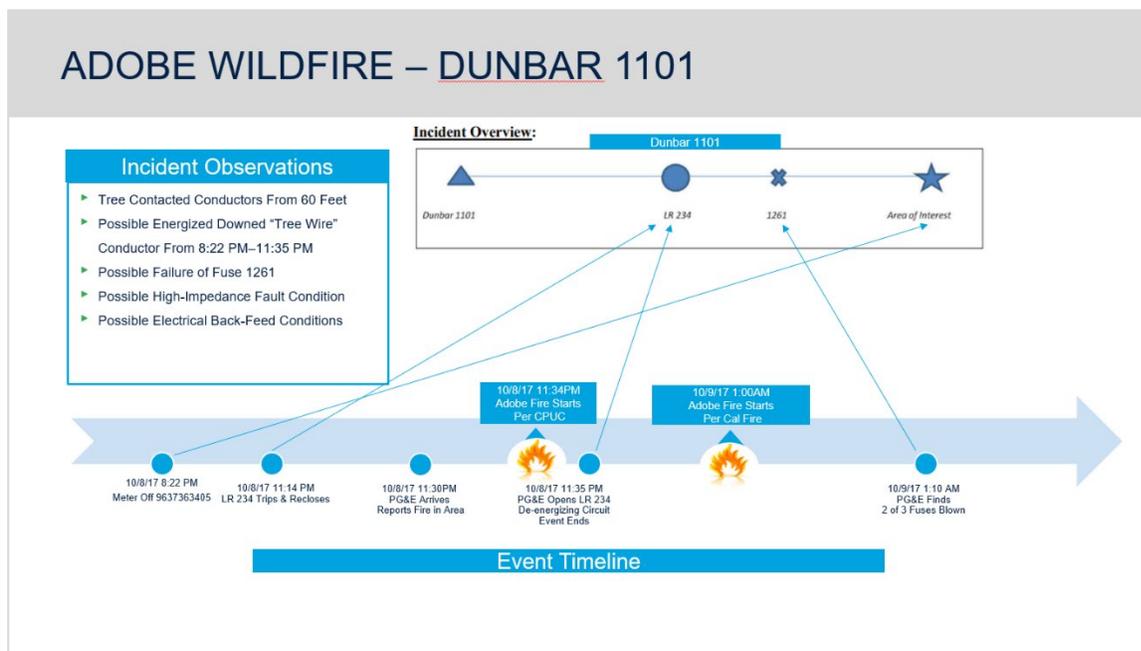
PG&E had installed 'tree wire' conductors to mitigate tree contact faults; however, the failure of one fuse to blow allowed one phase of the downed tree wire to remain energized. Tree wire is designed with minimal insulation, or covering, and in this case, may have unintentionally contributed to extending the high-impedance conditions and the duration of the energized downed conductor. The duration of the energized downed conductor was long enough to cause fulgurites to be formed by the arcing down conductors.

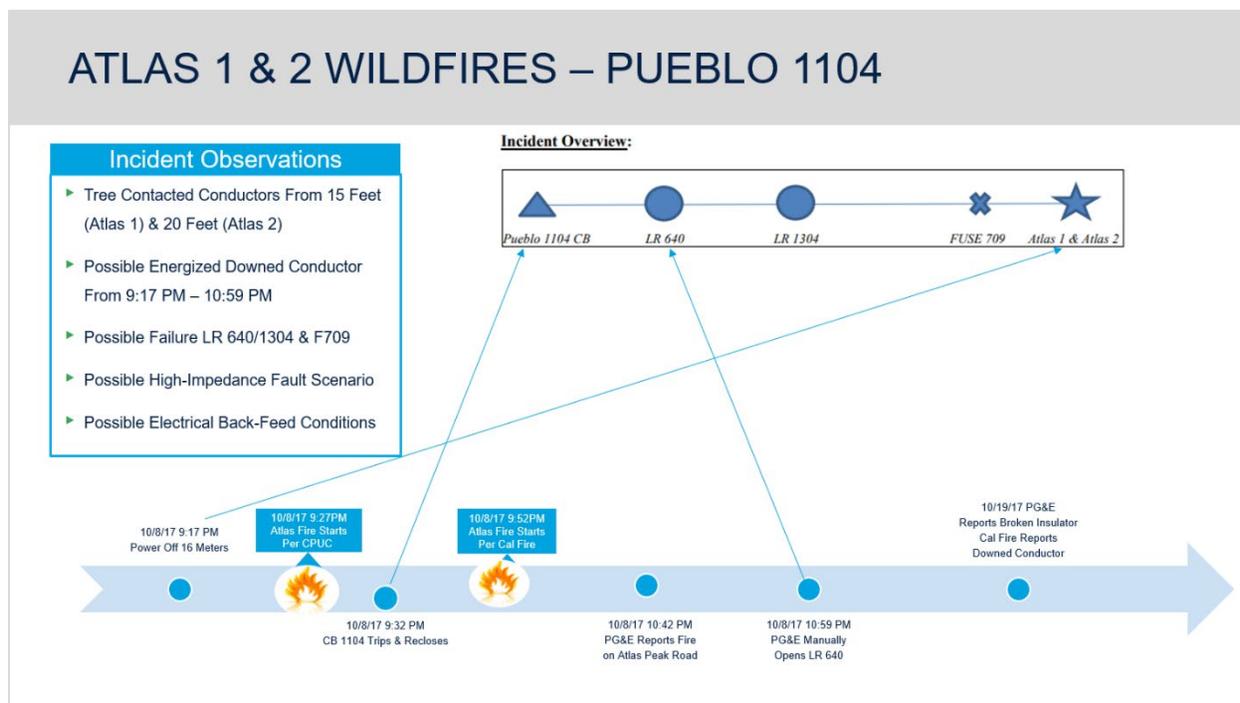
## Atlas 1 & 2 Wildfires – Pueblo 1104

The Atlas 1 & 2 Wildfires involved the Pueblo 1104, a 3-wire 12,000-volt circuit; the analysis found that two trees 15 and 20 feet away contacted the primary conductors. Smart meters located downstream of fuse 709 and LR1304 recorded power-off events beginning at 9:17 PM.

PG&E de-energized the location at 10:59 PM by manually operating LR640. Fulgurites were found at the incident location.

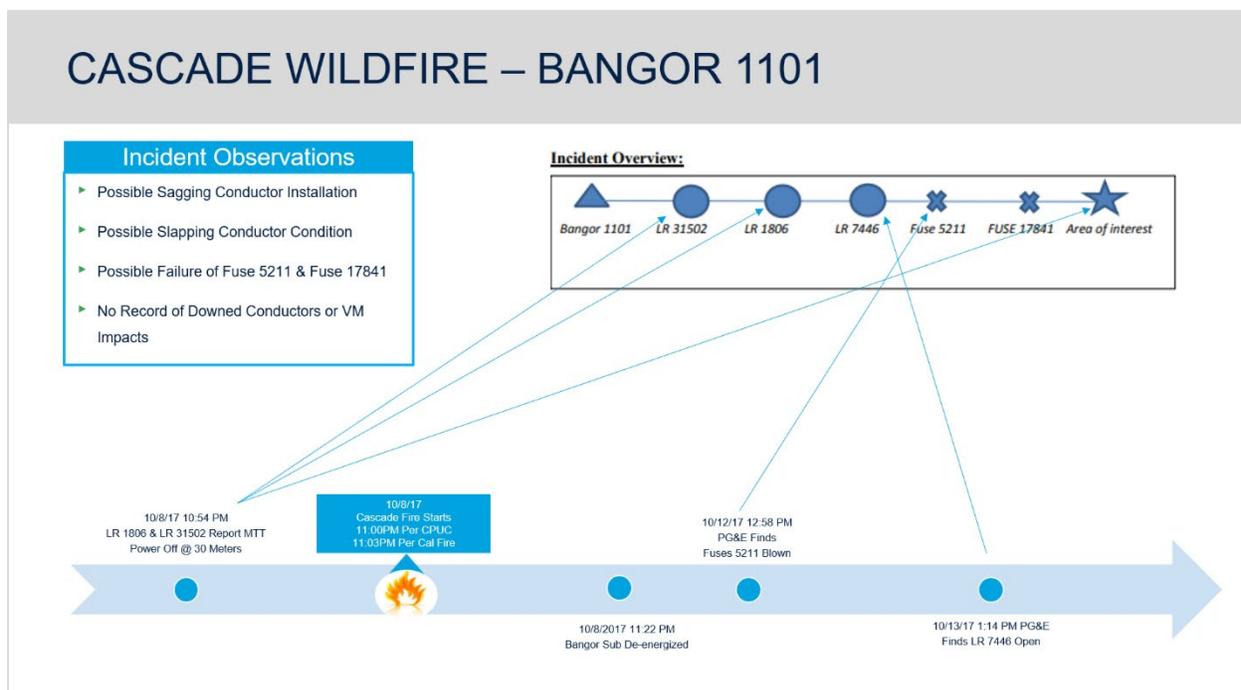
## Cascade Wildfire – Bangor 1101

The Cascade Wildfire involved the Bangor 1101, a 3-wire 12,000-volt circuit; the analysis determined the cause to be sagging phase conductors that came into contact due to wind conditions. The resulting phase-to-phase fault went undetected by fuse 17841.

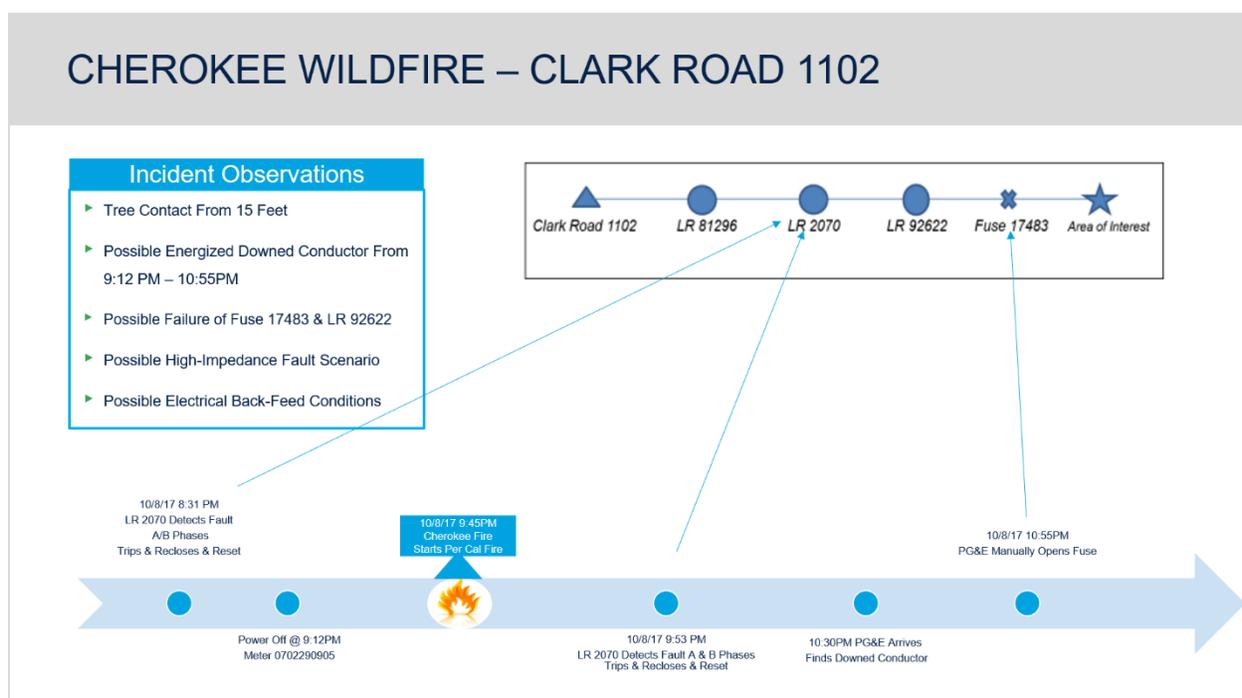
## Cherokee Wildfire – Clark Road 1102

PG&E de-energized the incident location at 10:55 PM by manually opening fuse 17483. Fuse 17483 did not blow, LR 92622 did not detect, and LR 2070 detected and reclosed at 9:12 PM and again at 9:53 PM. The faulted circuit location was a high-impedance fault condition, with back-feed that remained downed and energized for approximately 144 minutes.

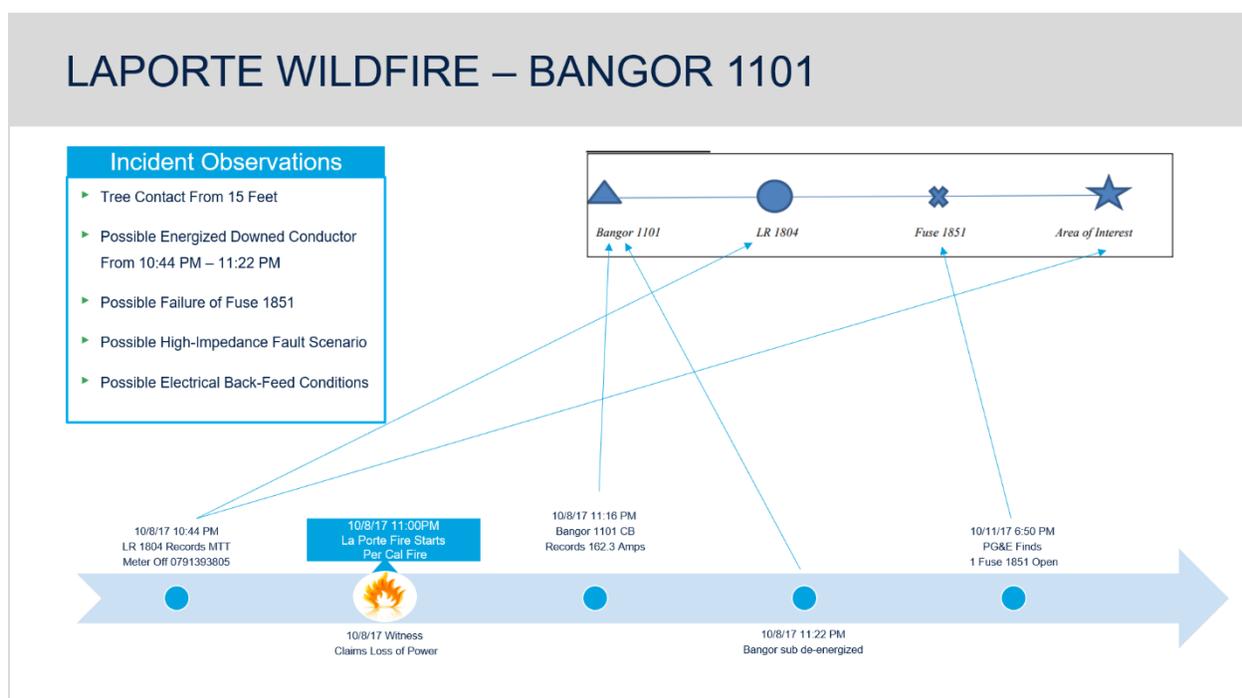
## LaPorte Wildfire – Bangor 1101

Only one of two fuses blew at fuse 1851; LR 1804 recorded MTT at 10:44 PM and again at 11:16 PM; the station breaker recorded 162 amps at this same time. The incident ended at 11:22 PM when the 60kV transmission circuit Colgate-Palermo tripped and deenergized the Bangor station.

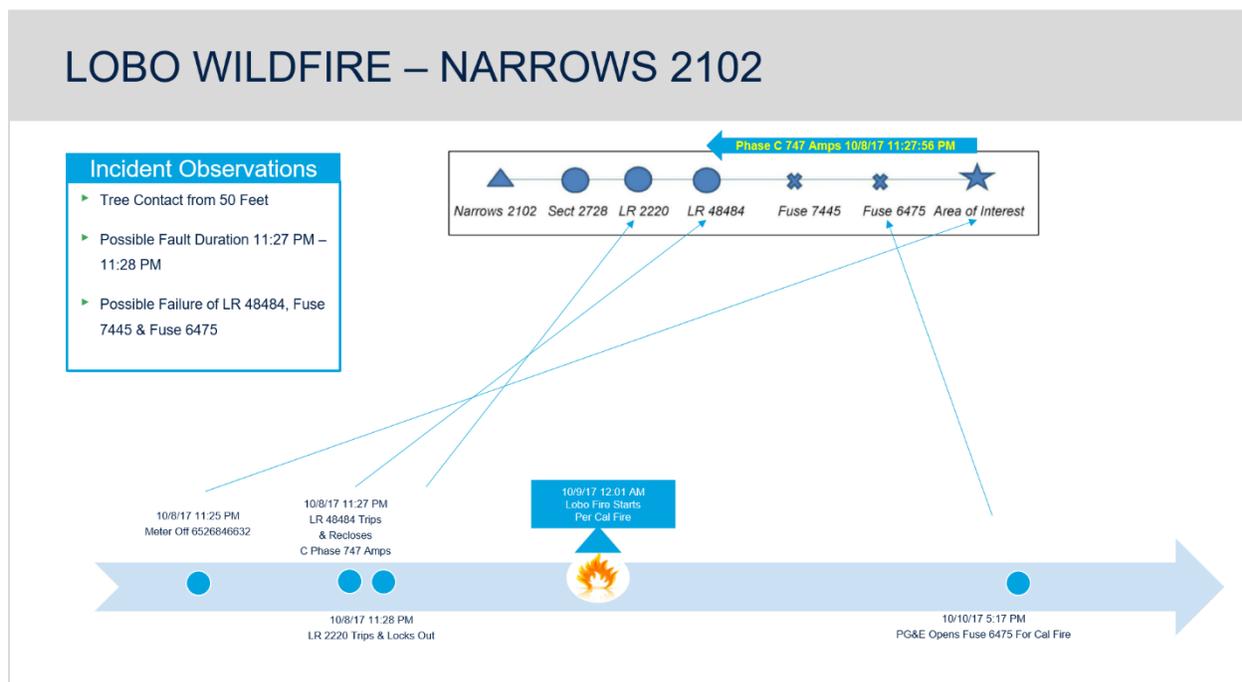
## Lobo Wildfire – Narrows 2102

However, fuse 6475, fuse 7445, and LR 48484 failed to detect the fault conditions and operate. This analysis was unable to determine the installed fuse size at fuses 6475 and 7445 or confirm any recordings or settings on LR 48484.

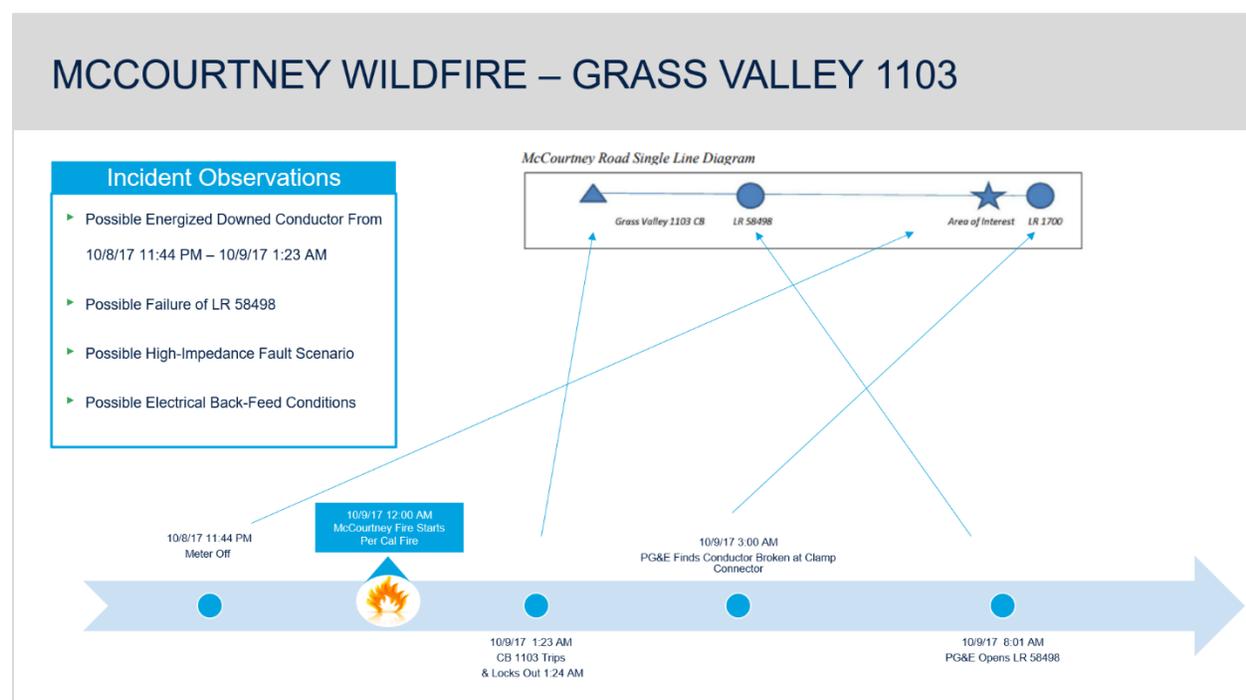
## McCourtney Wildfire – Grass Valley 1103

There were no available records for LR 58498; hence, the analysis was unable to make a conclusive determination as to why LR 58498 did not detect and trip. Absent the records, the analysis finds that LR 58498 did not detect the fault conditions; the fault was detected by the station circuit breaker at 1:24 AM.

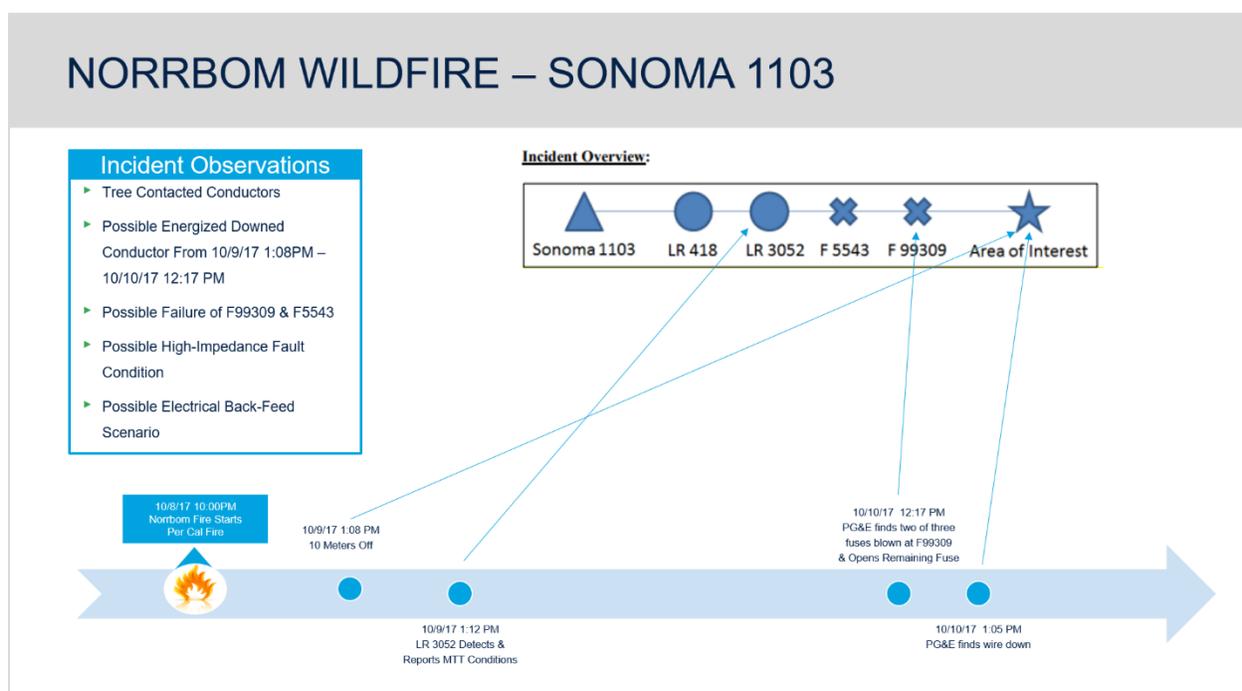
## Norrbom Wildfire – Sonoma 1103

None of the protective equipment installed performed as intended. The single-phase fuse that did not blow, at fuse 99309, energized the downed conductor and caused a back-feed condition to be present.

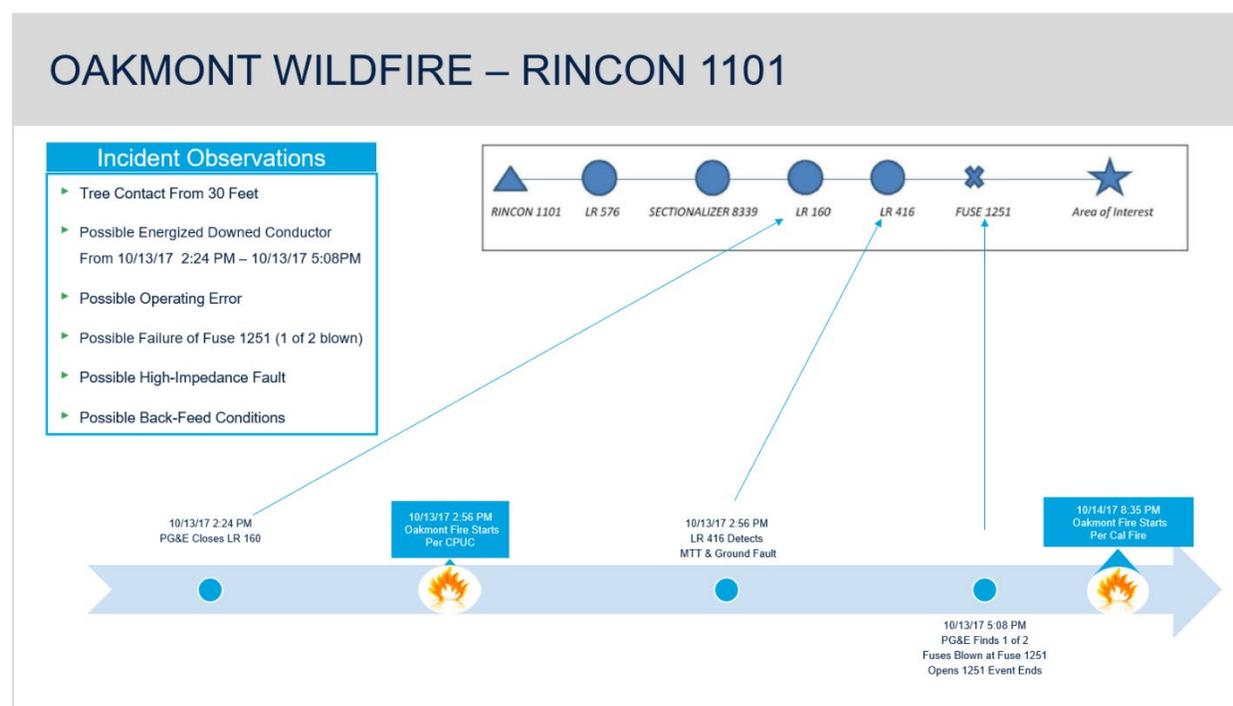
## Oakmont Wildfire – Rincon 1101

None of the remaining installed protective equipment detected the high-impedance fault condition and the conductor remained energized until PG&E manually opened the unblown fuse.

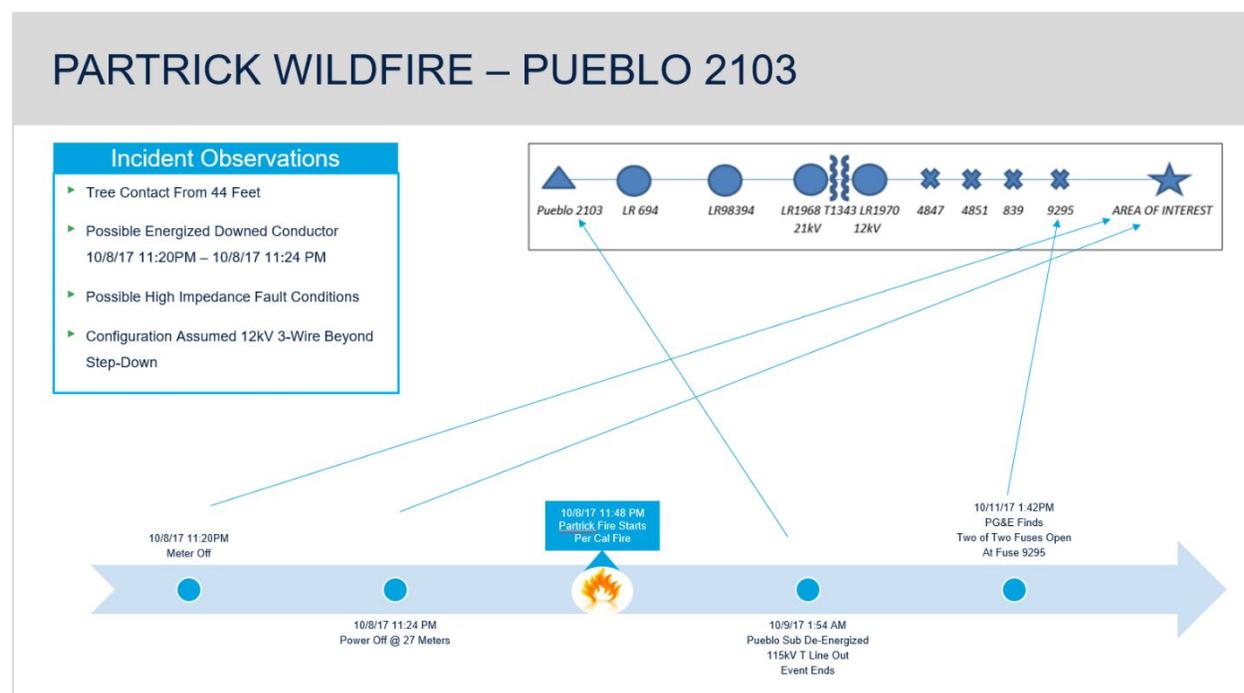
## Partrick Wildfire – Pueblo 2103

The available dataset does not support a conclusive incident observation regarding when the two fuses at 9295 opened. However, it is possible that fuse 9295 operated properly, and two fuses blew when the tree contacted the conductors, de-energizing the line immediately.

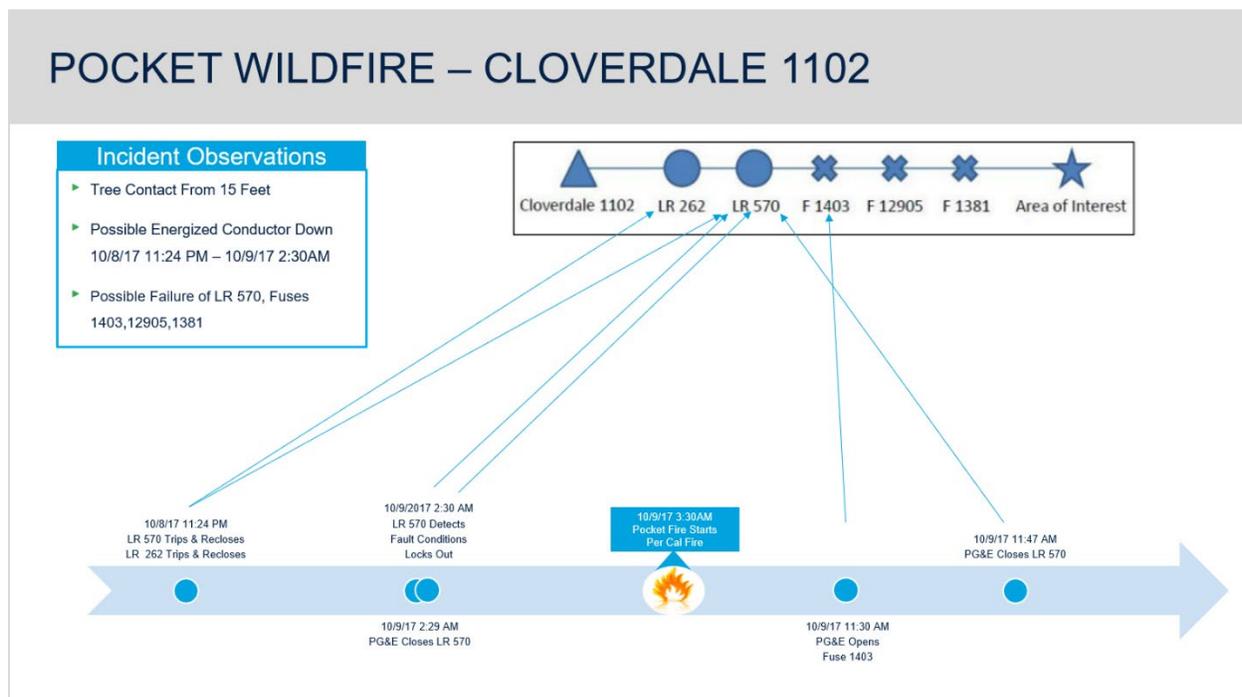
## Pocket Wildfire – Cloverdale 1102

However, the presence of fulgurites as found by CAL FIRE is indicative of a downed energized conductor with an extended duration, such as the timeframe from October 8, 2017 11:24 PM to October 9, 2017 2:30 AM or 186 minutes.

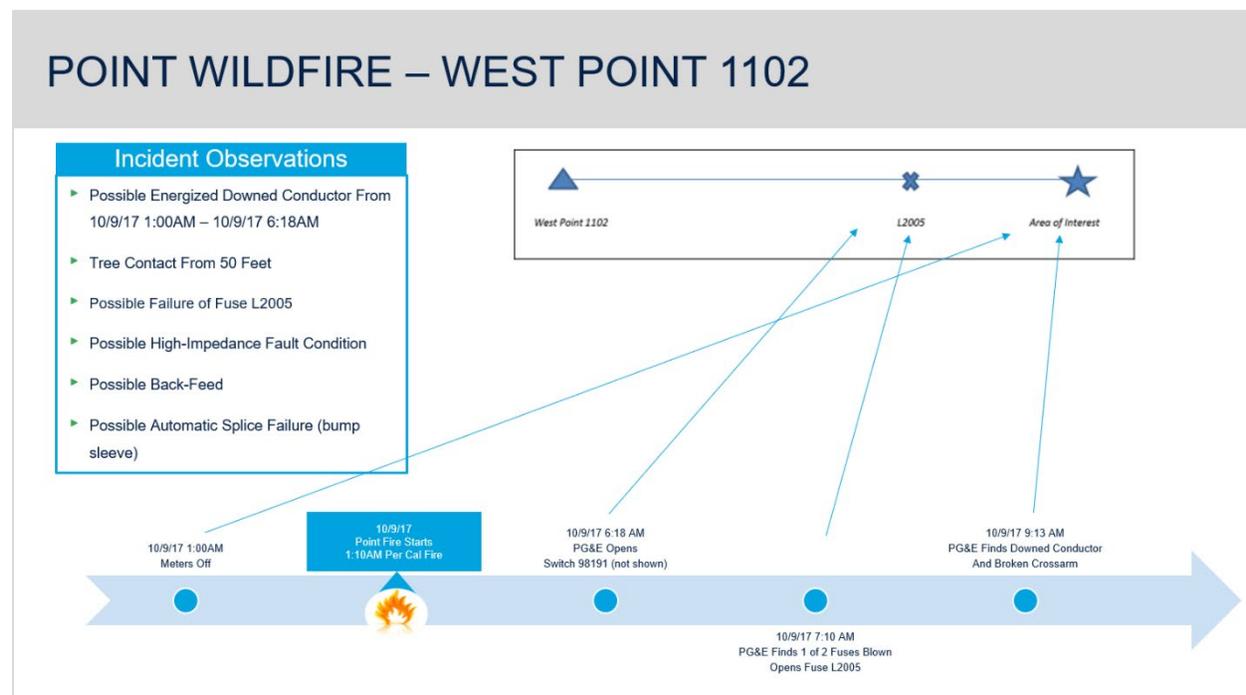
## Point Wildfire – West Point 1102

PG&E provided a detailed analysis of the smart meter data on meters downstream of LR 2005, confirming an energized wire down condition from 12:45 AM to 6:18 AM.

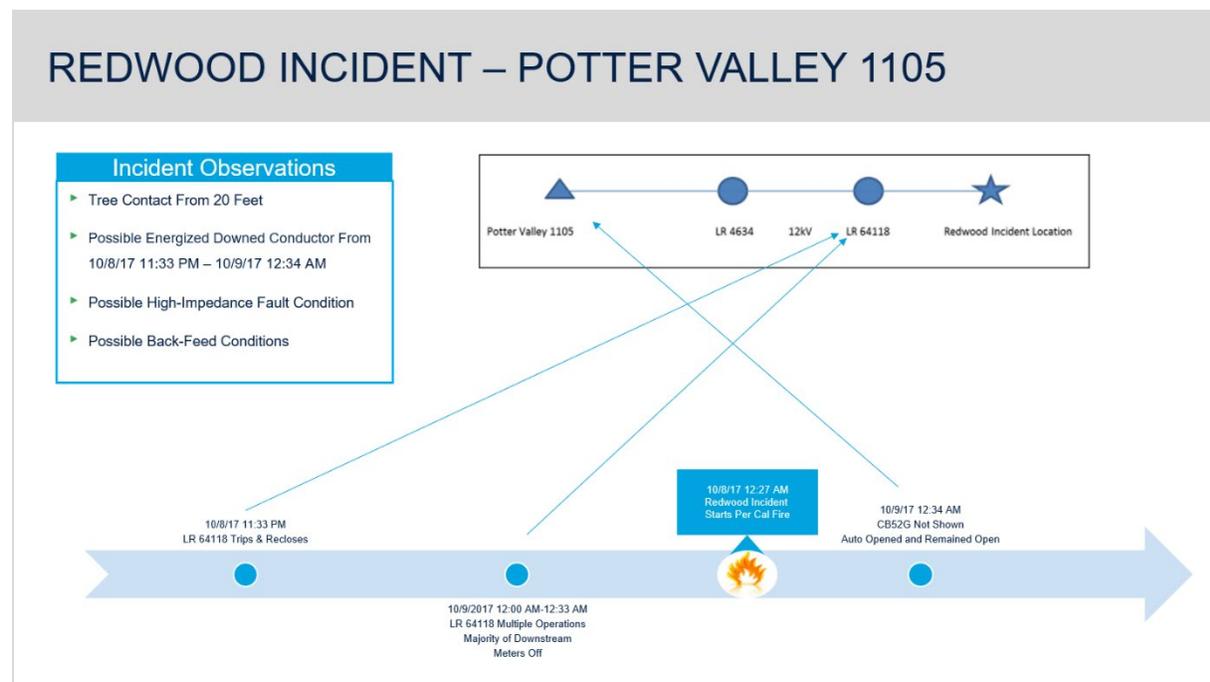
## Redwood Incident – Potter Valley 1105

The result was a downed energized conductor. LR 64118 and LR 4634 did not detect the fault conditions which were likely high impedance, with a long enough duration and intensity to cause fulgurites to be formed.

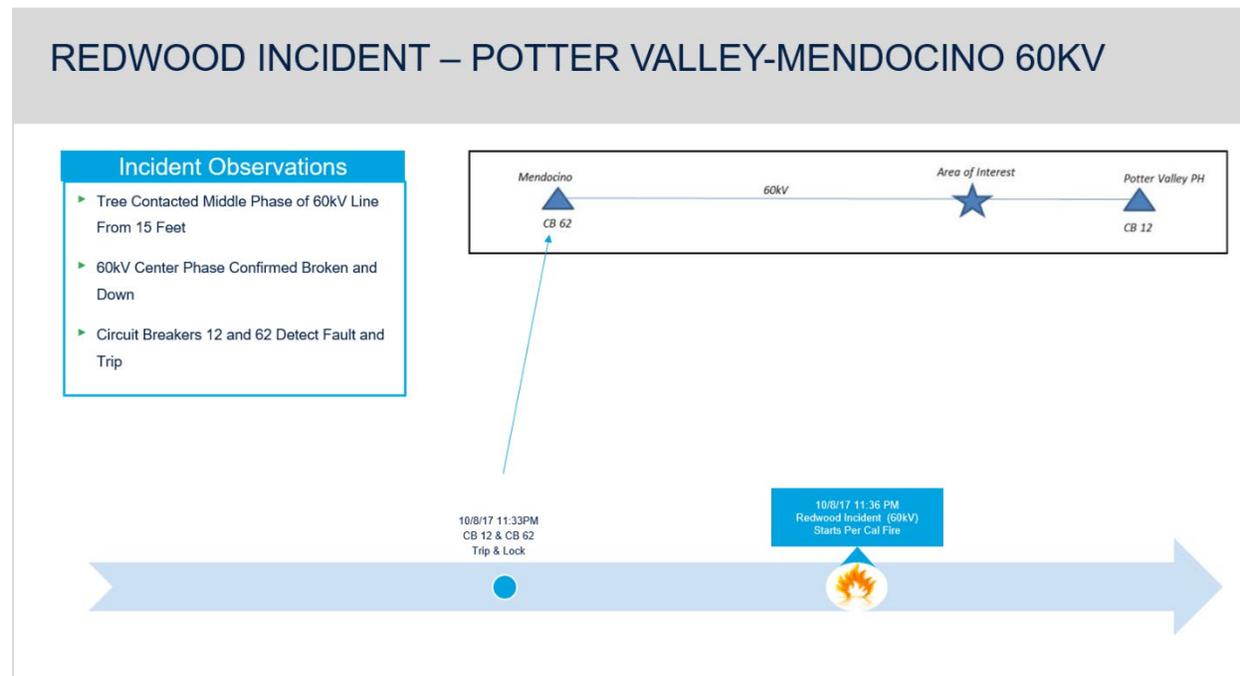
## Redwood Incident – Mendocino 60kV

The Redwood Incident also involved the Potter Valley-Mendocino 60,000-volt transmission line; the analysis found that a tree 15 feet away contacted the primary conductors at approximately 11:33 PM when station circuit breakers 12 & 62 detected fault conditions, tripped, tested the line, found a fault condition, and locked out.

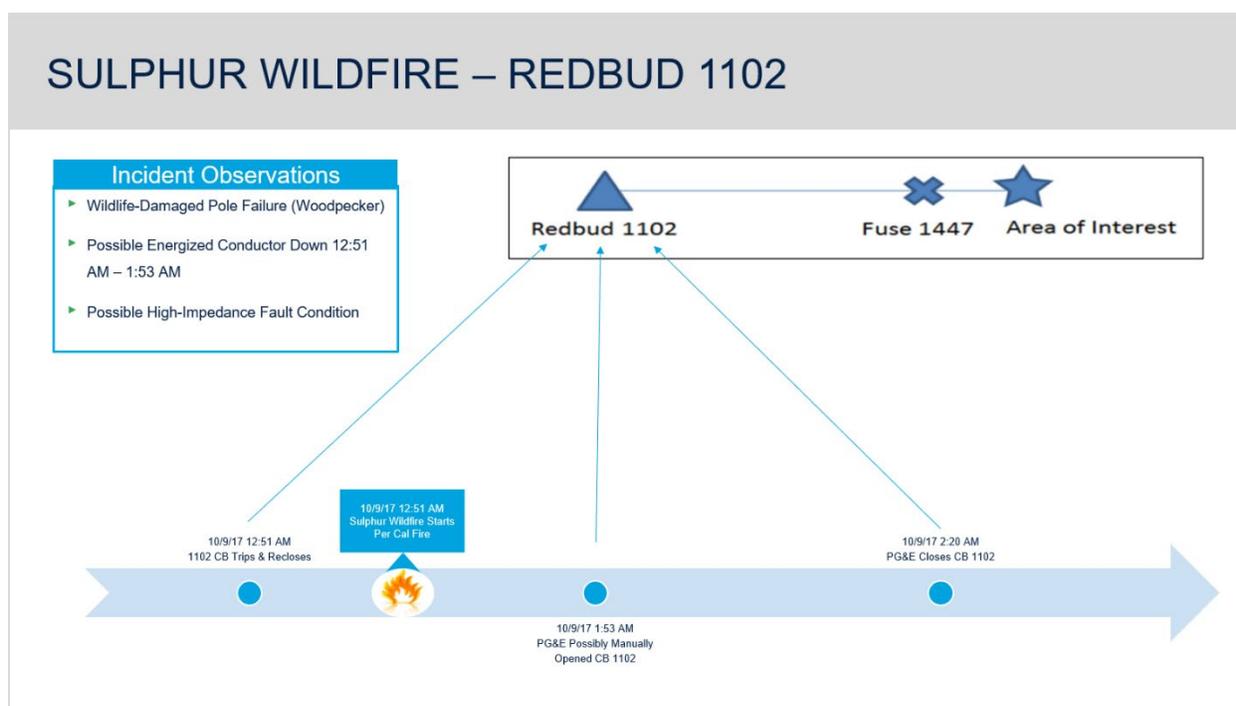
## Sulphur Wildfire – Redbud 1102

The PG&E Incident Description and Factual Summary indicates CB 1102 tripped and locked out at 12:51 AM; however, the records reviewed in this analysis show CB 1102 tripped at 12:51 AM and reclosed at 12:52 AM. The circuit remained energized until being remotely opened by PG&E at 1:53 AM.

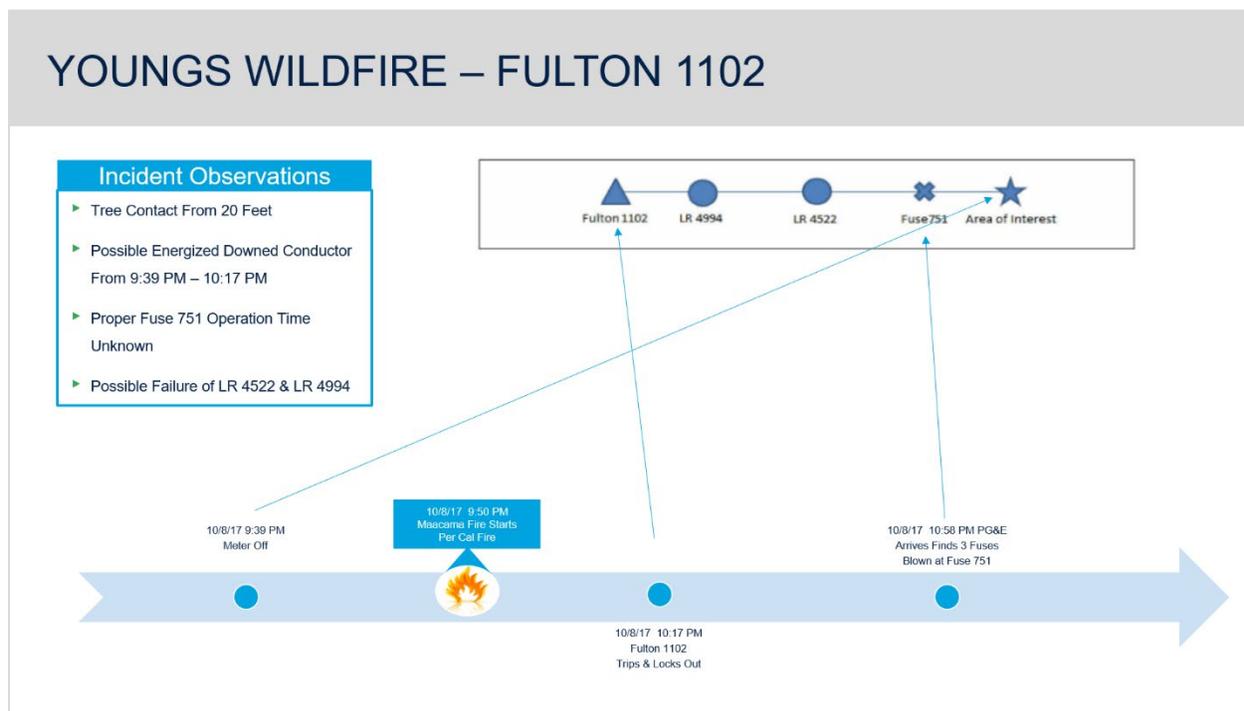
## Youngs Wildfire (Maacama Lane) – Fulton 1102

The analysis is incomplete without further smart meter data. The possibility of an energized downed conductor, between 9:39 PM and 10:17 PM for 38 minutes, cannot be ruled out.

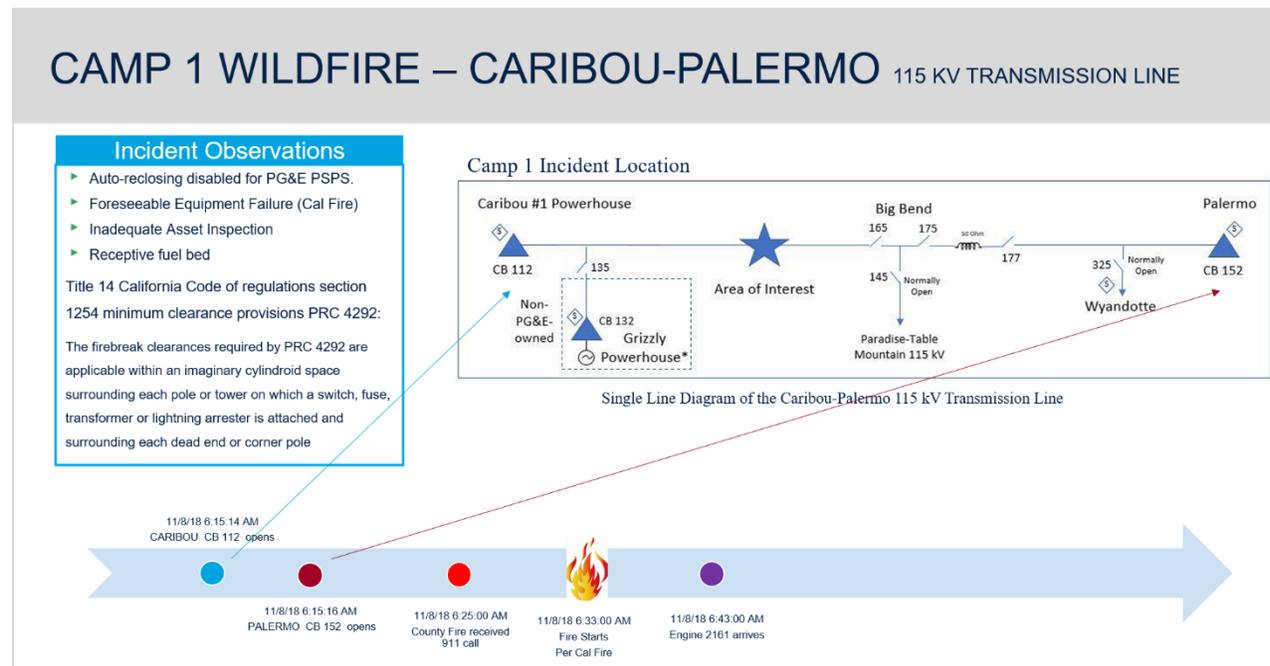
## Camp #1 Wildfire – Caribou-Palermo 115kV

A large volume of physical, technical, and other investigations and studies confirm the point of failure originated in a 'C' hook that suspended the conductors. Energized conductors contacted the tower causing a high-energy fault.

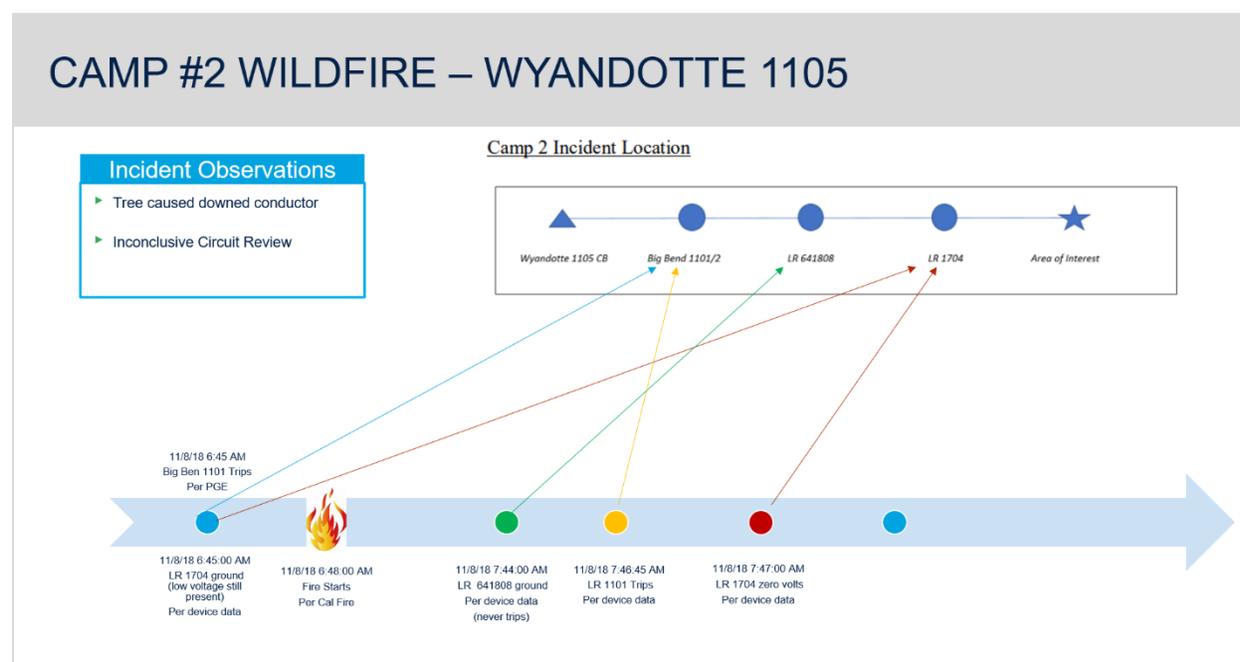
## Camp #2 Wildfire – Wyandotte 1105

It is possible the tree contact caused LR 1704 to detect and trip at 6:45 AM, and enough energy was released to cause an ignition.

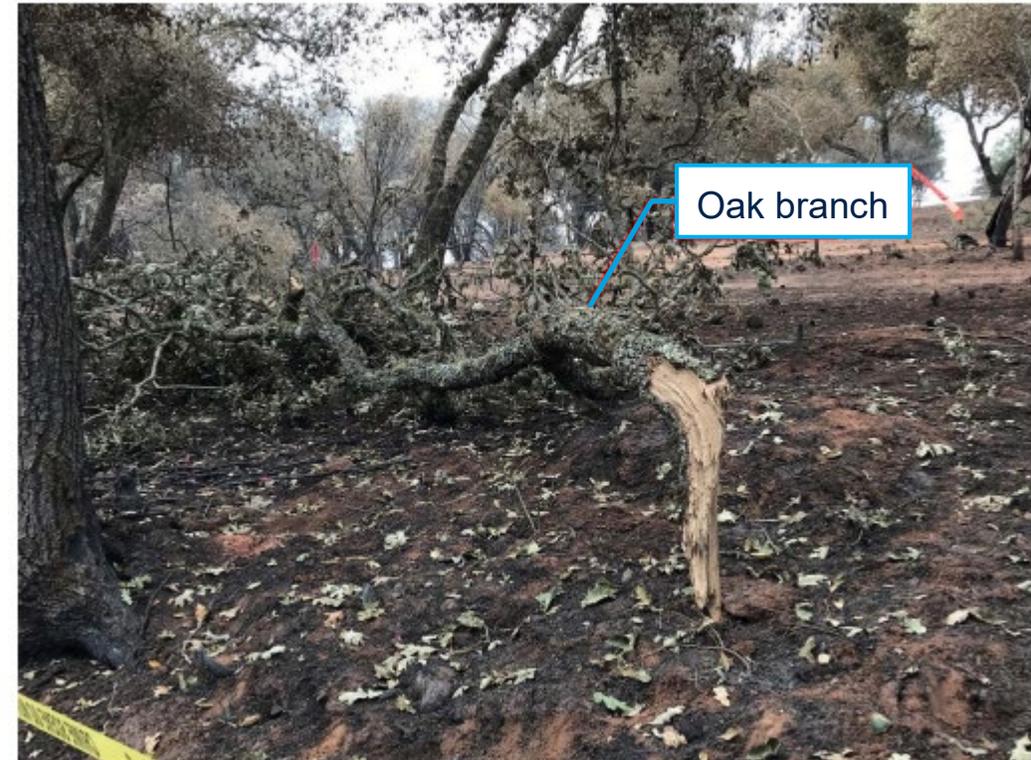
Figure 3. Atlas 2 - Failed Valley Oak branch removed from conductors.

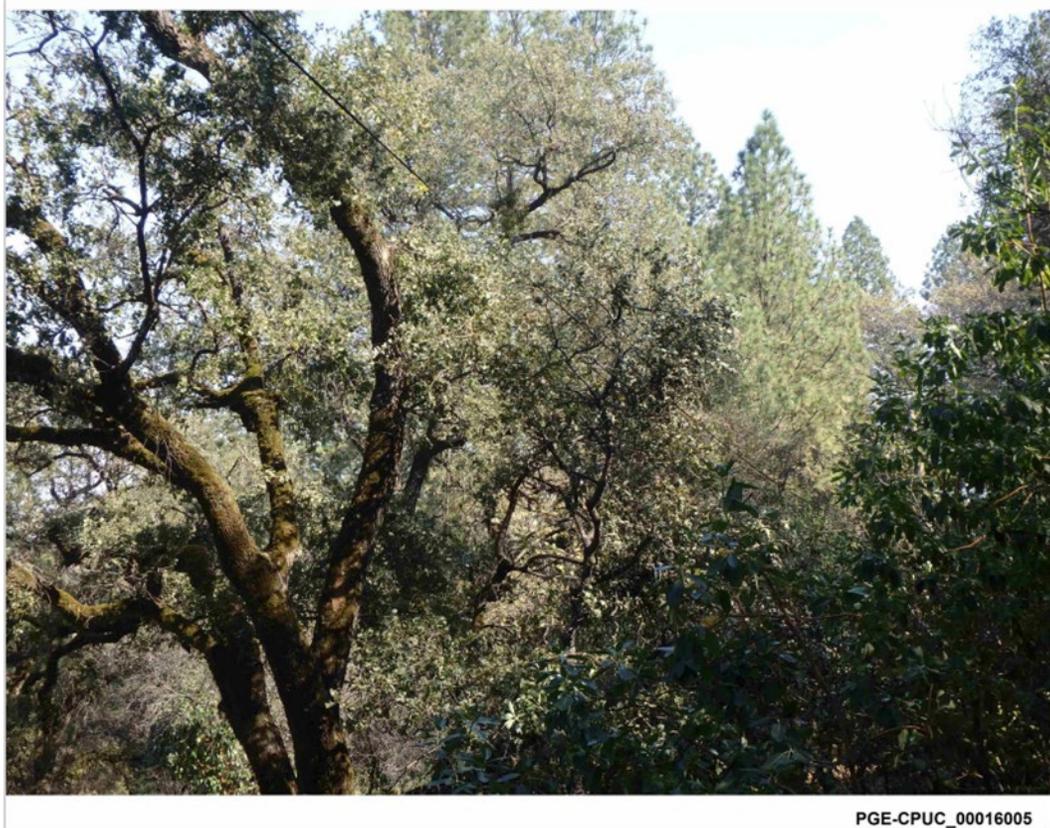
Figure 7. Burn mark from 12 kV conductor on the Valley Oak tree

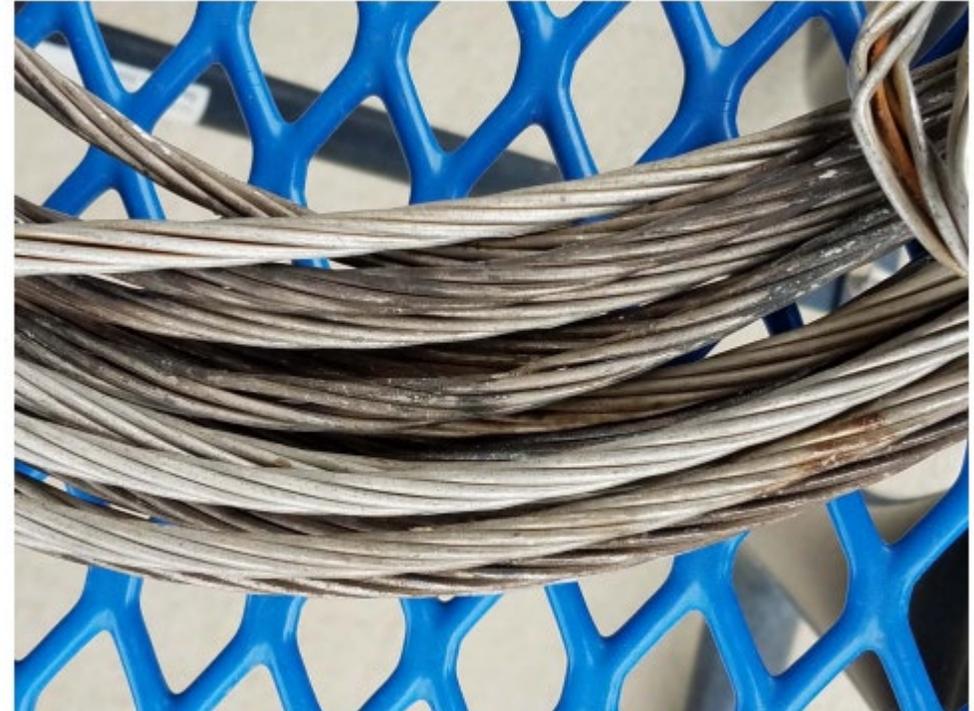
Figure 19: Burn Marks on Subject Conductor

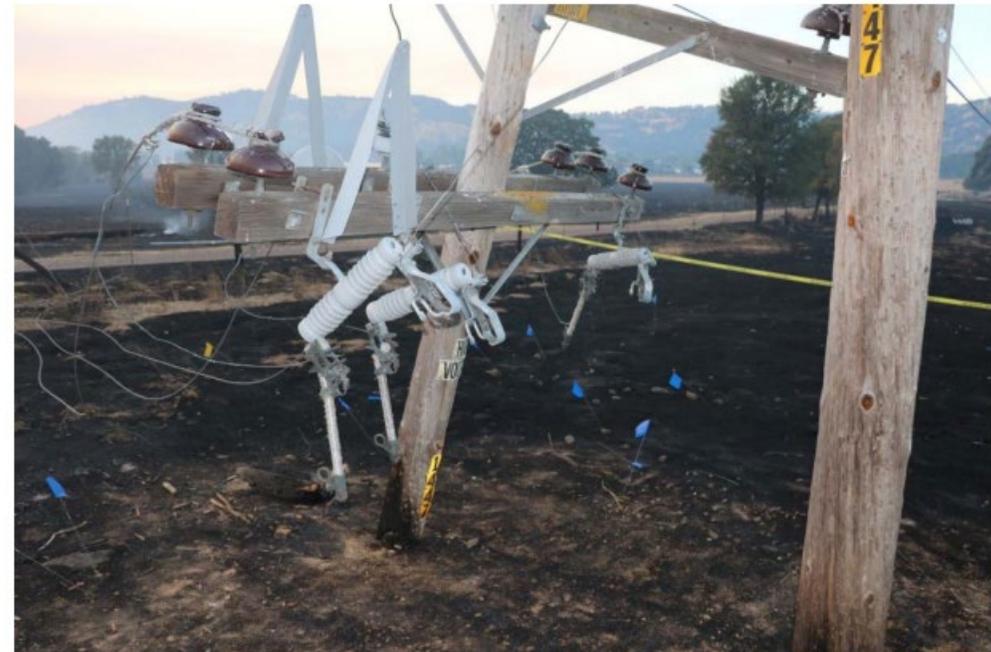
**Figure 6.** The subject pole (Fuse Cutout Pole 1447) found after arrival. (Source: CAL FIRE)
