SED INCIDENT INVESTIGATION REPORTS

**CALIFORNIA PUBLIC UTILITIES COMMISSION
Safety and Enforcement Division
Gas Safety and Reliability Branch**

Incident Investigation Report

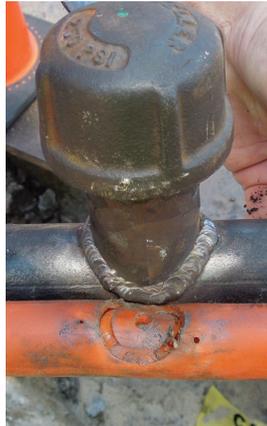
On July 30, 2013 at approximately 12:30 pm, [REDACTED], a PG&E welder, welded a tap fitting onto a 1 ¼-inch steel service line casing at [REDACTED] Charleston Road, Mountain View. This work was done as part of a project to replace 1575 feet of 2-inch steel distribution main with 1300 feet of 2-inch plastic distribution main. Additionally the project included the transfer of three inserted gas service lines ([REDACTED] Charleston Rd) to the new plastic distribution main, the installation of one new gas service line and the replacement of four steel gas service lines ([REDACTED] Charleston Rd) to plastic line. The PG&E crew was not aware that the 1 ¼ inch steel service line casing had an inserted 1-inch plastic line. The 1-inch plastic insert melted causing a release of gas and the damage is shown in Figure 1.

Figure 1. Damaged plastic service line insert and the tapping fitting welded onto the steel casing.

This incident was caused by PG&E’s failure to provide accurate information about the service line to its workers. Therefore, I find PG&E in violation of Title 49 CFR § 192.605(b) which states in part: *“The manual required by paragraph (a) of this section must include procedures for the following, if applicable, to provide safety during maintenance and operations... (3)Making construction records, maps, and operating history available to appropriate operating personnel.”*

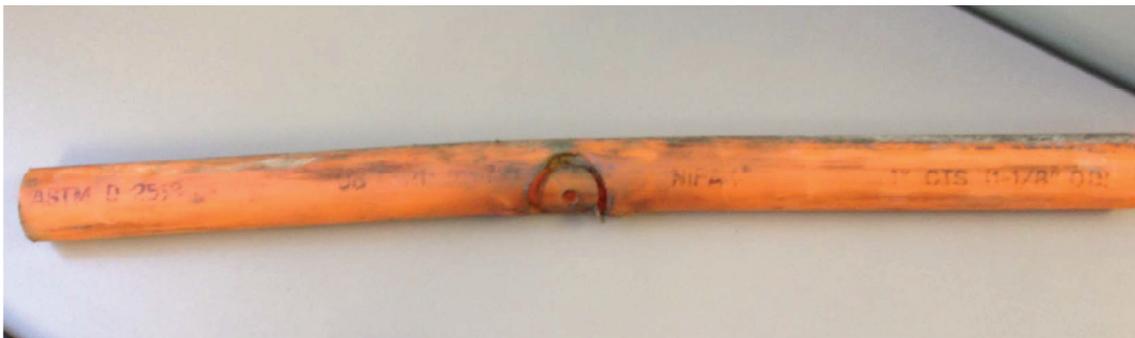
The 1 ¼-inch steel service line for address [REDACTED] Charleston Road, Mountain View was originally installed in 1947. The plastic pipe that melted is NIPAK TR 418 and the date of manufacture was June 21, 1972. PG&E identified the pipe material based upon a visual examination and the pipe is shown in Figure 2.

Figure 2. NIPAK TR-418 pipe with welding damage (Data Request #4160 "TR-418.pdf").

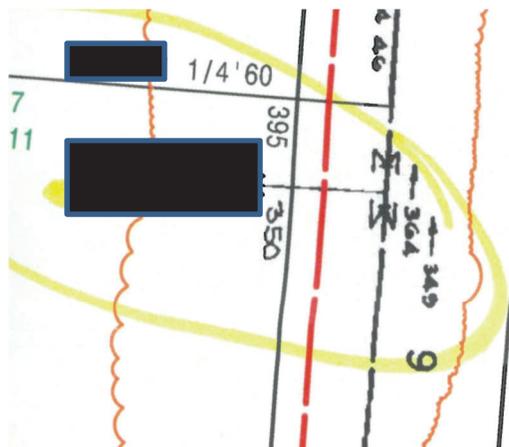
PG&E stated that the crew foreman typically uses the plat map to identify the facilities in the field. In this case, the crew foreman used construction documents for the replacement project as well as the plat map (Data Request #4160 "Plat_Map_CONF.pdf") neither of which indicated the presence of the plastic insert. The relevant portion of the Plat map is in Figure 3.

Figure 3. Plat map [REDACTED] showing address [REDACTED] Charleston Road and a 1 ¼ inch steel service line.

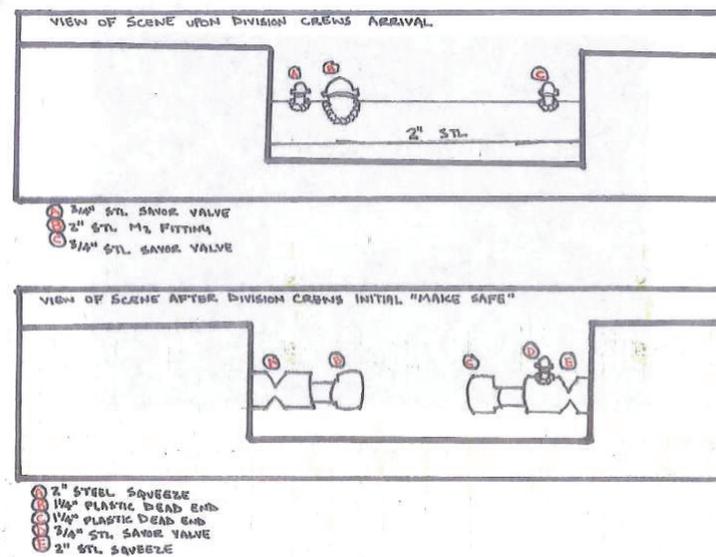
The division crew arrived at 11:38 am and stopped the flow of gas at 11:45 am. The division crew stopped the flow of gas by squeezing the steel casing down around the inserted plastic main at the east and west ends of the bell hole as shown in Figure 2. Additionally, PG&E conducted a special leak survey in the aftermath with no further indication of natural gas.

Figure 2: Sketch of how the division crew stopped the flow of gas⁹

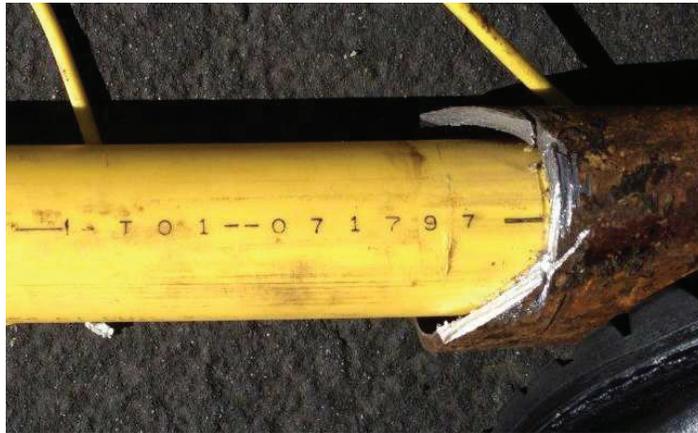
The inserted plastic on 3rd Avenue has a stamp of “071797” which indicates a manufacturing date of 7/17/1997, as shown in Figure 4. PG&E believes that the 1- $\frac{1}{4}$ inch plastic main was inserted into the 2-inch steel main sometime in 1997-1998. Similarly, the service line for customer service number [REDACTED] 3rd Avenue and Guadalupe Street also had an inserted plastic service shown in Figure 5. However, Plat [REDACTED] shows a $\frac{3}{4}$ -inch steel service pipe instead of an inserted $\frac{1}{2}$ -inch plastic service. Figure 6 shows a stamped date on the inserted service as “052697” indicating a manufacture date of May 26, 1997.

Figure 4. Date stamp on inserted plastic main indicating 071797

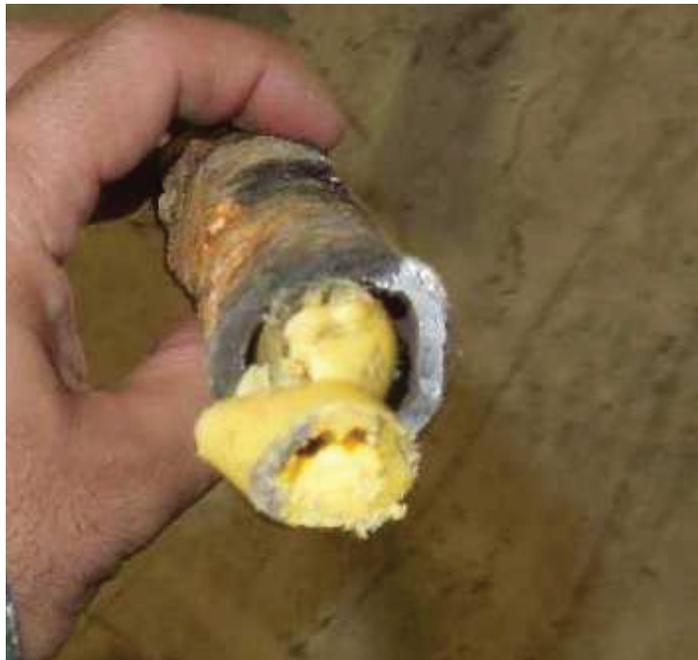
Figure 5: The service riser inserted with plastic.

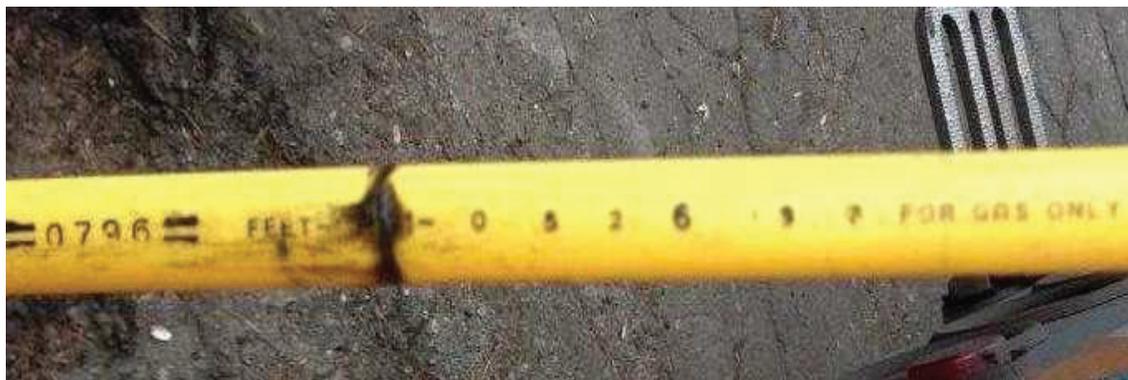
Figure 6: Date stamp on inserted plastic for service of [REDACTED] indicating 052697.

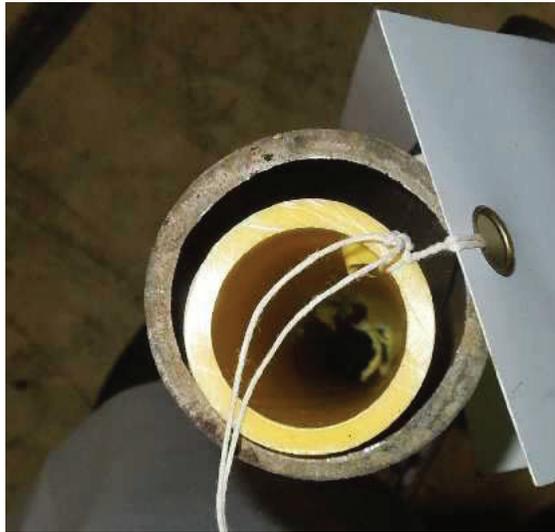
In the aftermath of the incident, PG&E hired a third party company, Exponent Failure Analysis Associates (Exponent), to conduct a failure analysis investigation of the incident. Examination of the 1-1/4 inch plastic distribution main showed that the inserted plastic main was damaged in two sections during the welding and tapping process. The welding and tapping of the save-a-valve caused the smaller hole in the 1 1/4-inch plastic main. At this point, gas was flowing down the annular space between the plastic main and steel casing, as shown in Figure 7, which was why the PG&E welders reported reading 48 psig with the pressure gauge. A reading of 48 psi would not be an indicator that there existed a problem as it is close to the operating pressure of 50 psi that the main typically is at.

Figure 7: 1-1/4 plastic main inserted into 2 inch steel.

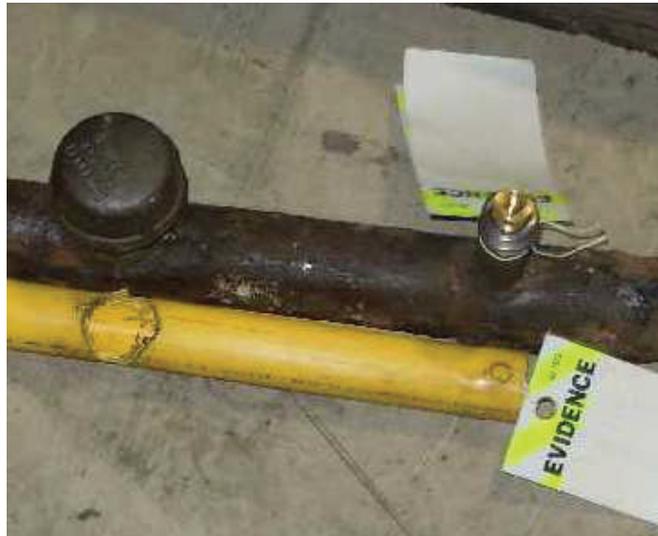
The welding and tapping of the M2 line stopper later caused a larger hole on the inserted plastic main causing further release of natural gas from the inserted plastic main. Figure 8 shows the smaller and larger holes caused by the installation of the save-a-valve and line stopper. The larger hole on the left was caused during the installation of M2 line stopper and the smaller hole on the right was caused by the save-a-valve installation.

Figure 8: Damaged plastic main insert and steel casing showing two damaged locations.
