**Arborist Report
Butte Fire Incident
15-CA-AEU-0024918**

prepared by Michael T Mahoney, RCA #353
32759 Greene Drive · Springville, CA 93265 · 949/283-6439
michael@michaeltmahoney.com

February 15, 2016

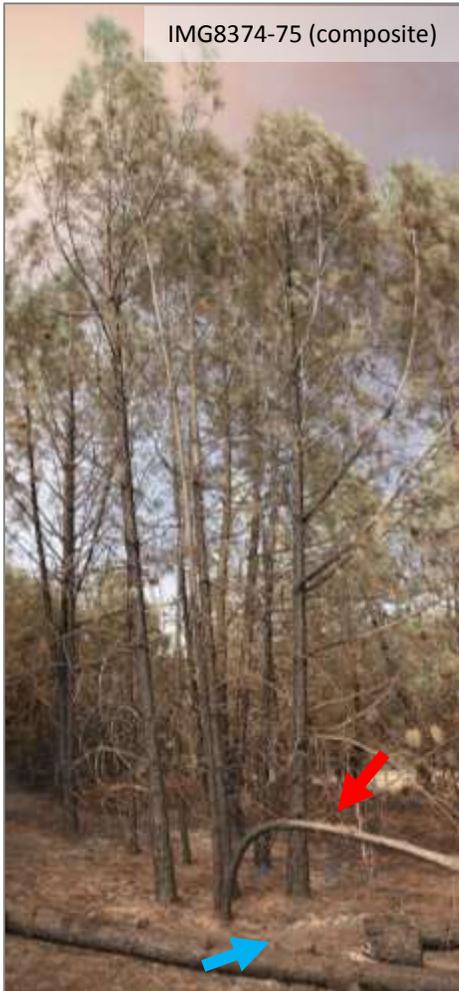
The surface grade is sloping in this locale, descending from the proximity of a power pole situated at the top of a rise. The 3-phase conductor span extends easterly over tree canopy and open-space to power poles in the distance. Images of the scene are shown on pages 2 and 3; a stand of Gray pines encompass the subject tree (seen here, left) with a red arrow indicating the subject tree extending out of the image, bottom right. A stand is a group of forest trees sufficiently similar in age, size and type to be considered a unit. Trees that are captured, and that develop within a closed stand, have narrow growth rings and poor stem taper. When the stand is altered and captured interior trees are exposed to open spaces, whether for right-of-way clearance or other reasons, they are prone to failure.

Two larger pines were situated on the south side at the edge of the stand; one of the remaining stumps is also visible here (shorter blue arrow). It is apparent that the act of cutting larger pines that previously contained the stand exposed interior trees.

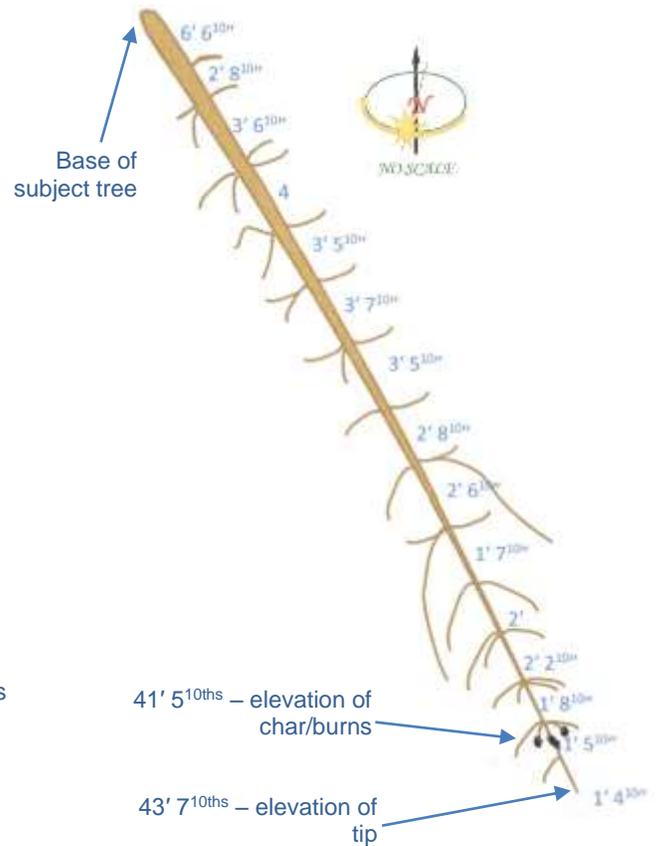
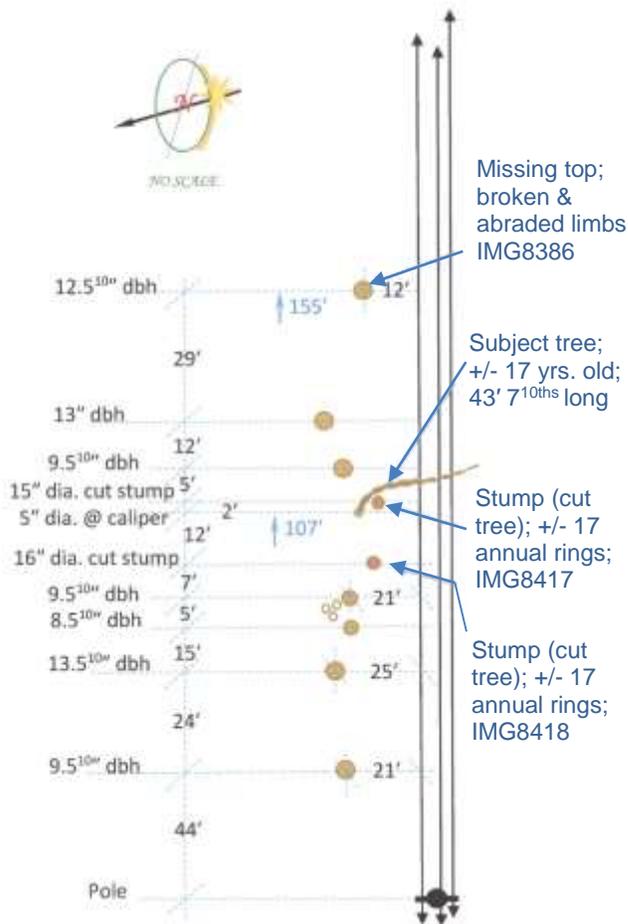
The site sketch (left) focuses on certain trees in the stand along the edge of the utility right-of-way; the subject tree and adjacent stumps; and a proximity with the tri-phase conductors south of the stand. Additional trees can be found beyond specific locations documented here.

Both the site sketch and the sketch of the subject tree are referenced with a compass rose and an indication of the path of the sun. It is well understood that trees and other green plants have a physical orientation toward the path of the sun and this can have significant consequences for maintaining safety.

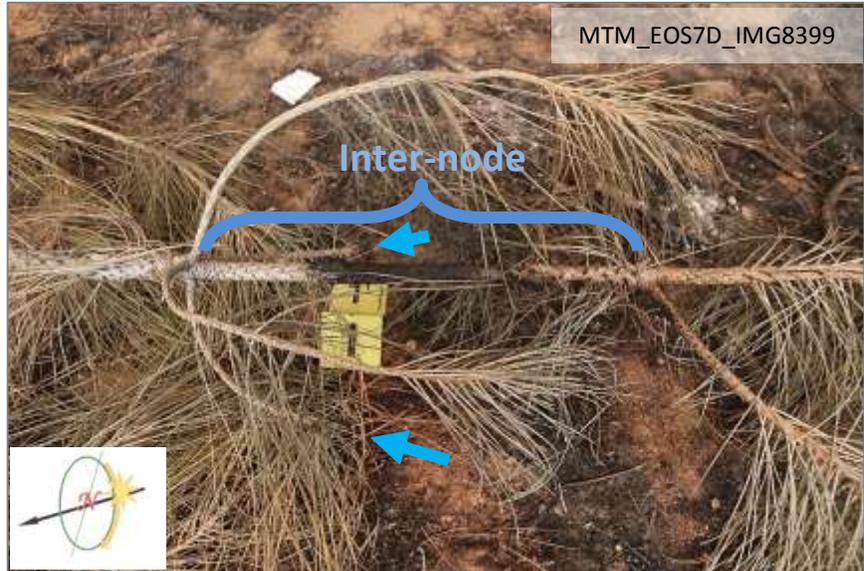
The top elevation of the subject tree is 43'7^{10th} and charring is found just two feet below at 41'5^{10th}. The burned section is the second increment beneath the top or tip of growth. These burn marks are characteristic of contact with energized electrical equipment. The image, right, shows a top view of the limb and clearly demonstrates an inter-node.
