# Failure Analysis of Leak in Well Line from Aliso Canyon Natural Gas Storage Field

Southern California Gas  
Los Angeles, California

Report No.: OAPUS308RRICK (PP164597)  
November 8, 2016

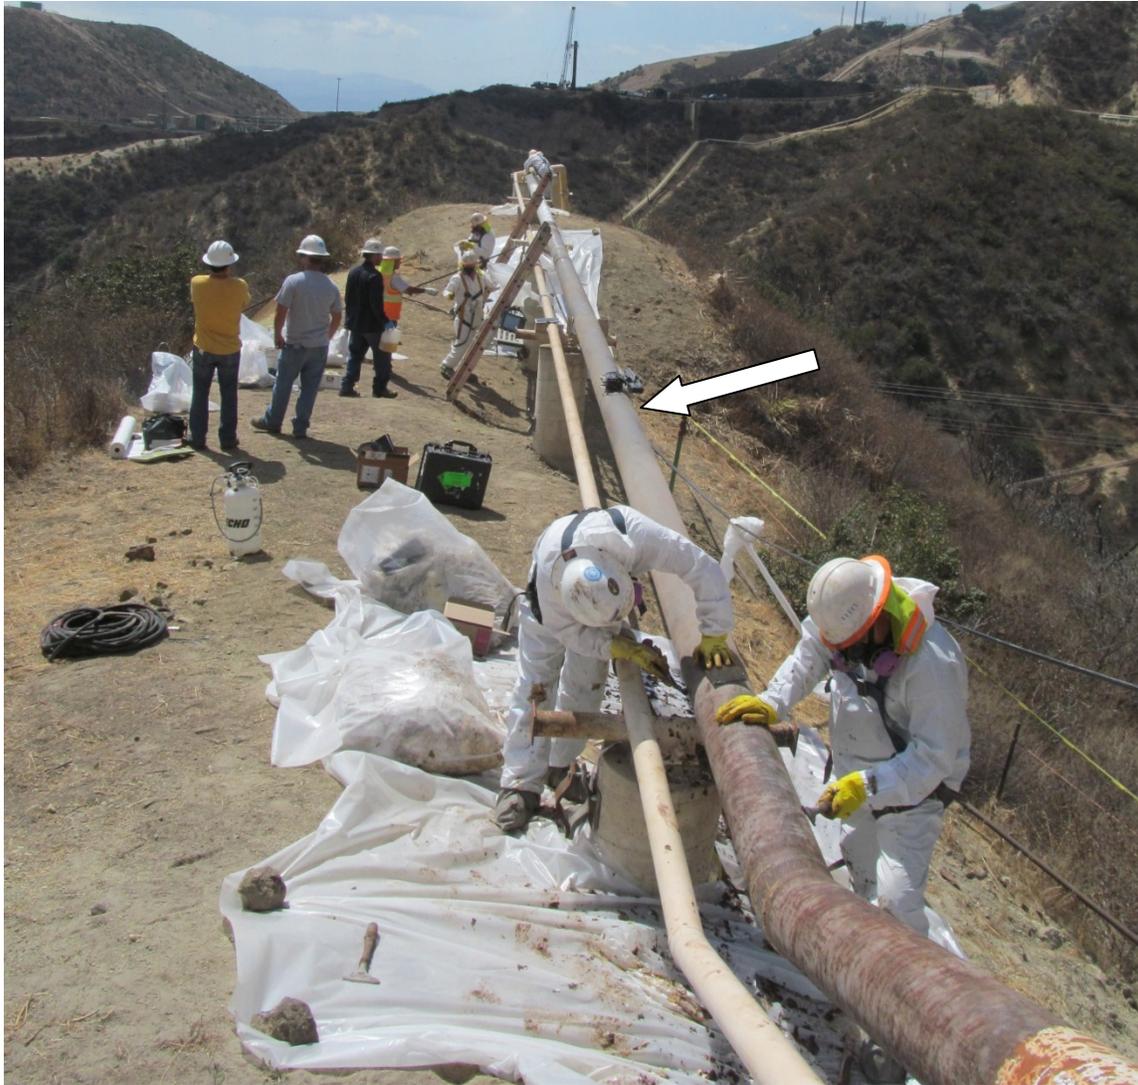
Figure 1 and Figure 2 show the Ward 3A well line viewing to the west and to the east, respectively, from near the leak location. The pipeline is relatively horizontal near the leak location with a slight decline. The leak occurred at a slight sag or local low spot, at what appeared as a small pinhole at the 6:00 position, near the ERW seam weld. No external corrosion was noted on the outer surface of the pipe.

Figure 1. View of the well line looking west (downstream). Approximate axial location of the leak is indicated by the arrow. The pipeline is relatively horizontal here and the leak was at a slight sag or low spot.

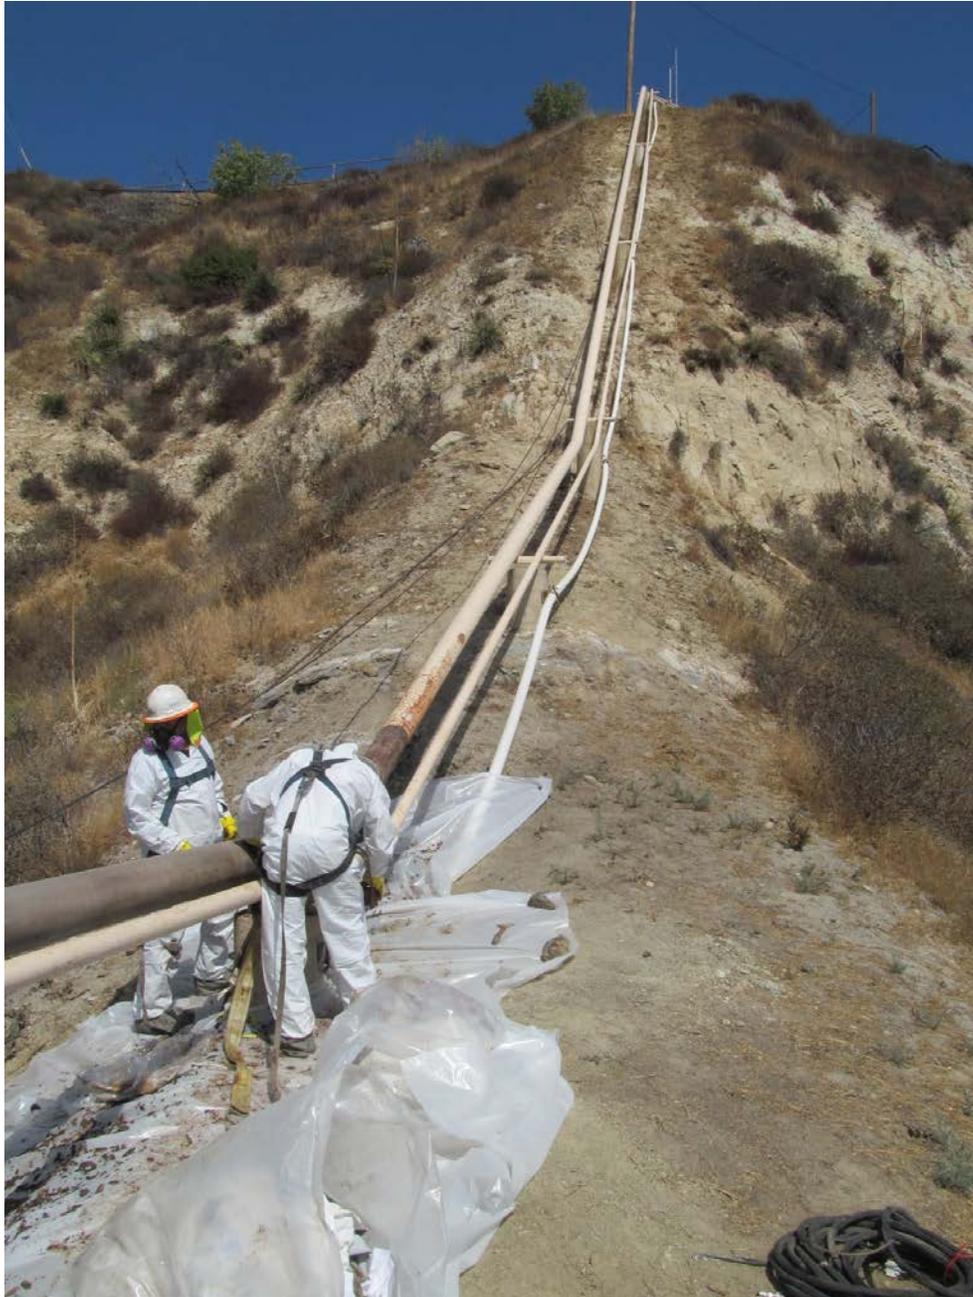
Figure 2. View from a location just upstream of the leak, looking east (upstream). Well location is beyond the top of the hill

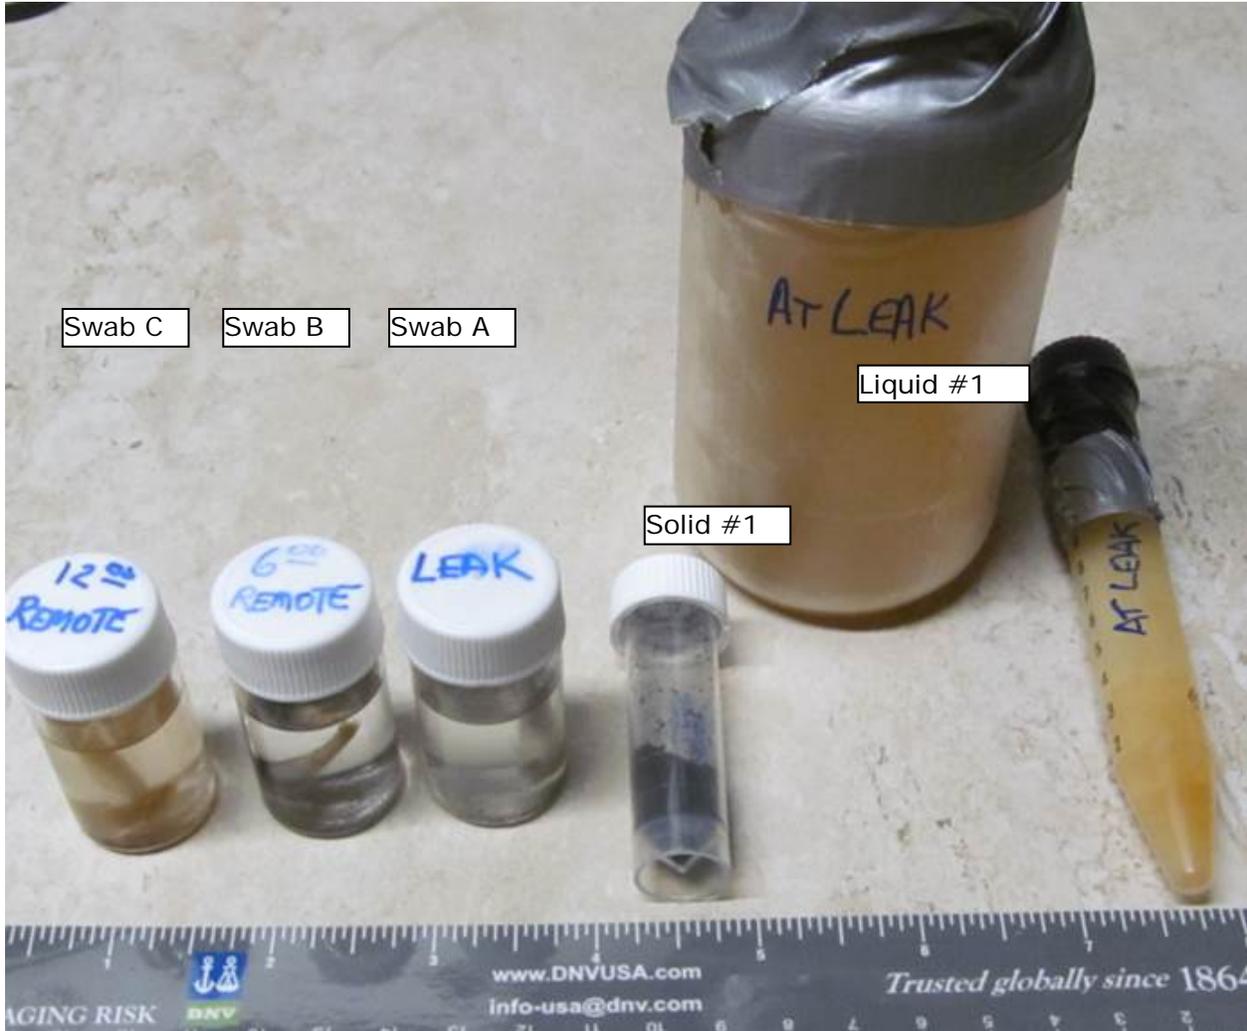
Figure 3. Surface swabs, solid, and liquid samples collected by DNV GL personnel in the field when the pipe section was cut out.

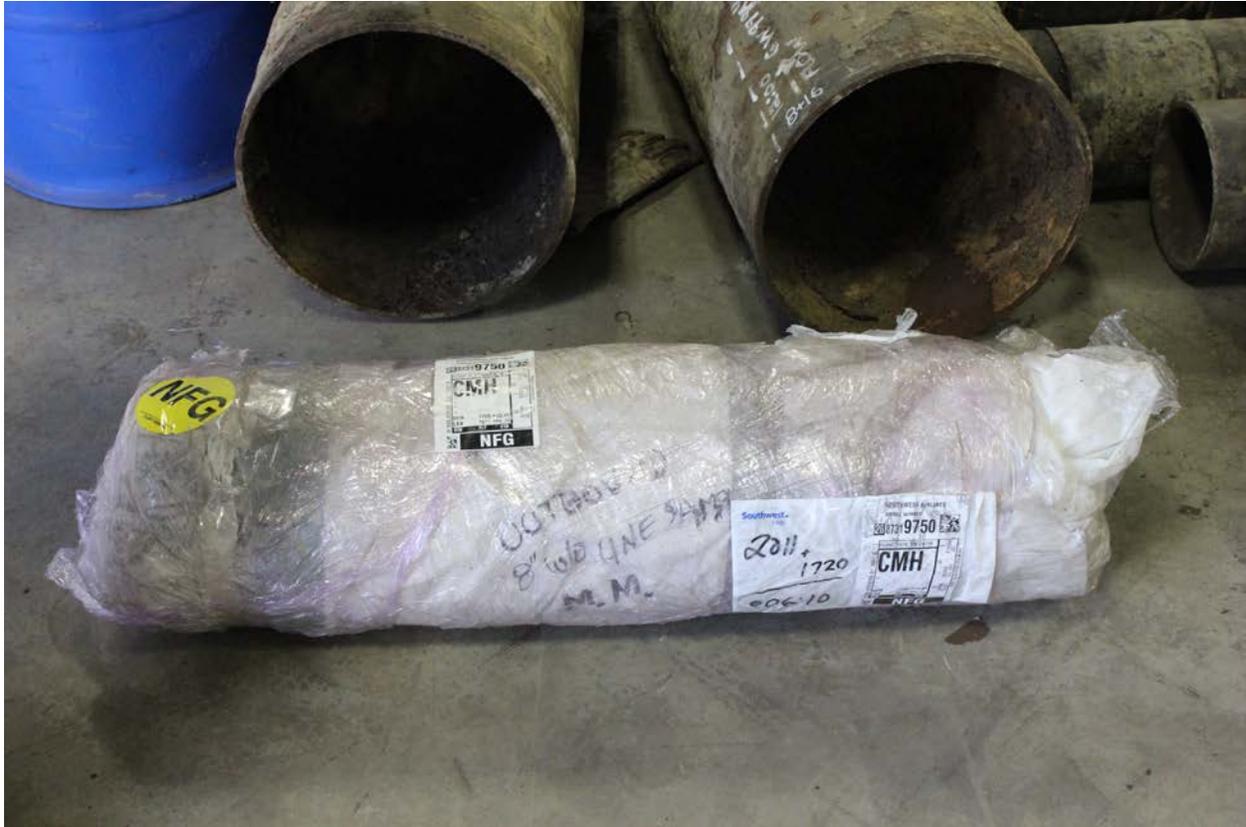
The pipe sample was documented in the condition in which it was received at DNV GL. Figure 4 shows the as-received condition of the pipe sample before unwrapping. The pipe was wrapped with plastic sheeting and the ends of the pipe were sealed with tape.

Figure 4. Photograph showing the as-received condition of the pipe sample; wrapped in plastic with the ends sealed.

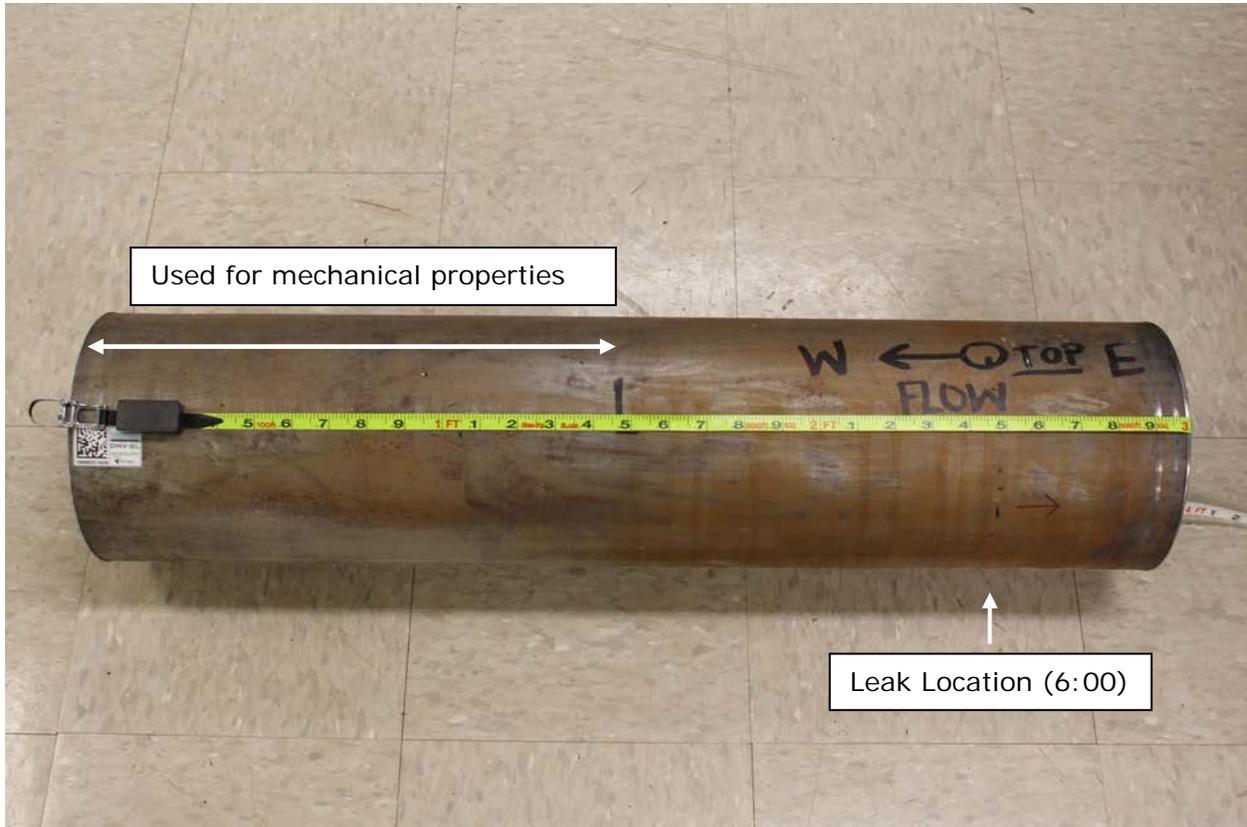
Figure 5 shows the pipe sample after unwrapping from the packaging. Field markings were present on the pipe and identified the flow direction and the 12:00 orientation. The pipe sample measured approximately 3 feet in length. The ERW weld seam was near the 6:00 orientation. No girth weld was present. The leak occurred at a pit on the internal surface located approximately 5 inches D/S from the U/S cut end. The leak/pit was not in the ERW seam but was located about 0.3 inches away circumferentially. No other visible pitting was observed before cleaning was performed on the internal surface. No evidence of general corrosion or pitting was observed on the external surface of the pipe. The external coating on the pipe was removed in the field before the pipe sample was cut out.

Figure 5. Photograph showing the pipe sample after unwrapping at the DNV GL lab. Flow direction and 12:00 position are marked on the pipe. Approximately half of the sample was used to machine specimens for mechanical testing. Location of leak (at 6:00) shown at arrow.

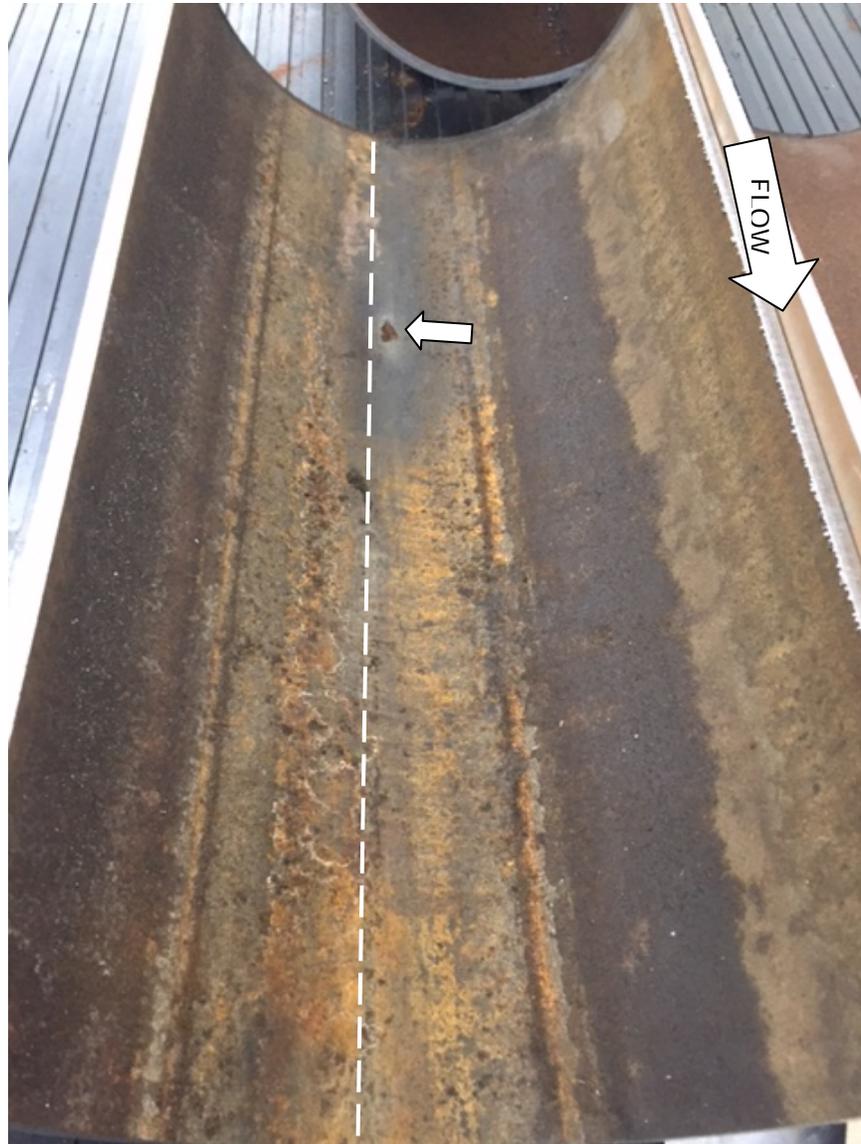
surface suggests the presence of historical liquid levels in the well line. No evidence of internal corrosion was noted on the top half of the pipe.

Figure 6. Photograph showing a portion of the bottom half of the internal surface of pipe sample after it was split by cutting at the 3 and 9 orientations. The 6:00 orientation is shown by the dashed line and the leak/pit is shown at the arrow. Coloration of deposits on the internal surface illustrates historical liquid-level lines.

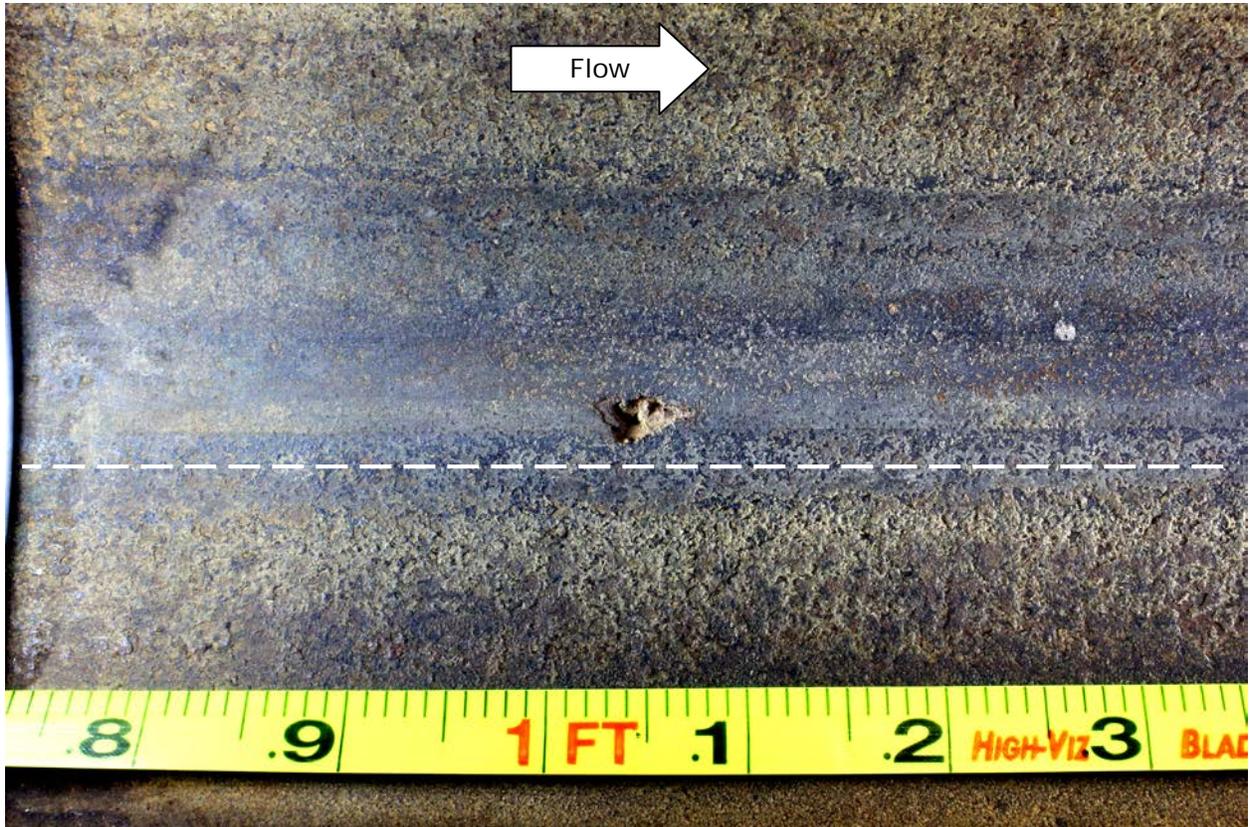
Figure 7 shows the leak location after cleaning the internal surface of the pipe sample. The surface texture of the pipe shows that the leak occurred in a smoother area or band along the bottom of the pipe (note: there was no wall loss in the band). Above the band, the pipe surface is more rough, with a hard, tenacious material on the surface that cannot easily be removed. Figure 8 shows a close up of the leak location after cleaning. The leak occurred at a pit approximately 0.4 inches long (axial) and 0.3 inches wide (circumferentially). The pit has an angular appearance at the pipe surface that is not typical of most corrosion. A few much smaller (<0.05 inches diameter and depth) pits were present in the smooth band along the bottom of the pipe; otherwise there was no other internal corrosion present.

Figure 7. Photograph showing the internal pipe surface at the leak/pit location after cleaning, dashed line shows the 6:00 orientation.

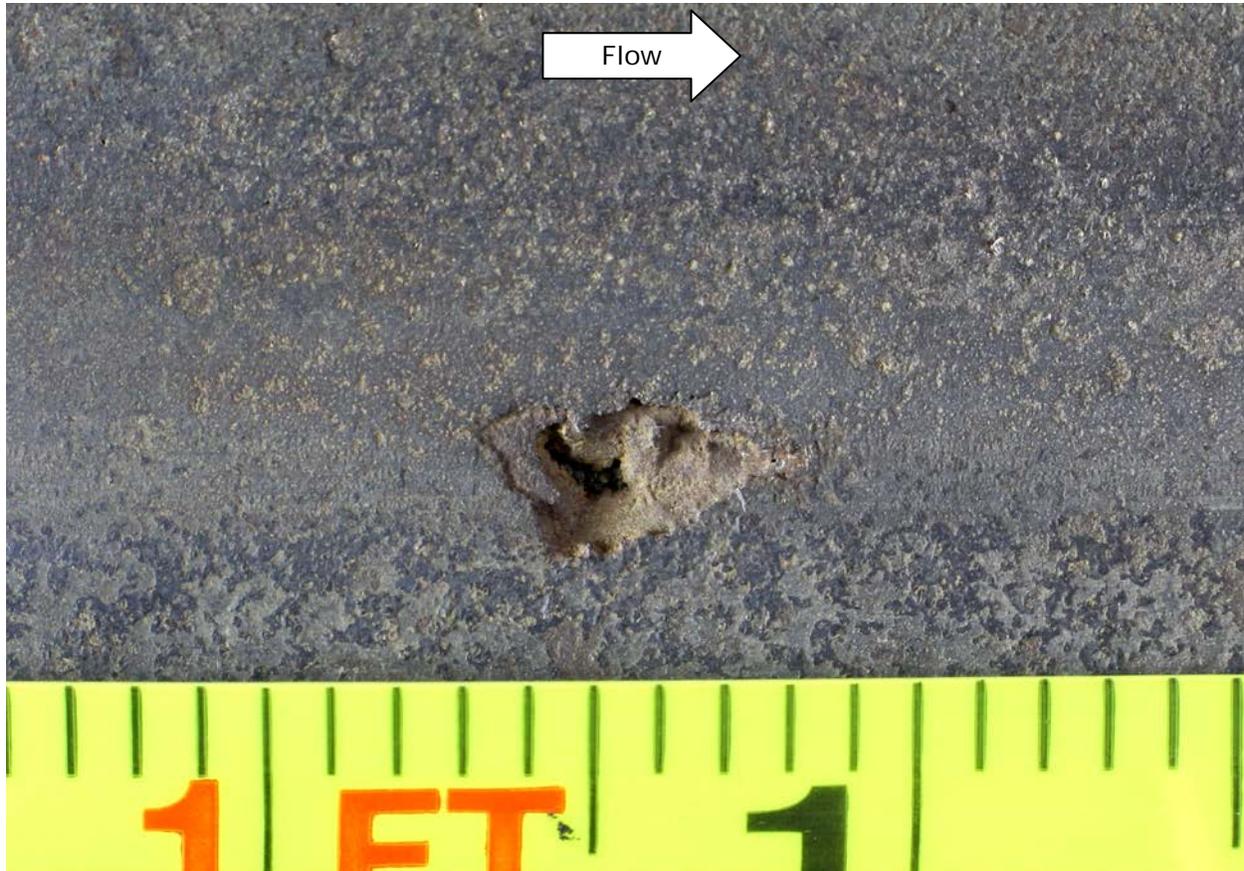
Figure 8. Photograph of the internal pipe surface at the leak/pit after cleaning.

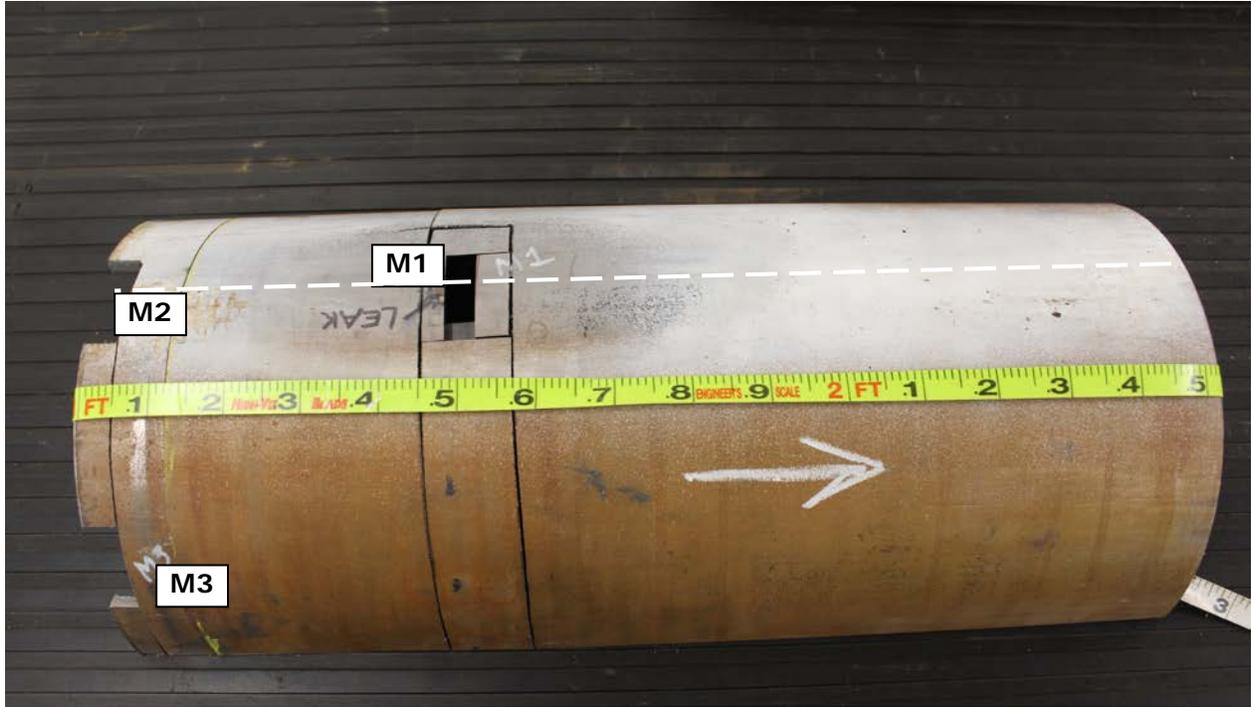
Three transverse cross-sections were removed through representative areas of the pipe sample for the preparation of metallographic mounts and for analysis. The locations of the Mounts M1, M2, and M3 are shown in Figure 10. Mount M1 was taken through the pit/leak, Mount M2 was taken away from the pit in the ERW seam, and Mount M3 was taken away from the pit in the pipe body.

Figure 10. Photograph showing the locations of three specimens removed for preparation of metallographic mounts from the pipe sample; M1 from the leak location, M2 from the ERW longitudinal seam and M3 from the pipe body. Dashed line shows orientation of ERM seam.

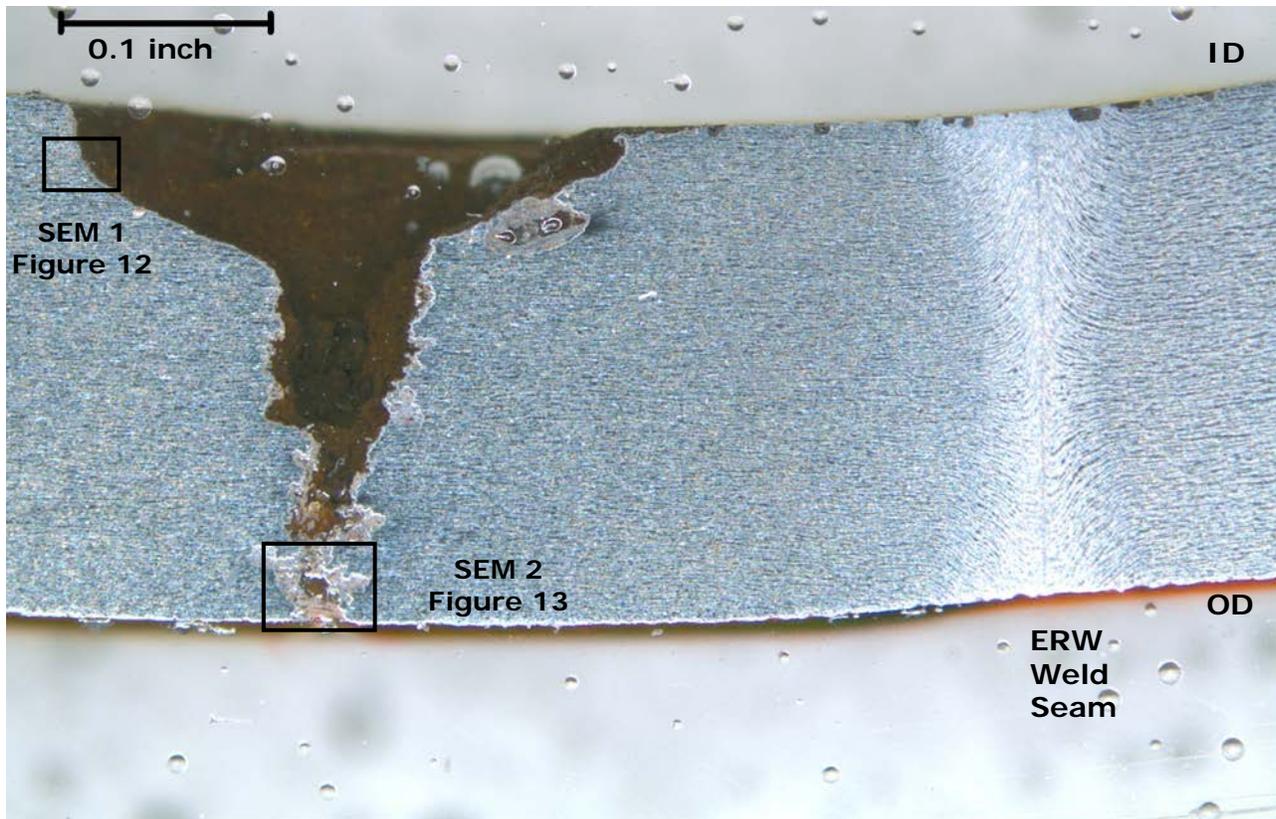
The ERW seam weld also is evident in Figure 11, located about 0.3 inches circumferentially from the through wall pit. The microstructure is typical of a high frequency ERW weld. A transverse cross section through the ERW seam weld, away from the corroded area, in Mount M2, is shown in Figure 16. The microstructure of the seam weld at this location and in Mount M1 showed no defects or unusual microstructural characteristics.

Figure 11. Photomicrograph of Mount M1, showing the pit/leak (left) and the ERW weld seam (right). Areas that were analyzed using SEM/EDS are shown by the boxes labelled SEM 1 and SEM 2. Nital etch.

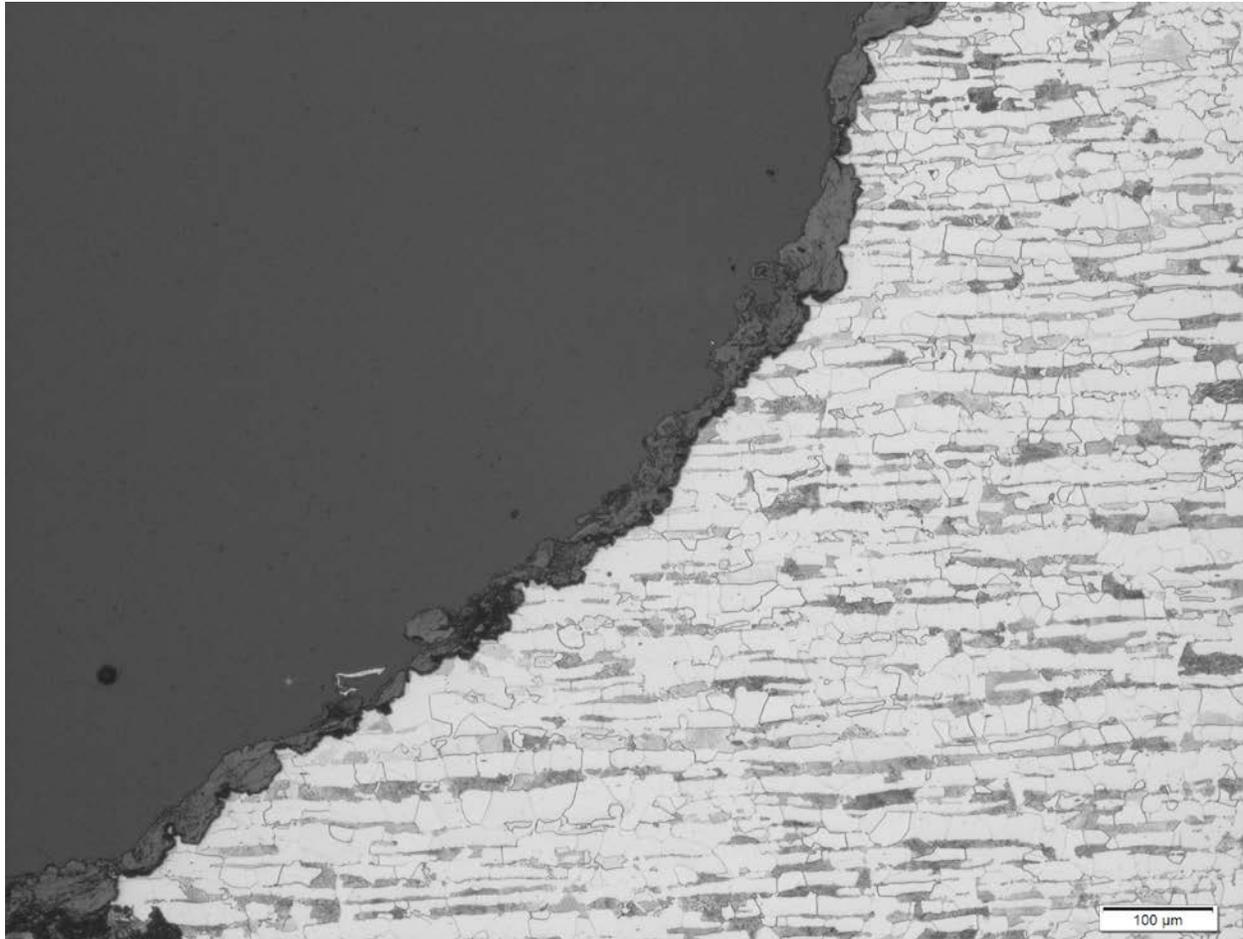
Figure 12. Photomicrograph of Mount M1 along the edge of the smooth, parabolic shaped zone of the pit cross section nearest the internal surface of the pipe. Magnification – 100X. Nital etch. (ID surface towards the top of photo; mirror image or area shown in Figure 11).

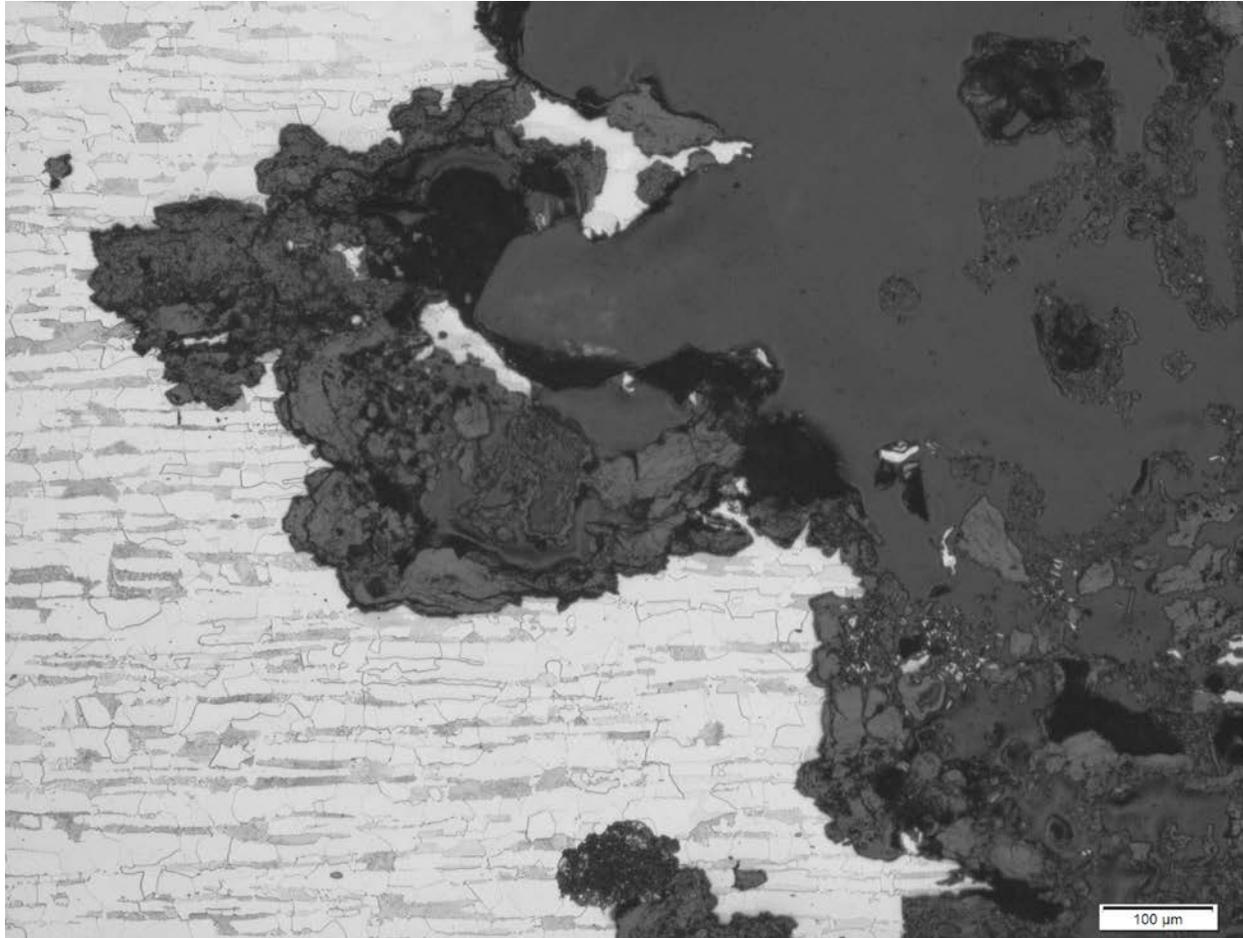
Figure 13. Photomicrograph of Mount M1 along the edge of the narrow zone in the pit cross section showing significant undercutting. Magnification – 100X. Nital etch. (ID surface towards the top of photo; mirror image or area shown in Figure 11).

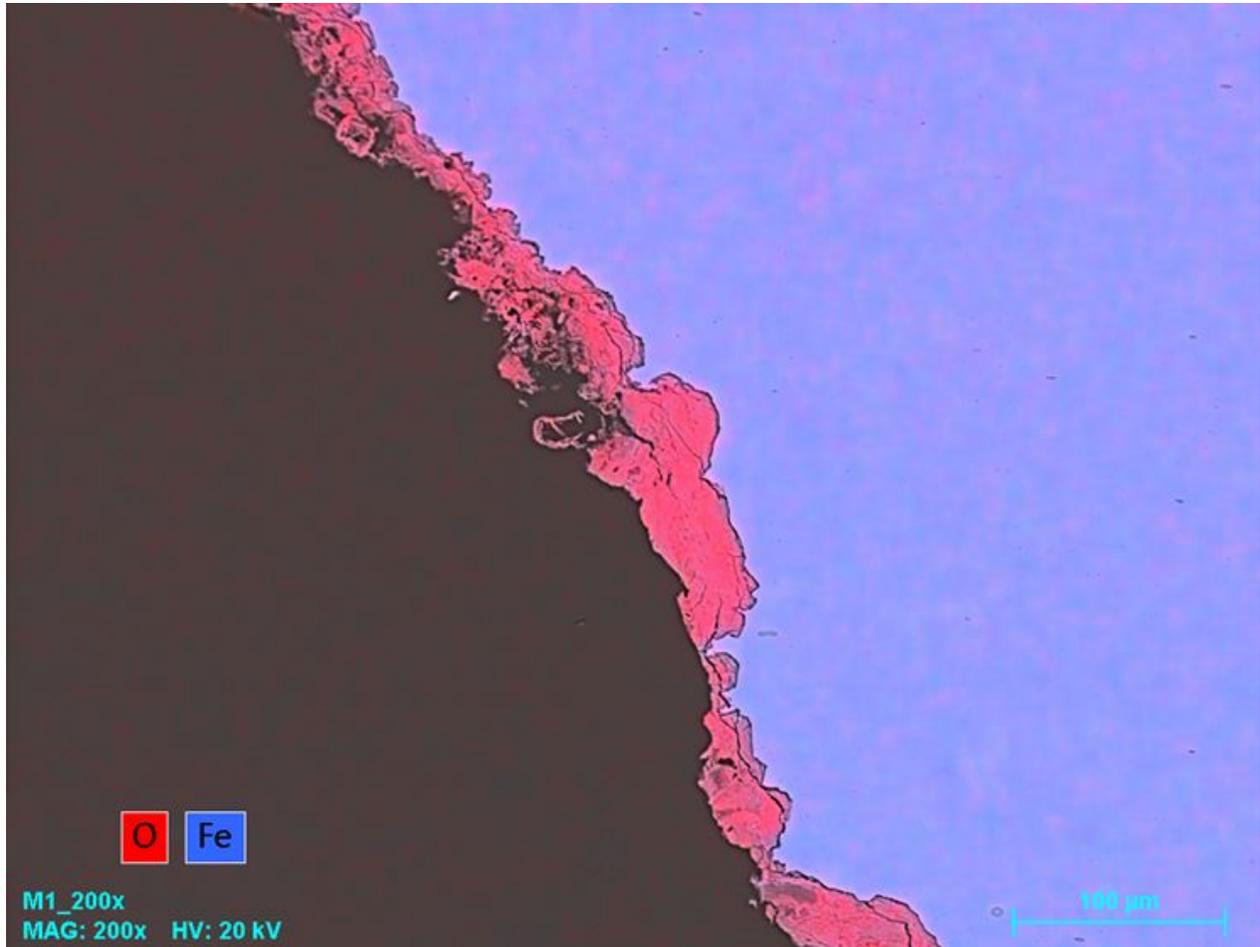
The adherent deposits present along the wall of the pit in Mount M1 were analyzed using SEM/EDS. Figure 14 shows a SEM/EDS composite image depicting the distribution of iron (Fe) and oxygen (O) in the deposit layer on the pit surface in the parabolic zone, location SEM 1 in Figure 11. Figure 15 is a SEM/EDS composite image in area SEM 2, depicting the distribution of iron (Fe) and oxygen (O) in the scale layer on the pit surface in the narrow zone. In the examination of both areas, some isolated areas of sulfur were observed and chlorine tended to be present at the interface between the deposit and the pipe steel. No major difference in the deposit composition between the two zones was observed and no unusual foreign material was found in the pit.

Figure 14. SEM/EDS composite image showing distribution of iron (Fe) and oxygen (O) in the deposit layer on the pit surface in the smooth, parabolic zone, location SEM 1 in Figure 11. Original magnification – 200X.

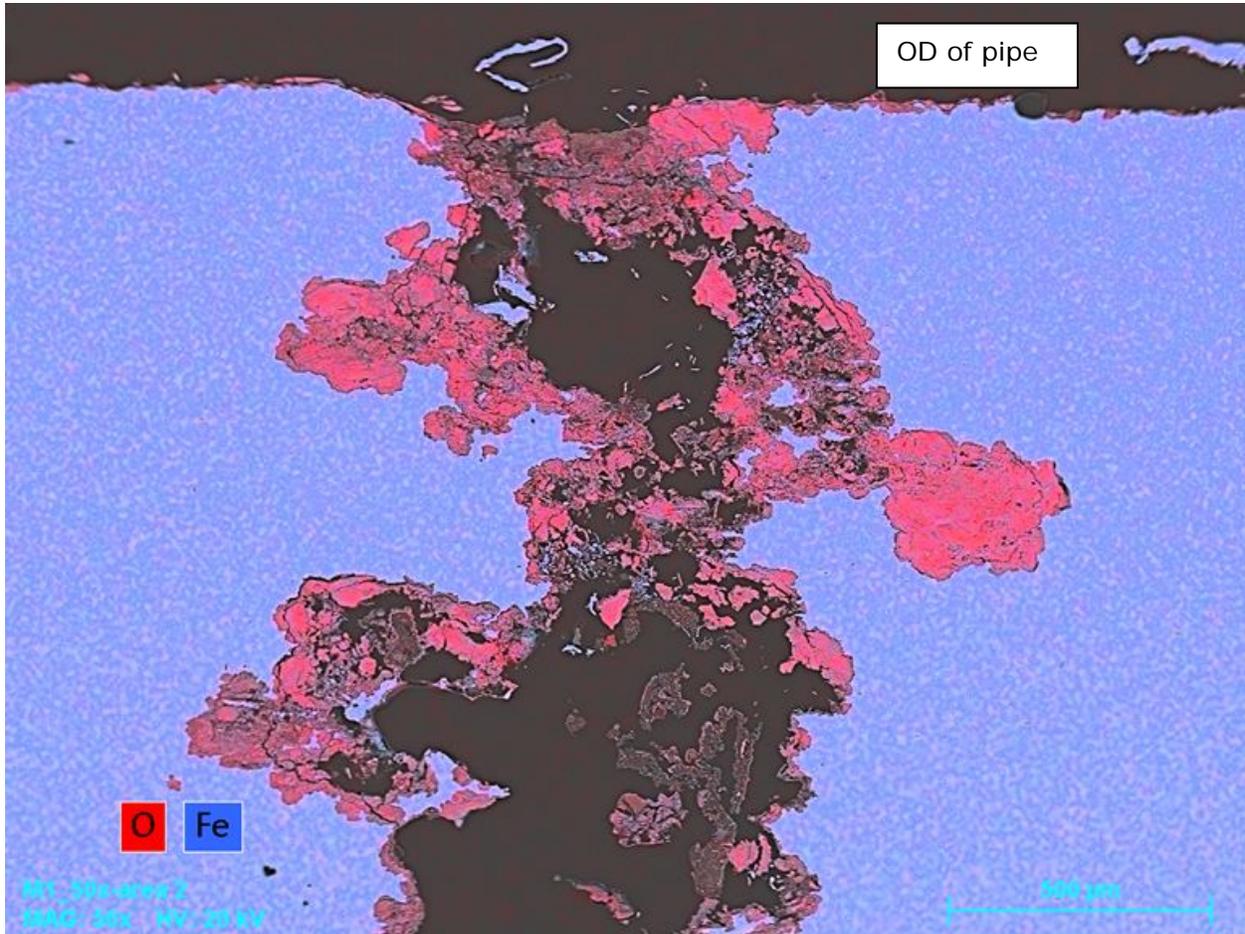
Figure 15. SEM/EDS composite image showing distribution of iron (Fe) and oxygen (O) in the scale layer on the pit surface near the leak at the OD surface, location SEM 2 in Figure 11; original magnification – 50X. (Image inverted from its actual position in service.)

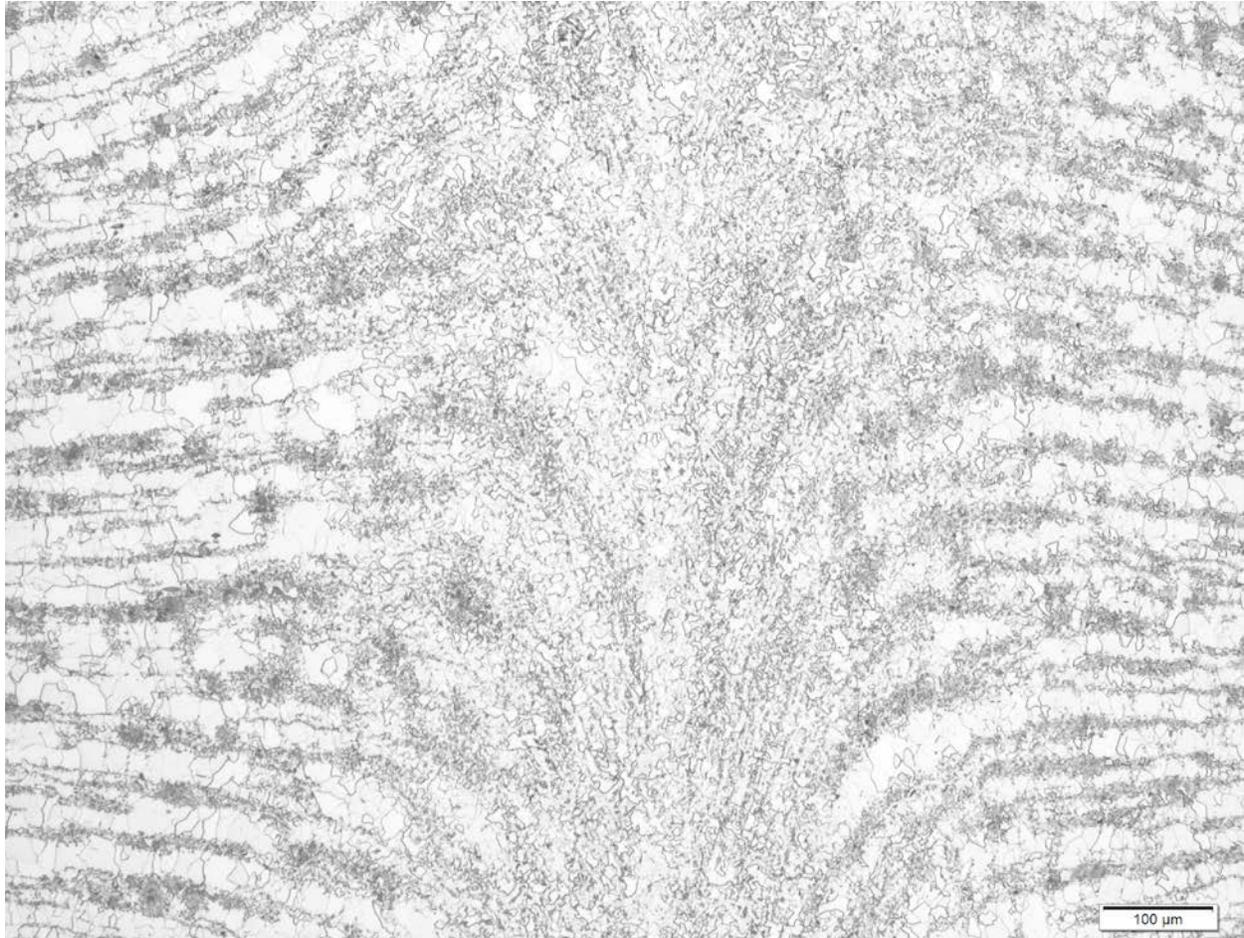
Figure 16. Photomicrograph of Mount M2 showing the centerline of the ERW seam weld (center of photo). Magnification – 100X. Nital etch.

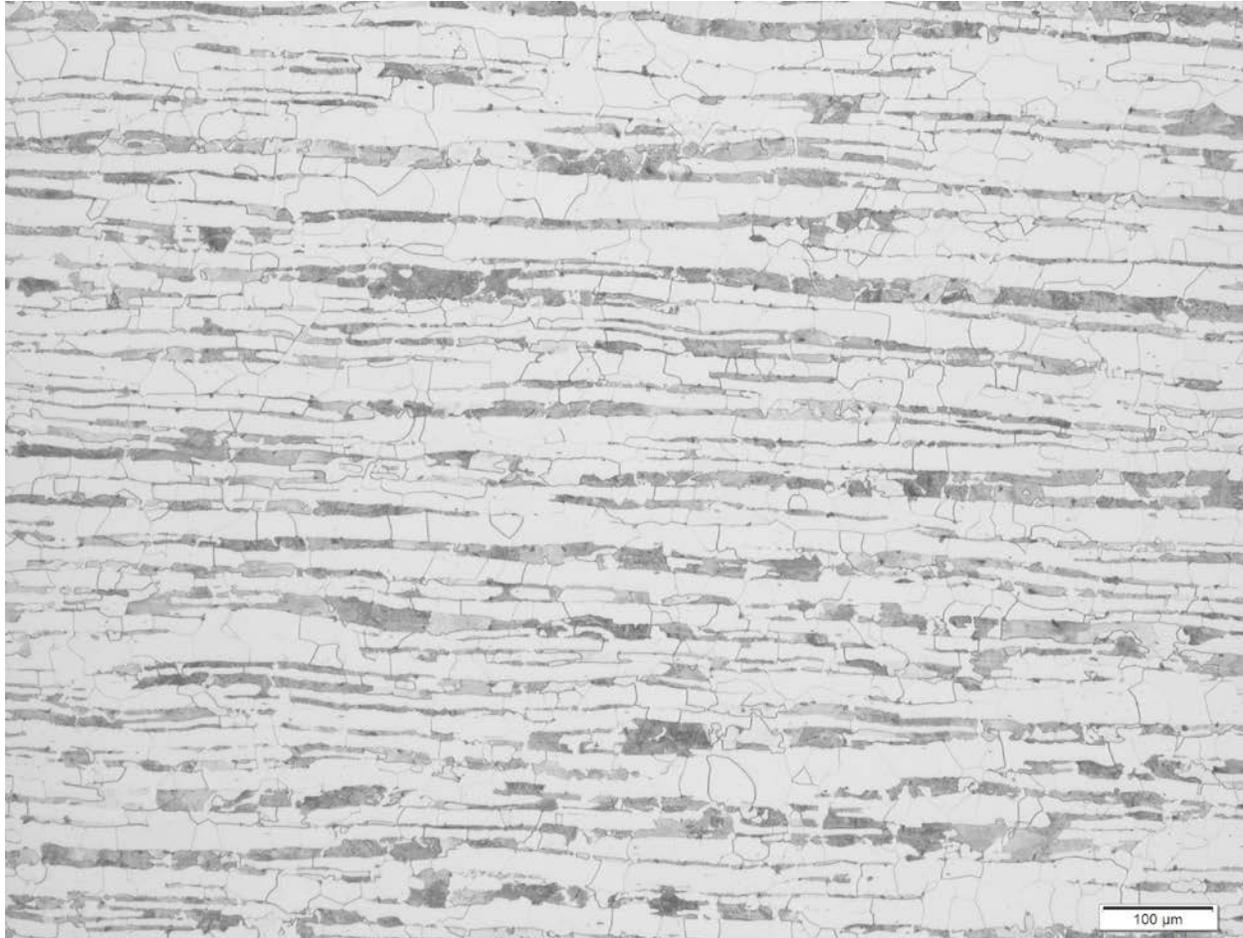
Figure 17 is a light photomicrograph showing the typical base metal microstructure for the pipe steel, in Mount M3. The microstructure consists of ferrite (white areas) and pearlite (black areas). This microstructure is typical for the grade and vintage of pipe.

Figure 17. Photomicrograph of Mount M3 showing the microstructure of the pipe body away from the leak and away from the ERW weld. Magnification – 100X. Nital etch.

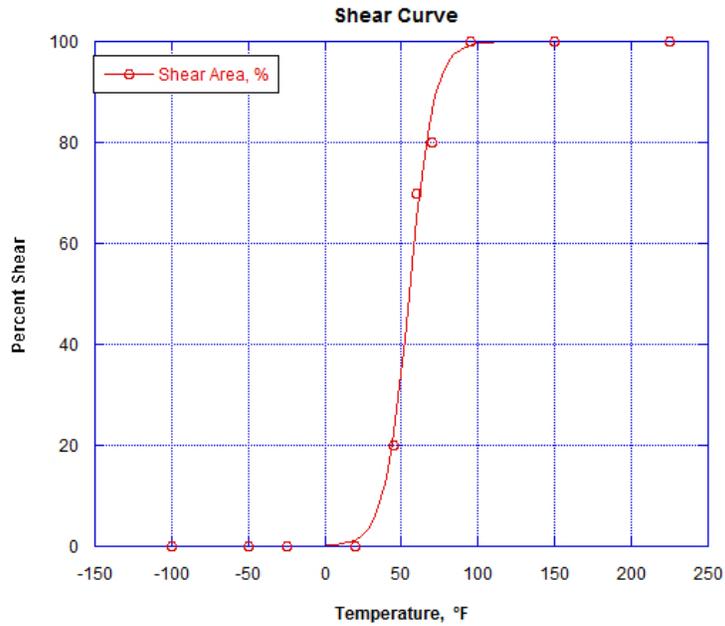
Table 11 and Table 12 present the detailed results of Charpy impact testing performed on transverse base metal and ERW seam weld (notch at weld centerline) specimens, respectively. Figure 18 and Figure 19 show the Charpy percent shear and impact energy curves for the base metal, respectively. Figure 20 and Figure 21 show the Charpy percent shear and impact energy curves for the seam weld specimens, respectively. An analysis of the data indicates that the 85% fracture appearance transition temperature (FATT) for the base metal is 69°F and the upper shelf Charpy energy is 35.2 ft·lbs, full size. The FATT for the seam weld was 97°F and the upper shelf Charpy energy is 24 ft·lbs, full size. See Table 13.

Figure 18. Percent shear from Charpy V-notch tests as a function of temperature for transverse specimens removed from the base metal of the pipe sample.

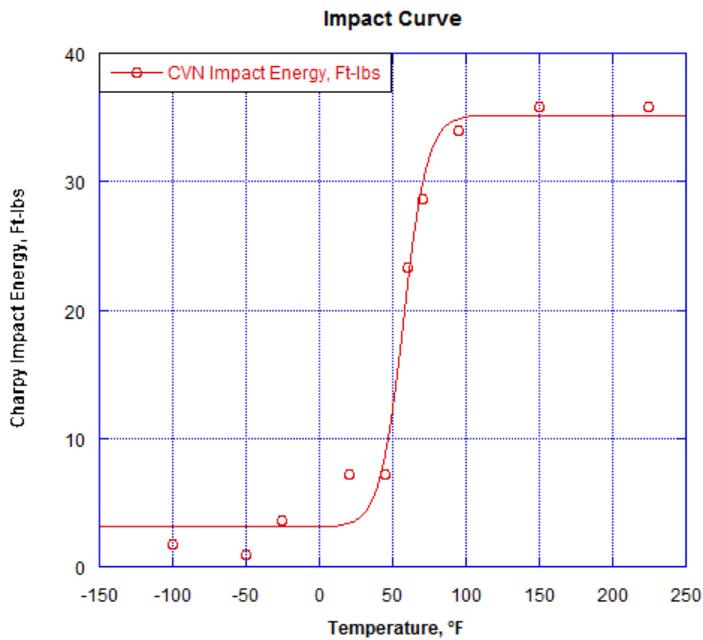
Figure 19. Charpy V-notch impact energy as a function of temperature for transverse specimens removed from the base metal of the pipe sample.

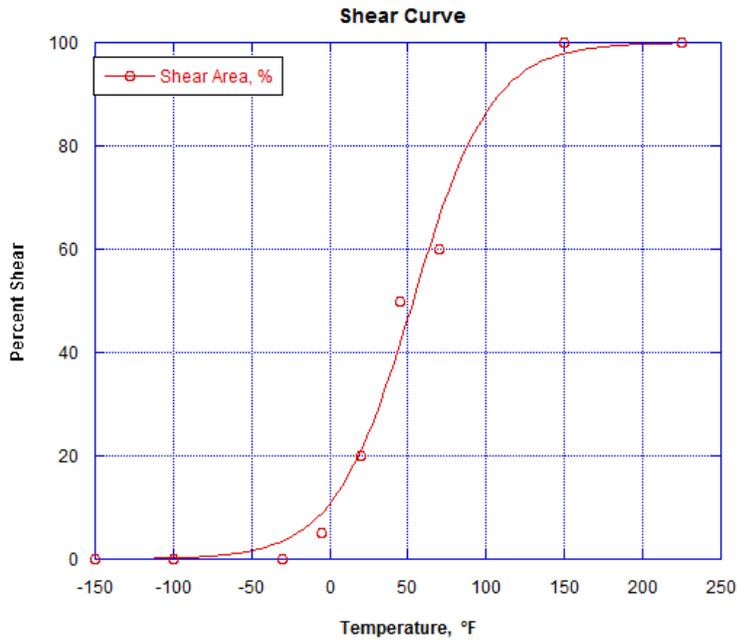
Figure 20. Percent shear from CVN tests as a function of temperature for transverse specimens removed from the seam weld centerline of the pipe sample.

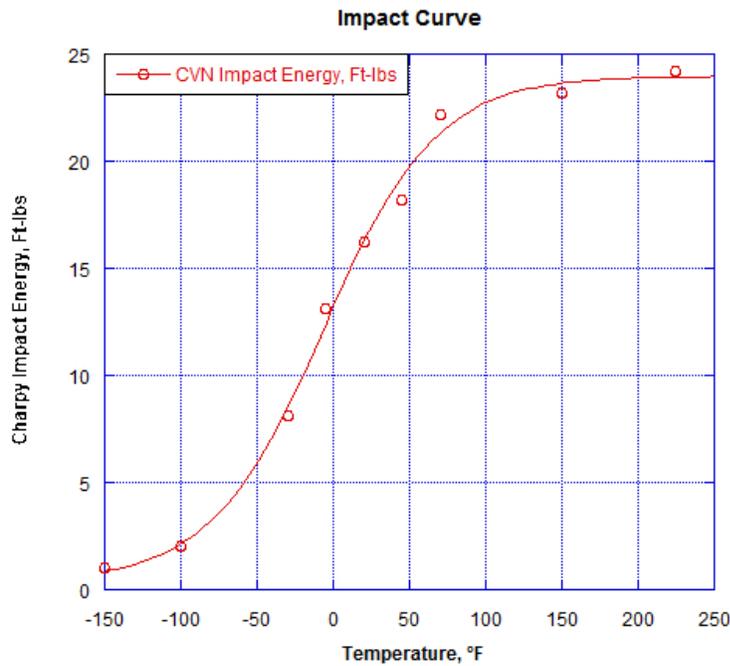
Figure 21. CVN impact energy as a function of temperature for transverse specimens removed from the seam weld of the pipe sample.
