**Outage Investigation  
Larkin Substation Outage on  
April 21, 2017**

Exponent  
149 Commonwealth Drive  
Menlo Park, CA 94025

September 15, 2017

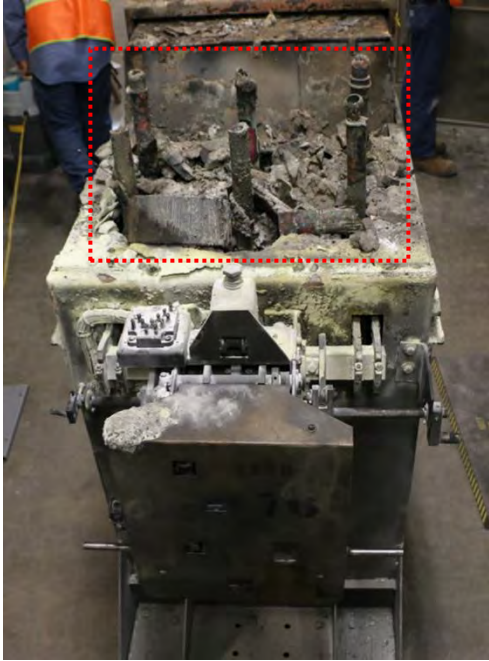
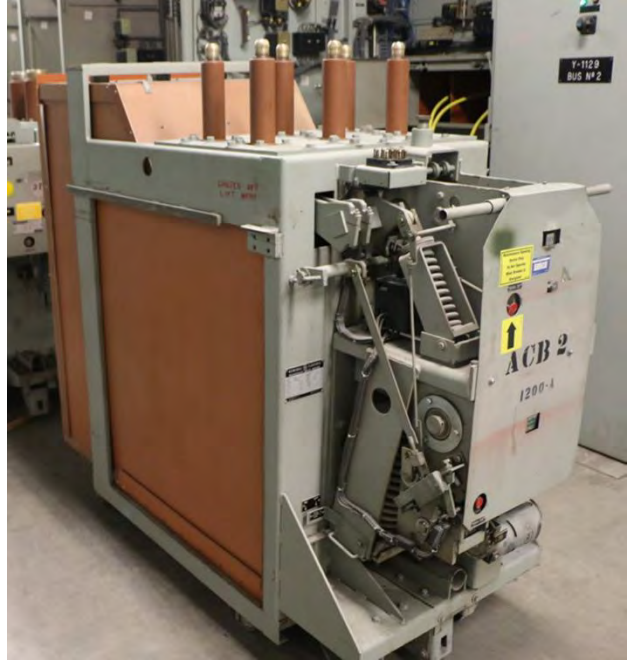
Figure 1. The incident breaker (left) and an exemplar circuit breaker of similar type (right). Most of the damage at the incident circuit breaker is near the top of the incident circuit breaker at the connection points.

The failure most likely originated near the top of the incident circuit breaker at the electrical connection points. This is based on the fire and arc flash analysis of the incident breaker cabinet. Additionally, the area on top of the breaker and at the switchgear bus bars running near the top of the cabinet show notably greater thermal damage as compared to other areas within the cabinet. There is also extensive arc damage on the top of the incident circuit breaker. Connections at the top of the circuit breaker in an exemplar breaker cabinet is shown in Figure 6. It should be noted that the PG&E personnel were able to manually trip the incident breaker during the restoration process using the trip button on the face of the breaker (Figure 10). This further shows that the breaker internal components were less damaged compared to the outside, suggesting that the area of the fault origin was outside of the circuit breaker.

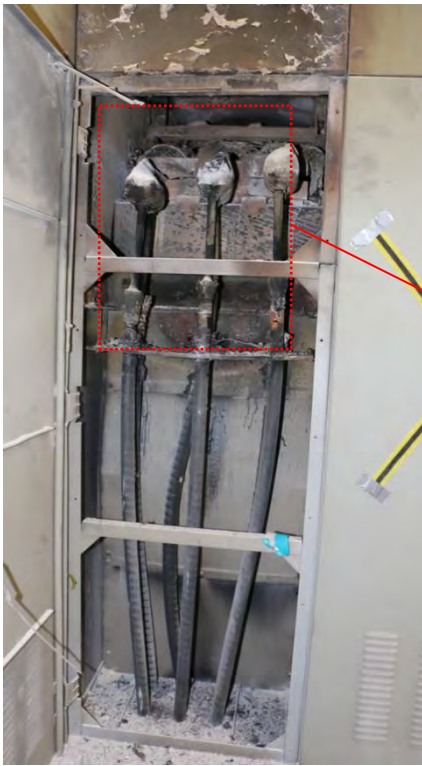
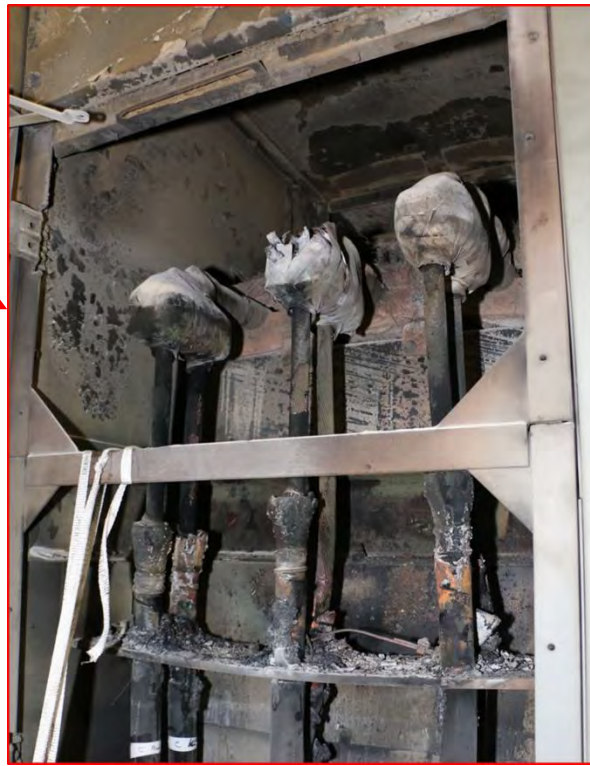
Figure 2. Damage at the “Tee tap” near the back of the incident cabinet.

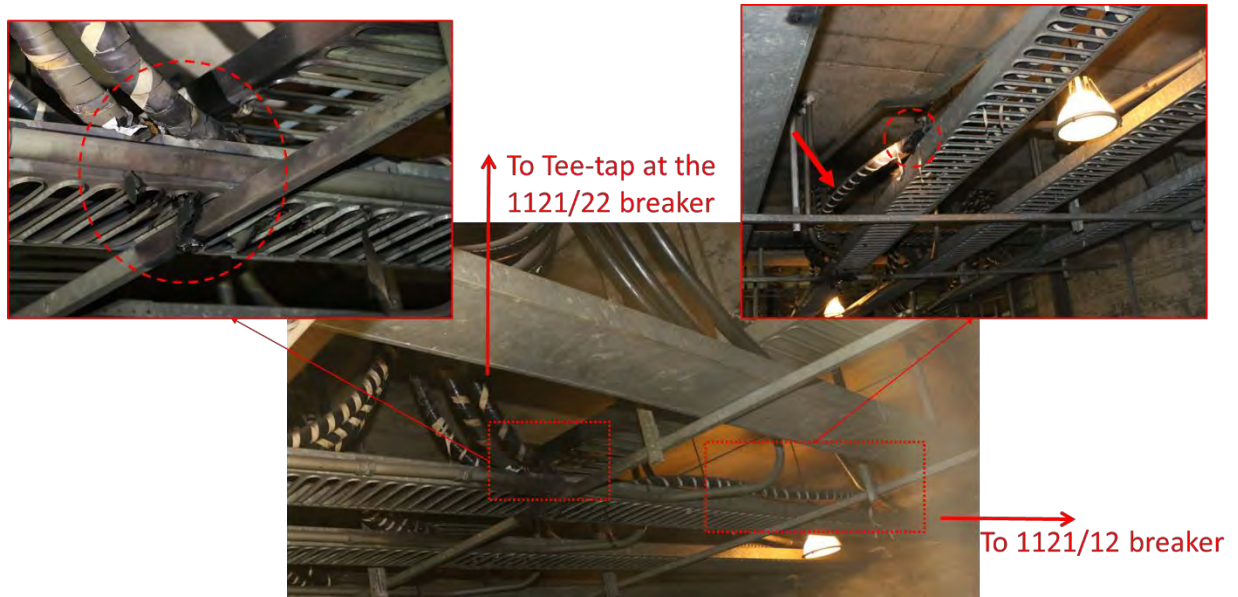
Figure 3. Damage discovered in the cable tray and cables between the two circuit breakers at the incident feeder (Y1121).

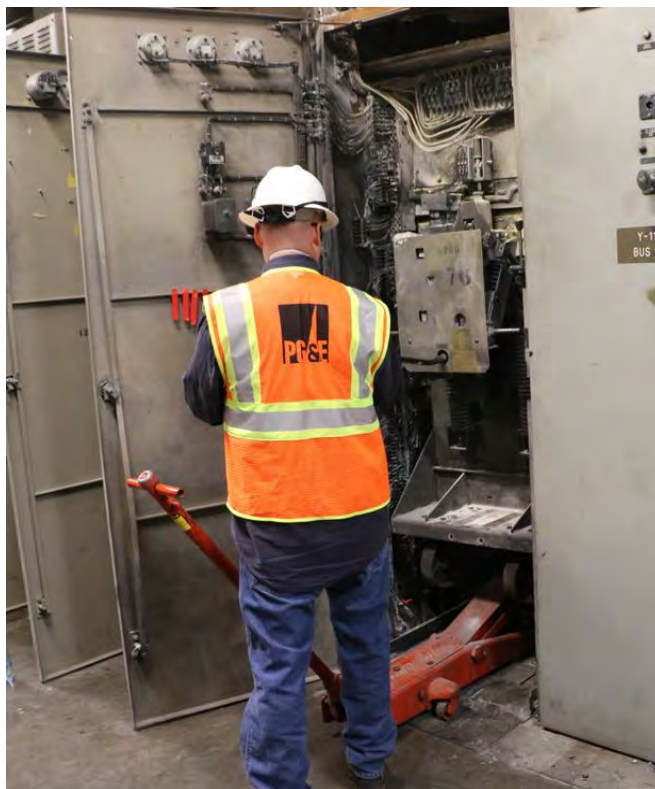
Figure 10. PG&E personnel were able to manually trip the incident breaker during the restoration process; this shows that the incident breaker did not operate at the time of the incident.

The incident breaker (CB1121/22) did not operate, likely because the breaker cabinet was damaged due to the arc flash. It is unclear whether the fault would have been interrupted if the incident circuit breaker had operated. This is due to the extent of the damage near the top of the circuit breaker. The area of the fault origination near the top includes electrical connections at

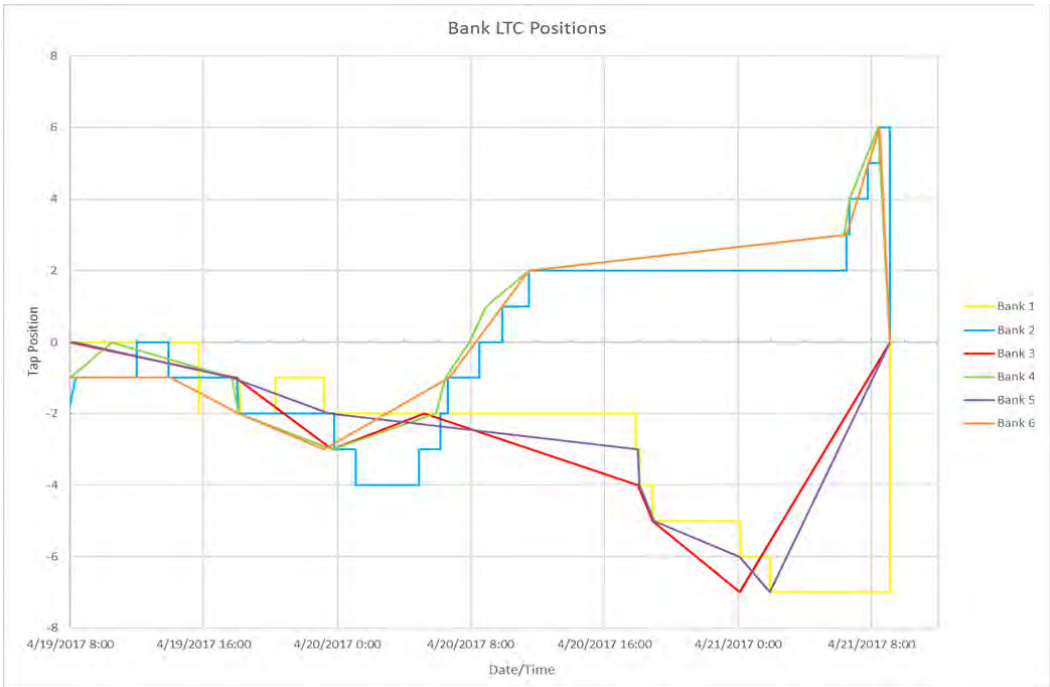
Recorded LTC positions by SCADA after the substation entered an abnormal configuration 27 hours prior to the incident shows increasing voltage deviation at the two parallel bus burs during that time period. The recorded data is shown in Figure 11. This data is interpolated for the missing time periods to provide a more accurate representation of the transformer bank tap positions. The interpolated data is shown in Figure 12. Increasing voltage deviation resulting from the increasing difference between the transformer tap positions translates in increasing circulating current at the incident feeder where the two substation bus bars are made in parallel during the abnormal configuration. The maximum tap position difference between the sets of transformers banks between bus bar No. 1 and bus bar No. 2 and the corresponding circulating current are calculated and plotted in Figure 13. It can be seen from this plot that the circulating current during the station abnormal configuration increased to approximately 1,800 Amperes before the incident occurred. This is beyond the maximum capacity of the incident transformer and its associated components (rated for maximum 1200 Amperes).

Figure 11. Recorded data of the transformer banks' LTC position.

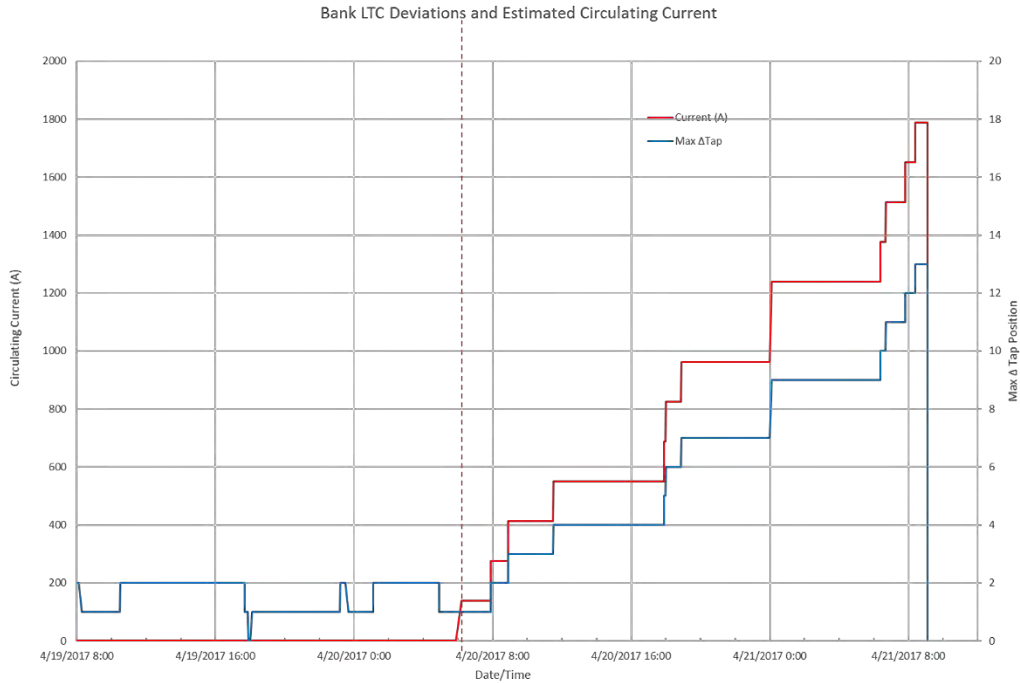
Figure 13. Maximum tap position difference and estimated circulating current.

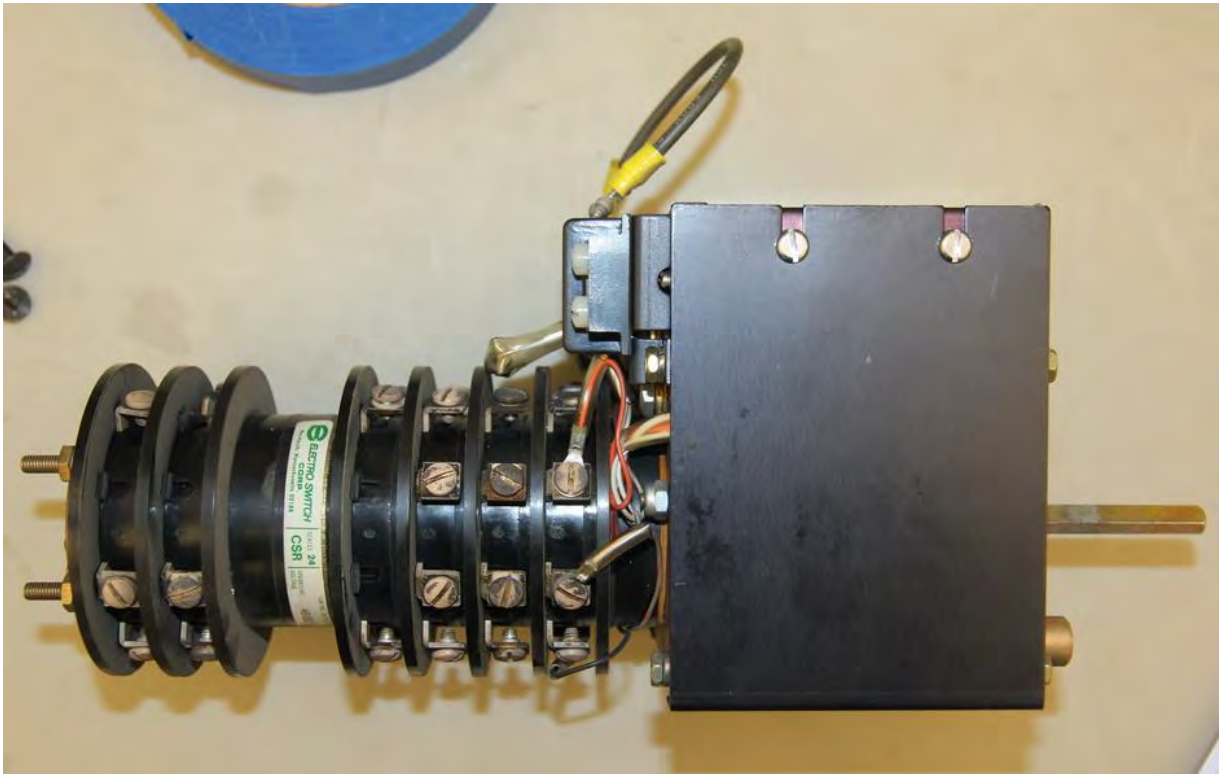
Figure 1. The incident switch removed from the control room in Larkin substation.

1. Replace the remotely operable switch for the second circuit breaker (CB 1121/12) at the incident feeder inside the station (completed).
2. Develop an improved approach to identify and alarm the parallel bus configuration via feeder breakers, including:
  - a. Reevaluate the SCADA alarm categories, priorities of the alarms, and which alarms should be audible.
  - b. Replace the existing tabular reports of the breakers status in the Larkin station with a graphical (single-line diagram) report for ease of identification (completed).
  - c. Provide a separate detection and alarm system using SCADA for the closed feeder breakers causing a parallel bus bar in the Larkin station (in progress).

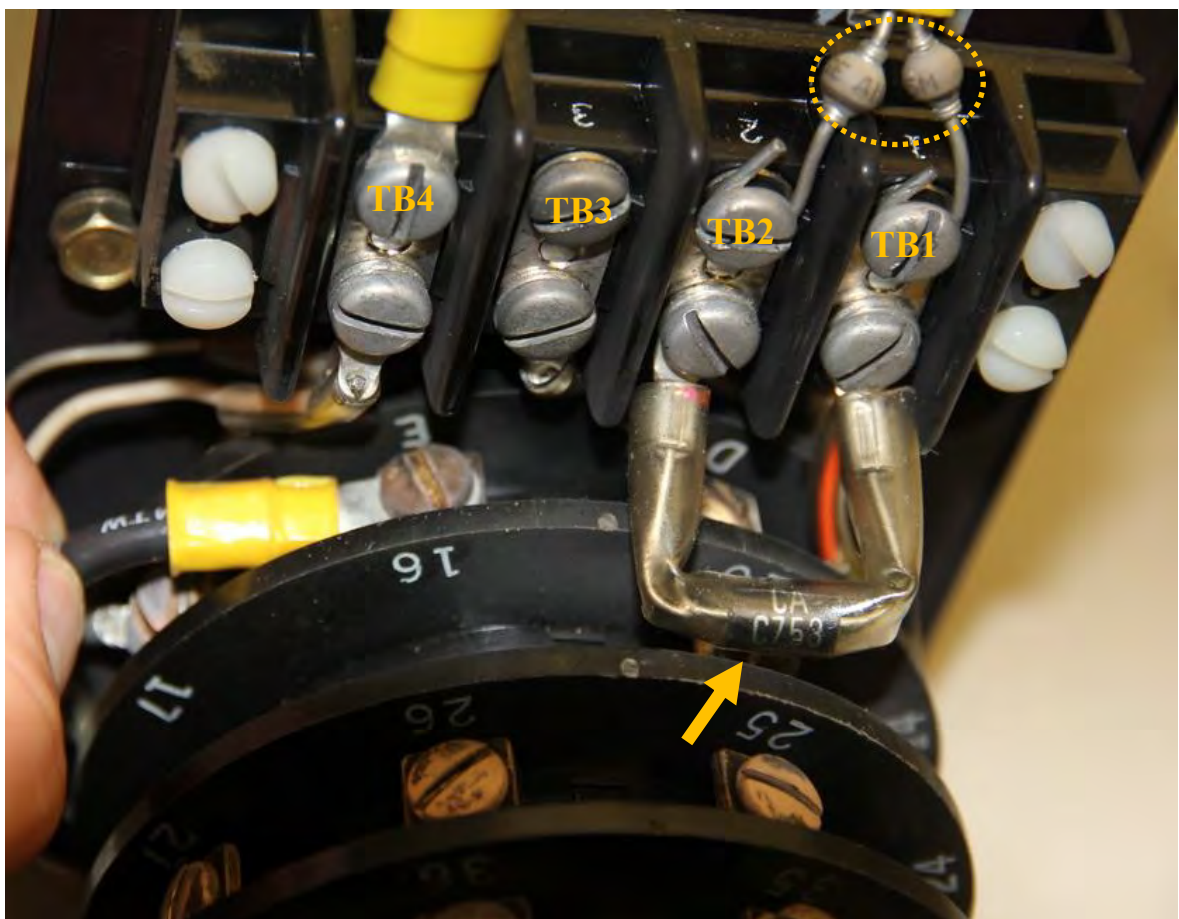
The incident switch was installed with three external components attached to its terminals. Two 600V fast recovery diodes were attached between the ground (TB4) and the Trip (TB1) and the Close (TB2) terminals of the switch. A 200V Transient Voltage Surge Suppressor diode (Transil Diode) was attached between the Trip (TB1) and Close (TB2) terminals of the switch. These components were still attached to the incident switch terminals when received by Exponent and are shown in Figure 3.

Figure 3. Two 600V fast recovery diodes (shown in yellow circle) and a bipolar diode (indicated by yellow arrow) attached to the incident switch terminals. The switch terminal points are marked TB1 to TB4.

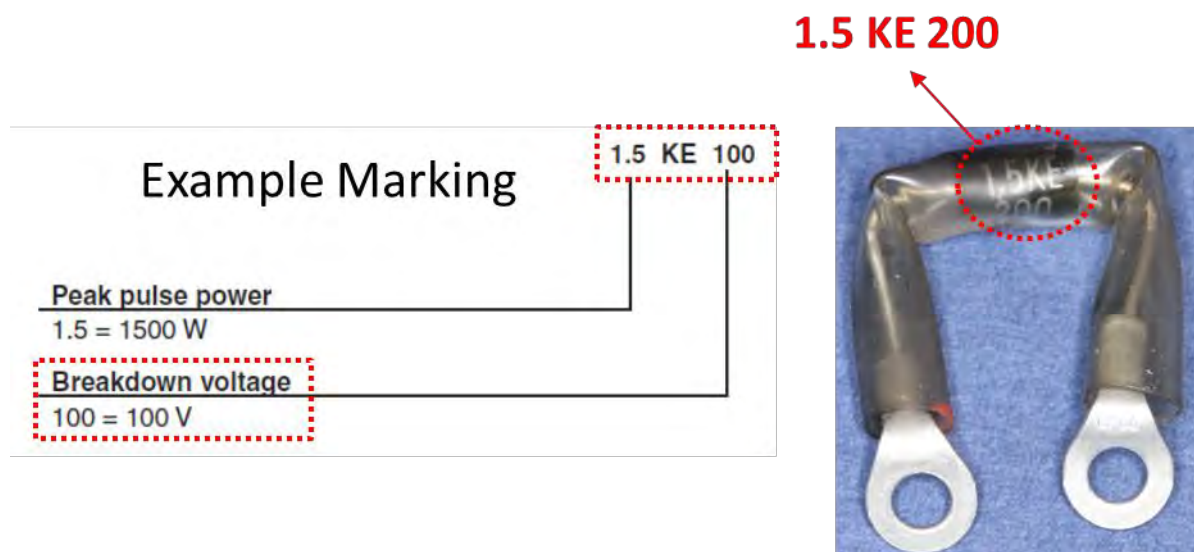
It appears from the technical document that a 200V diode is sufficient to protect the 125 VDC control switch against transient over voltages. However, the same type of protection is used for the 48 VDC control circuit of the incident switch. It is not clear why a voltage clipping closer to 48 VDC is not selected to protect this type of switch against transient over voltages.

Figure 6. The transient voltage surge suppressor diode that was attached to the incident switch with markings that read 1.5KE200 indicating a breakdown voltage of 200V.

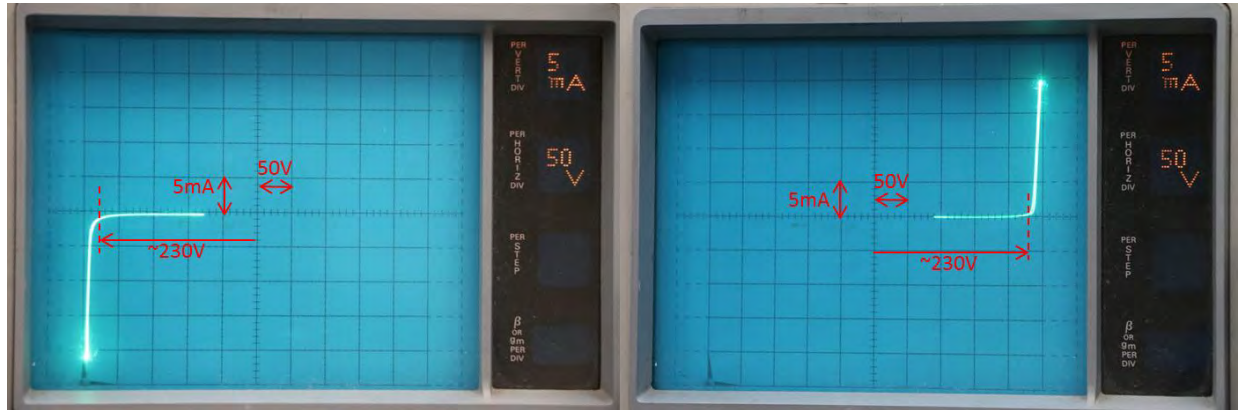
It was discovered that the reverse voltages of all the diodes had changed but were greater than their specified values. The 200V Transil diode attached to the incident switch had peak reverse voltage of 240V rather than 200V (Figure 11). Also, the reverse breakdown voltage of the 600V fast recovery diodes had increased to approximately 1000V (Figure 12).

Figure 11. Measured Positive and Negative clamp voltages of 230V for the 200V Transil Diode.

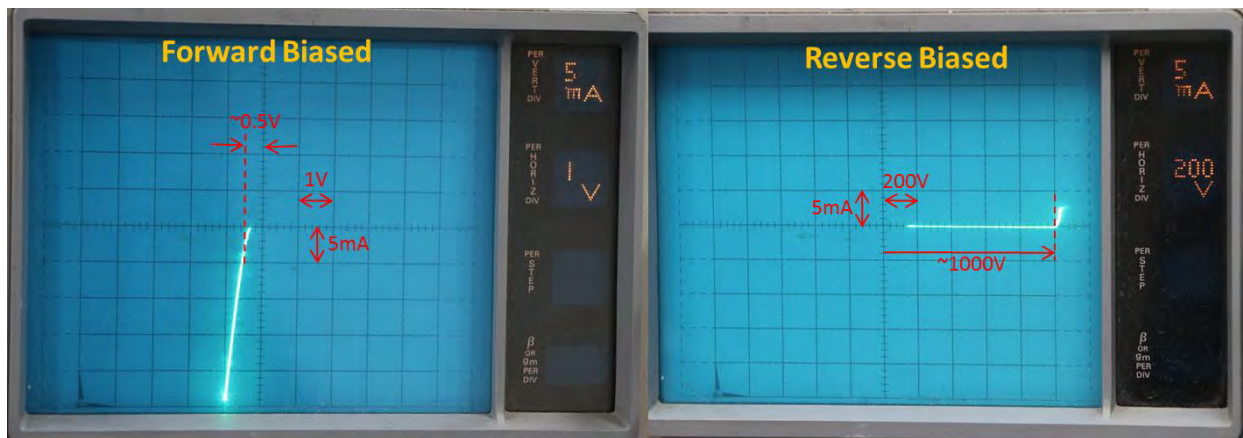
Figure 12. Measured reverse breakdown voltage of approximately 1000V for the 600 V rectifier diode.

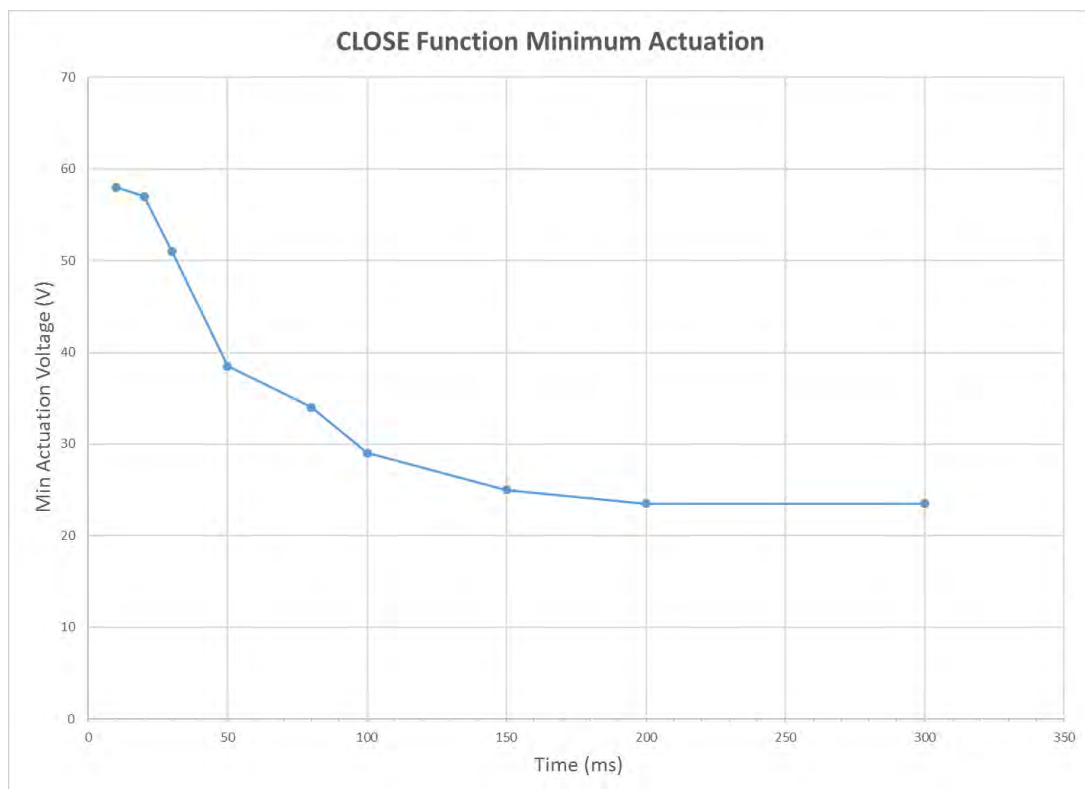
Figure 14. Minimum voltage levels that could trigger a CLOSE function with various switching times.

It was discovered that a 10 ms signal with a magnitude of 58V could assert a CLOSE command that would cause the switch to actuate and close. An oscilloscope image of such transient voltage is shown in Figure 15. Channel 1 (CH1) of the oscilloscope shows the voltage across an external relay that created the 10 ms, 58V signal to the CLOSE terminal of the test switch. Channel 2 (CH2) of the oscilloscope shows the current drawn by the test switch at the time of actuation. As can be seen from the oscilloscope image, after the 10 ms closing of the 58 V service voltage, the input voltage to the CLOSE terminal drops to approximately 20 V (one third of the DC supply voltage), but does not go to zero until after the switch actuation. The shape of the voltage signal after 10 ms until the time of the switch actuation suggests that the input current to the CLOSE terminal does not go to zero after 10 ms, but rather continues to flow despite the attempt by the external controls to shut down the CLOSE signal. It is likely that the current could not be interrupted due to large inductance of the linear solenoid, LS1, within the switch at the CLOSE circuit that would lead to continued supply of current and eventually the switch actuation to the CLOSE position. This shows that the switch is vulnerable to some system transients that could result in closing of the switch.

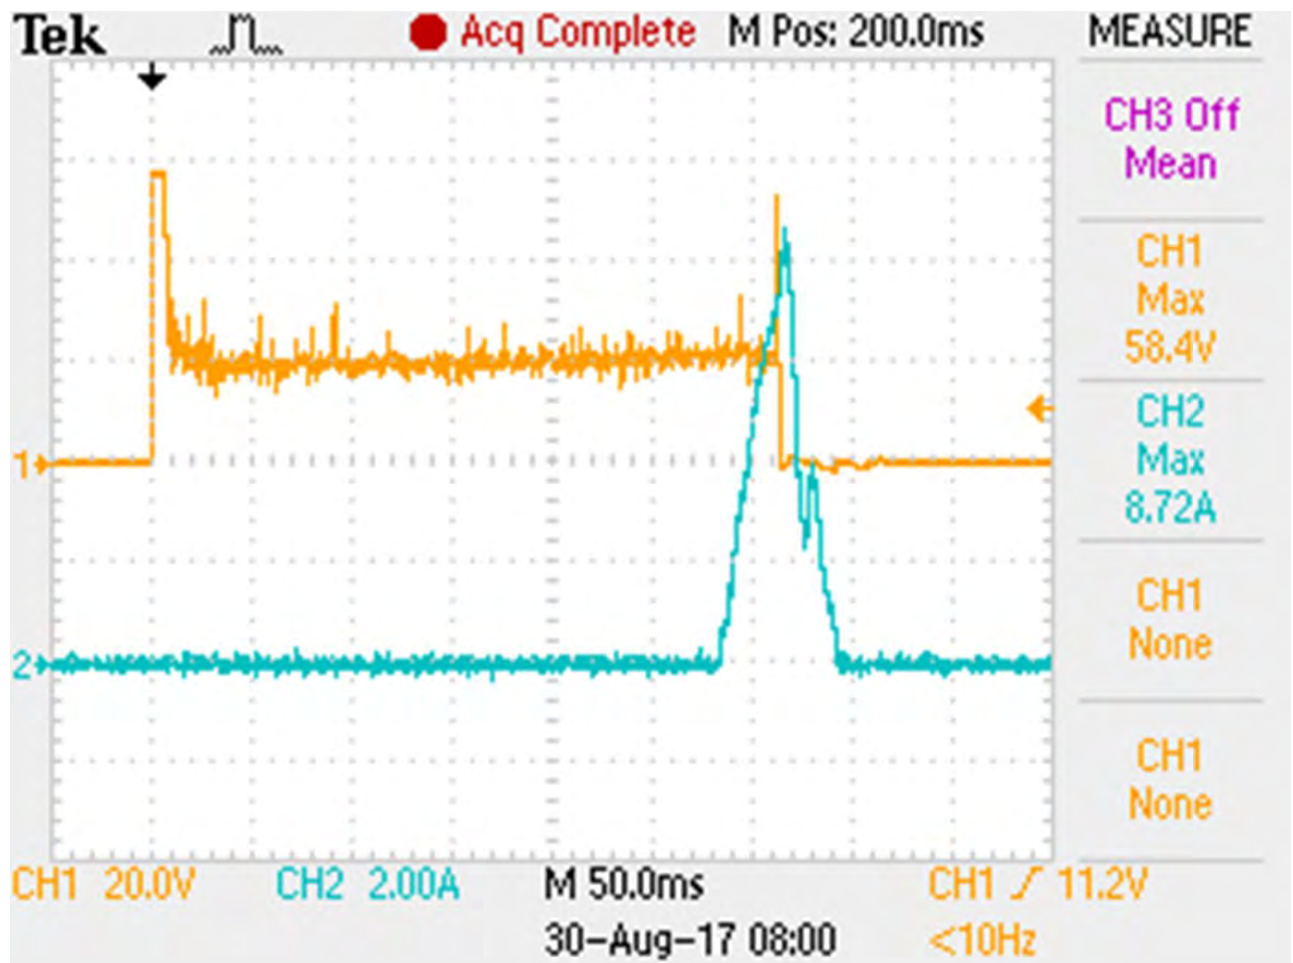
Figure 15. Oscilloscope image of a transient signal that led to closing of the switch.
