CALIFORNIA PUBLIC UTILITIES COMMISSION
Safety and Enforcement Division
Electric Safety and Reliability Branch

Incident Investigation Report

Incident Number: E20150801-01

Utility: SCE

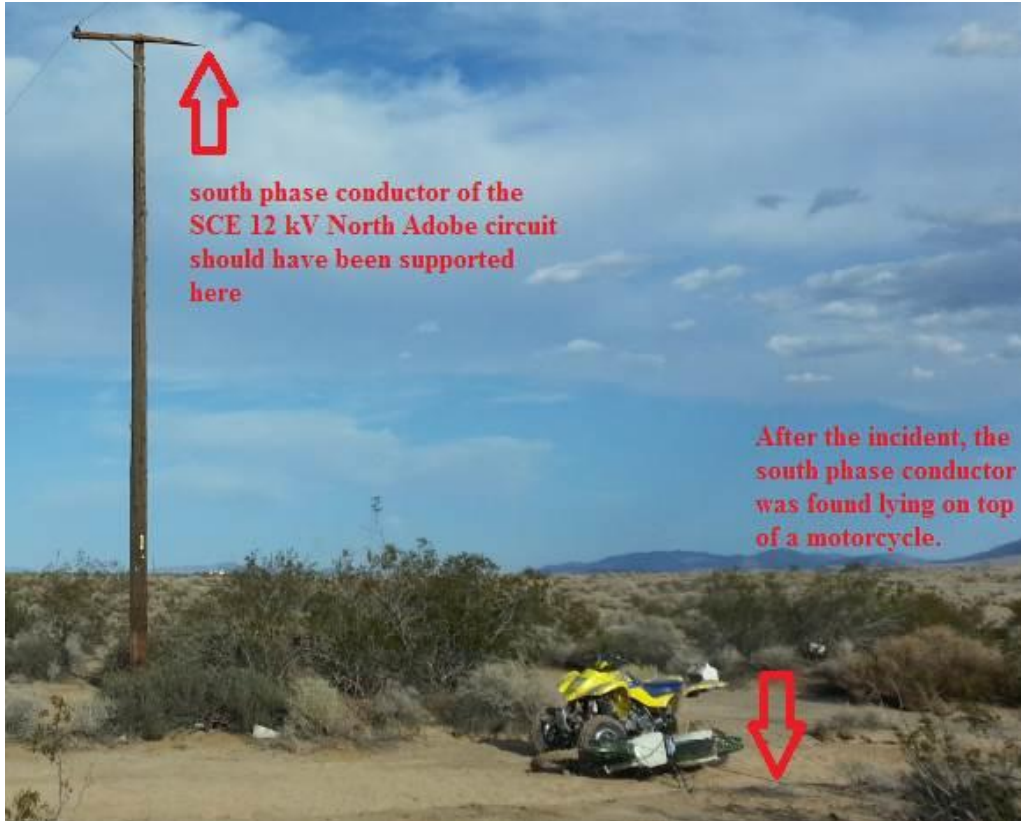
Later the same day, Staff visited the incident site and discovered the following: A 10 foot crossarm on pole number 43502S was broken (see Figure 1), and part of the crossarm and an insulator that was originally installed on the crossarm was on the ground near the base of the pole (see Figure 2)⁵. The south phase conductor of a branch of the North Adobe 12kV circuit (AWG No. 6 stranded copper conductor), which was initially supported by the insulator was lying on the ground, on bushes, and on top of REDACTED motorcycle (see Figure 3). The conductor was broken into two pieces, and the two broken ends of the conductor exhibited signs of necking (necking indicates that the conductor’s cross-sectional area has begun to decrease in a particular region as a result of tensile stress). The seat height of REDACTED motorcycle (2015 Kawasaki KMX) was approximately 2.8 feet.

Figure 1. Image of the incident site showing the broken crossarm on Pole number 43502S.

Based on the evidence, Staff concludes that it is likely that prior to the incident, the crossarm on pole number 43502S broke, causing the south phase conductor of the subject branch of the SCE 12 kV North Adobe circuit – which was supported on the aforementioned pole – to become supported by poles numbered 43501S and 43503S. This caused the conductor’s ground clearance as shown in figure 5 to be reduced to less than 8 feet. In a letter dated August 28, 2015, Julie Olin, SCE Claims Representative, stated, “It is believed this storm broke a ten (10) foot cross-arm attached to Pole No. 43502S. As a result of the broken cross-arm, the south phase of #6 stranded copper conductor came down and was isolated above ground between Pole Nos. 43501S and 43503S. Post incident visual examination of the cross-arm did not reveal any pre-existing decay or damage.”

⁵ On August 2, 2015, the day after the incident, SCE completed repairs to pole number 43502S.

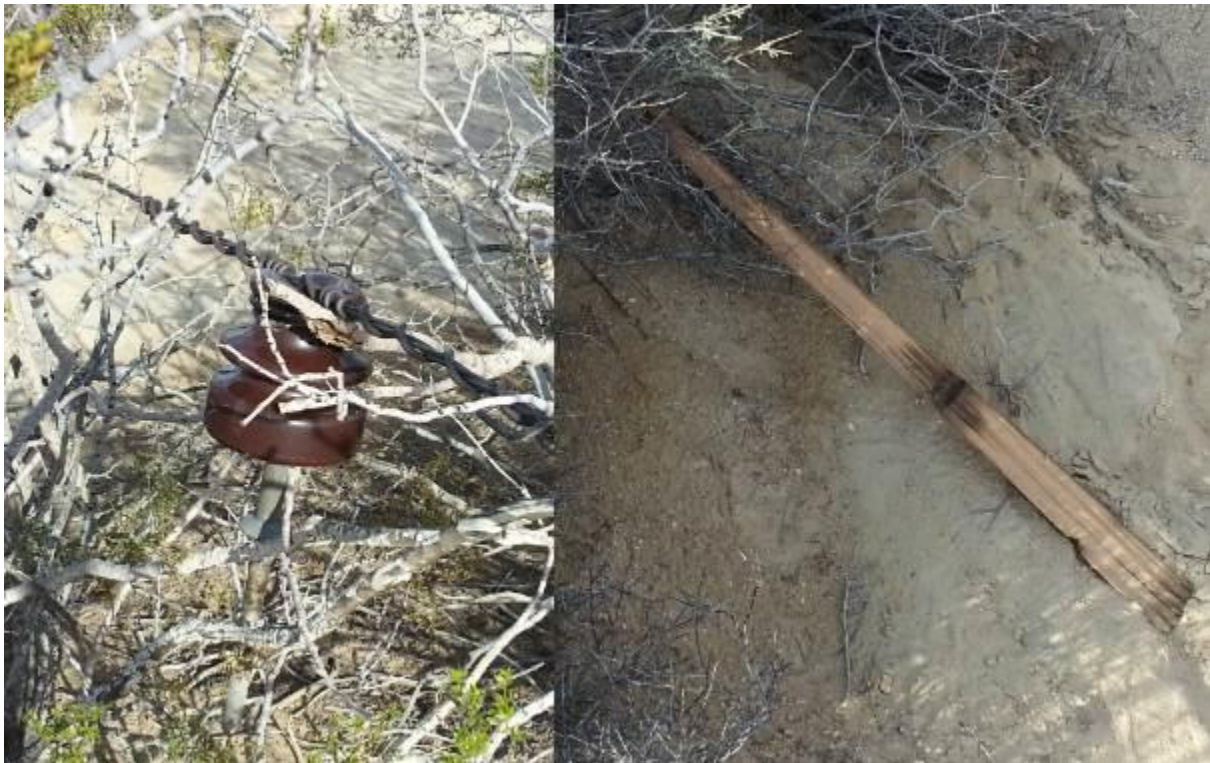
Figure 2. The left and right images show the insulator and crossarm that were supported on pole number 43502S.

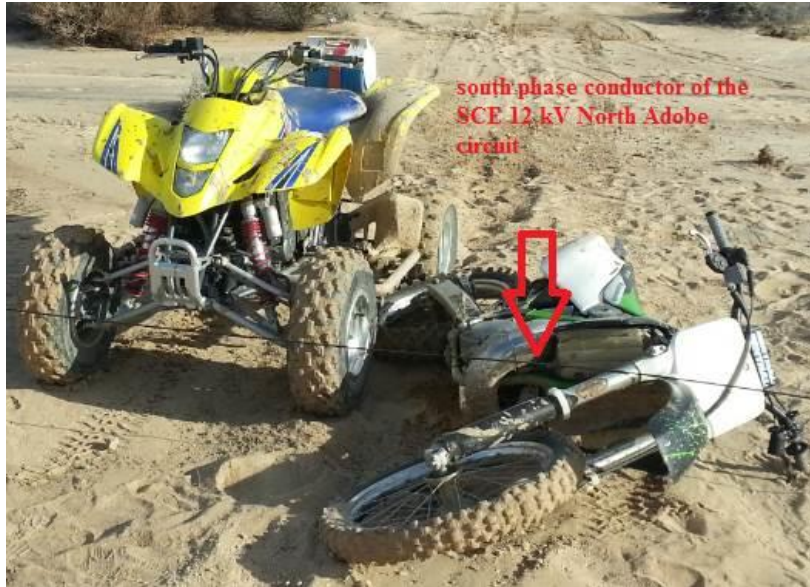
Figure 3. The south phase conductor of the SCE 12 kV North Adobe circuit was found on top of a motorcycle.

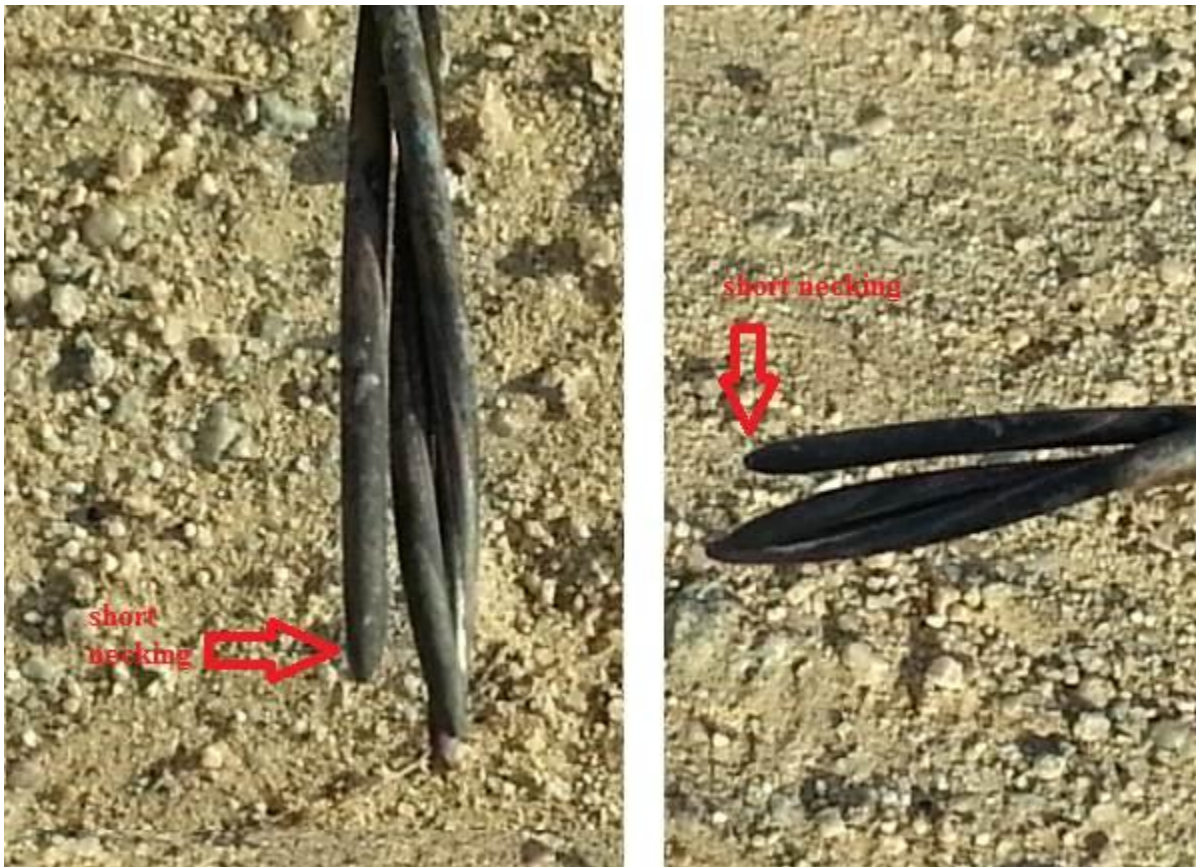
Figure 4. After the incident, the south phase conductor of the SCE 12 kV North Adobe circuit was found broken into two pieces and lying on the ground. The broken ends of the conductor exhibit short necking.

2. Pole number 43502S exhibited several fresh scratches on the face of the pole at 4.8 feet, 6.6 feet, and 8 feet from the ground (see Figure 6).
3. The two broken ends of the conductor exhibited signs of necking, which may indicate that the conductor broke due to tension. This is consistent with REDACTED striking the conductor, and the force of the collision may have pulled apart the conductor.

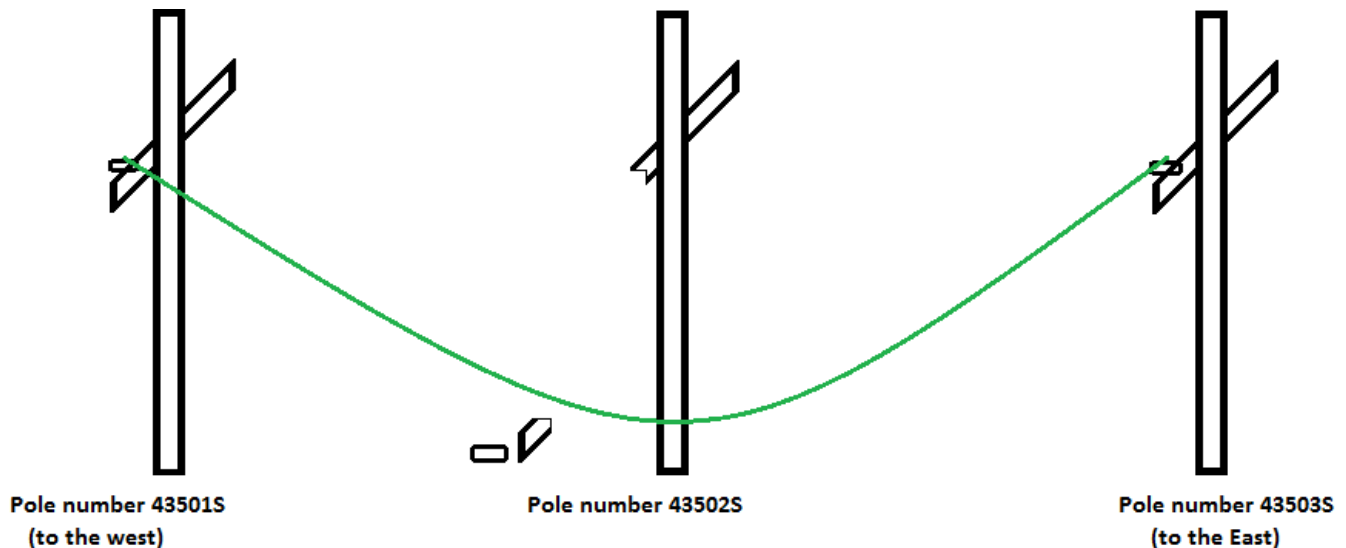
Figure 5: Configuration of SCE facilities just prior to the incident. The crossarm on Pole number 43502S was broken, causing the south conductor to be supported by Poles numbered 43501S and 43503S.

thoroughfares in rural districts or across other areas capable of being traversed by vehicles or agricultural equipment to maintain a minimum ground clearance of 25 feet. At the time of the incident, the SCE overhead conductor had an above ground clearance less than 8 feet, which is less than the GO 95 minimum requirement of 25 feet. Therefore, SCE is in violation of GO 95, Rule 37 for failing to ensure that its 12 kV overhead conductor maintained at least a 25 foot ground clearance above a thoroughfare capable of being traversed by vehicles.

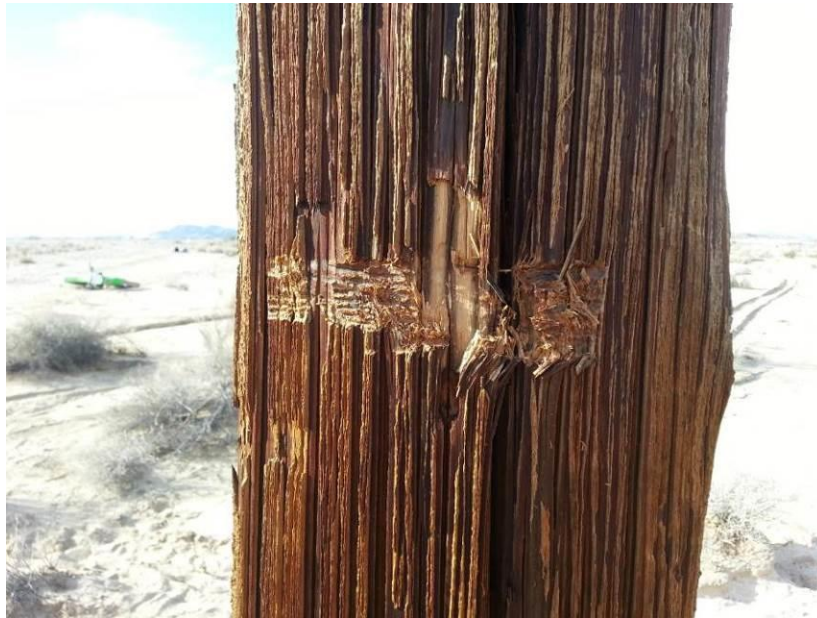
Figure 6: A scratch mark on Pole number 43502S.
