CALIFORNIA PUBLIC UTILITIES COMMISSION
Safety and Enforcement Division
Electric Safety and Reliability Branch

Supplemental Incident Investigation Report

Incident Number: E20150801-01

Utility: SCE

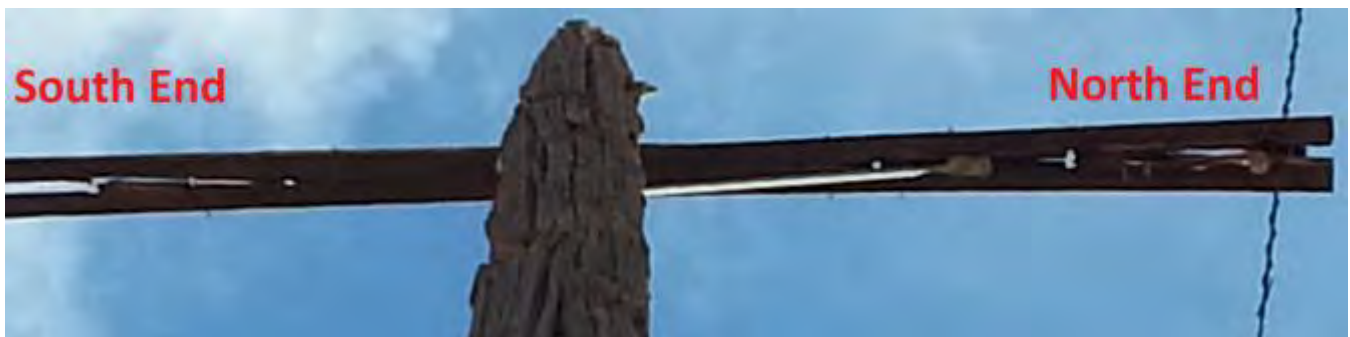
Figure A-1: The crossarm on SCE pole number 43502S. Source: SED

- Figures A-1 and A-2 above show that the crossarm was sheared along a Vertical Shearing Plane. Shearing is a failure mechanism that results in cracks and splits. The Vertical Shearing Plane is defined as a plane between and parallel to the front and back faces of the crossarm. The Vertical Shearing Plane is the red plane depicted in Figures A-9 and A-10 below.

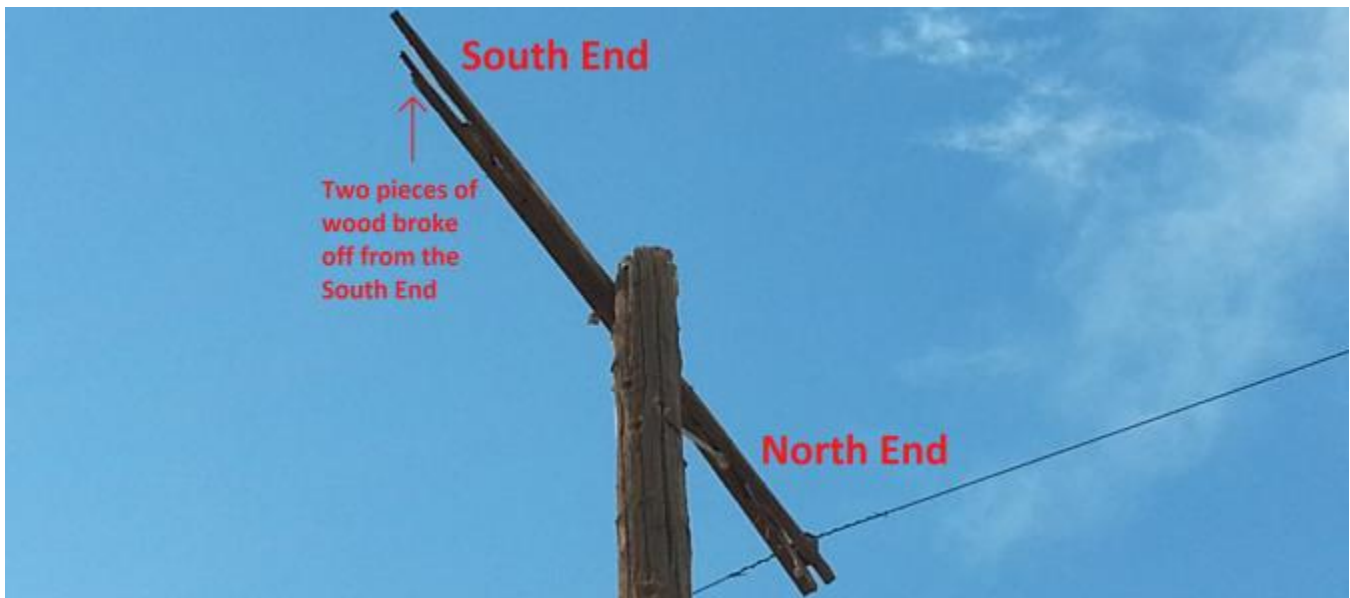
Figure A-2: The crossarm on SCE pole number 43502S. Source: SED

- Figure A-2 shows that pieces of the South End broke and fell to the ground.
- Figures A-3 through A-7 show that the Vertical Shearing Plane on the South End was incomplete due to the presence of an "Anti-split" throughbolt. The throughbolt caused a portion of the Vertical Shearing Plane to fold over into a Horizontal Shearing Plane. The Horizontal Shearing Plane is defined as a plane between and parallel to the top and bottom faces of the crossarm. The Horizontal Shearing Plane is the blue plane depicted in Figures A-9 and A-10. The reason the throughbolt created a Horizontal Shearing Plane is that shearing planes are typically parallel to bolt or screw holes, as holes (particularly those subject to tensile stress) create areas of stress concentration.

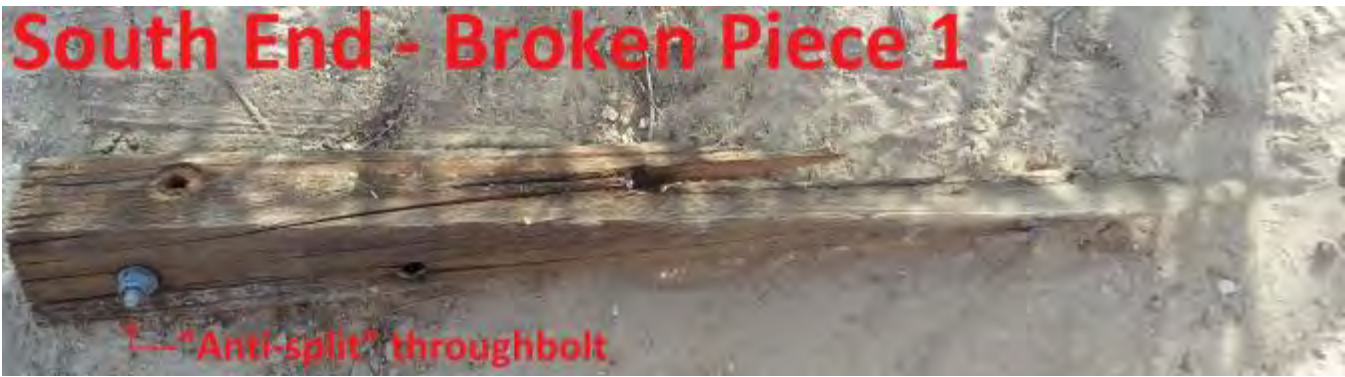
Figure A-3: "South End – Broken Piece 1" (photo 1/4) is the larger of the two pieces that broke off from the South End.

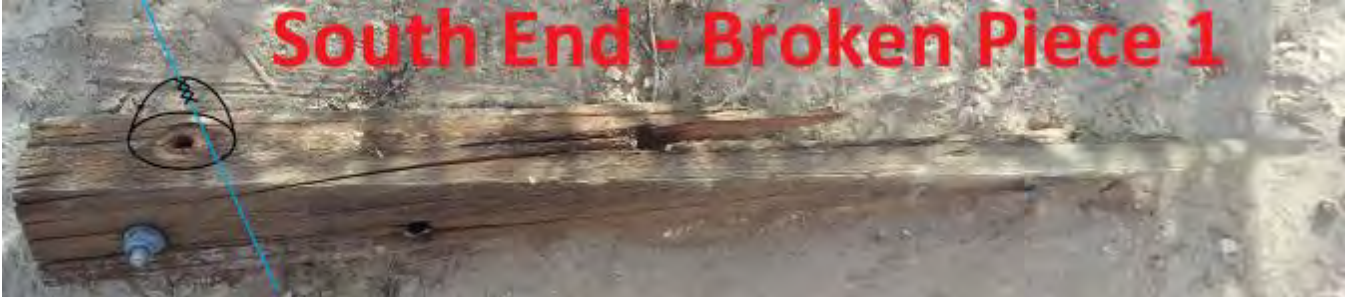
Figure A-4: "South End – Broken Piece 1" (photo 2/4) showing where the insulator would have been installed. Source: SED

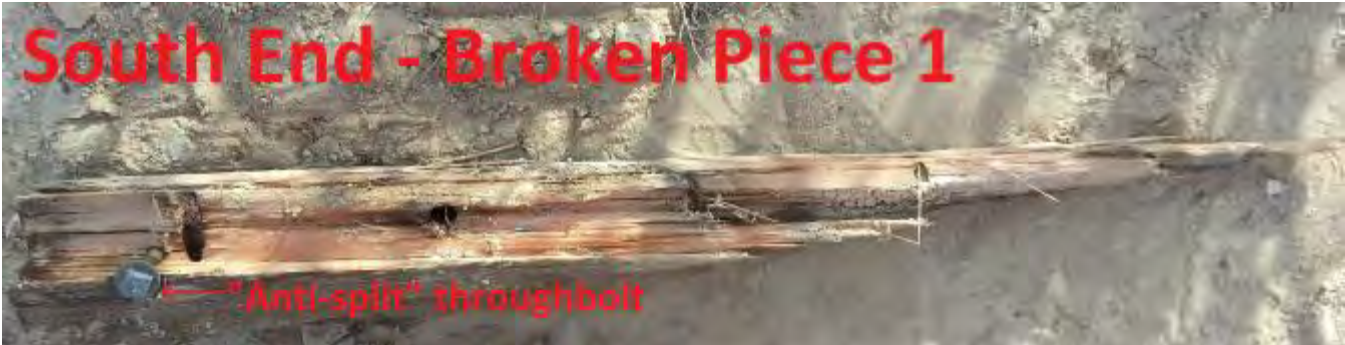
Figure A-5: "South End – Broken Piece 1" (photo 3/4). The "Anti-split" throughbolt did not support insulators. Source: SED

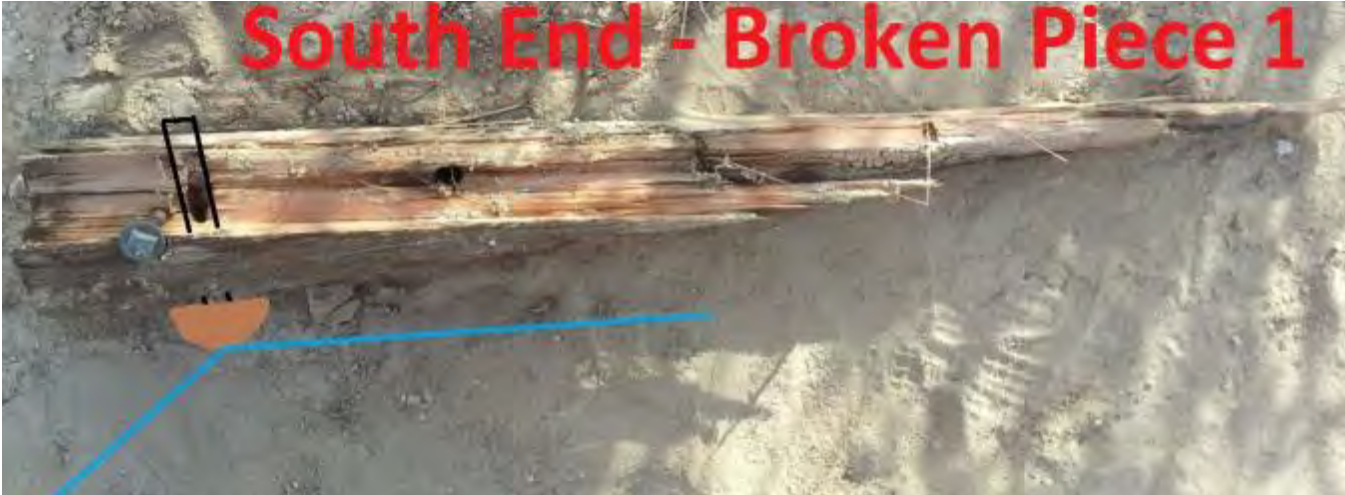
Figure A-6: "South End – Broken Piece 1" (photo 4/4) showing where the insulator & pin would have been installed. Source: SED.

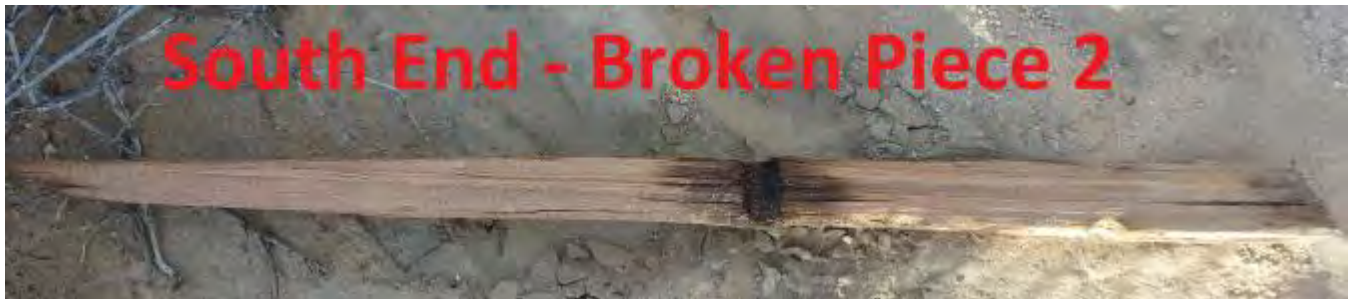
Figure A-7: "South End – Broken Piece 2" is the smaller of the two pieces that broke off from the South End. Source: SED

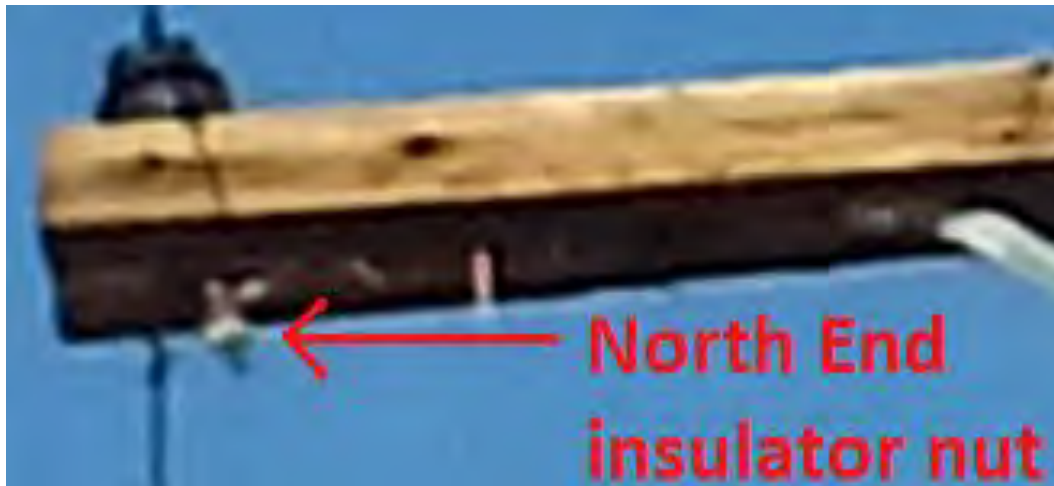
Figure A-8: The photo shows the insulator nut on the "North End" insulator. Source: SED.

- Figure A-8 shows that the North End insulator, which did not fall off the crossarm during the incident, had an intact insulator nut.

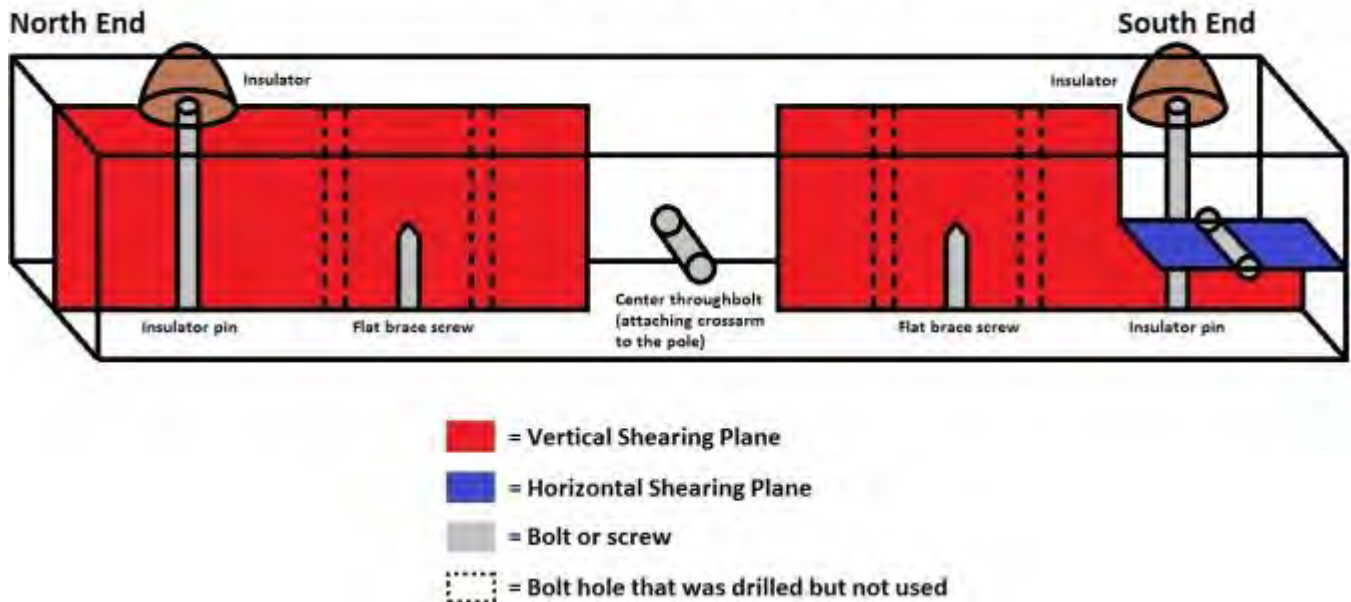
Figure A-9: A depiction of the crossarm showing the Vertical Shearing Plane and the Horizontal Shearing Plane. The figure also shows the vertically-oriented bolts/screws and the horizontally-oriented bolt that contributed to the shearing pattern. Note: Not shown are three pre-drilled horizontally-oriented bolt holes that did not contribute to either shearing plane. Source: SED

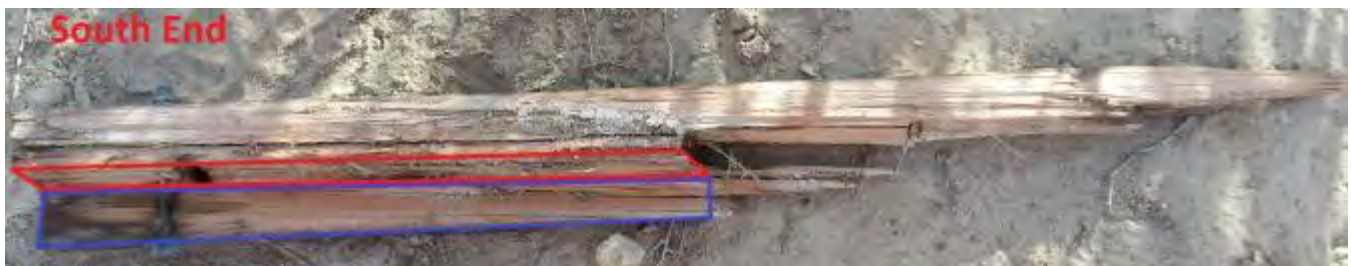
Figure A-10: "South End – Broken Piece 1" showing part of the Vertical Shearing Plane and part of the Horizontal Shearing Plane. It is clear from this figure that the "Anti-split" throughbolt caused the Horizontal Shearing Plane. Source: SED

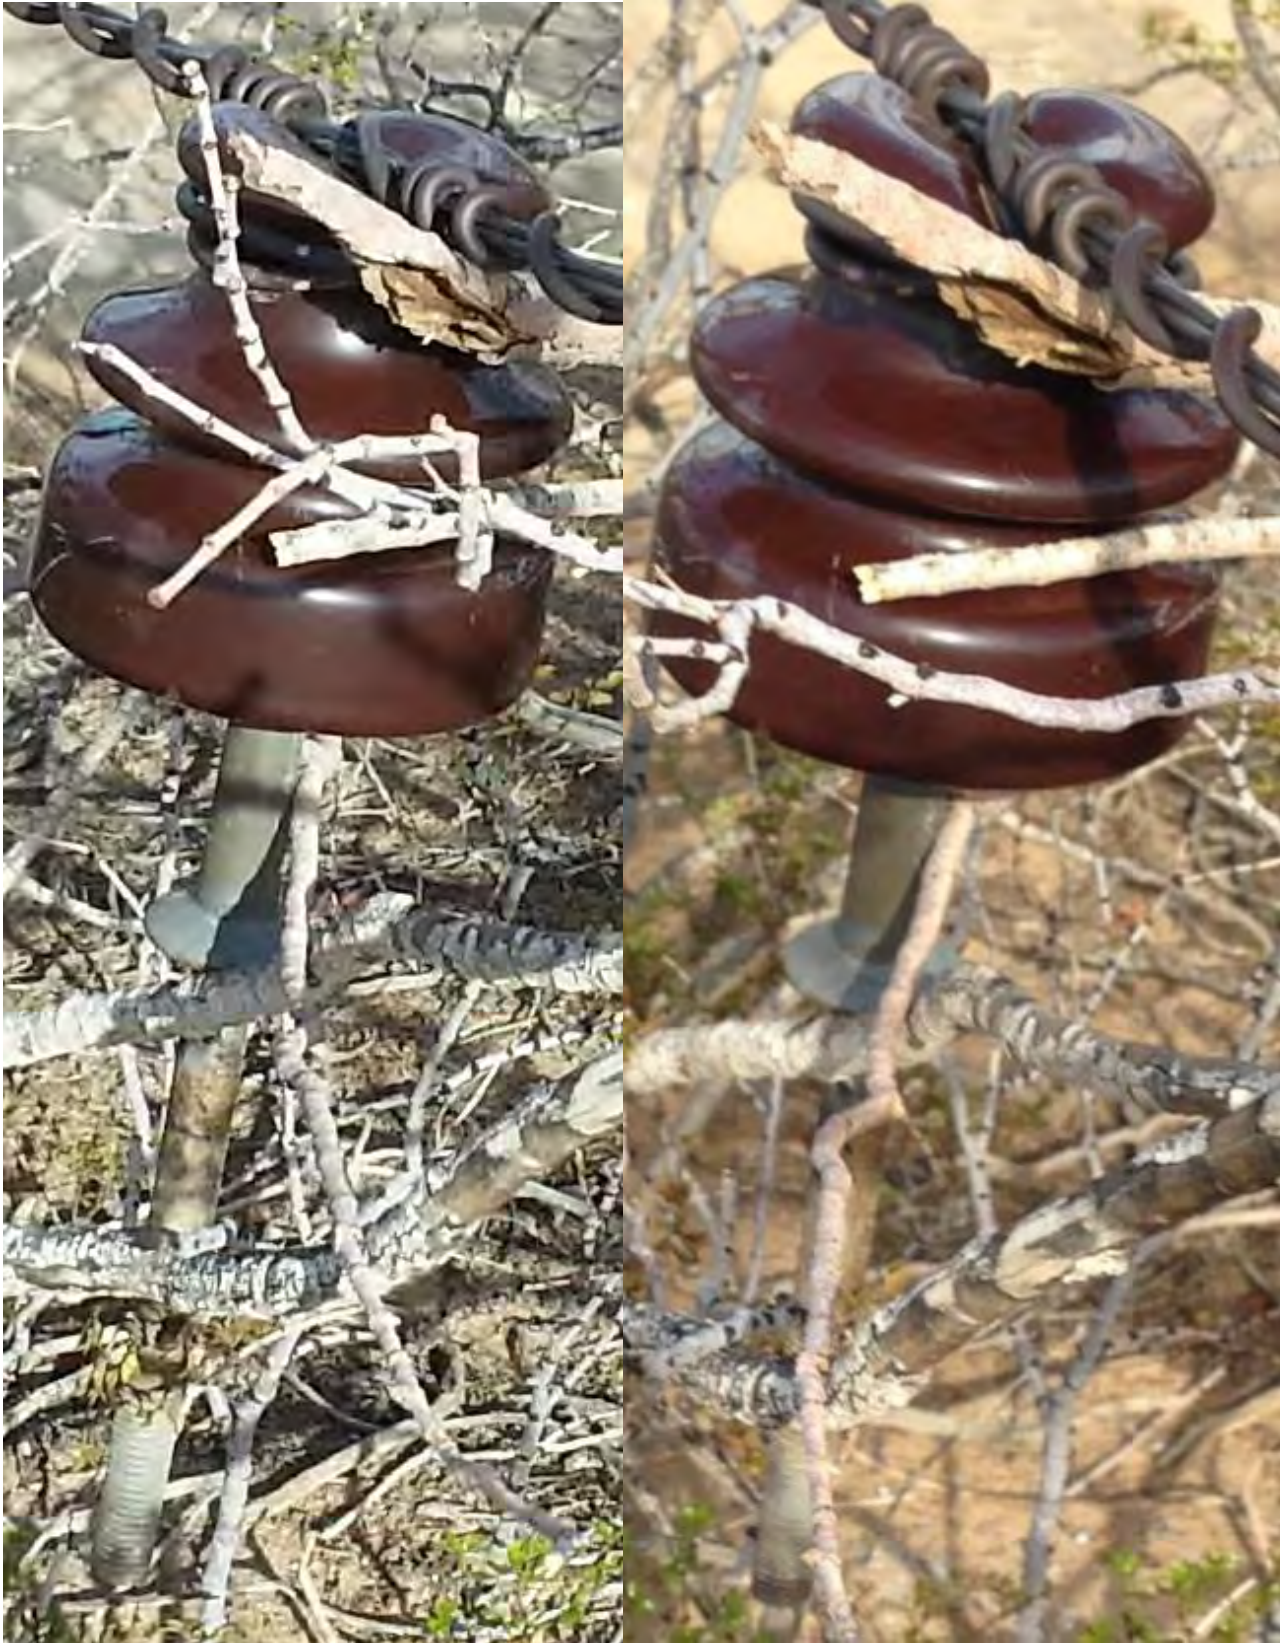
Damage Causes: On July 27, 2018, during preparations related to K.18-03-008, SED found SCE Notification No. 403983607, which indicated that an insulator supported on pole number 43502S had a nut missing from its pin (see Figure A-11). Subsequently, SED Staff reviewed its earlier photographs, taken on August 1, 2015, of the insulator that fell to the ground, which demonstrated that the insulator pin was missing the nut (see Figure A-12).

Figure A-12: Two views of the insulator that had been supported on the South End of the failed crossarm of pole number 43502S showing no nut attached to threaded portion of the insulator pin. Source: SED (left) and SCE (right)

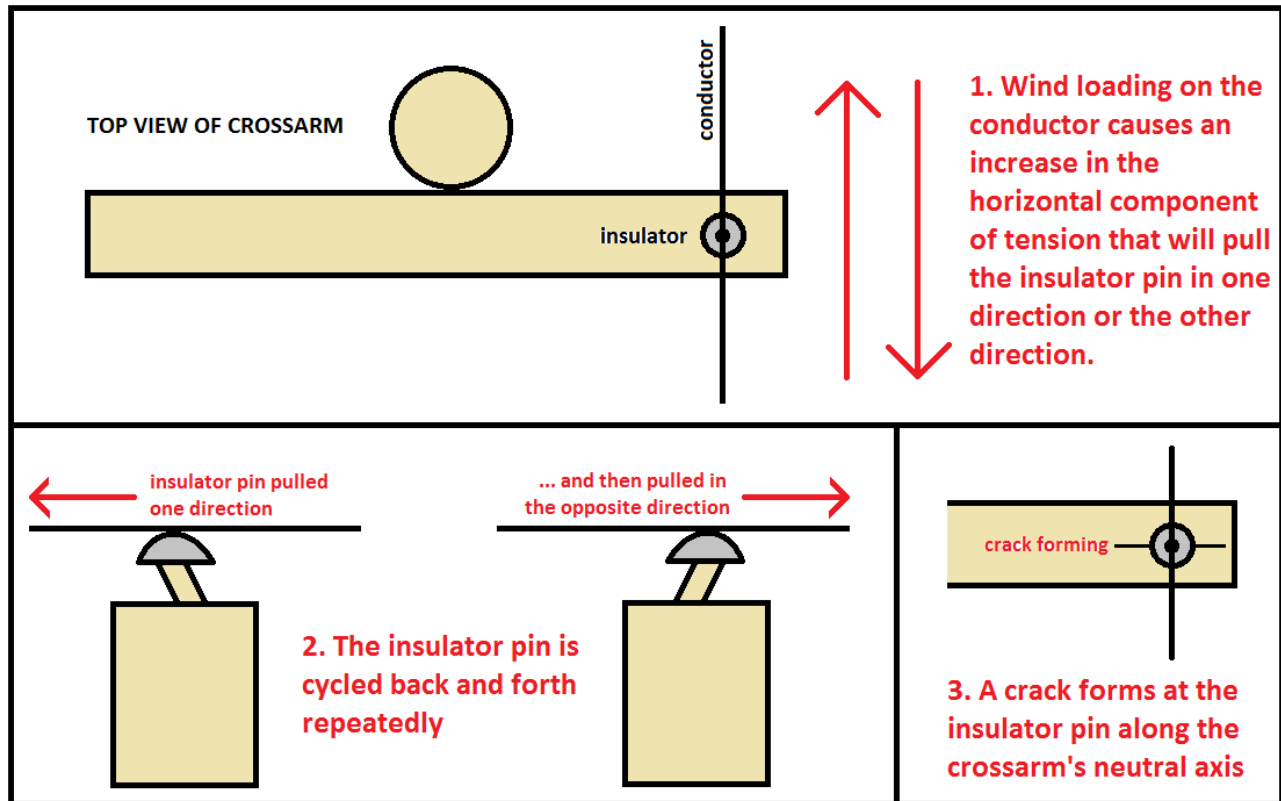
Based on the facts and evidence available, SED concludes that the shearing damage in the crossarm was caused, in part, by cyclic loading (see Figures A-13 and A-14) of both the North End insulator pin, which did not fall off the crossarm in the incident, and the South End insulator pin, which *did* fall off the crossarm in the incident. The cyclic loading resulted in tensile stress and shearing of the crossarm along both the Vertical Shearing Plane and the Horizontal Shearing Plane. Additionally, SED concludes that the bending damage at the South End of the crossarm (resulting in South End – Broken Piece 1 and South End – Broken Piece 2 breaking off and falling to the ground) was due to the crossarm becoming weakened as a result of shearing along the Vertical Shearing Plane, making the crossarm susceptible to bending failure due to wind loading. It is likely that visible shearing of the South End along the Vertical Shearing Plane prompted utility personnel at some time prior to the incident to install the “Anti-split” throughbolt (see Figures A-3 through A-6). This conclusion is based on the fact that the South End of the crossarm exhibited a partial Vertical Shearing Plane despite having the “Anti-split” throughbolt, indicating that it was already sheared prior to the “Anti-split” throughbolt’s installation. Additionally, the Vertical Shearing Plane passes along the bottom of the “Anti-split” throughbolt, meaning that the shearing would have been visible to utility personnel standing on the ground. Finally, the installation of “Anti-split” throughbolts at the time of construction is not a known utility practice.

Figure A-13: Tensile stress along the neutral plane of the crossarm due to an insulator pin cycling back and forth imposing cyclic loading conditions unaccounted for in the original design.

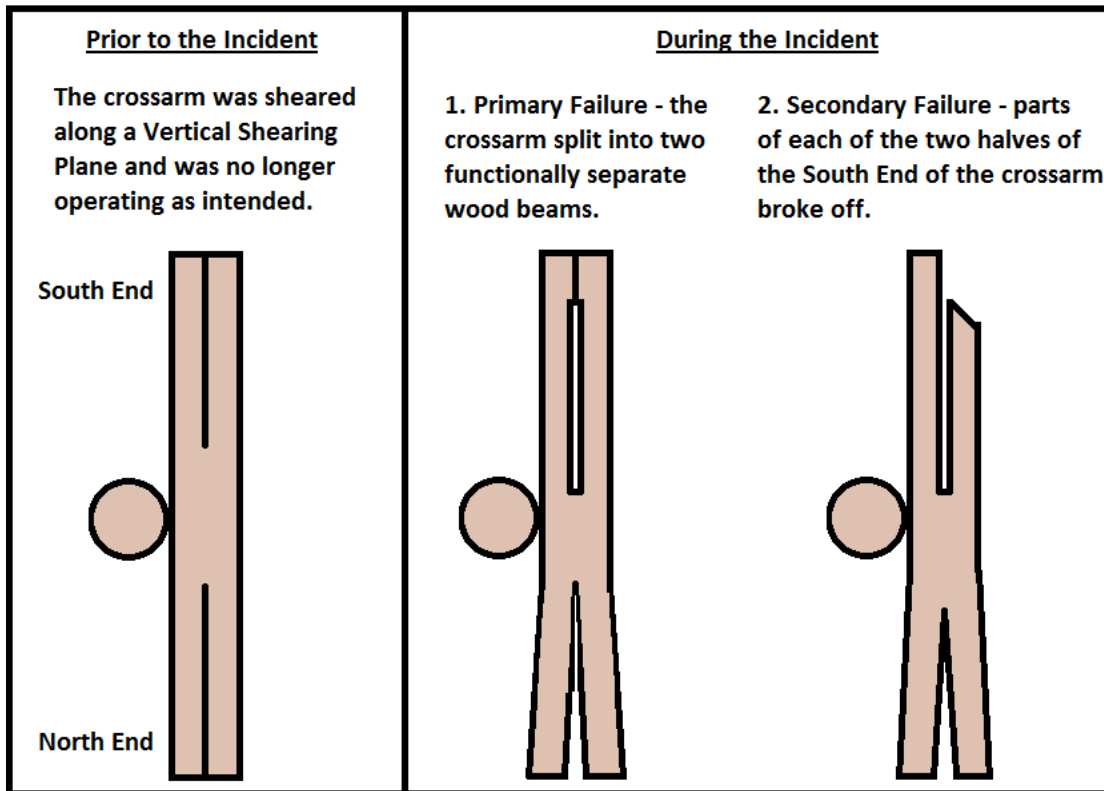
Prior to the incident, the front and back halves of the crossarm had a severe crack and perhaps even a complete split between them (Figure A-15). Because of this, the crossarm can be considered as two separate crossarms: a front crossarm and a back crossarm. One would imagine that a crossarm that is split between its front and back faces would separate completely. However, this crack or split did not occur over the entire length of the crossarm for two reasons: (1) the crossarm was supported on the pole via a throughbolt located at the center of the crossarm (“Center Throughbolt” as shown in Figure A-9), which prevented shearing in the vicinity of the center of the crossarm; and (2) the crossarm also had an “Anti-split” throughbolt installed at the South End of the crossarm which partially held together the front and back halves of the crossarm. See Figures A-9 and A-10 above.

Figure A-15: The condition of the crossarm prior to the incident and during the incident.

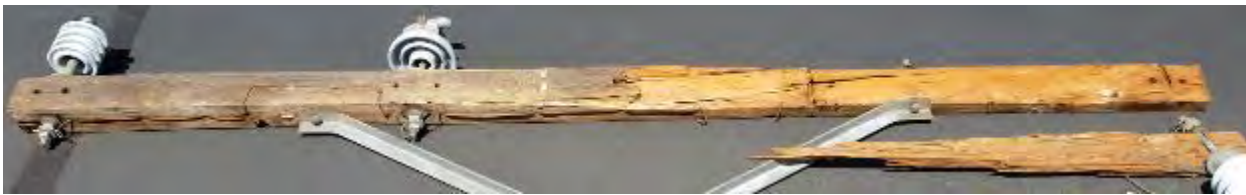
Figure B-1: The front face of Specimen 1.

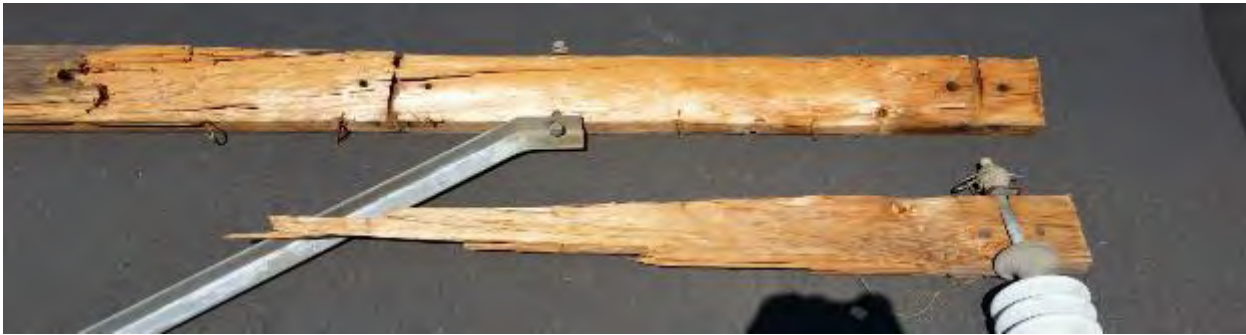
Figure B-2: The front face of Specimen 1 – right side close-up.

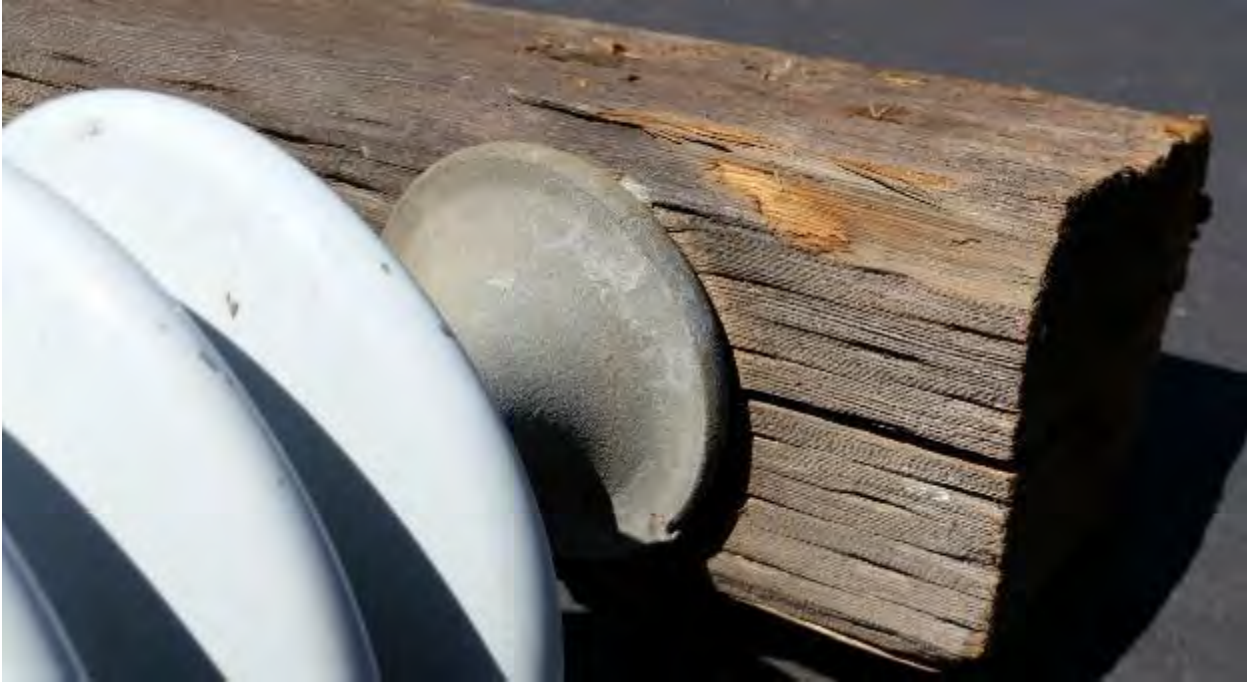
Figure B-3: The top face of Specimen 1 – left side close-up.

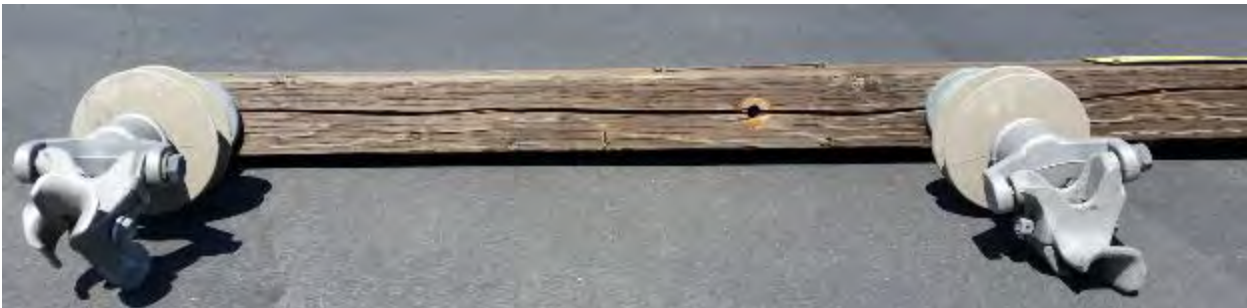
Figure B-5: The top face of Specimen 2 – left side close-up

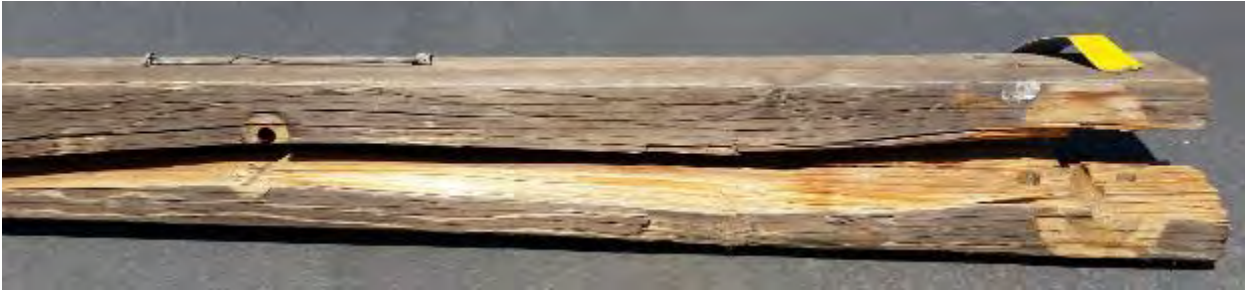
Figure B-6: The top face of Specimen 2 – right side close-up

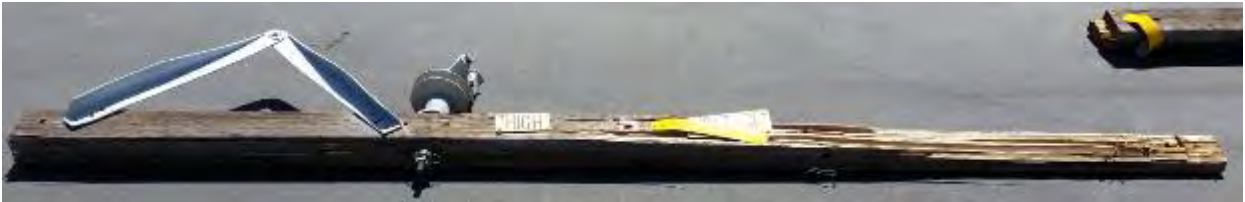
Figure B-7: The front face (supporting the HIGH VOLTAGE sign) of Specimen 3.

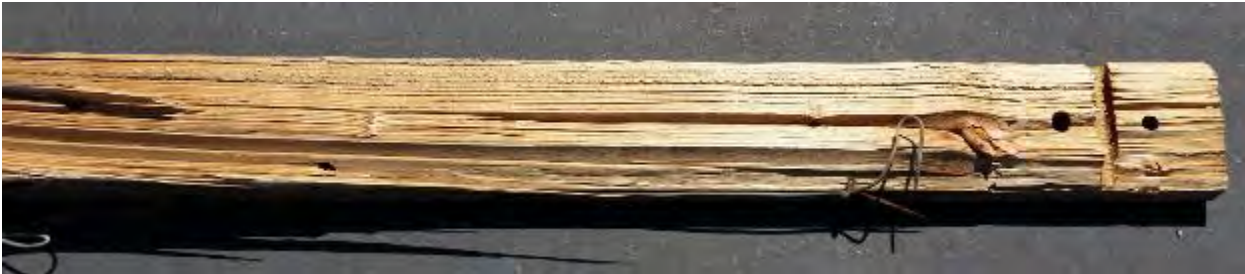
Figure B-8: The front face of Specimen 3 – right side close-up.

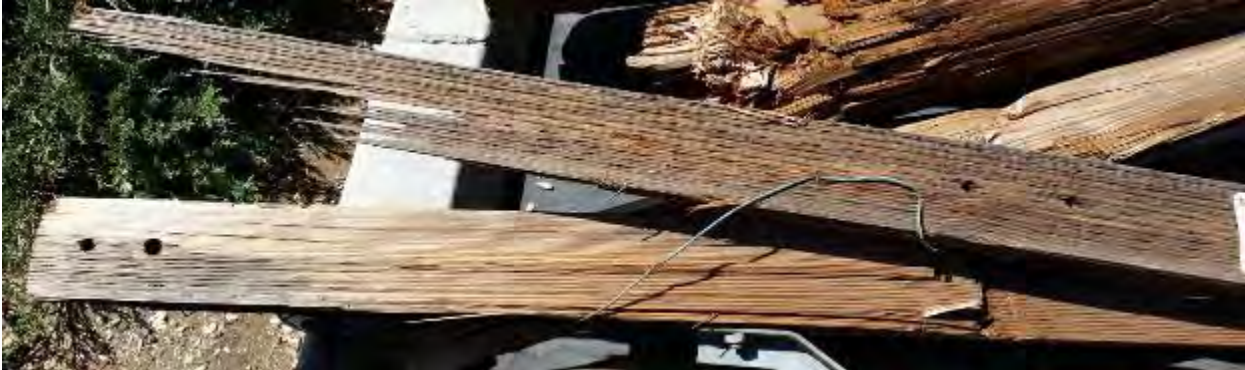
Figure B-9: The front face of Specimen 4 – left side close-up.

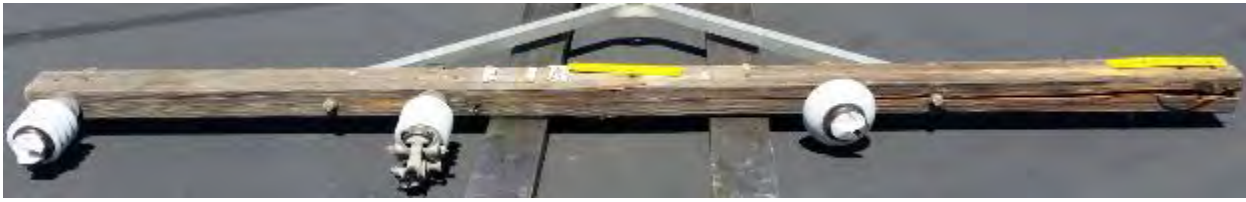
Figure B-10: The top face (the face supporting the three insulators) of Specimen 5.

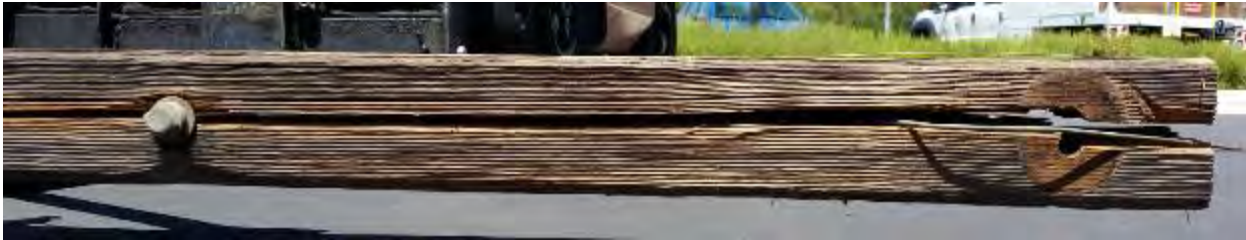
Figure B-11: The top face of Specimen 5 – right side close-up.

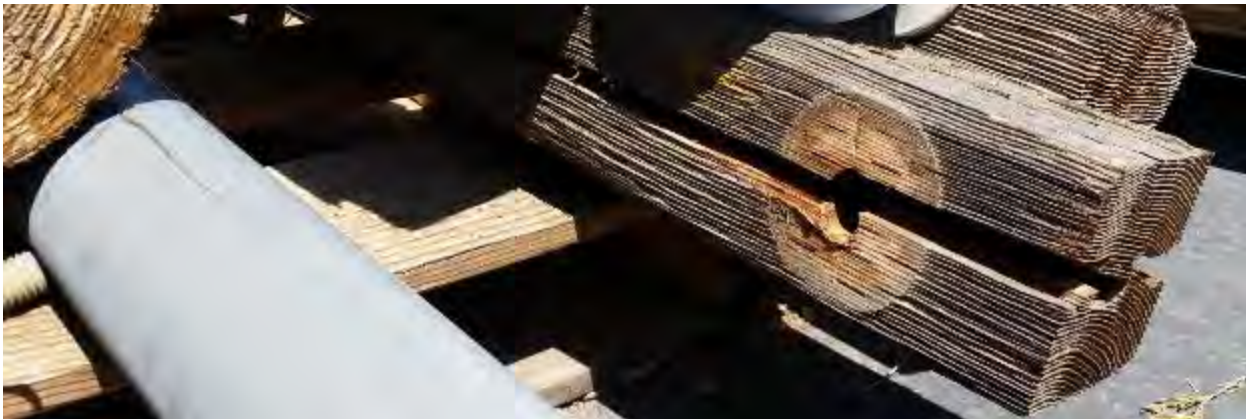
Figure B-12: The top face of Specimen 6 – right side close-up.
