**CALIFORNIA PUBLIC UTILITIES COMMISSION
Safety and Enforcement Division
Electric Safety and Reliability Branch**

Incident Investigation Report

Incident Number: E20150801-01

Utility: SCE

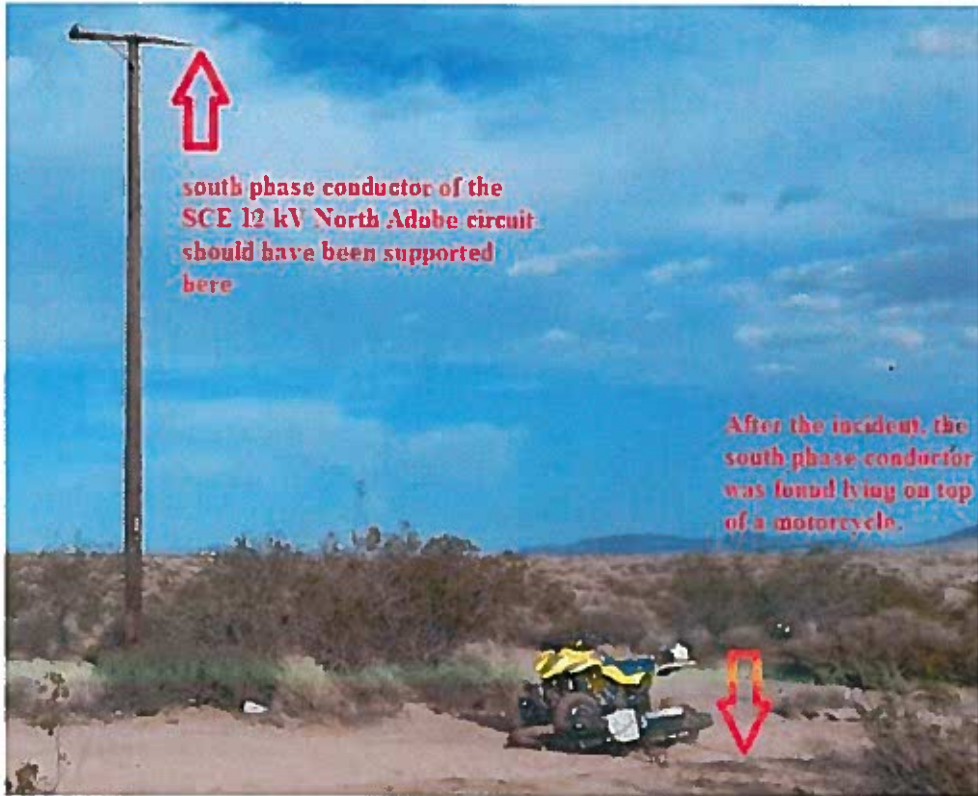
Later the same day, Staff visited the incident site and discovered the following: A 10 foot crossarm on pole number 43502S was broken (see Figure 1), and part of the crossarm and an insulator that was originally installed on the crossarm was on the ground near the base of the pole (see Figure 2)⁵. The south phase conductor of a branch of the North Adobe 12kV circuit (AWG No. 6 stranded copper conductor), which was initially supported by the insulator was lying on the ground, on bushes, and on top of [REDACTED] motorcycle (see Figure 3). The conductor was broken into two pieces, and the two broken ends of the conductor exhibited signs of necking (necking indicates that the conductor's cross-sectional area has begun to decrease in a particular region as a result of tensile stress). The seat height of [REDACTED] motorcycle (2015 Kawasaki KMX) was approximately 2.8 feet.

south phase conductor of the
SCE 12 kV North Adobe circuit
should have been supported
here

After the incident, the
south phase conductor
was found lying on top
of a motorcycle.

Figure 1. Image of the incident site showing the broken crossarm on Pole number 43502S.

⁵ On August 2, 2015, the day after the incident, SCE completed repairs to pole number 43502S.

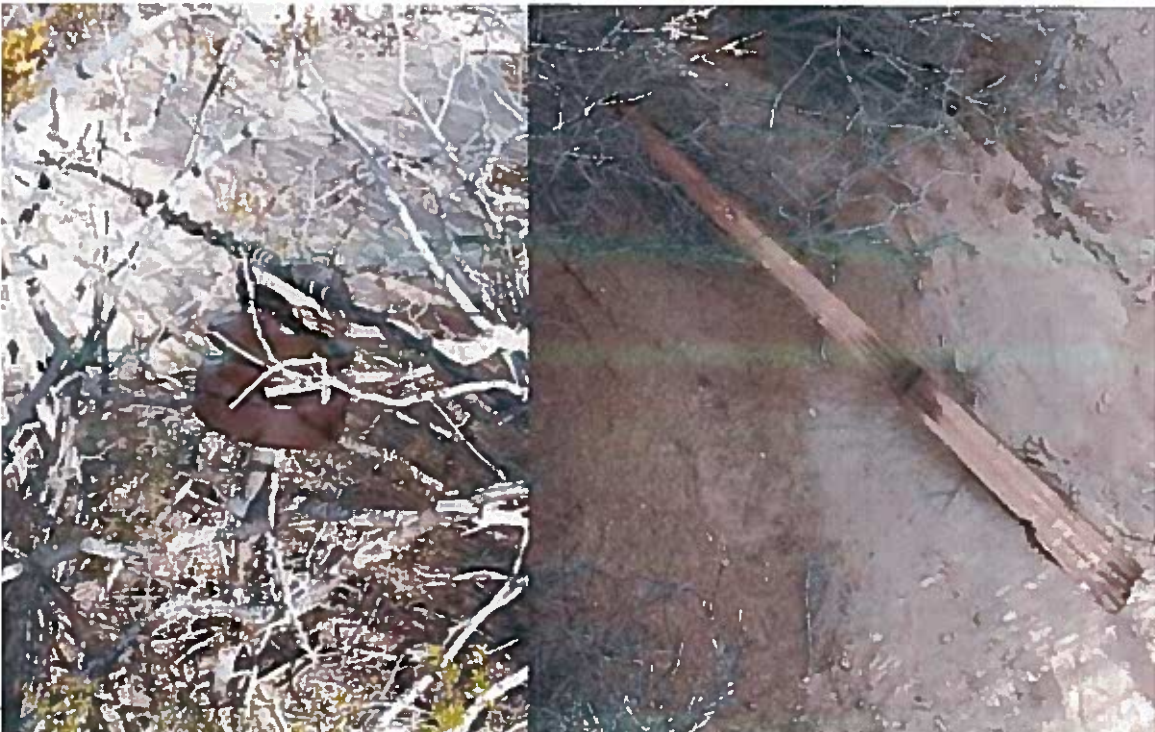
Figure 2. The left and right images show the insulator and crossarm that were supported on pole number 43502S.

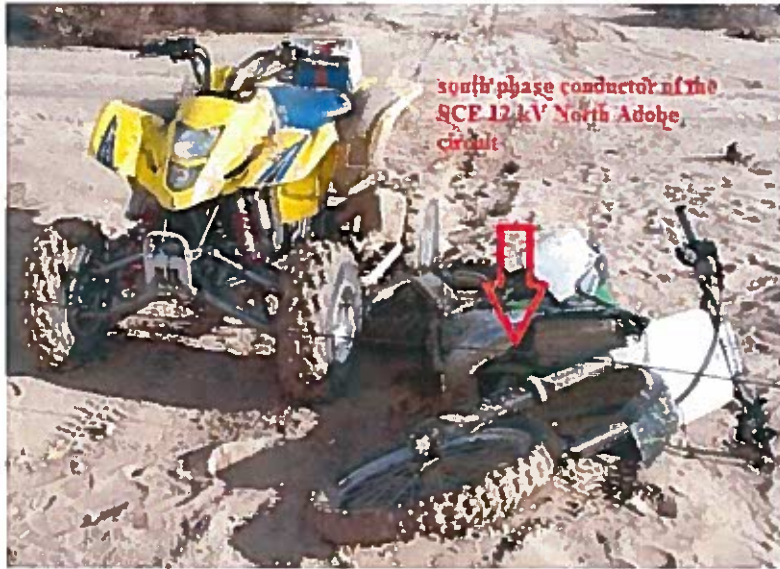
Figure 3. The south phase conductor of the SCE 12 kV North Adobe circuit was found on top of a motorcycle.

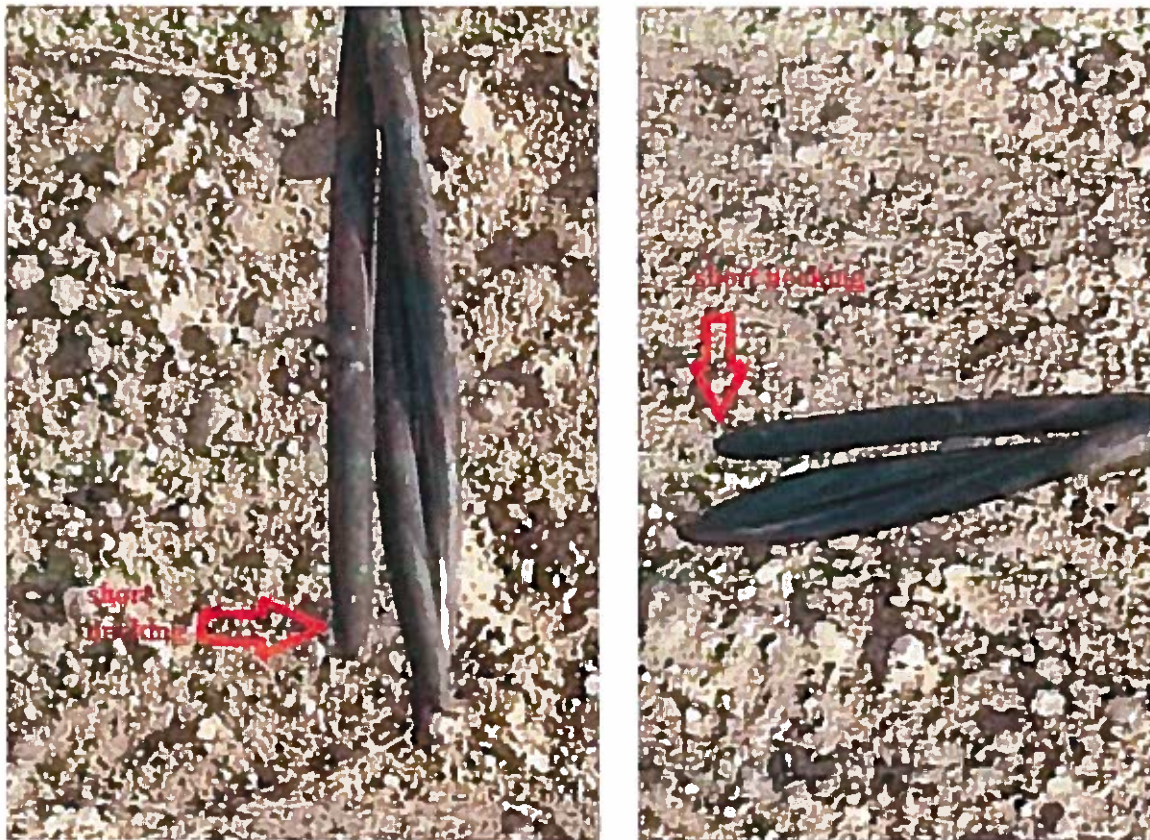
Figure 4. After the incident, the south phase conductor of the SCE 12 kV North Adobe circuit was found broken into two pieces and lying on the ground. The broken ends of the conductor exhibit short necking.

2. Pole number 43502S exhibited several fresh scratches on the face of the pole at 4.8 feet, 6.6 feet, and 8 feet from the ground (see Figure 6).
3. The two broken ends of the conductor exhibited signs of necking, which may indicate that the conductor broke due to tension. This is consistent with [REDACTED] striking the conductor, and the force of the collision may have pulled apart the conductor.

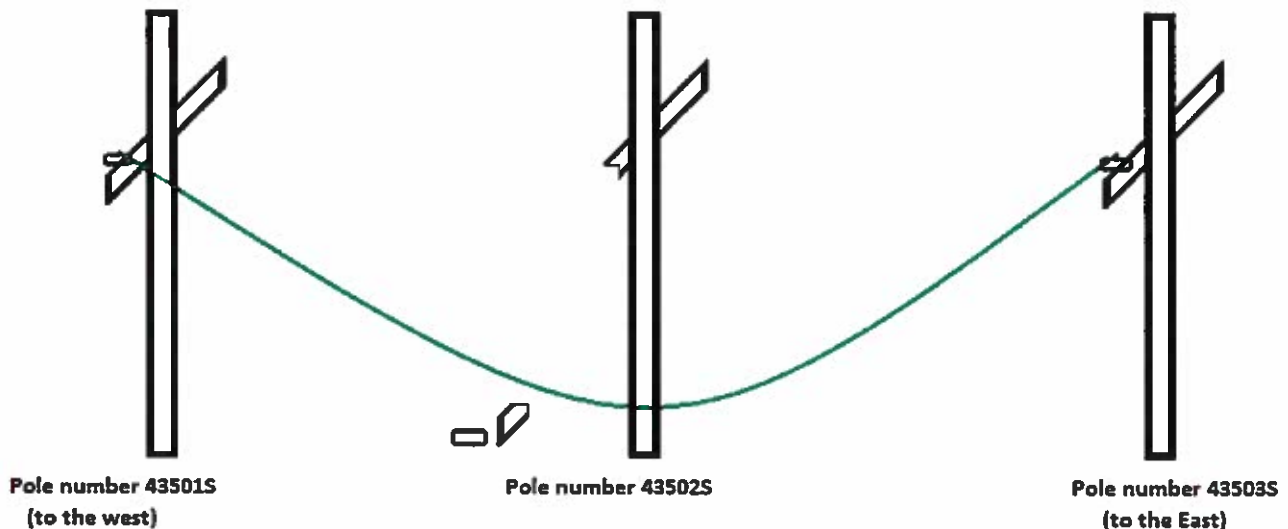
Figure 5: Configuration of SCE facilities just prior to the incident. The crossarm on Pole number 43502S was broken, causing the south conductor to be supported by Poles numbered 43501S and 43503S.

Based on the evidence, Staff concludes that it is likely that prior to the incident, the crossarm on pole number 43502S broke, causing the south phase conductor of the subject branch of the SCE 12 kV North Adobe circuit – which was supported on the aforementioned pole – to become supported by poles numbered 43501S and 43503S. This caused the conductor’s ground clearance as shown in figure 5 to be reduced to less than 8 feet.

thoroughfares in rural districts or across other areas capable of being traversed by vehicles or agricultural equipment to maintain a minimum ground clearance of 25 feet. At the time of the incident, the SCE overhead conductor had an above ground clearance less than 8 feet, which is less than the GO 95 minimum requirement of 25 feet. Therefore, SCE is in violation of GO 95, Rule 37 for failing to ensure that its 12 kV overhead conductor maintained at least a 25 foot ground clearance above a thoroughfare capable of being traversed by vehicles.

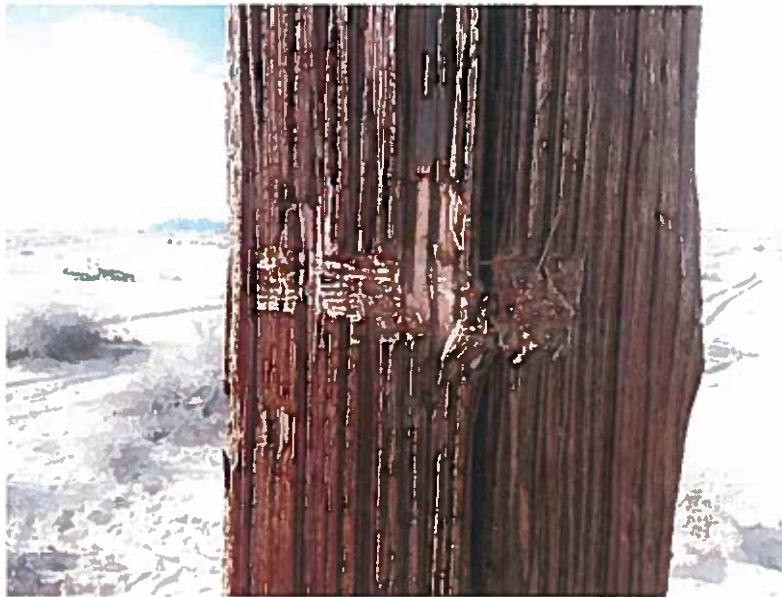
Figure 6: A scratch mark on Pole number 43502S.
