# Confidential Incident Investigation Report

## Incident Investigation Report

**Incident Number:** E20151018-01

**Location of the Incident:** Moss Landing Substation, Moss Landing  
County: Monterey

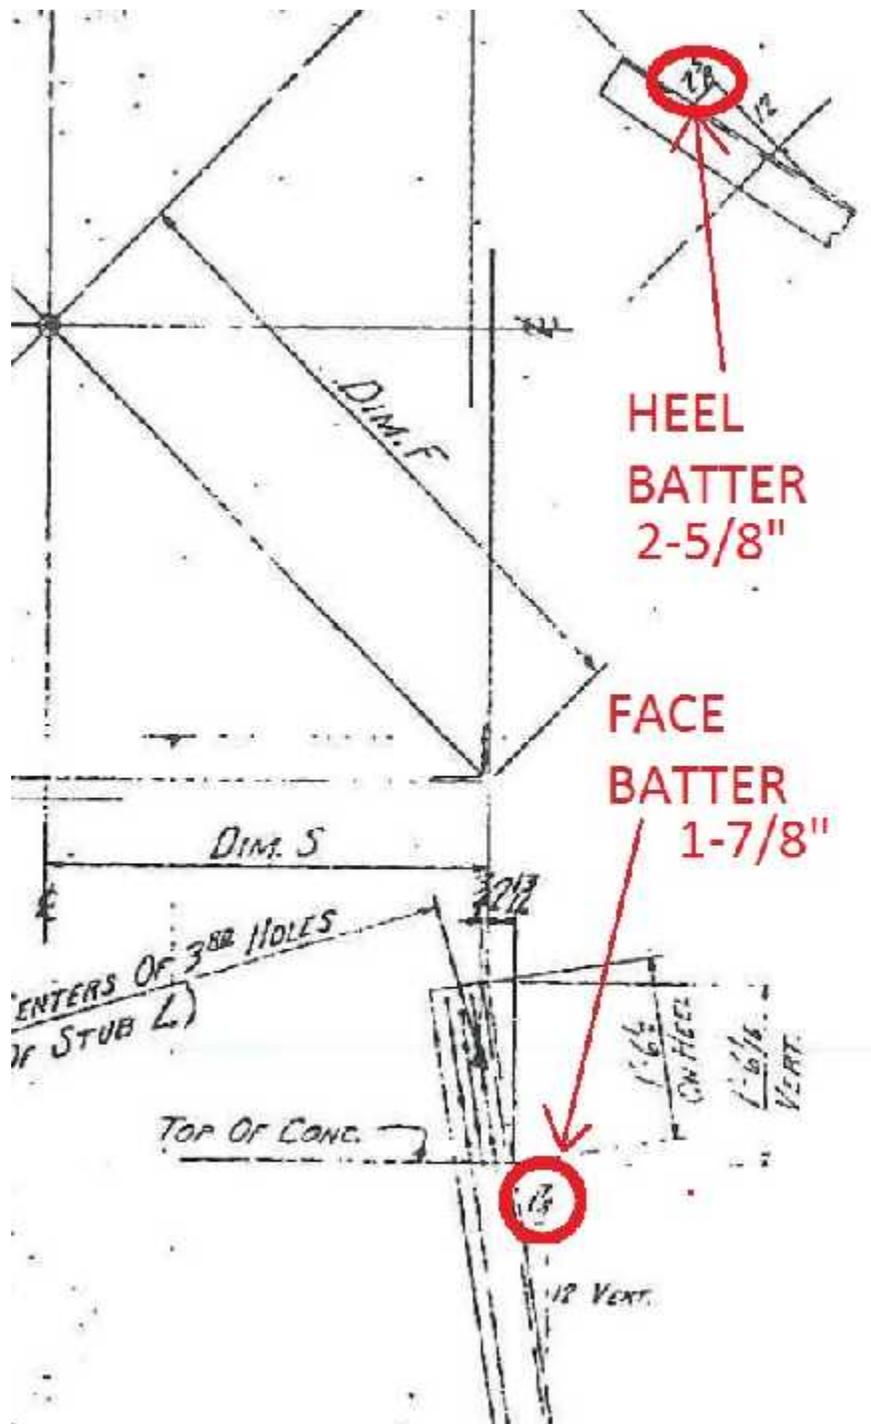
Figure 5 – Heel batter vs. face batter

Record 621915 had two batter dimensions for the concrete footing and stub angles (collectively referred to as “foundation stubs”): the “heel batter” and the “face batter.” The heel batter had a lower slope – 2-5/8 inch by 12-inch – while the face batter had a higher slope – 1-7/8 inch by 12-inch (see Figure 5). The batter board is supposed to be crafted based on the heel batter and not the face batter.

On February, 18, 2016, ██████████ indicated to Staff that he recalled ██████████ instructing ██████████ to make a “1-7/8-inch batter board”; instead of “2-5/8-inch”<sup>4</sup> as prescribed by PG&E’s Record 621915.

On March 3, 2016, ██████████ indicated to the Staff that although he had no recollection of doing so, he believed that he might have mistaken the face batter with the heel batter on the same drawing, and provided the mistaken dimension to ██████████ in making the batter board.

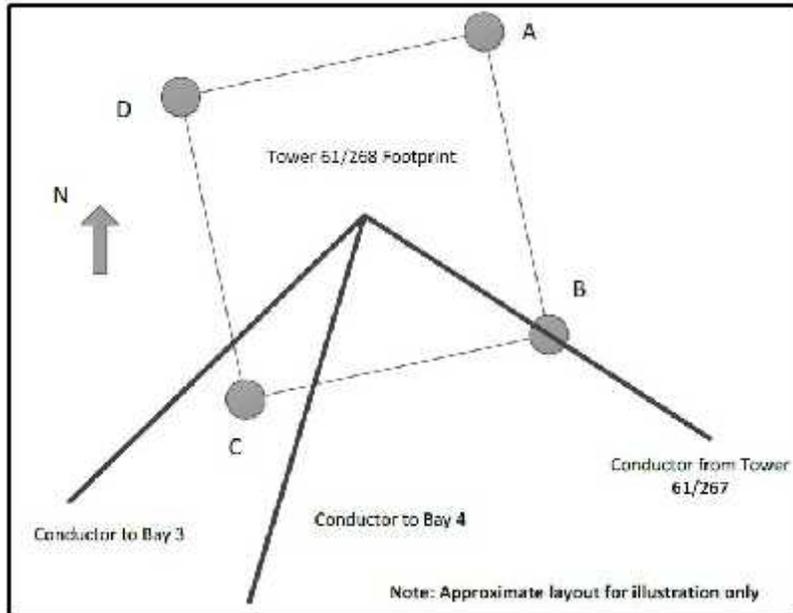
Figure 8 – Tower Legs Identification

While connecting the horizontal stringer between Legs D and A (the last side of the tower to be laced), [REDACTED] saw a gap of two to four inches between the two legs and stringer (see Figure 8 and 9). Due to the significant gap, the crew was not able to

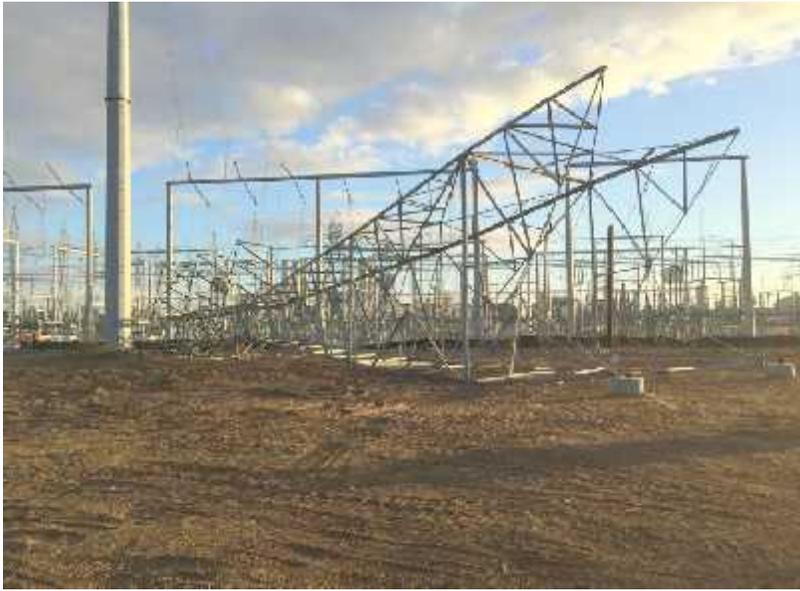
Figure 11 – Collapsed Tower 61/268

On October 18, 2015 at 0700 hours, a Dynegy employee from the adjacent Moss Landing Power Plant noted Tower 61/128 collapsed and immediately notified PG&E (see Figure 11). PG&E reported the incident to CPUC at 0909 hours. Service to 55,000 customers was affected and restored by 2359 hours on the same day.

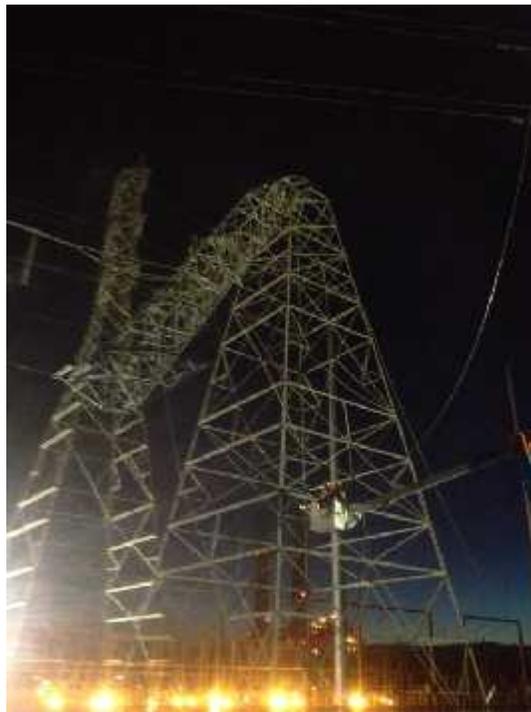
Figure 12 – Buckled Tower 61/267

Besides the collapsed Tower 61/268, the adjacent Tower 61/267 buckled at its midsection due to longitudinal load imbalance from the collapsed tower (see Figure 12). Following the incident, PG&E inspected Tower 61/267 and determined it was not the source of failure. Tower 61/267 was later repaired and put back in service.

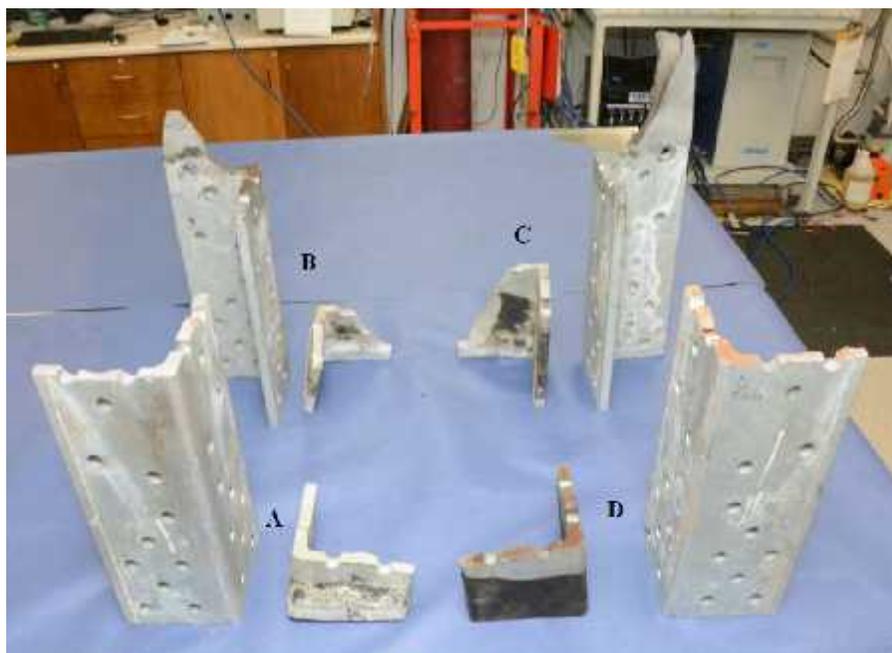
Figure 13 – Stub A through D

On October 21, 2015, Staff visited the lab where the stubs were being materially analyzed and noticed that Stub D and Stub B had rust on their cracked surface (see Figure 13). This suggests that sometime after the tower was installed, a stress fracture occurred on Stub D and Stub B. This stress fracture could have been caused by the bending moment created when the tower leg was forcefully aligned and bolted onto the foundation stub.

PG&E's first Tower Collapse Direct-Cause Analysis report, dated December 31, 2015, concluded that the tower collapsed due to all four foundation stubs not being aligned properly as indicated in the design plans. The stubs were designed to have a heel batter of 2-5/8 inches by 12-inches, but the as-measured heel batter was 1-5/8 inches by 12

inches for Stubs B, C and D, and 1-6/8 inches by 12 inches for Stub A<sup>3</sup>. Thus, the foundation stubs were misaligned.

As a result of the misaligned stubs, the attached tower legs did not fit well with other components of the 17-5-foot tower body extension during assembly. In order to close the gaps, the PG&E crew connected the tower segments by force fit; in doing so, the tower legs produced bending moments in the stub angles which exceeded their stress limits, eventually cracked, and caused tower to collapse.
