**Enclosure 3 – PG&E Moss Landing Tower Collapse Root
Cause Analysis**

**Moss Landing Tower Collapse
Root Cause Analysis**

Prepared for

April 4, 2016

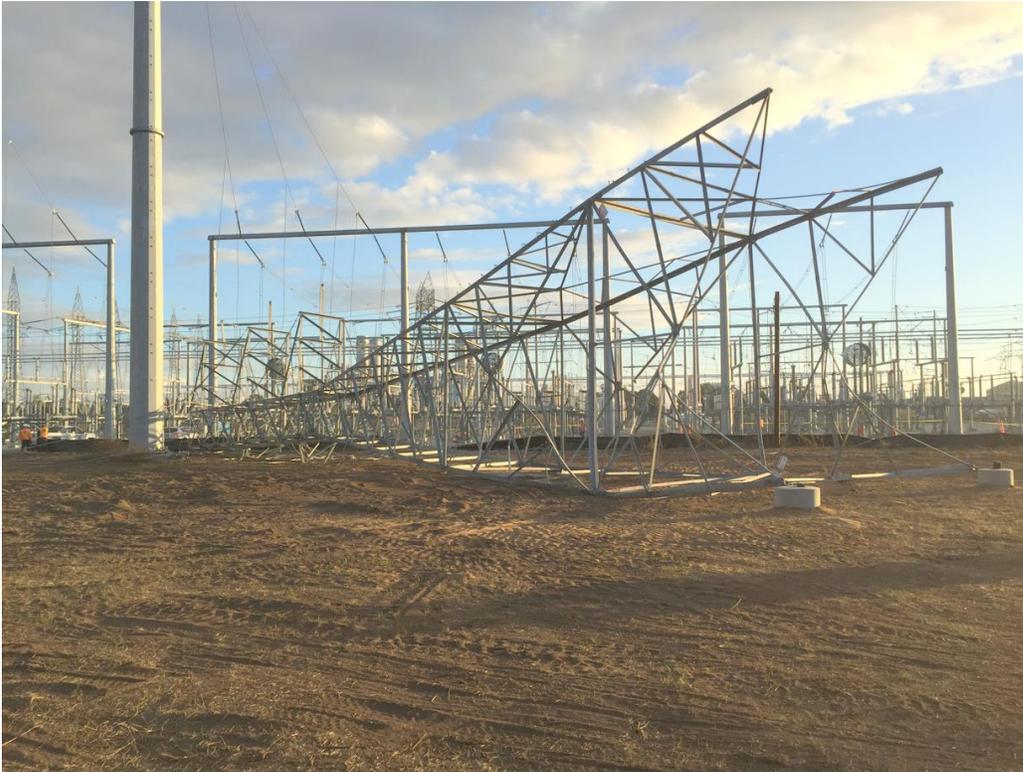
Figure 1: Moss Landing Tower Collapse Site Photo

The tower collapse occurred on October 15, 2015 and Figure 1 shows a photograph of the site shortly after the tower collapse.⁷

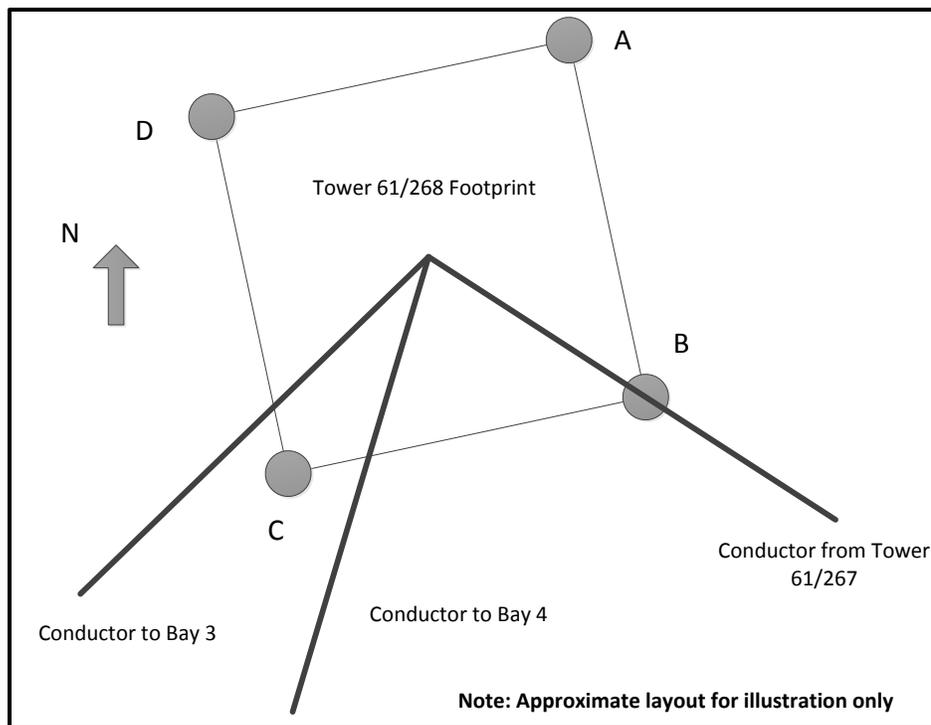
Figure 2: Tower Foundation Layout and Conductor Location

The subject tower supported two circuits designated as Metcalf – Moss Landing 1 and Metcalf – Moss Landing 2. Both circuits made an approximately 90 degree angle at the tower, resulting in a net overturning load to the southeast⁸. Figure 2 shows the foundation layout of the tower and the location of the conductors for illustrative purposes. The tower toppled to the southeast after failure of the stub angles. The stub angles at legs B and D exhibited corroded fracture surfaces at the time of collapse, indicating that these developed cracks prior to the tower collapse⁹. The stub angles at legs A and C showed no signs of corrosion, indicating that they most likely failed at the time of the collapse.

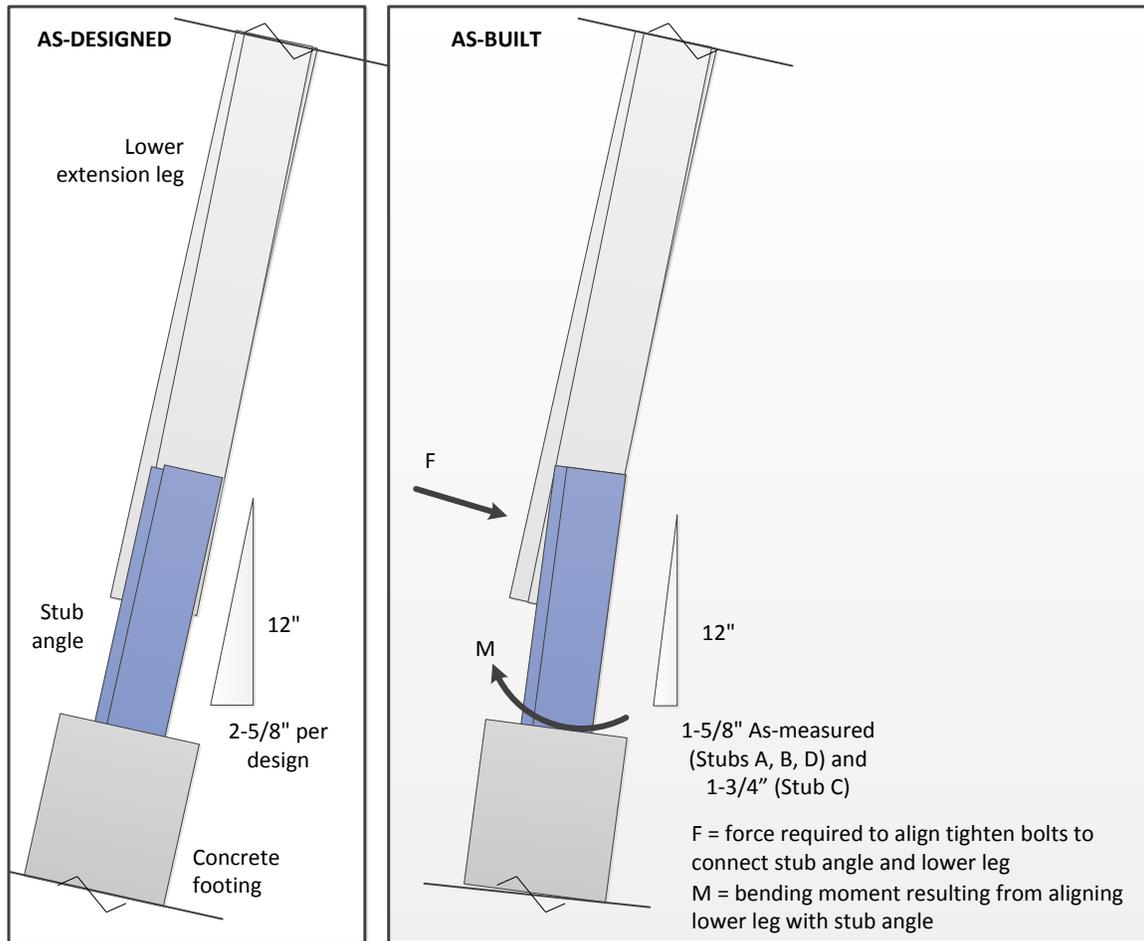
Figure 3: Stub Angle – Lower Tower Leg Orientation (for illustrative purposes only)

- Based on measurements made of the foundations after the accident, the stub angles were not oriented correctly at the time of construction. Rather than being tilted to match the sloped tower legs, the stub angles were installed with insufficient batter (angle). The correct heel batter angle is $2\text{-}5/8^{\circ}$ ¹¹. The as-built (as-measured) heel batter of the foundation stub angles was too steep relative to the design drawings, and as such, the top of any tower leg bolted to them would have been significantly outboard of its intended position.¹² Figure 3 provides an illustration of this condition.

The “as-designed” requirements for the stub angles is that the lower legs and stub angles are parallel (as shown in the left graphic in Figure 3) such that there is no lateral force (F) or bending moment (M) on the stub angle. The “as-built” configuration measured in the field after the tower failure showed that the stub angle and lower leg were out-of-alignment (as shown in the right graphic in Figure 3). When the bolts were tightened to

¹² Reference 1: Exponent Failure Analysis Report. The as-measured heel batter was $1\text{-}5/8^{\circ}$ for three of the stub angles. The fourth stub angle was measured at $1\text{-}3/4^{\circ}$.

bring these components together, this produced bending moments in the stub angles which exceeded the stress limits in the stub angle material and resulted in the failure as identified in Reference 1.

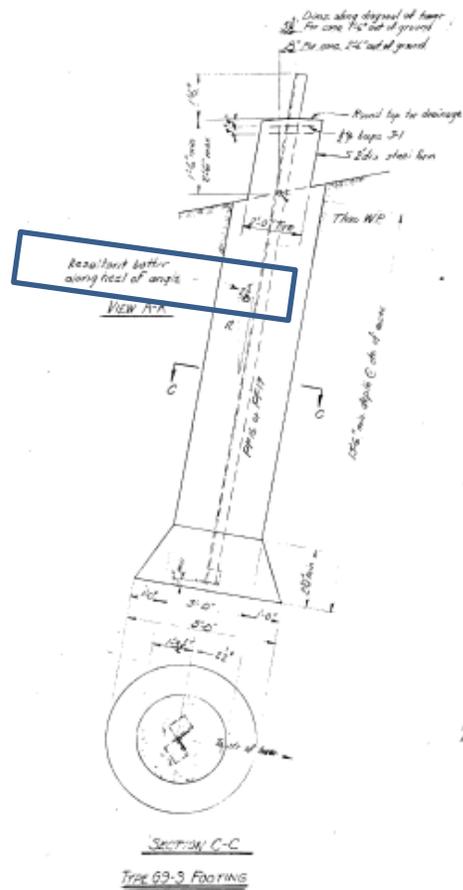
Figure 5: Heel Batter Designation from Drawing 313438

The structural data sheet references structural drawing 403912 for the G95 tower. This drawing and the structural data sheet references drawing 309933 for the foundations. This drawing references drawing 313438 and Rec. 621915 for additional foundation and stub angle details. The correct heel batter is indicated in Section C-C of drawing 313438. The heel batter is indicated as 2-5/8" per 12". The crew foreman indicated that he did not use this drawing for determination of the heel batter, but used the referenced Rec. 621915 for the heel batter determination. Figure 5 below shows the heel batter designation from drawing 313438.

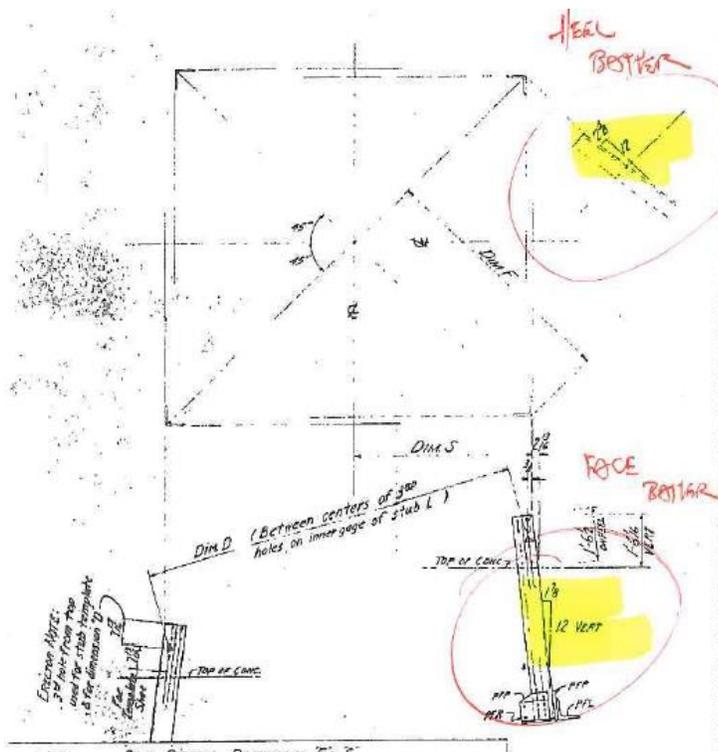
Figure 6: Stub Batter Angles from Rec. 621915

Note 4: (Finding) Misread required batter from Rec. 621915 and miscommunicated to crew

Rec. 621915 is provided for additional foundation and stub angle details. The correct heel batter is indicated in Section C-C of drawing 313438 and also in the diagram in the top right of Rec. 621915. The heel batter is indicated as 2-5/8” per 12”. There is additional information in the diagram in the top right of Rec. 621915 that shows both a face batter and a heel batter, but with no specific identifier (“heel” or “face”) next to the values. Discussions with the crew indicated that the foreman miscommunicated the heel batter to the crew for use in setting the footings and stub angle.^{29,30} The information from Rec. 621915 is shown in Figure 6 below. This incorrect heel batter angle led to a condition which introduced excessive stress on the stub angle (see Note 8 later).

- During the review of the job package, the foreman indicated that he misread the heel batter inclination on Rec 621915. Additionally, drawing 313438 was not used to determine the heel batter. These actions for ineffective review were caused by inadequate training, relative to transferring design information into the construction plan for the footing set-up. The inadequate training is caused because there is no formal training program for the construction crews on interpreting the design-related information to construction. Currently, on-the-job training is relied upon for transferring knowledge to the crew. This approach may have been effective in the past, but there are fewer towers being constructed today, and the on-the-job training approach may no longer be sufficient. The lack of a formal training program is caused by inadequate program design to identify the need for formal training of the crew, relative to understanding and interpreting the design drawings for construction.

- A lack of clarity and confusing information in the construction drawing (Rec. 621915) also resulted in the misreading of the tower design drawing³⁹. This is caused by the use of legacy drawings (dating from the 1960's). The legacy tower drawings may not reflect the current needs of crews who perform the tower installations on an infrequent basis. The lack of drawing clarity results from

CC2: Inadequate maintenance (update) of drawings relative to legacy tower drawings may not reflect the current needs of crews who perform the tower installations on an infrequent basis	<p>Update tower drawings to ensure legibility and more accurate information (especially related to stub angle measurements)</p> <p>Evaluate the need to create project specific drawings relative to current generic drawing approach</p>
CC3: Inadequate process design relative to training requirements for tower drawings on dimensional tolerances and potential field issue	See CC1 recommended actions
