## PUBLIC UTILITIES COMMISSION

SA2019-828

**SUBJECT:** Substation Audit of PG&E Moss Landing

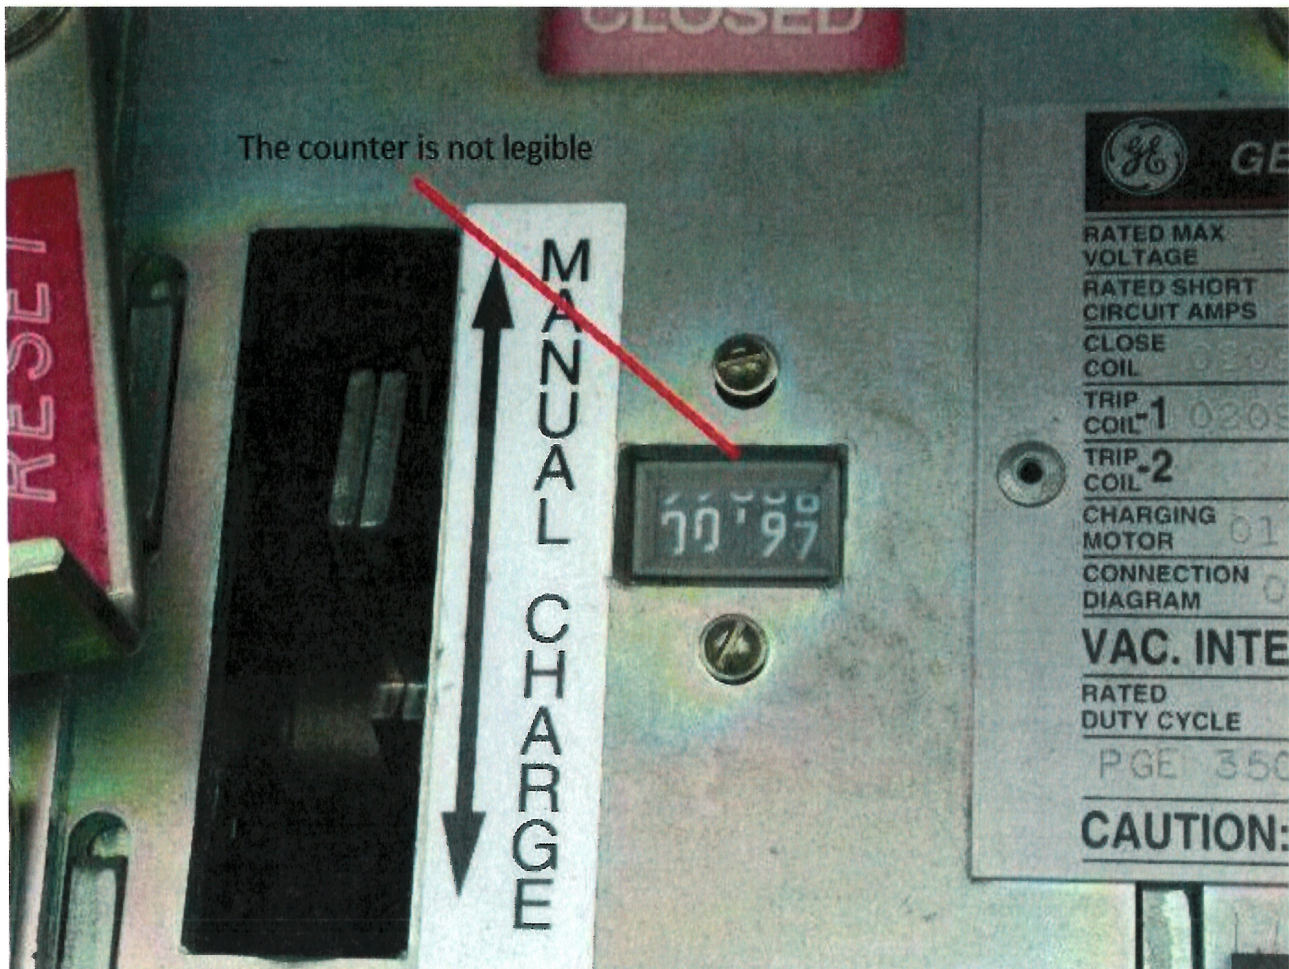
1. The counter on Circuit Breaker 1106 was worn out and not legible.

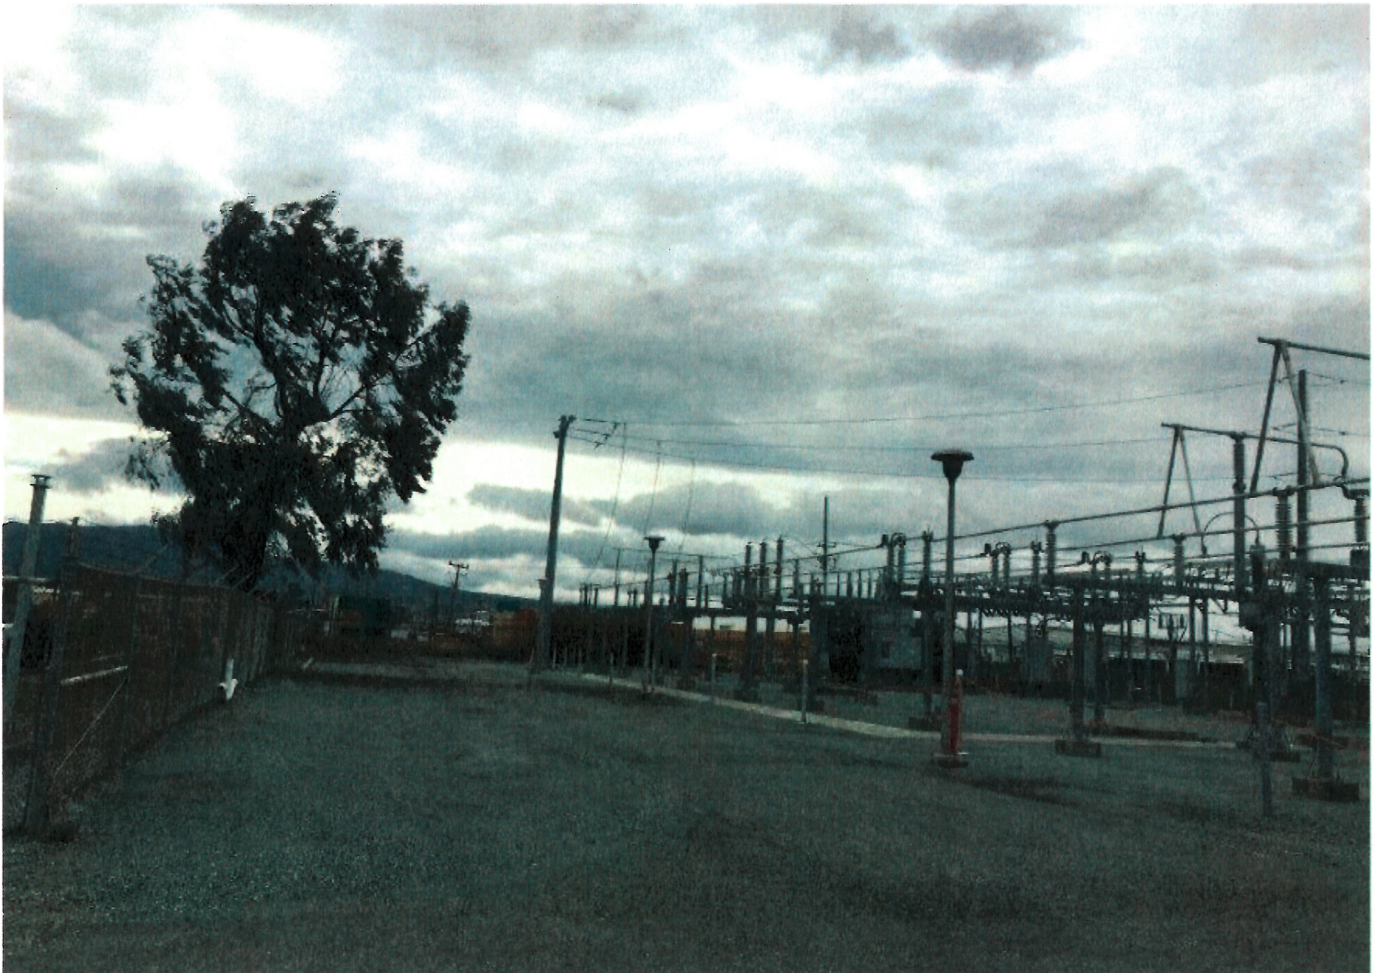
2. A tree's branches overhang into the Buena Vista Substation yard and are a potential risk to PG&E's substation electrical facilities.

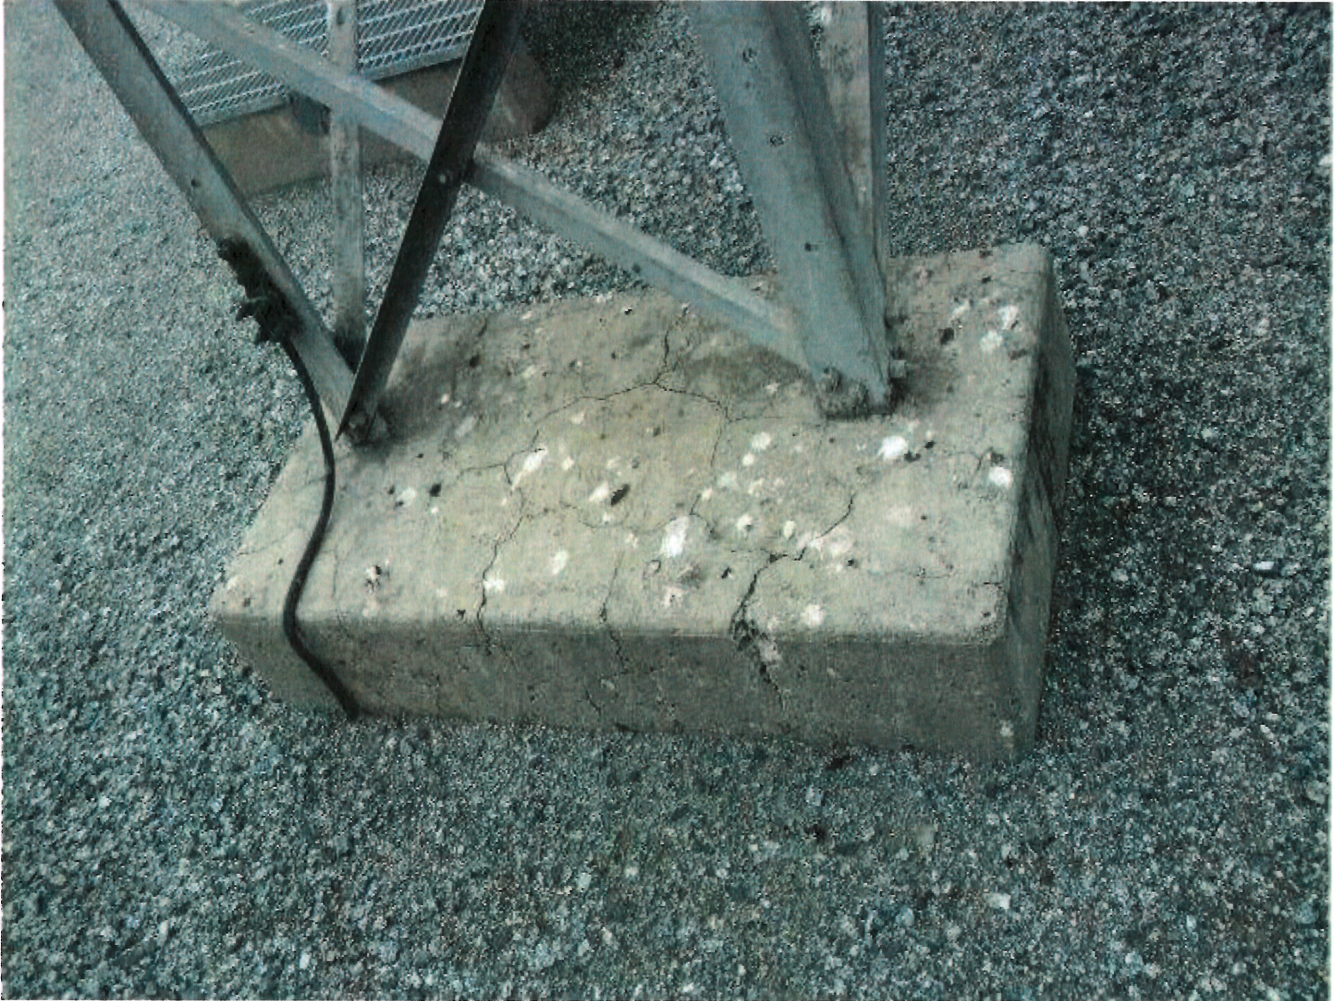
Salinas Substation

- ESRB observed cracks on Transformer Bank 4's concrete foundation.

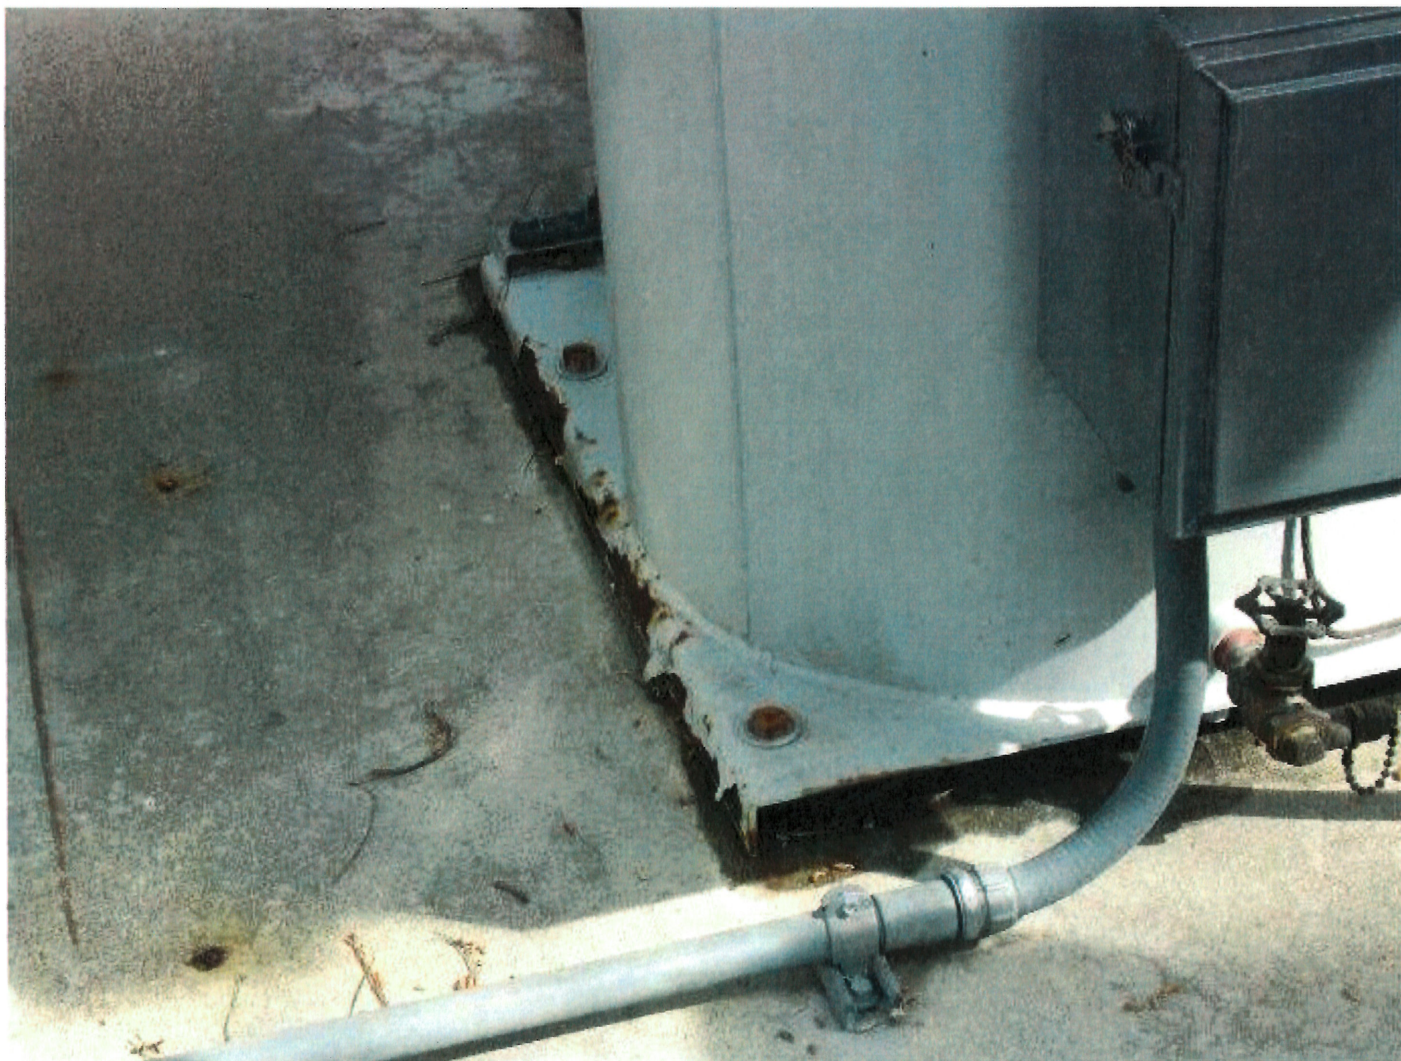
Hatton Substation

- ESRB observed atmospheric corrosion at the base of the Regulator #1 B-phase.

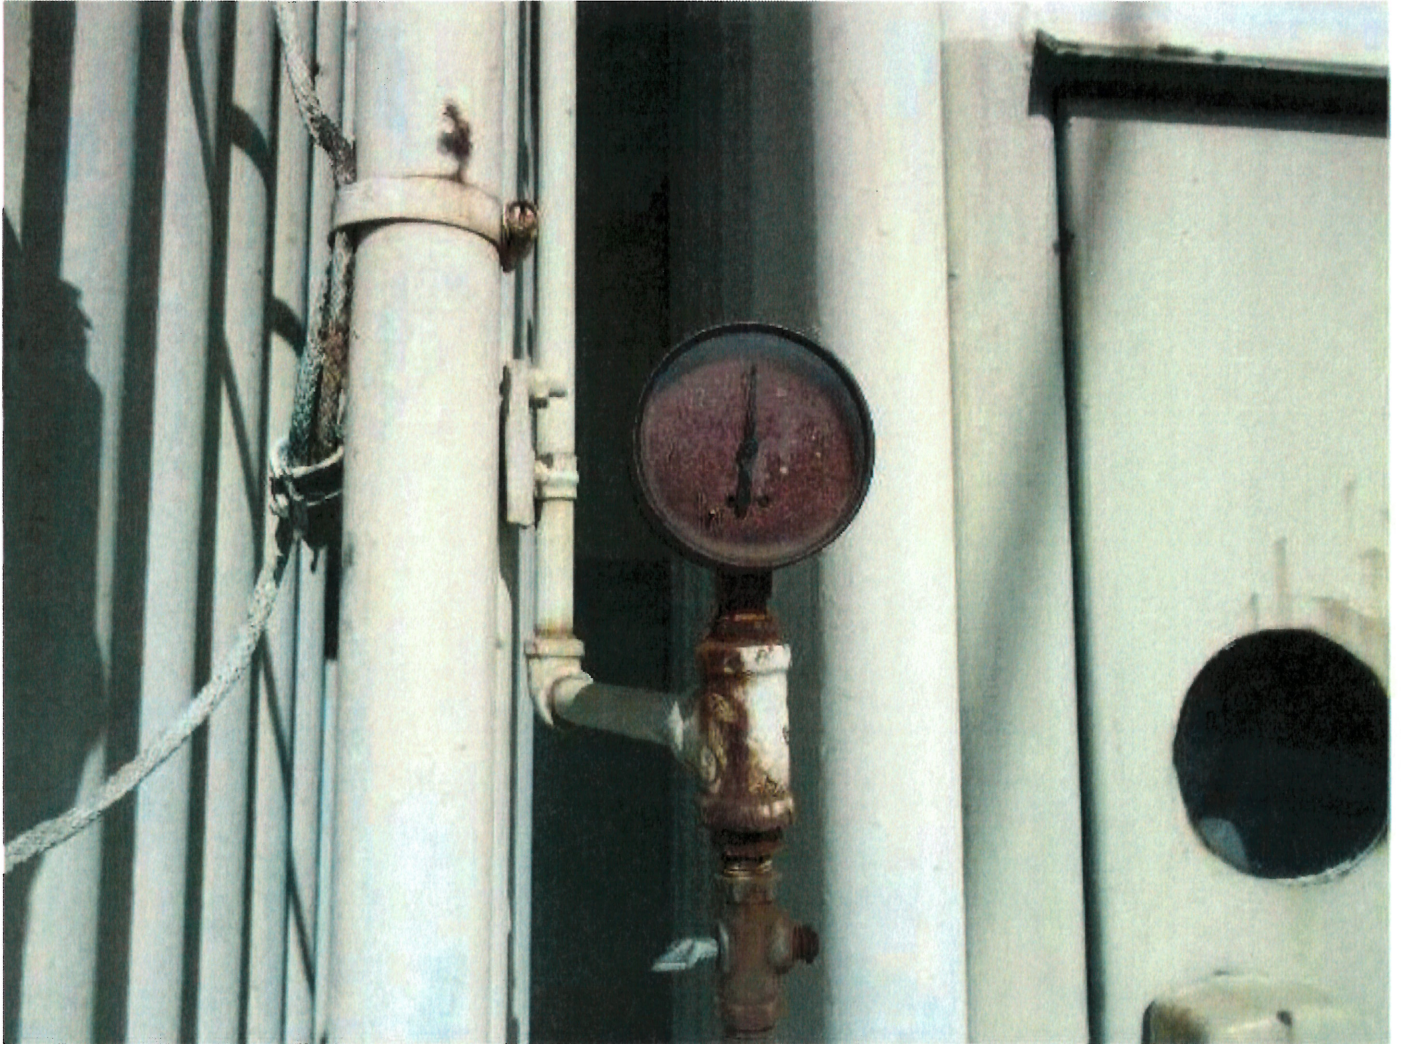
Erta Substation

- Transformer #2 internal pressure gauge is illegible.

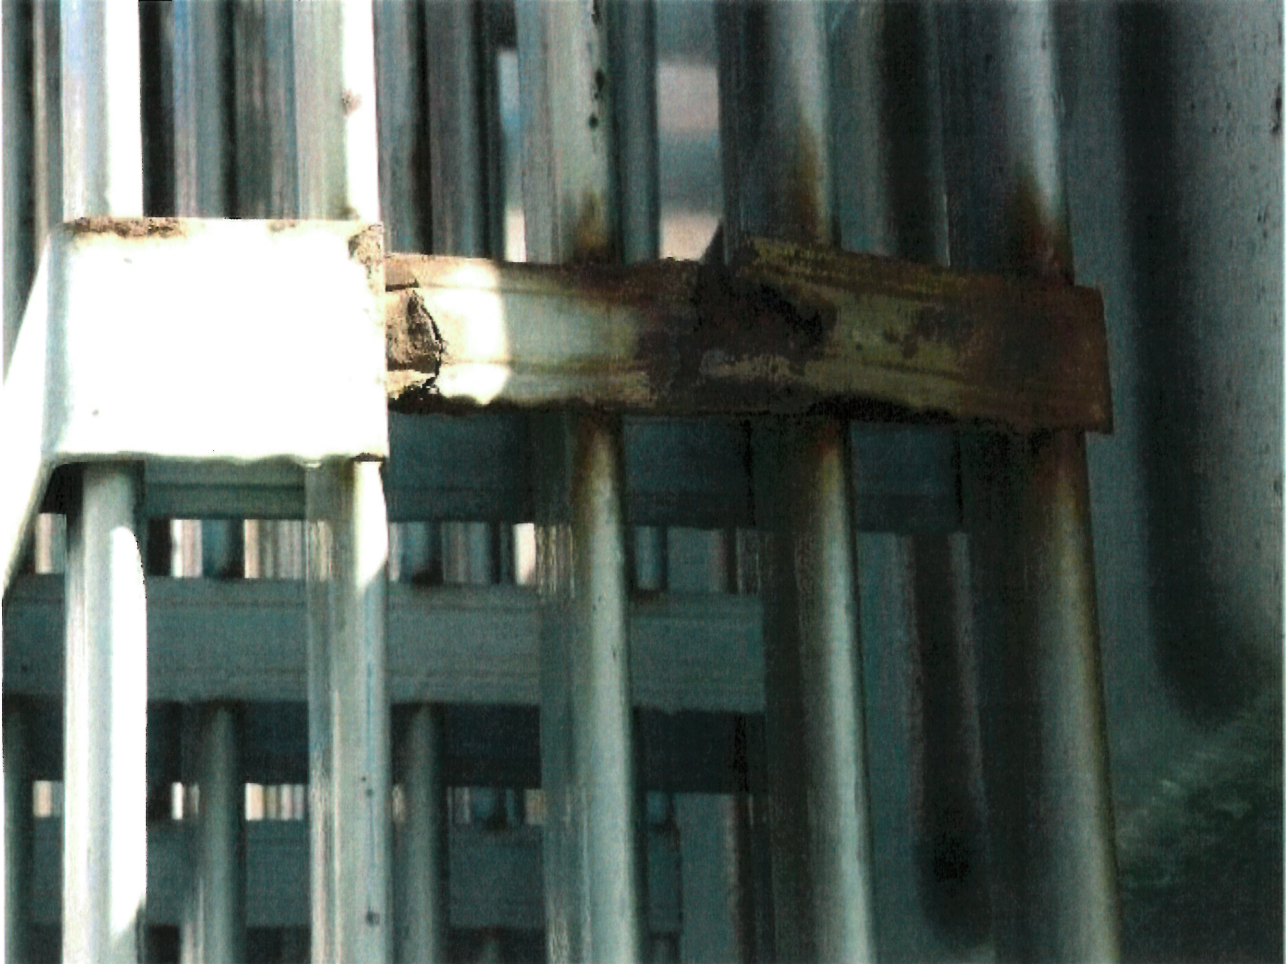
Watsonville Substation

- ESRB observed atmospheric corrosion and deterioration on one of Bank 3's radiator fin brackets.

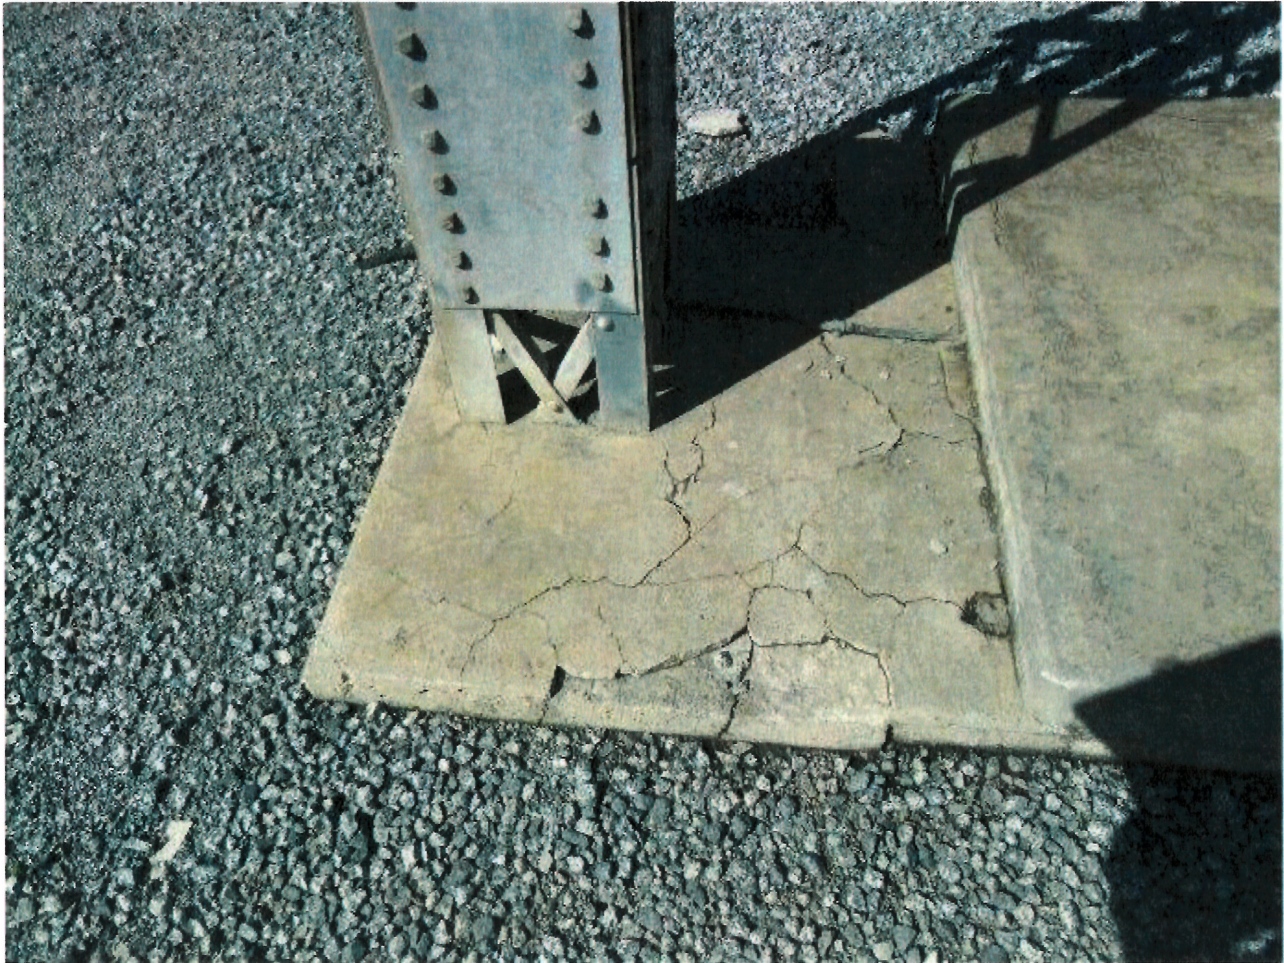
- ESRB observed cracks and deterioration on Circuit Breaker 2101's structural foundation.

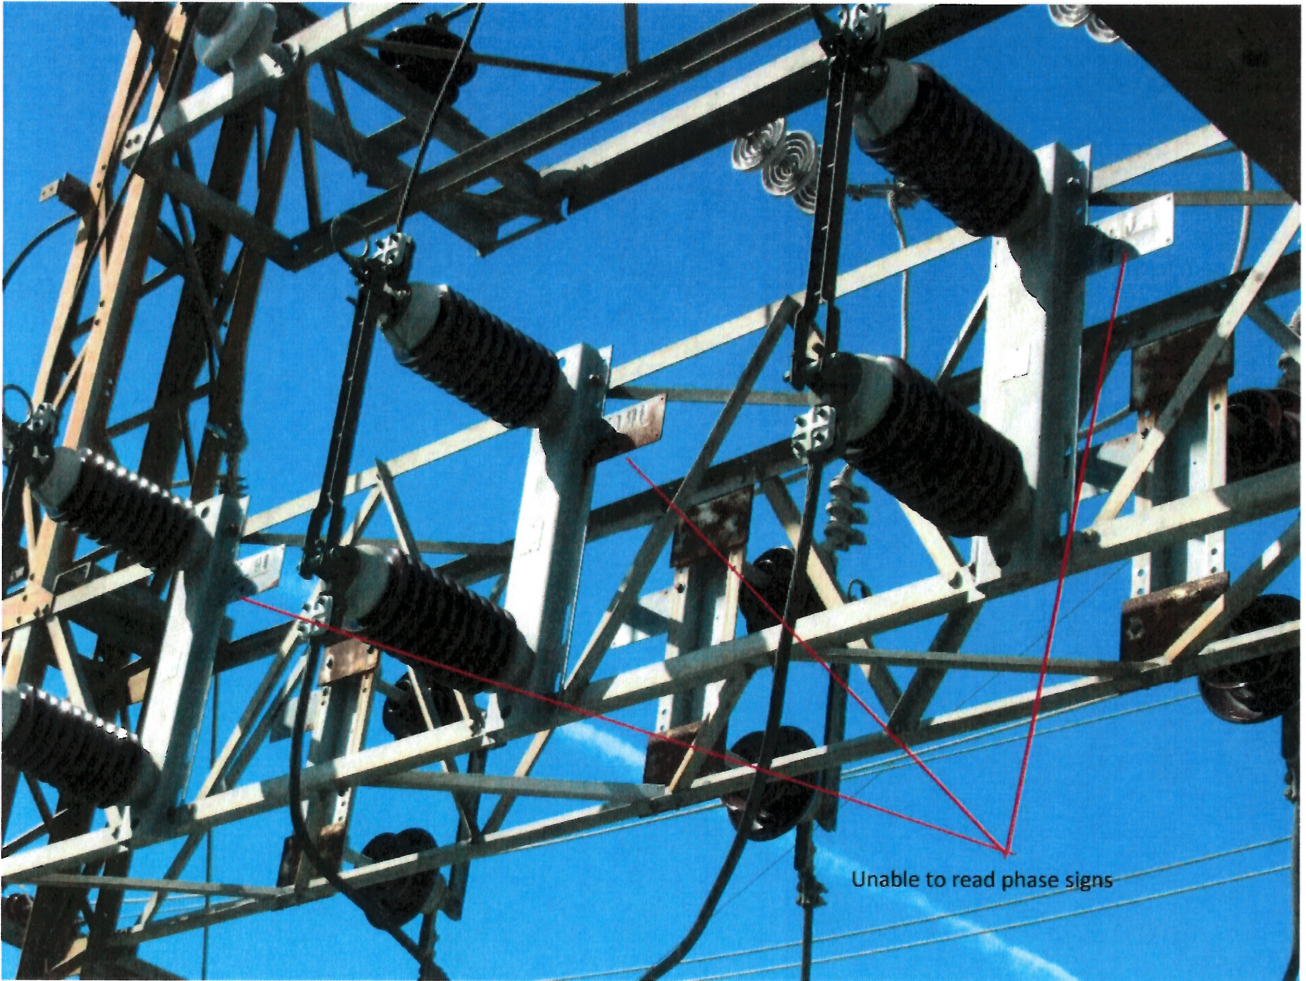
- The signs which indicate the phases on Circuit Breaker 2101 are illegible.
