SA2020-854

SUBJECT: Field Inspection Findings – PG&E’s San Carlos Headquarters Substation Audit

**CPUC FIELD AUDIT FINDINGS OF
PG&E SAN CARLOS SUBSTATION HEADQUARTERS
OCTOBER 12 - 15, 2020**

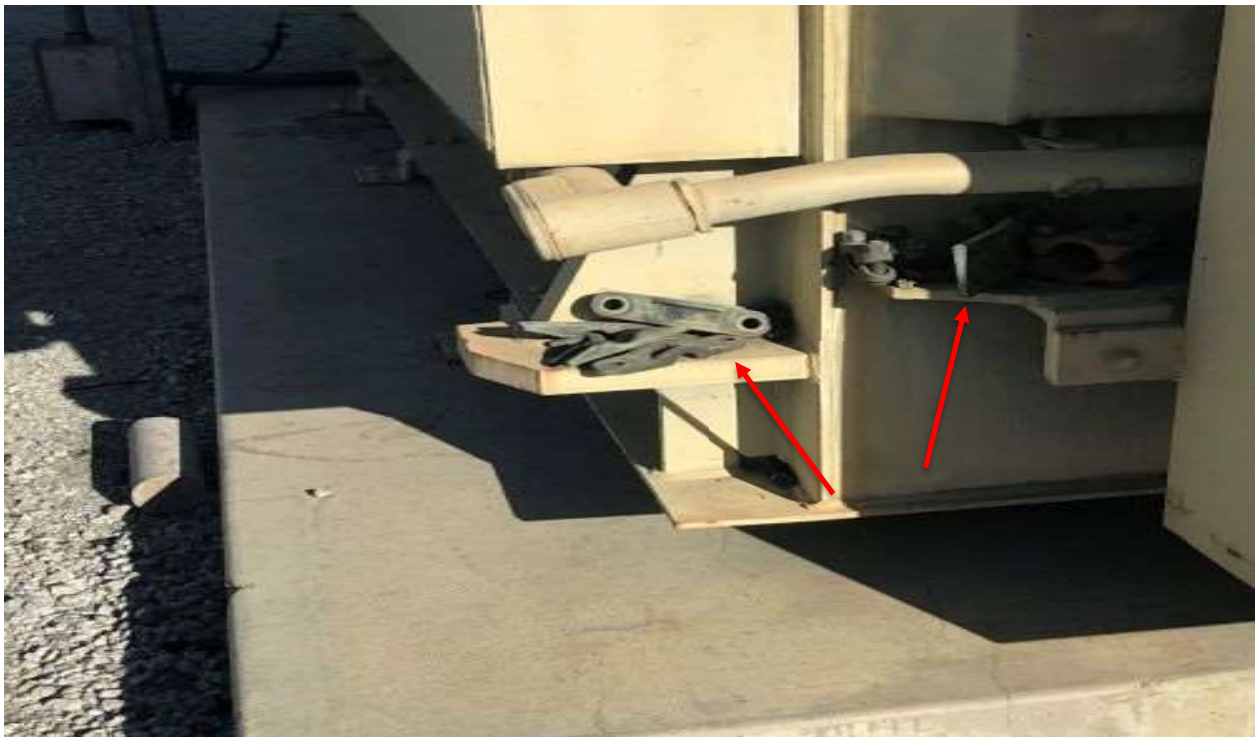
- 1.1. Potential oil leaks on the radiator for Transformer Bank #1.
- 1.2. A high insulator/bushing oil level on Transformer Bank #4.
- 1.3. Housekeeping issues: Equipment parts left lying around at Transformer Bank #2.
(Figures 1 and 2)

Figure 1: Parts left around Transformer Bank #2.

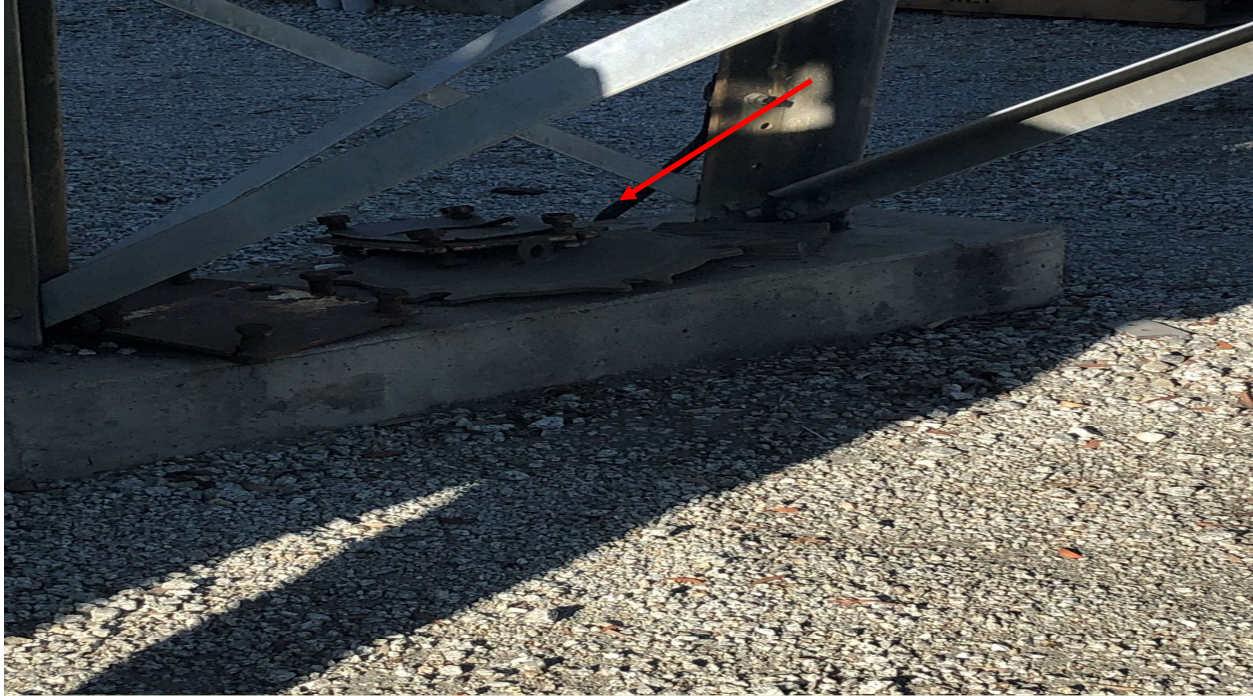
Figure 2: Parts left under Transformer Bank #2.

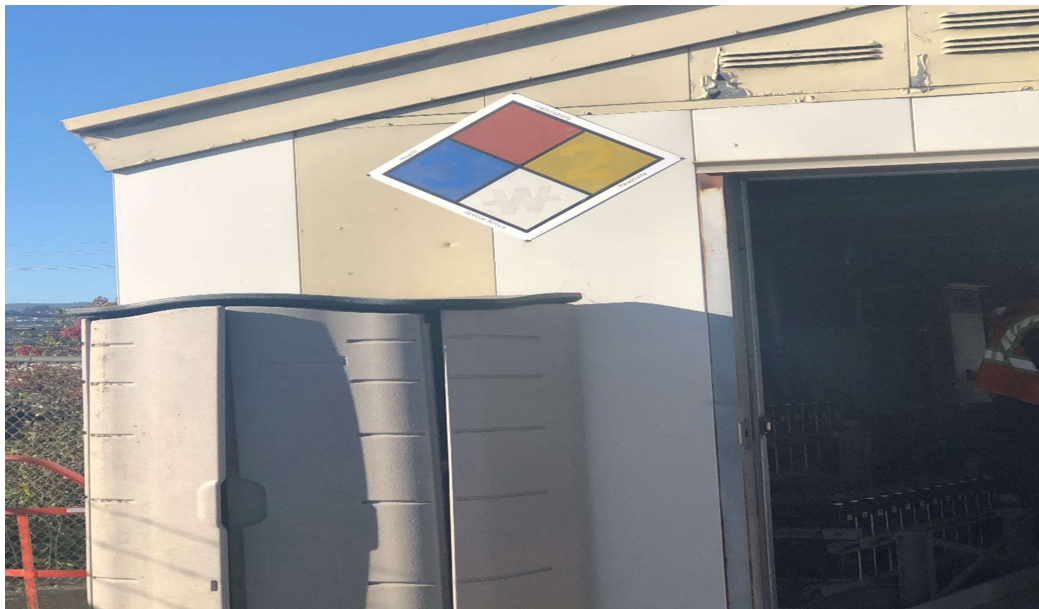
1.4. The National Fire Protection Association (NFPA) 704 Diamond on one of the control room entrances was faded and no longer legible. (Figure 3)

Figure 3: Faded NFPA diamond.

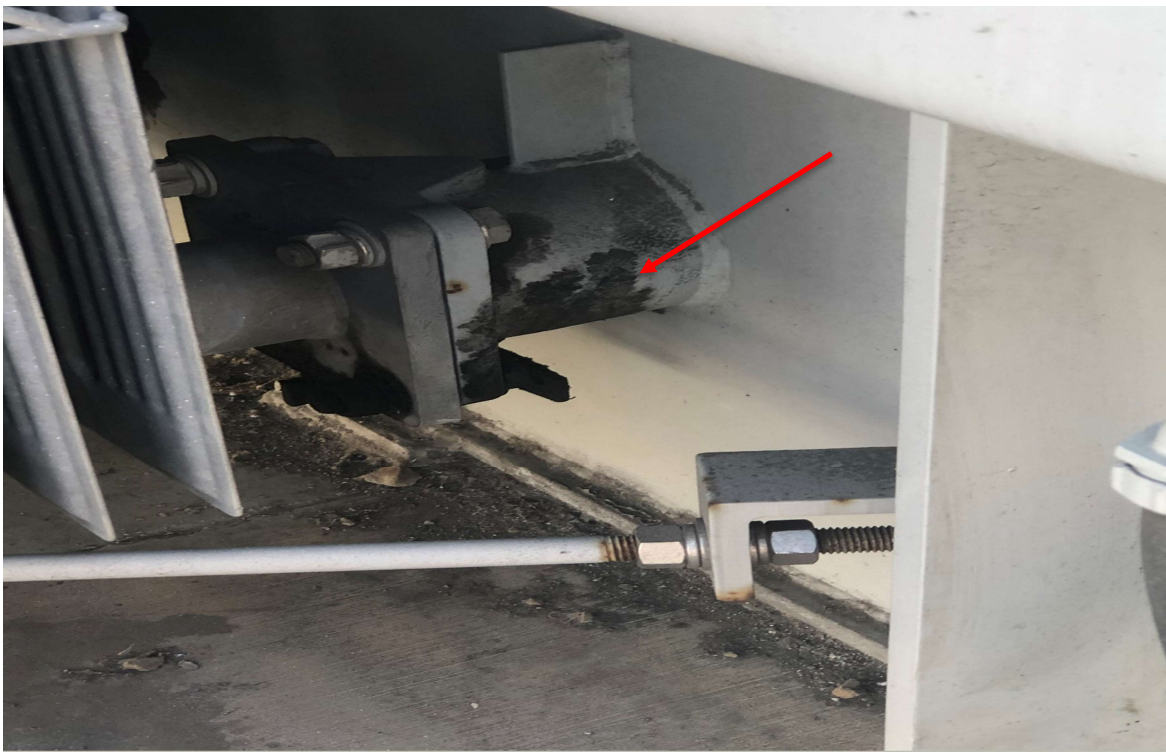
2.3. Potential oil weeps at the radiator flanges of 3-phase transformer Banks #1, #2, and #3. (Figure 4)

Figure 4: Example of oil weep at flange of one of the Transformer Banks.

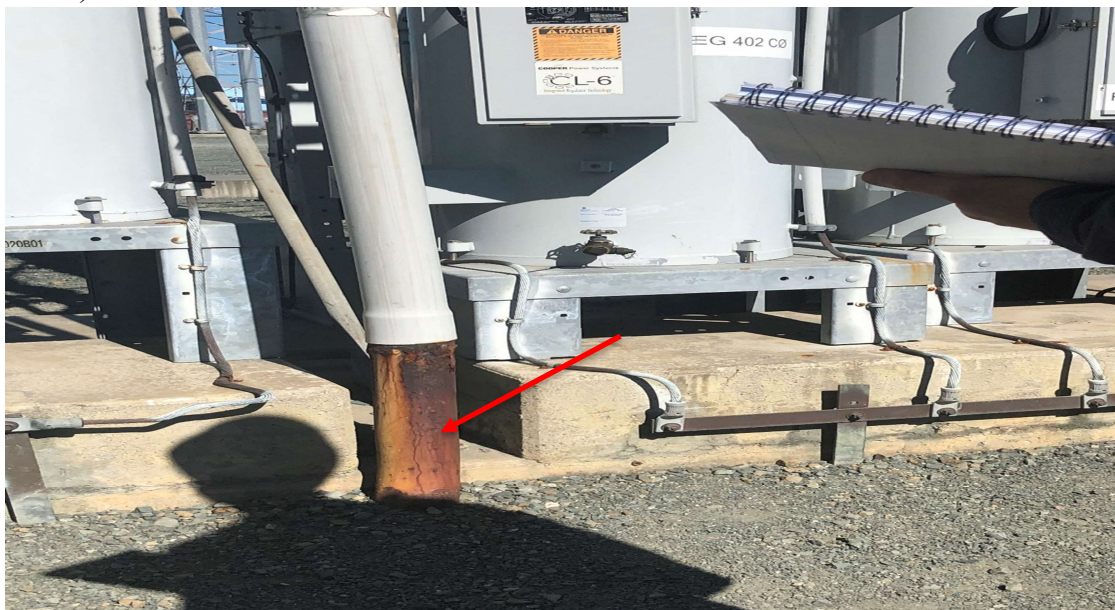
2.4. Atmospheric corrosion at the base of a conduit by the C-Phase Regulator #401. (Figure 5)

Figure 5: Atmospheric corrosion on the conduit supporting Regulator #401.

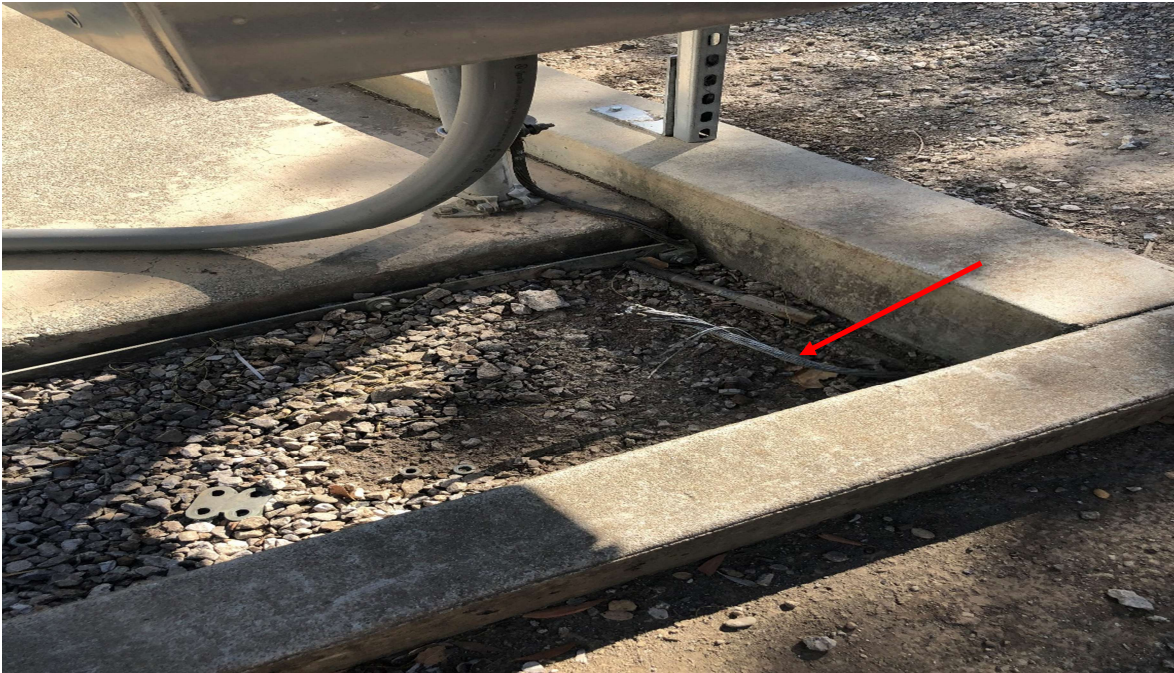
3.1. An abandoned ground wire protruding from the ground near distribution Circuit Breaker #405. (Figure 6)

Figure 6: Abandoned ground wire protruding from the ground near Circuit Breaker #405.

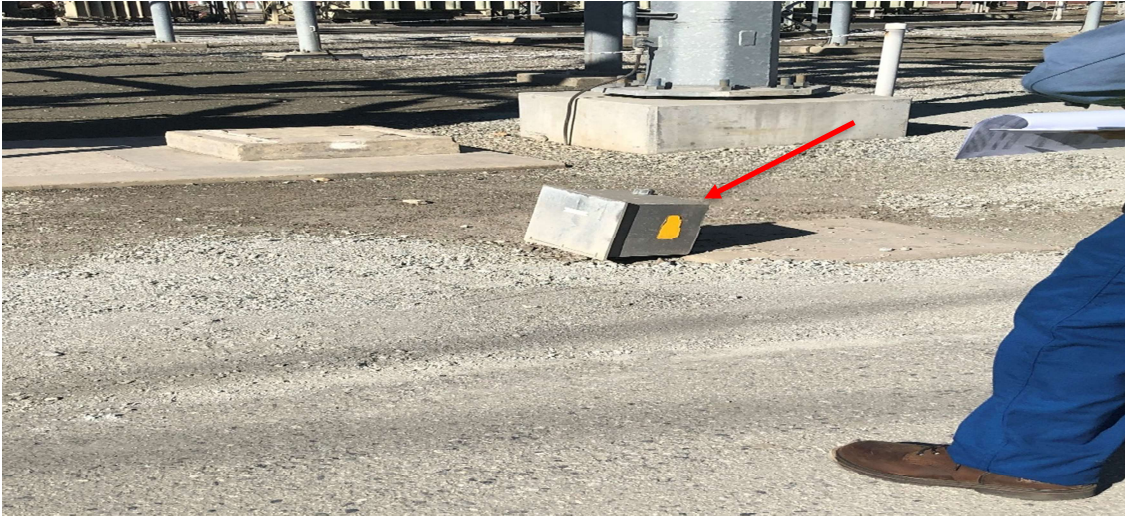
- 5.1. Audible noises heard from the Section D bus at the 12kV secondary (potential partial discharge/corona).
- 5.2. A junction box near Circuit Breaker #24 identified as a trip hazard. (Figure 7)

Figure 7: Junction box near Circuit Breaker #24.

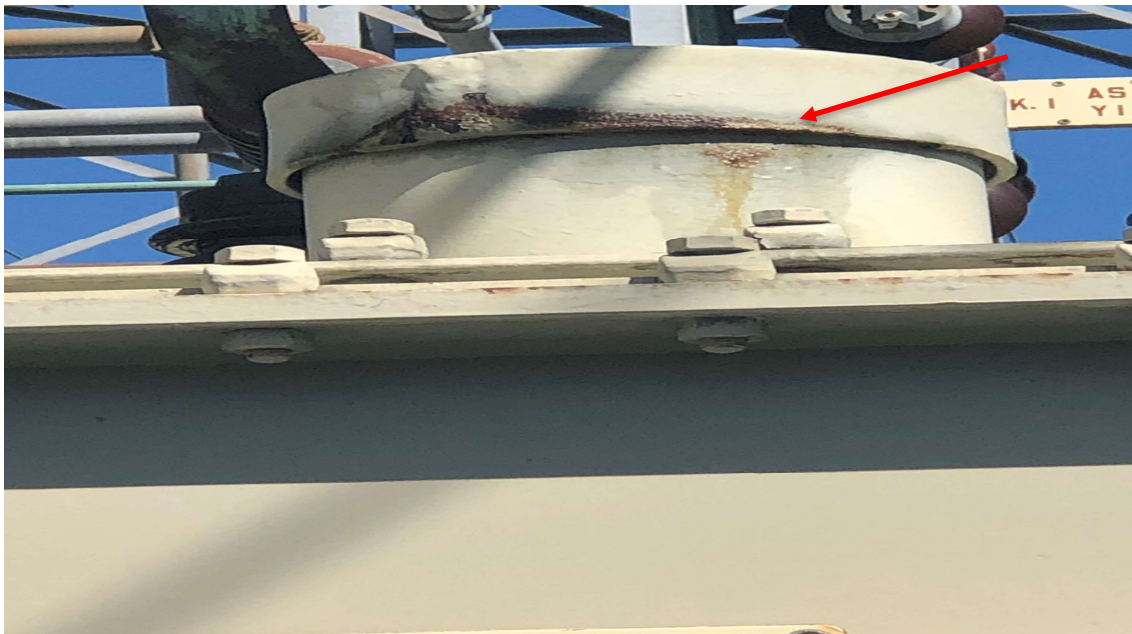
6.1. Potential oil leak at the lid of Regulator #403. (Figure 8)

Figure 8: Potential oil leak on Regulator #403.

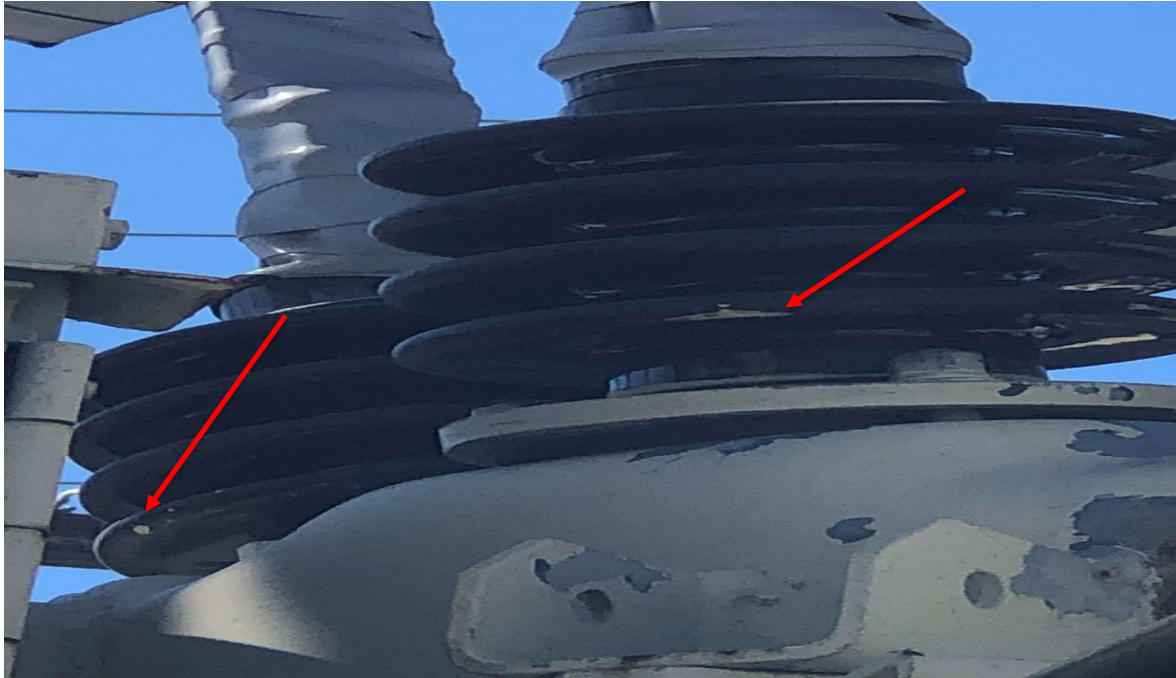
6.2. An insulator disk/bushing on pole #2 of distribution Circuit Breaker #1101 was chipped/damaged. (Figure 9)

Figure 9: Chipped/ damaged insulator disk/bushing on Circuit Breaker #1101.

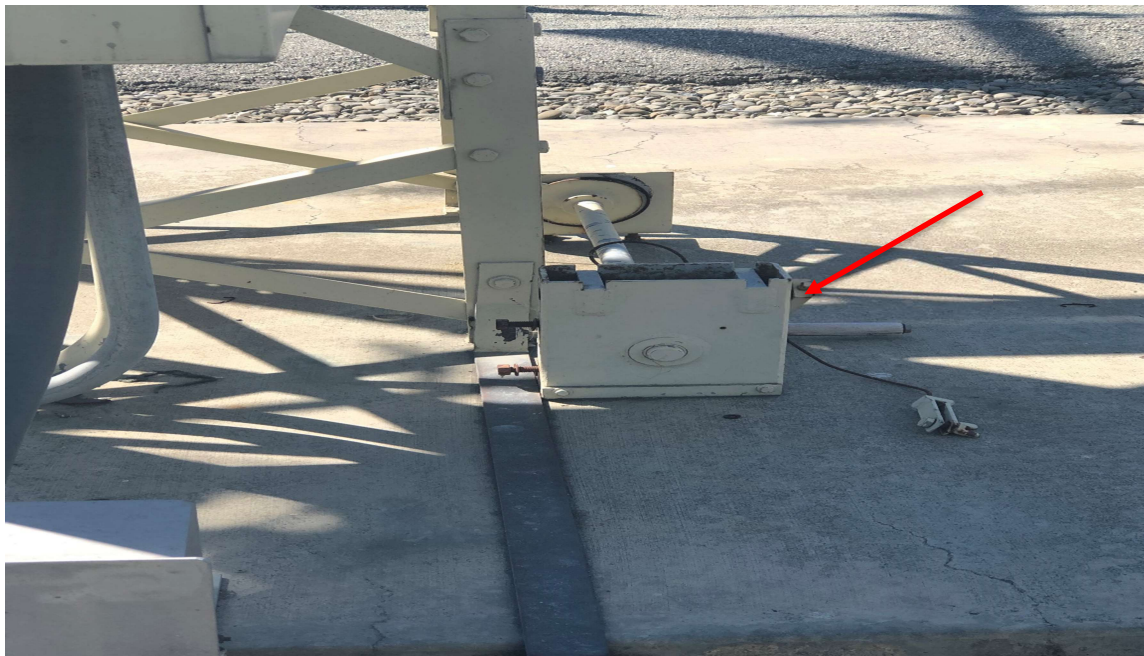
6.4. Tripping hazard: The lowering jack near Circuit Breaker #1101. (Figure 10)

Figure 10: Lowering jack on the ground near Circuit Breaker #1101.
