CALIFORNIA PUBLIC UTILITIES COMMISSION
Safety and Enforcement Division
Gas Safety and Reliability Branch
Gas Engineering and Compliance Section

Incident Investigation Report

Incident Number: G 20140303-01

Utility: Pacific Gas & Electric (PG&E)

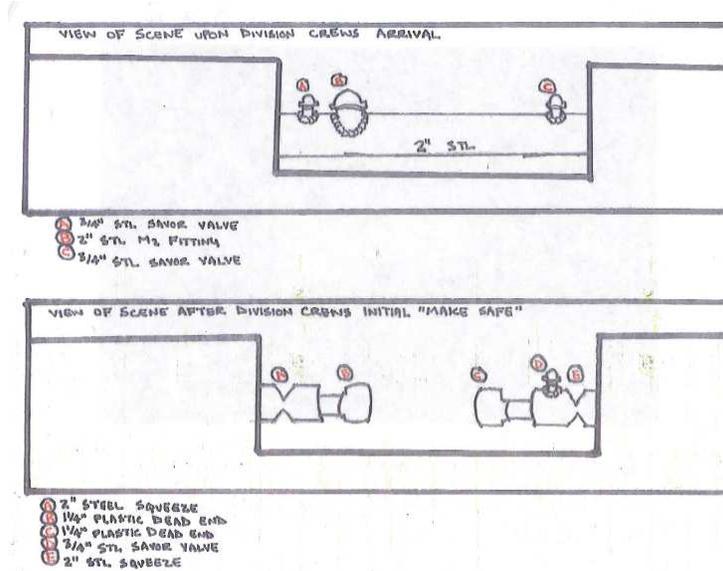
The division crew arrived at 11:38 am and stopped the flow of gas at 11:45 am. The division crew stopped the flow of gas by squeezing the steel casing down around the inserted plastic main at the east and west ends of the bell hole as shown in Figure 2. Additionally, PG&E conducted a special leak survey in the aftermath with no further indication of natural gas.

Figure 2: Sketch of how the division crew stopped the flow of gas⁹

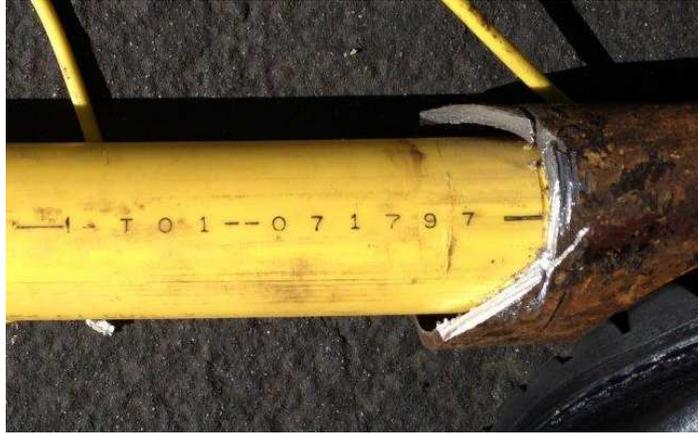
The inserted plastic on 3rd Avenue has a stamp of “071797” which indicates a manufacturing date of 7/17/1997, as shown in Figure 4. PG&E believes that the 1-¼ inch plastic main was inserted into the 2-inch steel main sometime in 1997-1998. Similarly, the service line for customer service number [REDACTED] 3rd Avenue and Guadalupe Street also had an inserted plastic service shown in Figure 5. However, Plat [REDACTED] shows a ¾-inch steel service pipe instead of an inserted ½-inch plastic service. Figure 6 shows a stamped date on the inserted service as “052697” indicating a manufacture date of May 26, 1997.

Figure 4. Date stamp on inserted plastic main indicating 071797

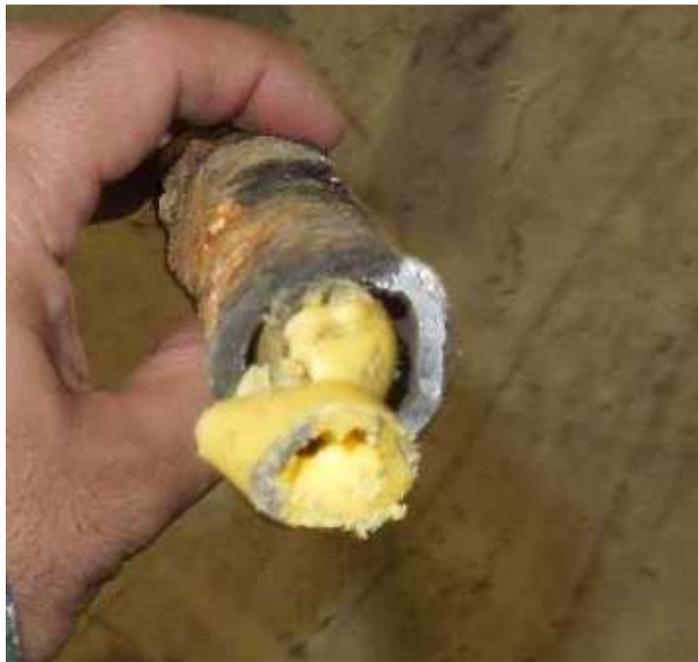
Figure 5: The service riser inserted with plastic.

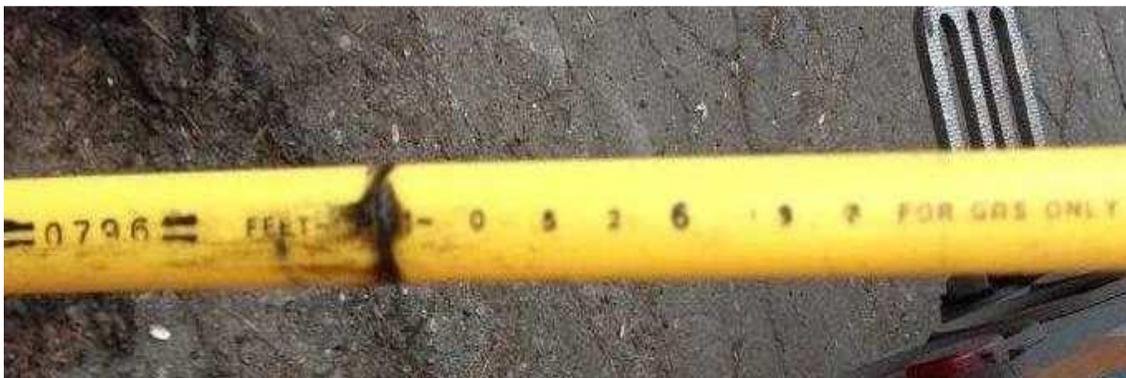
Figure 6: Date stamp on inserted plastic for service of [REDACTED] indicating 052697.
Failure Analysis

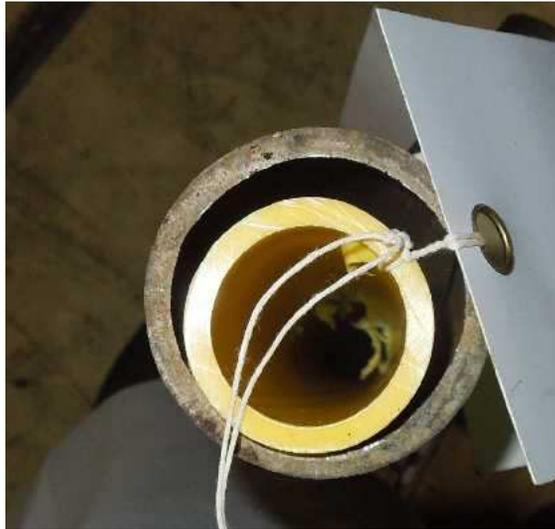
In the aftermath of the incident, PG&E hired a third party company, Exponent Failure Analysis Associates (Exponent), to conduct a failure analysis investigation of the incident. Examination of the 1-1/4 inch plastic distribution main showed that the inserted plastic main was damaged in two sections during the welding and tapping process. The welding and tapping of the save-a-valve caused the smaller hole in the 1 1/4-inch plastic main. At this point, gas was flowing down the annular space between the plastic main and steel casing, as shown in Figure 7, which was why the PG&E welders reported reading 48 psig with the pressure gauge. A reading of 48 psi would not be an indicator that there existed a problem as it is close to the operating pressure of 50 psi that the main typically is at.

Figure 7: 1-1/4 plastic main inserted into 2 inch steel.

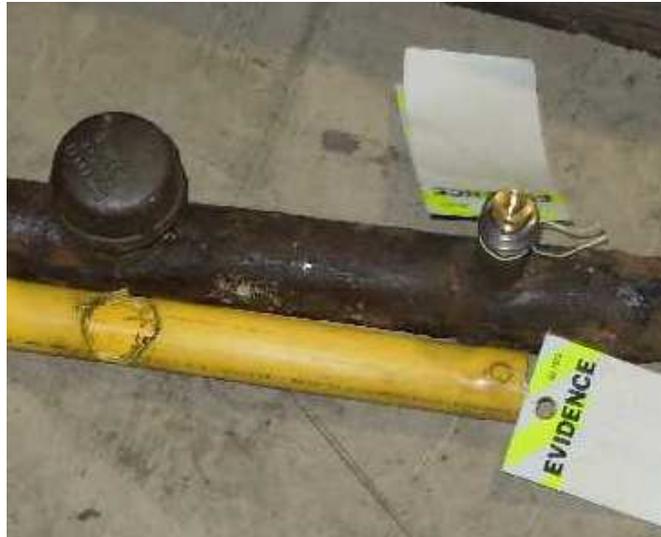
The welding and tapping of the M2 line stopper later caused a larger hole on the inserted plastic main causing further release of natural gas from the inserted plastic main. Figure 8 shows the smaller and larger holes caused by the installation of the save-a-valve and line stopper. The larger hole on the left was caused during the installation of M2 line stopper and the smaller hole on the right was caused by the save-a-valve installation.

Figure 8: Damaged plastic main insert and steel casing showing two damaged locations.
