CALIFORNIA PUBLIC UTILITIES COMMISSION

Incident Investigation Report

Incident Number: G20170112-2136

Utility: Pacific Gas & Electric Co. (PG&E)

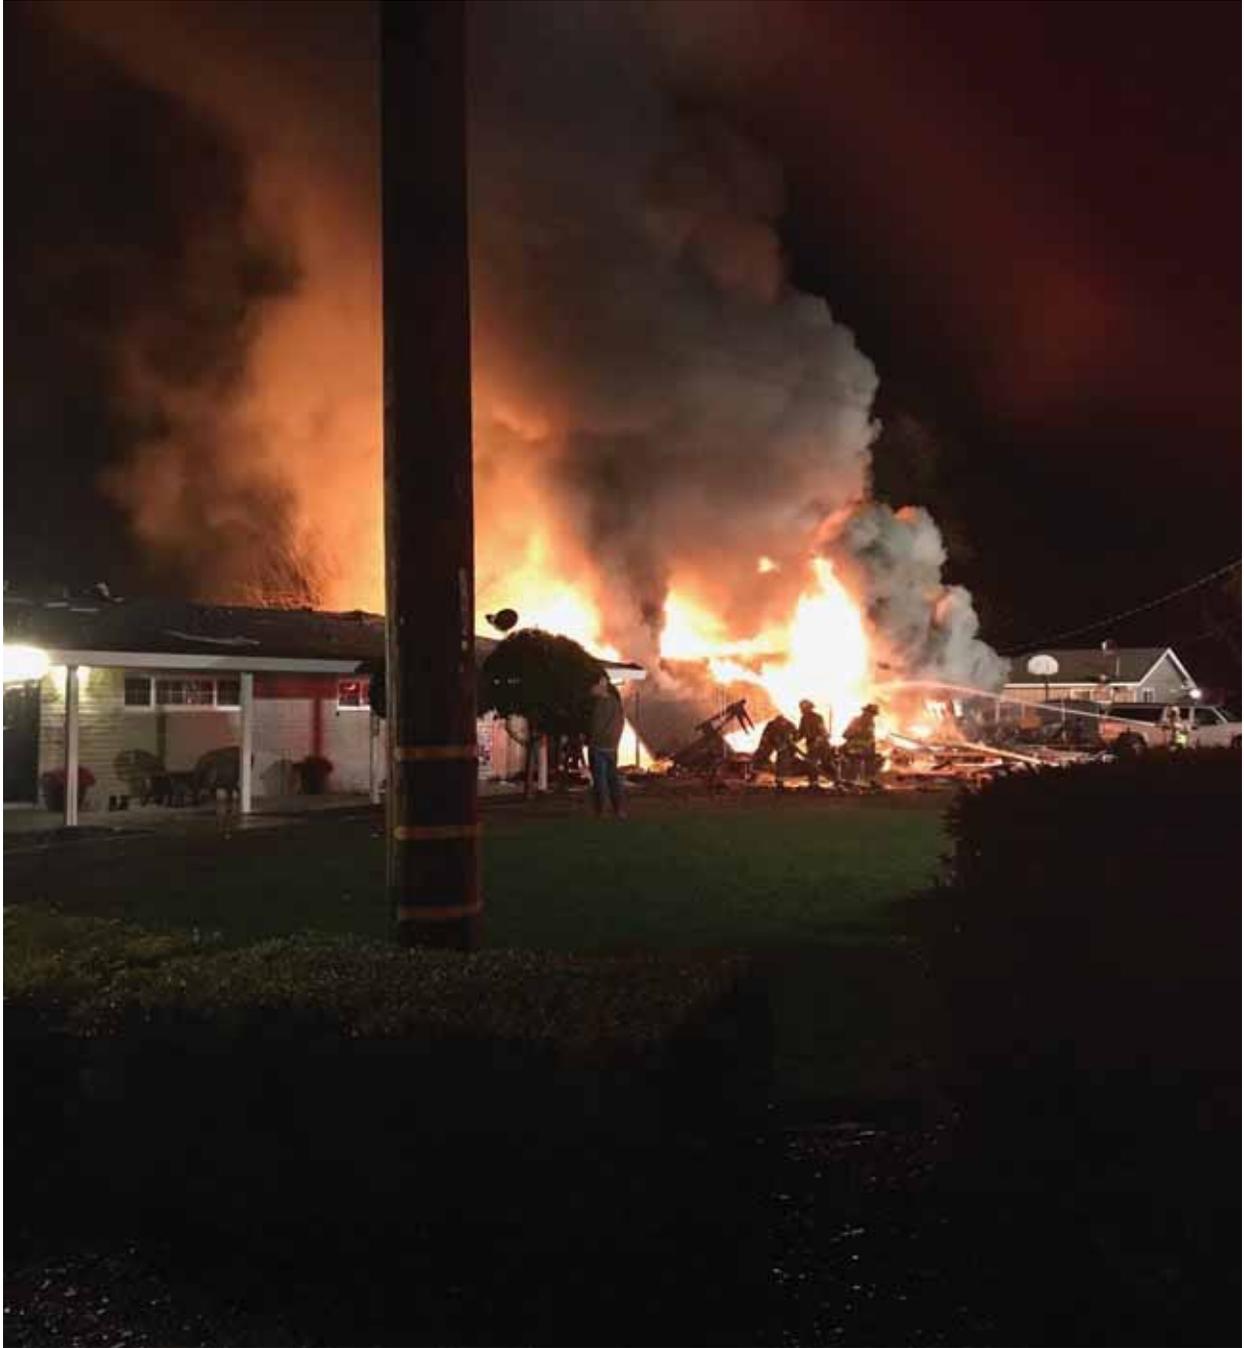
Figure 3 shows a photograph, provided by Witness #3, of the residence engulfed in flames.

Figure 3. Structure fire at [REDACTED].

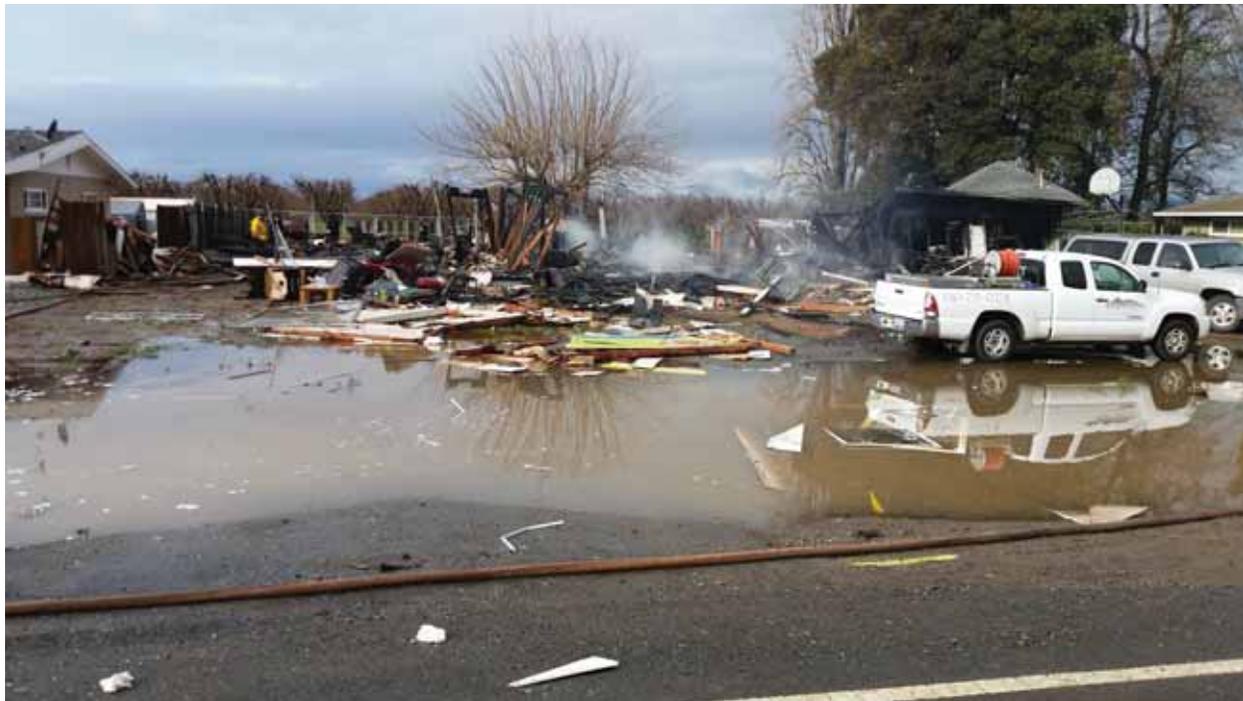
Figure 4. [REDACTED] on the morning of the incident

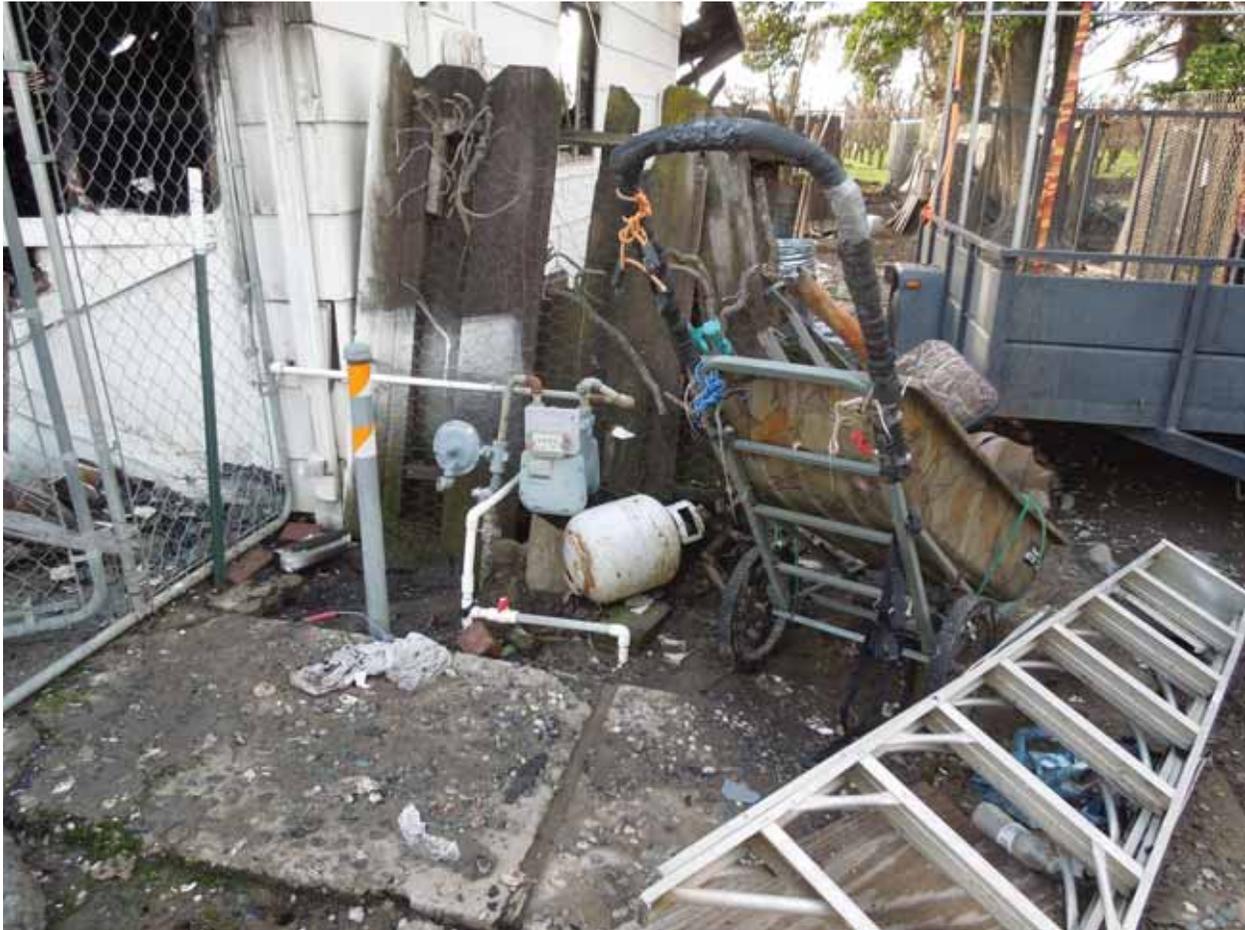
Figure 5. The meter set assembly (MSA)

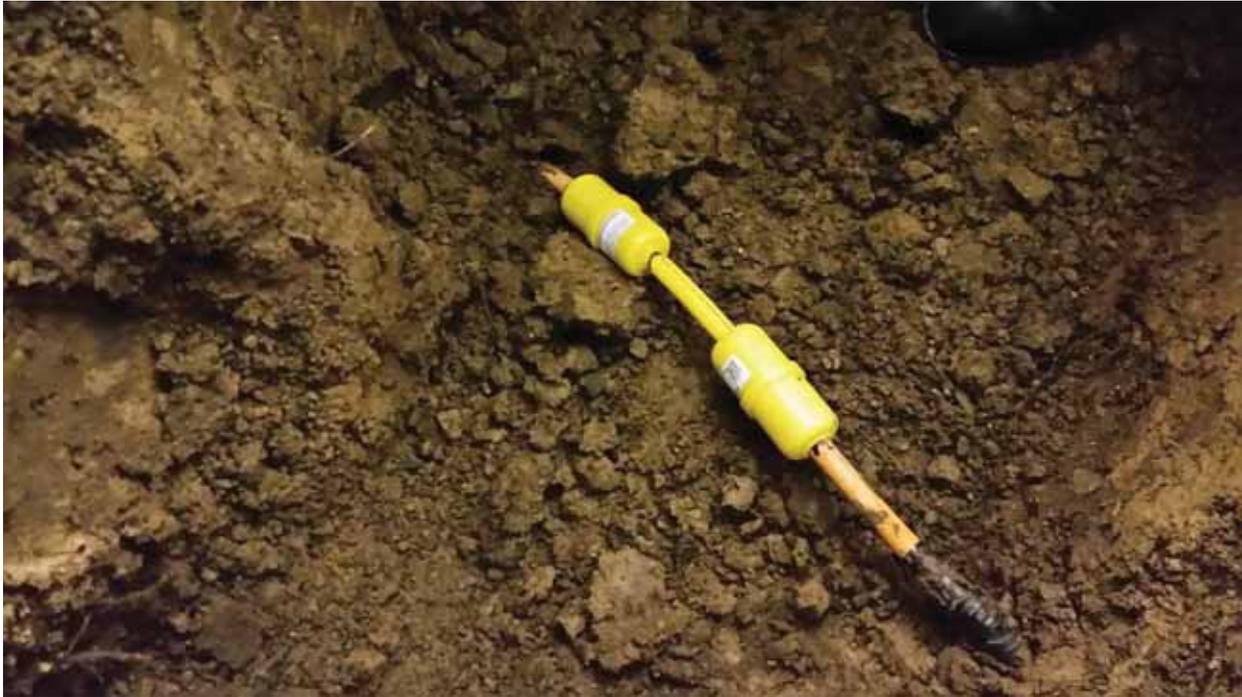
Figure 6. Severed service line repair at [REDACTED].

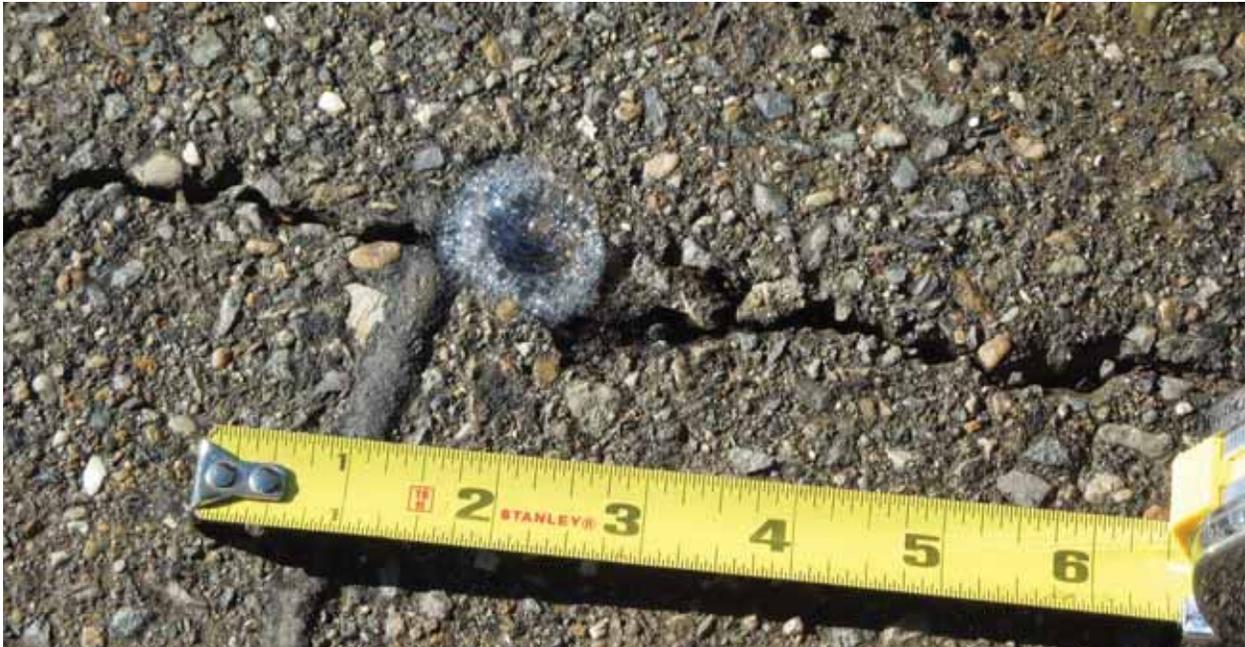
Figure 7. Air bubbles in driveway crack at [REDACTED]

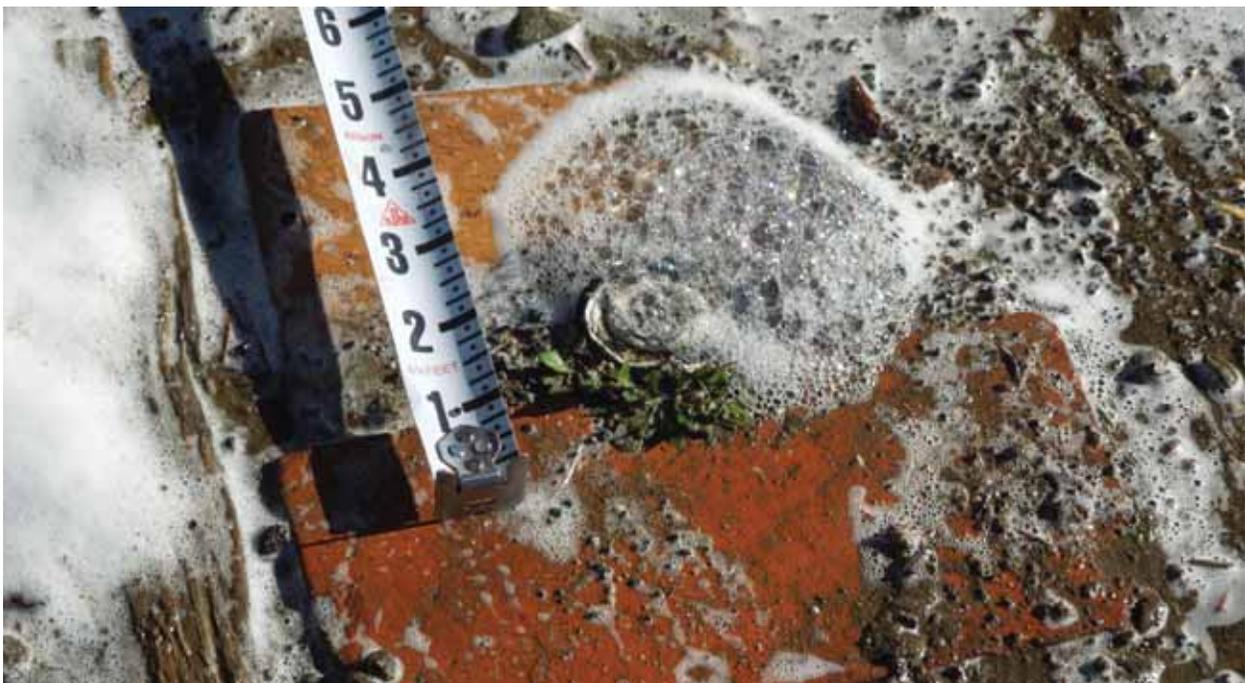
Figure 8. Air bubbles around a sprinkler head

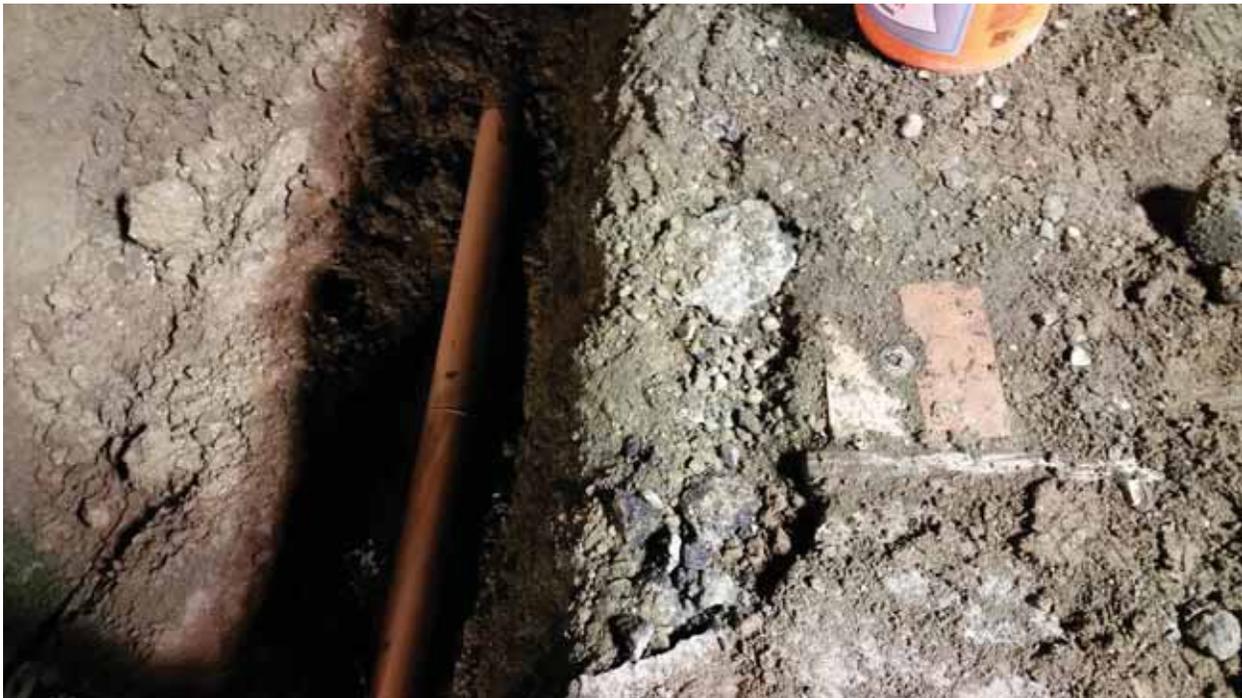
Figure 9 shows an exposed segment of main with the joint that was the source of the leak. Note the close proximity of the sprinkler head where air bubbling was observed during the leak test.

Figure 9. Exposed segment of main with the joint that was the source of the leak.

- *The direct cause of the leak was a fabrication error during original installation of the main in late 1973 or early 1974. Specifically, the end of the upstream pipe comprising the joint had not been fully faced flat and square with the axis of the pipe. Thus, when this pipe was butt-fused to the downstream pipe, a portion of the contact plane failed to melt and fuse, forming crack-like defect open to the interior of the pipe on the eastern side of the joint.*

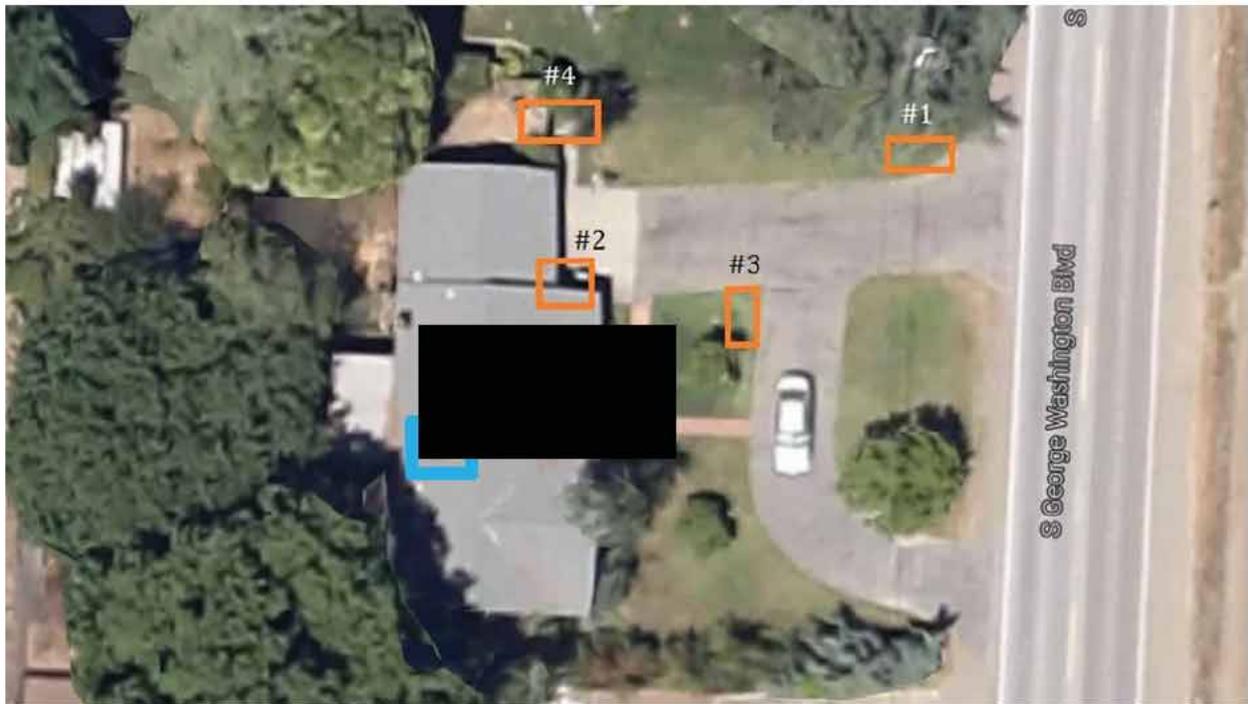
Figure 10 shows approximate areas of the soil sample excavation holes dug at [REDACTED] on 02/28/2017 outlined in orange. The combination heating/air-conditioning unit is on the roof, outlined in blue.

Figure 10. Excavation holes dug and combination heating/air-conditioning unit

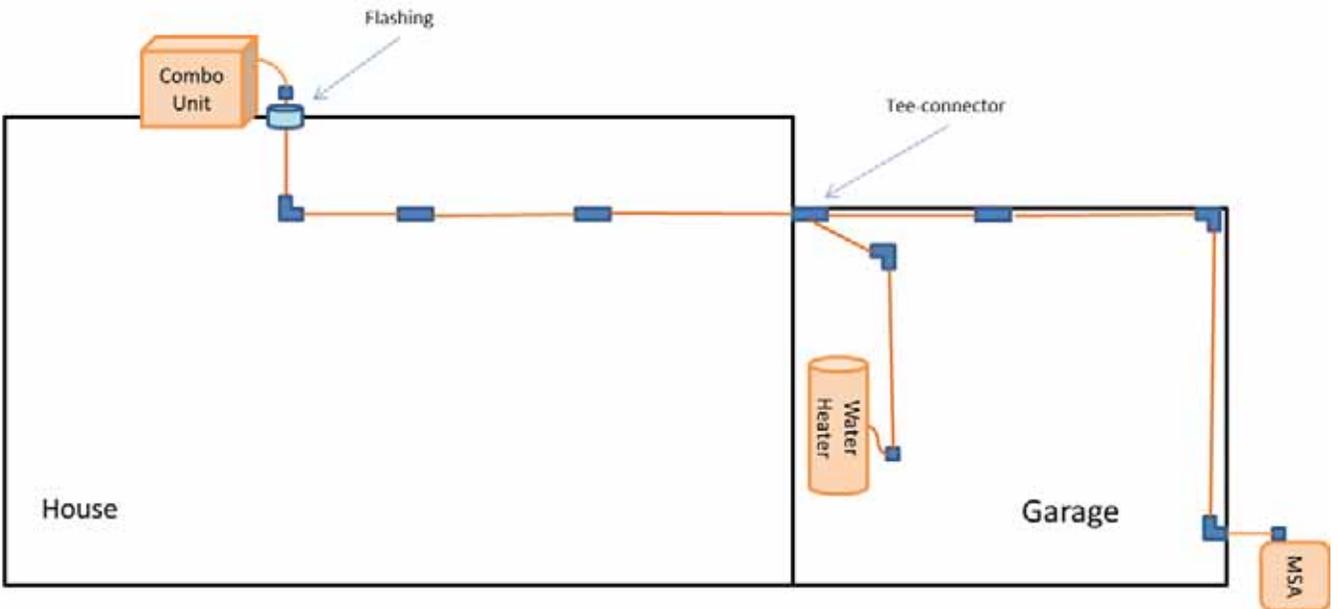
Figure 11 below shows the assumed pre-incident layout of the house gas line system. The view is looking at the front of the house (east face). The orange lines represent gas lines, and the blue block shapes represent threaded connectors. The figure is not to scale.

Figure 11: Assumed layout of the house gas line system, pre-incident.
