CALIFORNIA PUBLIC UTILITIES COMMISSION

Incident Investigation Report

Incident Number: G20160810-2059

Summary of Incident: On August 10, 2016 two PG&E employees were dispatched to [REDACTED] Deer Park to perform maintenance on a Nordstrom-type customer service valve that was stuck in the open position. During an attempt to free the stuck valve, the valve came apart forcefully and gas began flowing through openings in the valve body. The gas flow ignited on the pilot light of a nearby water heater, and the resulting fire burned two utility workers, and caused severe damage to the house. SED found that PG&E personnel did not follow utility procedures, and this directly contributed to the incident. SED also determined that deficiencies within PG&E's maintenance procedures and Operator Qualification program contributed to the incident.

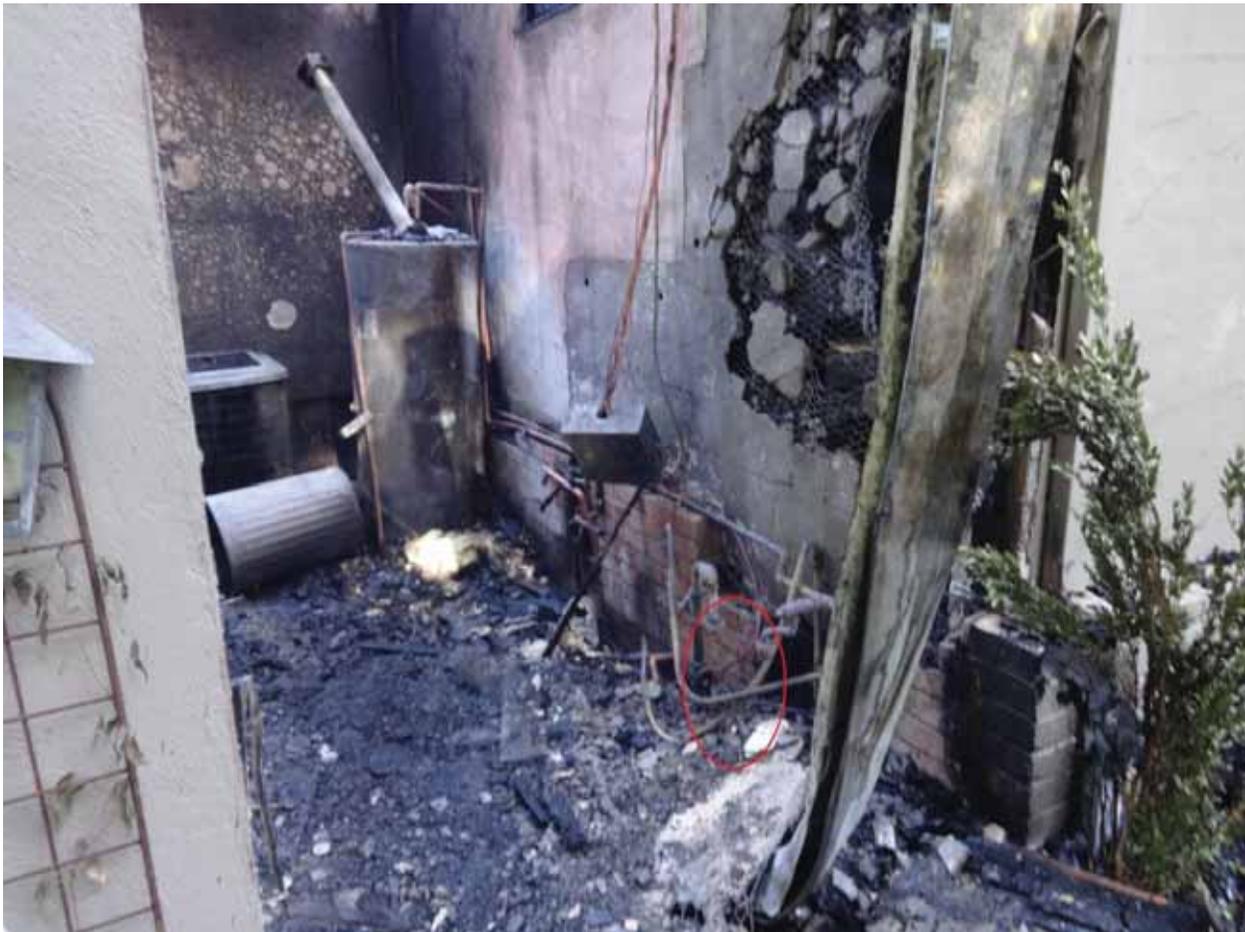
Figure 1: The roofless enclosure that contained the gas meter, a water heater, an electrical service box, and an air conditioning unit. The red circle represents where the gas meter had been.

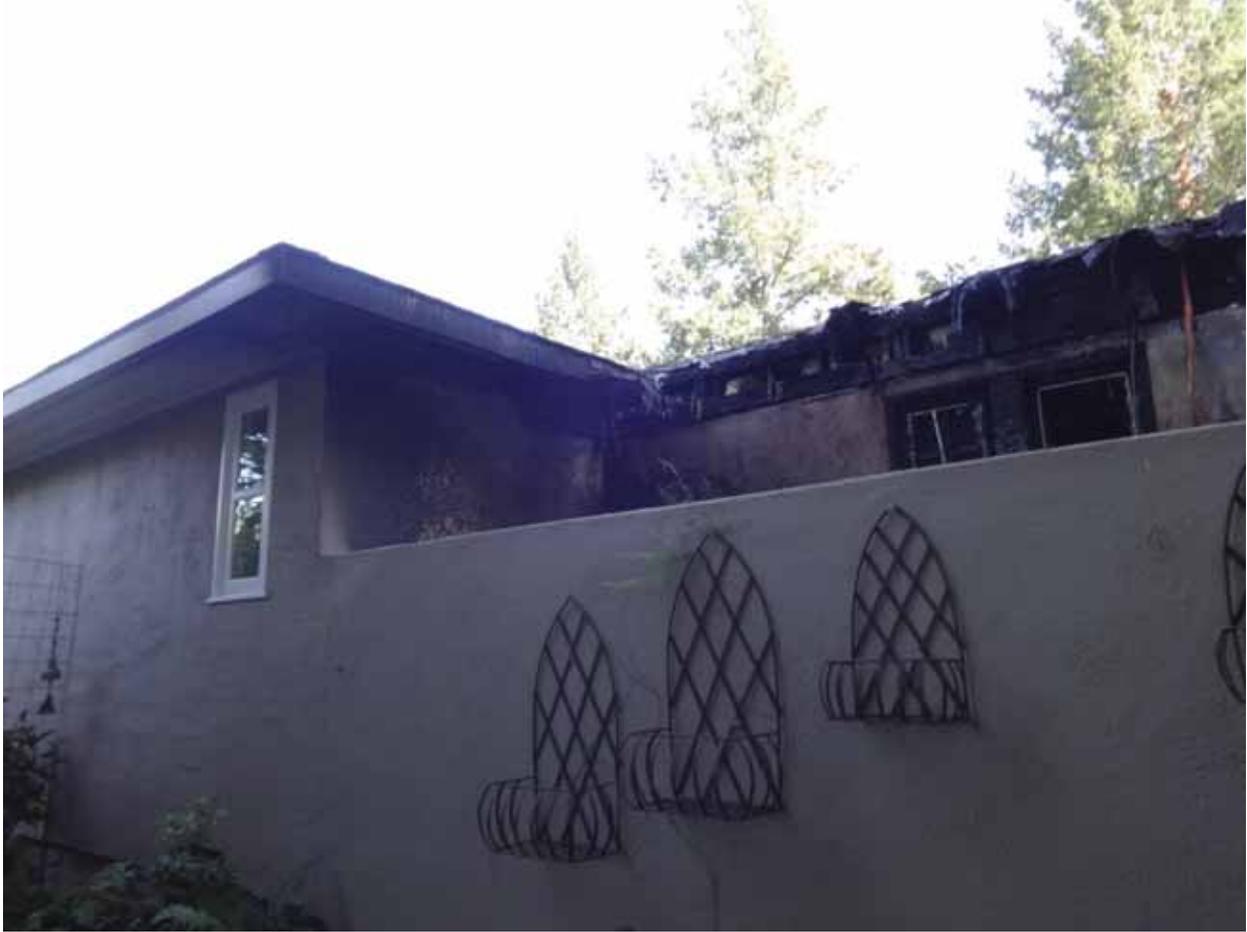
Figure 2: The eaves above the gas meter and water heater burned away, exposing the interior of the attic. This picture is taken outside the small roofless enclosure, facing south.

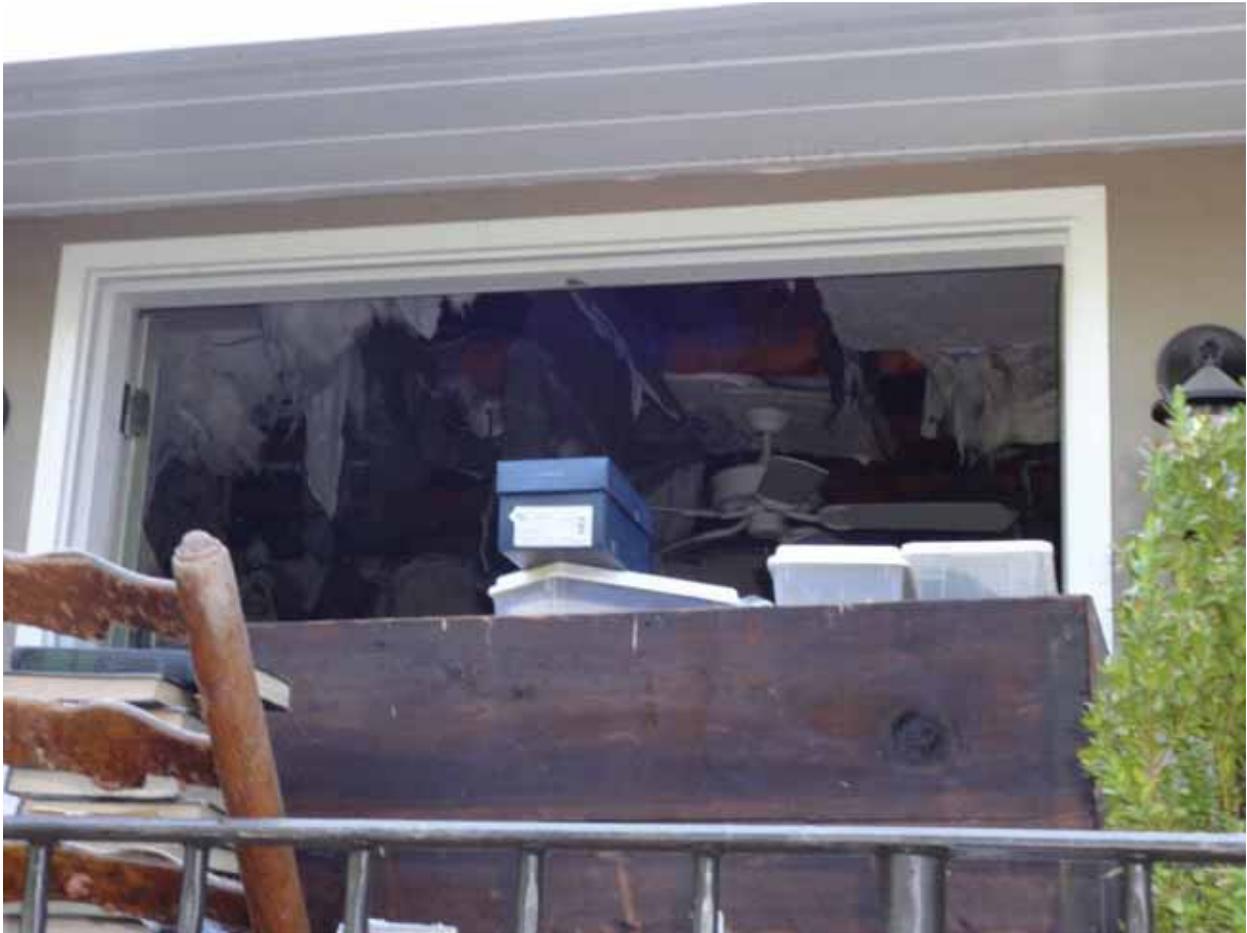
Figure 3: A view of the interior ceiling as seen from the outside.

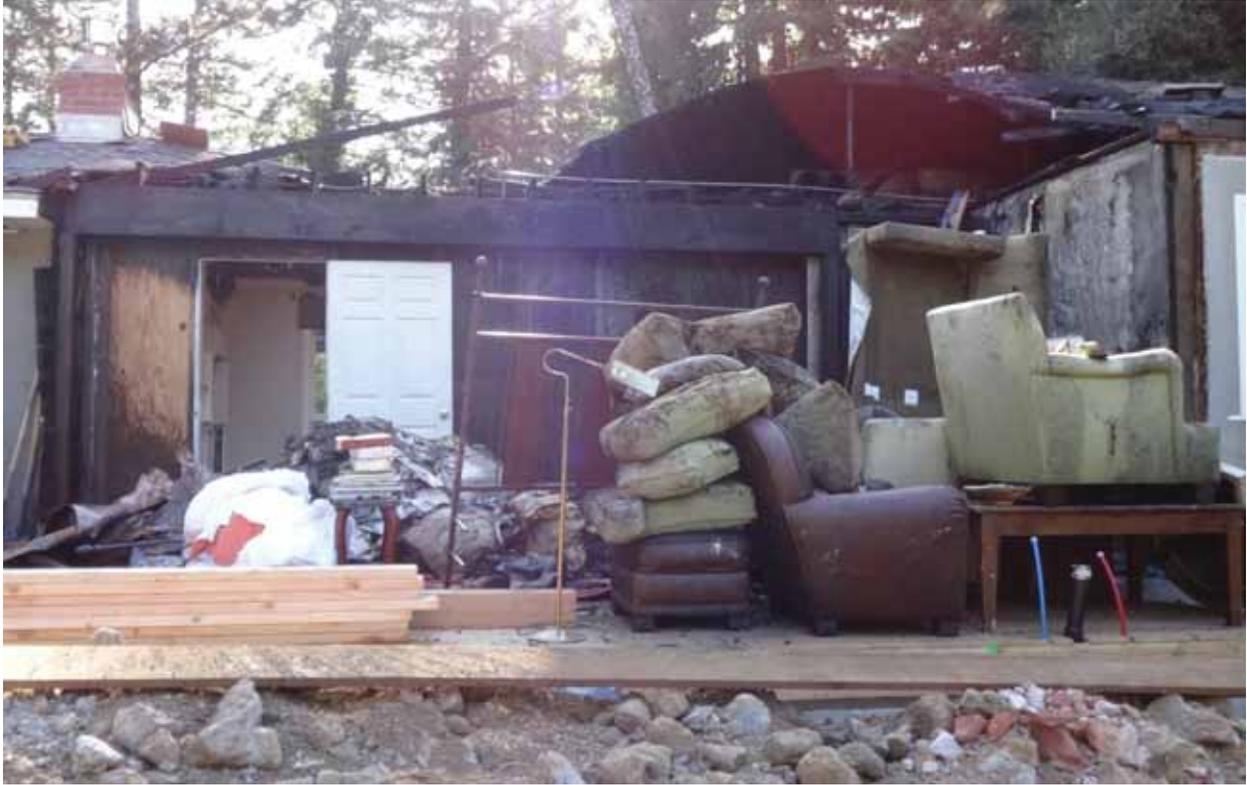
Figure 4: The east side of the house; severely burned, with part of the roof burned away, or collapsed. The furniture had been removed for a remodeling project and is sitting on an outside porch.

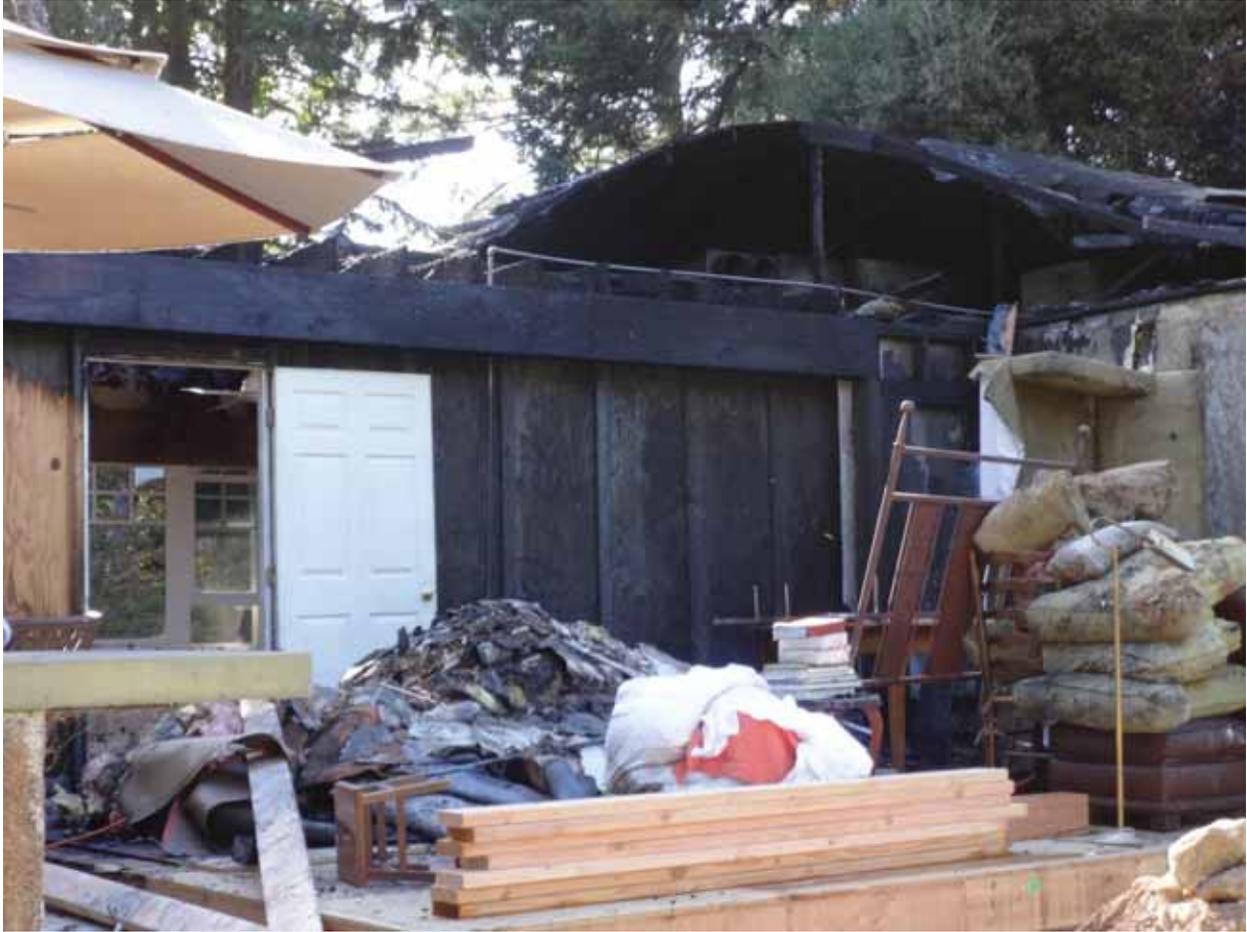
Figure 5: A different angle of the east side of the house; severely burned, with part of the roof burned away, or collapsed. The furniture had been removed for a remodeling project and is sitting on an outside porch.

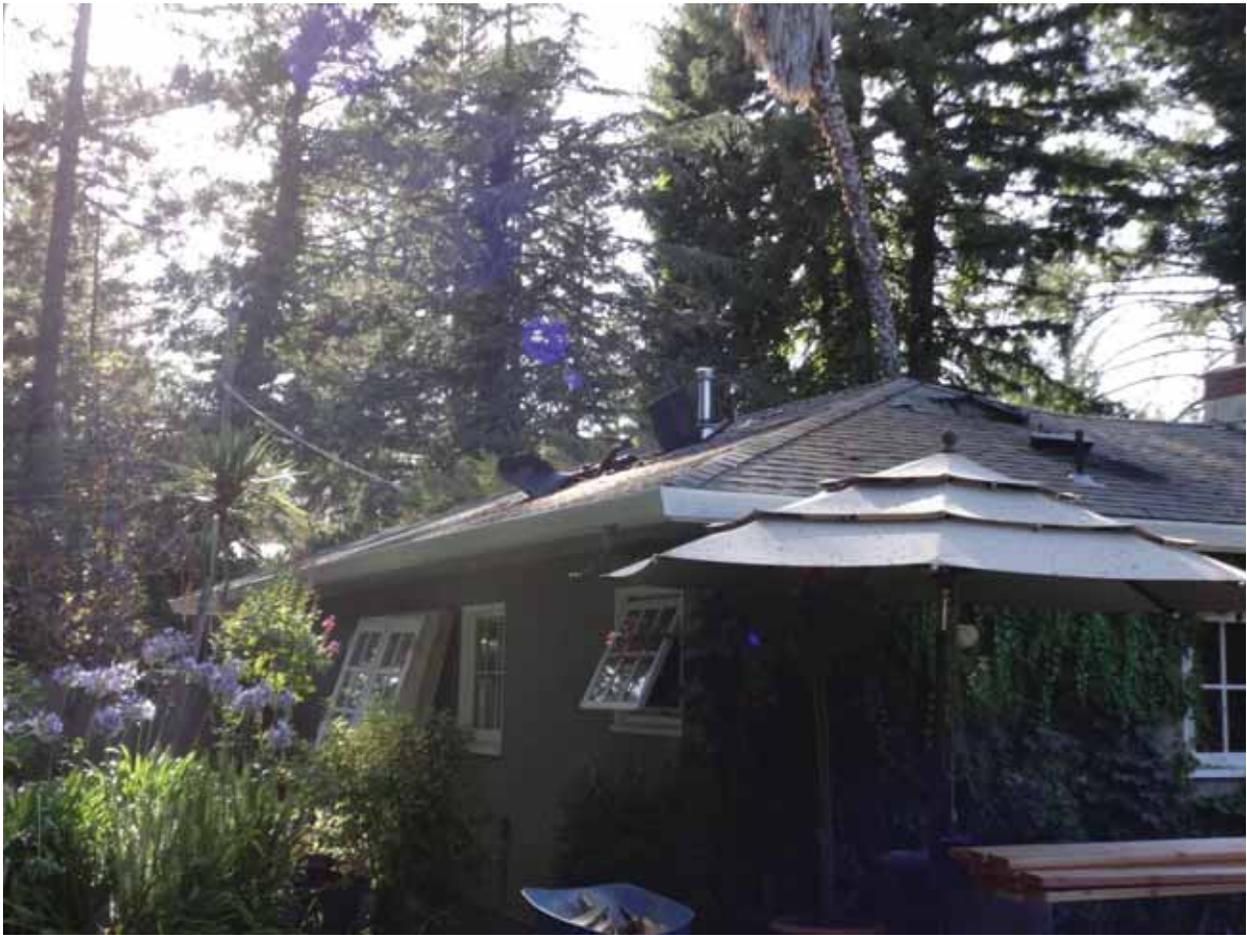
At the southeast corner of the house (the furthest point from the gas service) there was damage to the roof from where the attic fire had burned through (Figure 6 and 7).

Figure 6: The southeast corner of the house. Notice the blackened spots on the roof.

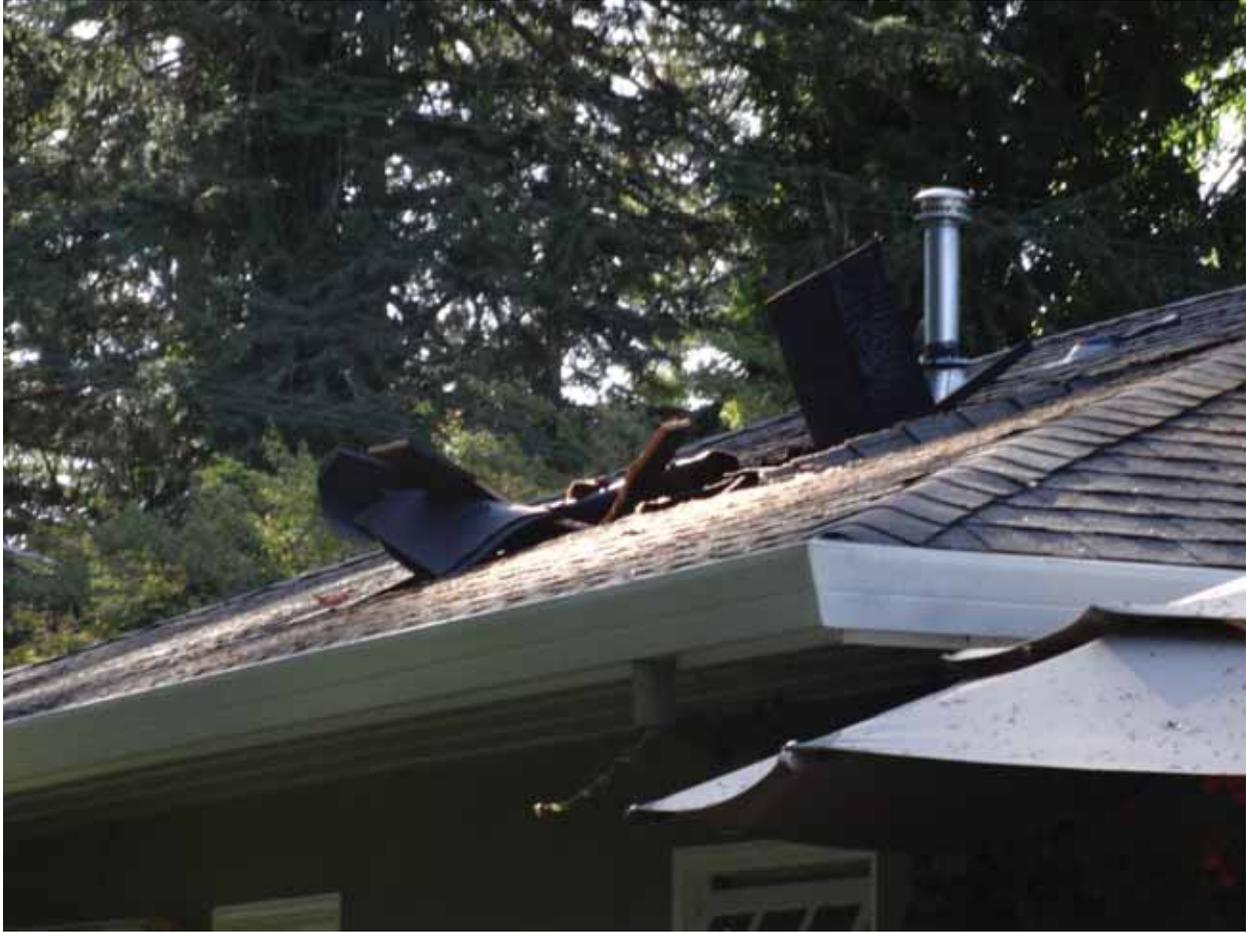
Figure 7: A close-up of a damaged piece of roof on the southeast corner of the house.

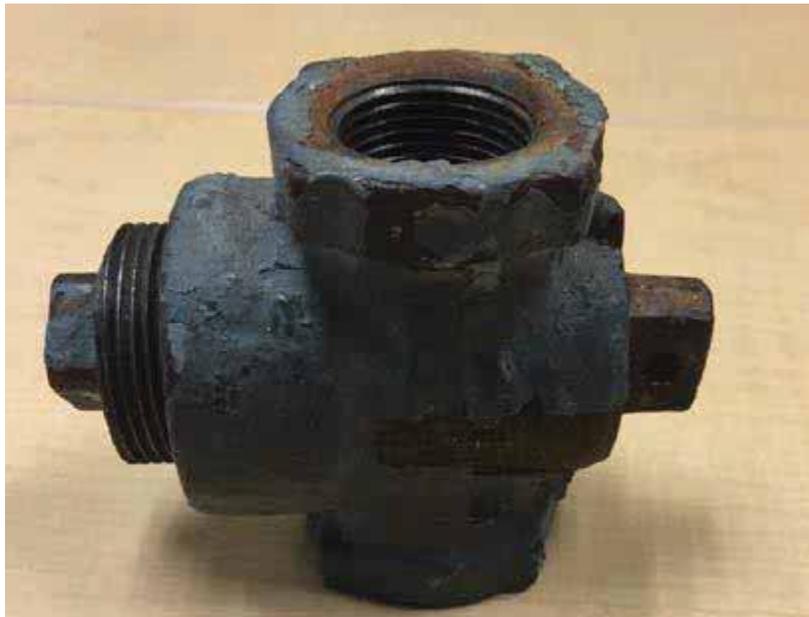
Figure 9: A typical Nordstrom valve. The packing nut is on the left of the valve body, and the tang is to the right. The tang of the valve at [REDACTED] had been broken off, and the valve was inoperable.

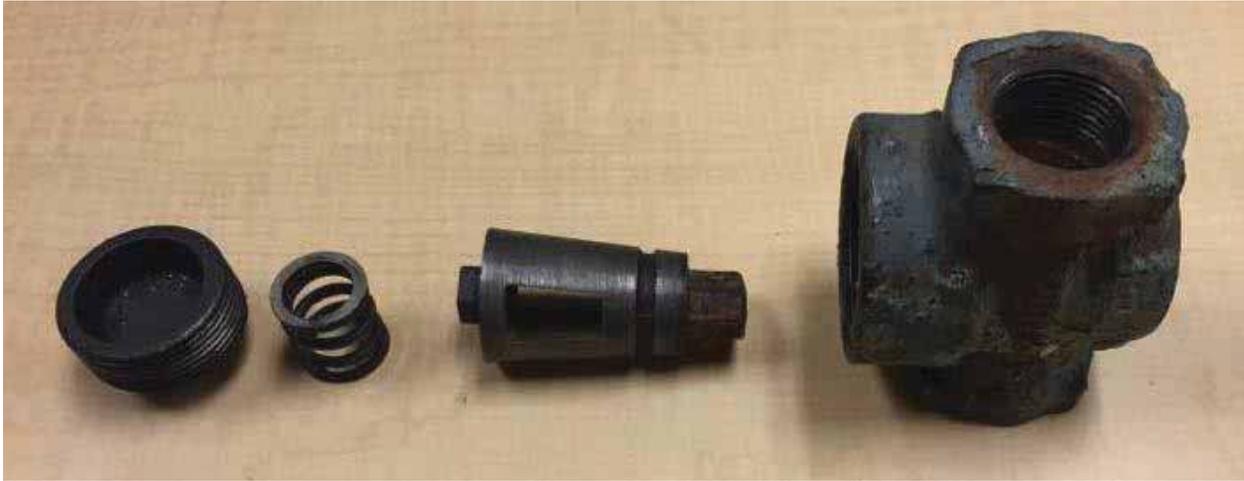
Figure 10: The various parts of a typical Nordstrom valve, from left to right: packing nut, spring, valve core (with tang on the right-hand side), and valve body. When the nut, spring, and core are removed, there are 2 openings on the sides of the valve body that gas can flow out from.

PG&E collected the Nordstrom valve to have it analyzed for mechanical damage and corrosion. Their report shows that there was no mechanical damage to any component of the valve, except the broken tang, which was “almost completely absent”. Moderate corrosion was found on the interior of the valve body, but no indication of corrosion was found on the threads. The valve plug was severely corroded, including the broken surface of the small remaining tang section. The packing nut showed moderate interior and exterior corrosion. The spring was covered in dry grease and debris, but showed no signs of mechanical damage. The threads on the body and the packing nut were continuous and showed no signs of mechanical damage. All components of the valve fit together well when reassembled. 4 turns were needed to fit the packing nut properly in the body, and a ¼-turn is the minimum thread engagement needed before the packing nut falls out of the body, when the spring is in place.

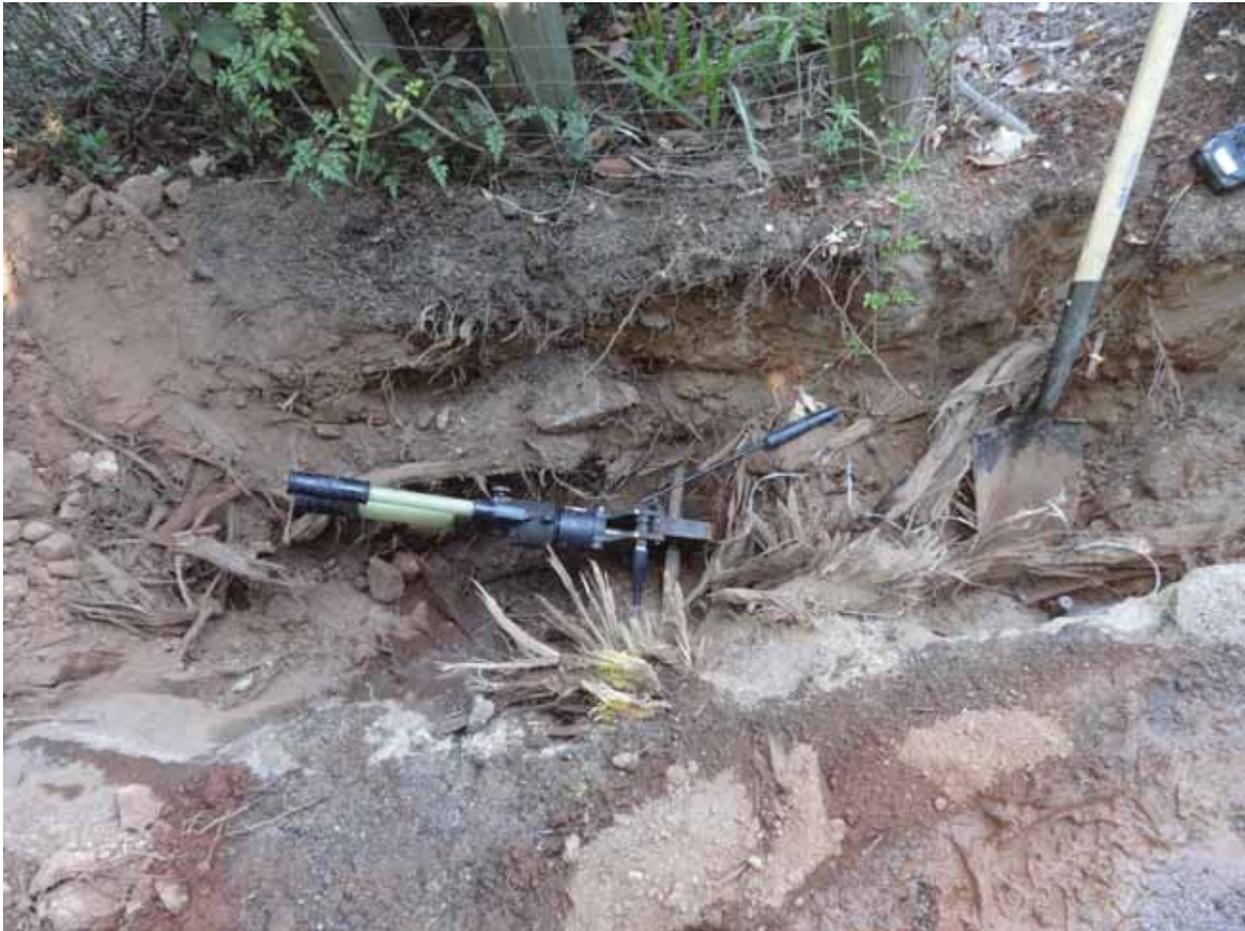
Figure 13: The clamp squeezing the ¾-inch steel line shut at the front of the property.

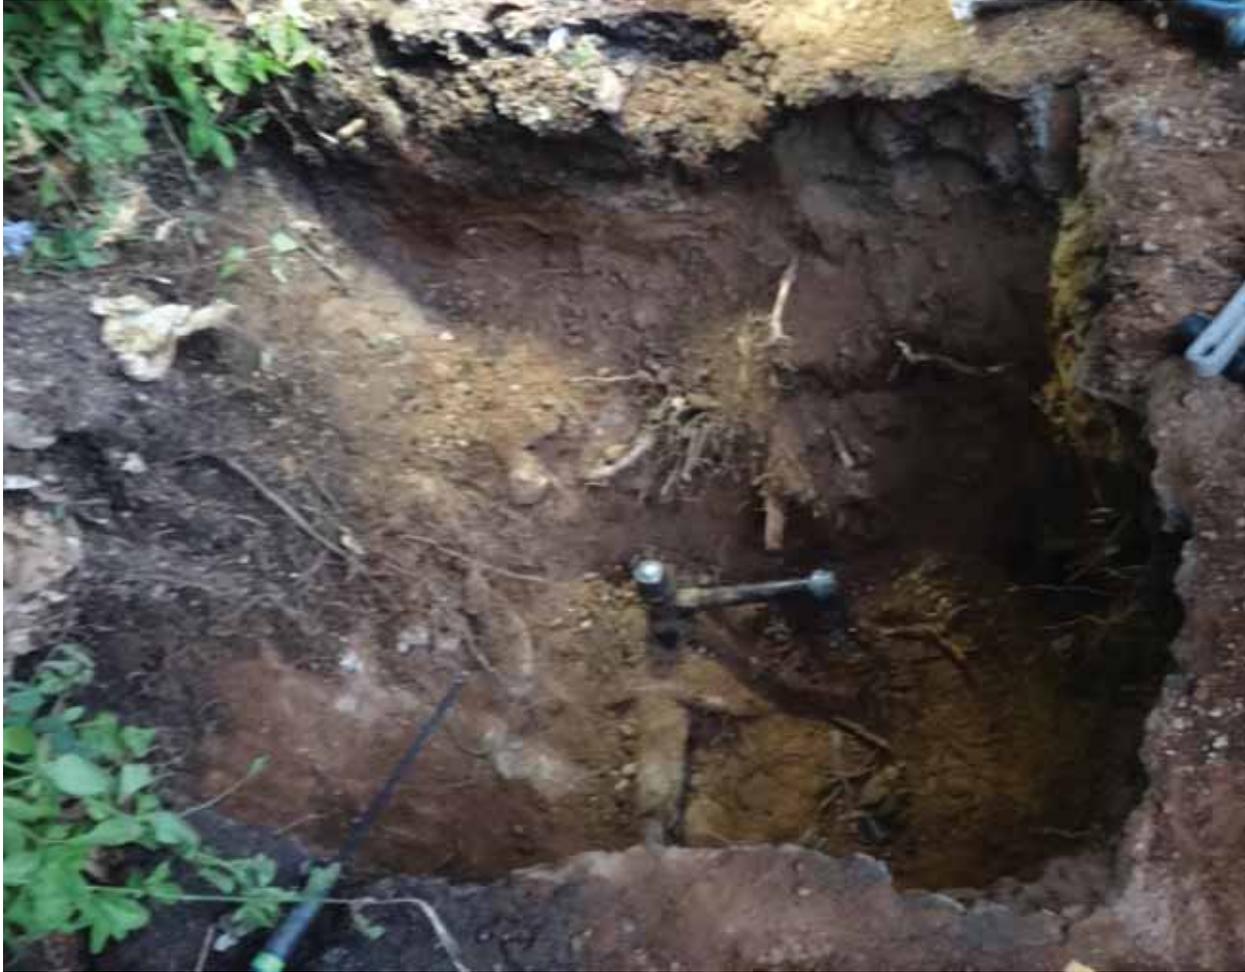
Figure 14: The service line at the main; cut and capped.
