**CALIFORNIA PUBLIC UTILITIES COMMISSION**  
**Safety and Enforcement Division**  
**Incident Investigation Report**

**Incident Number:** G20150417-01

**Utility:** Pacific Gas and Electric (PG&E)

**Location of the Incident:** 7633 N. Weber Ave  
Fresno, CA  
Fresno County

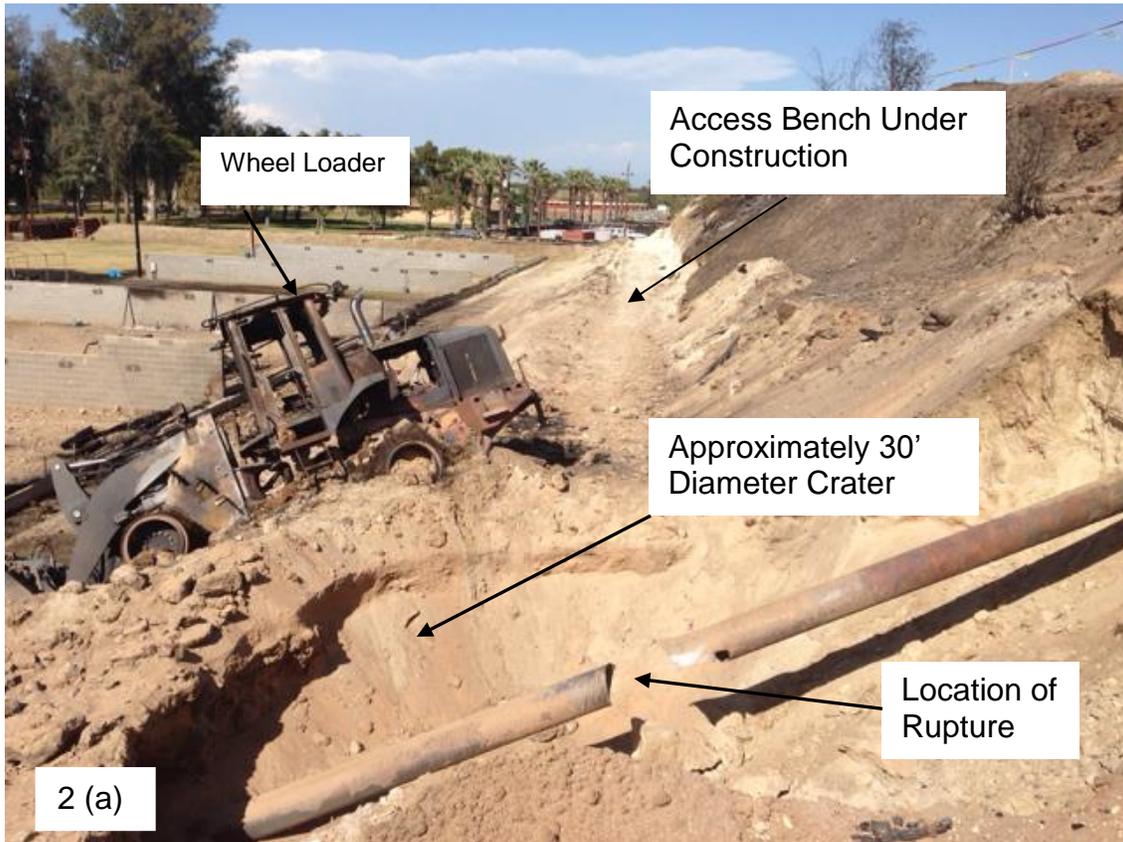
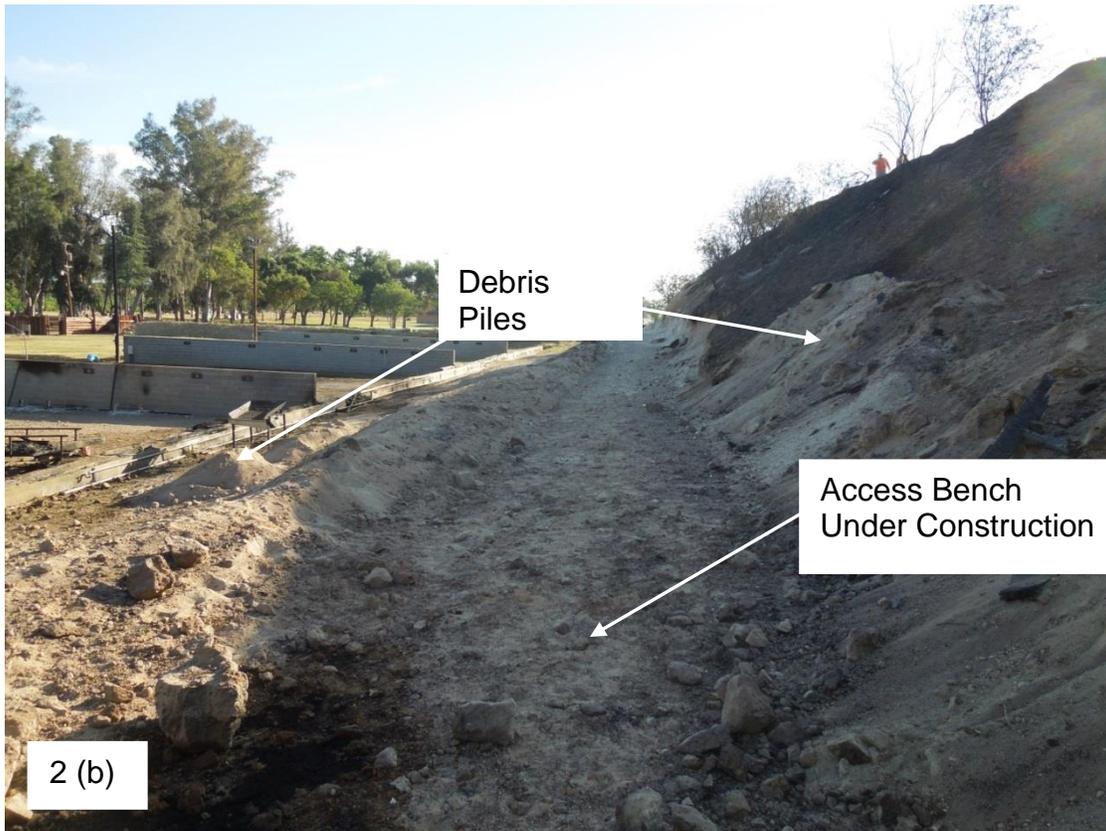
Figure 2(a) shows the ruptured pipe with the loader and the access bench under construction with the surroundings destroyed by the fire, and 2(b) shows the expanded view of the access road. Piles of debris indicate that the road was recently graded.

**Figure 2:** (a) Crater with the Ruptured Pipeline, Wheel Loader, and Access Bench; (b) An Expanded View of the Access Bench

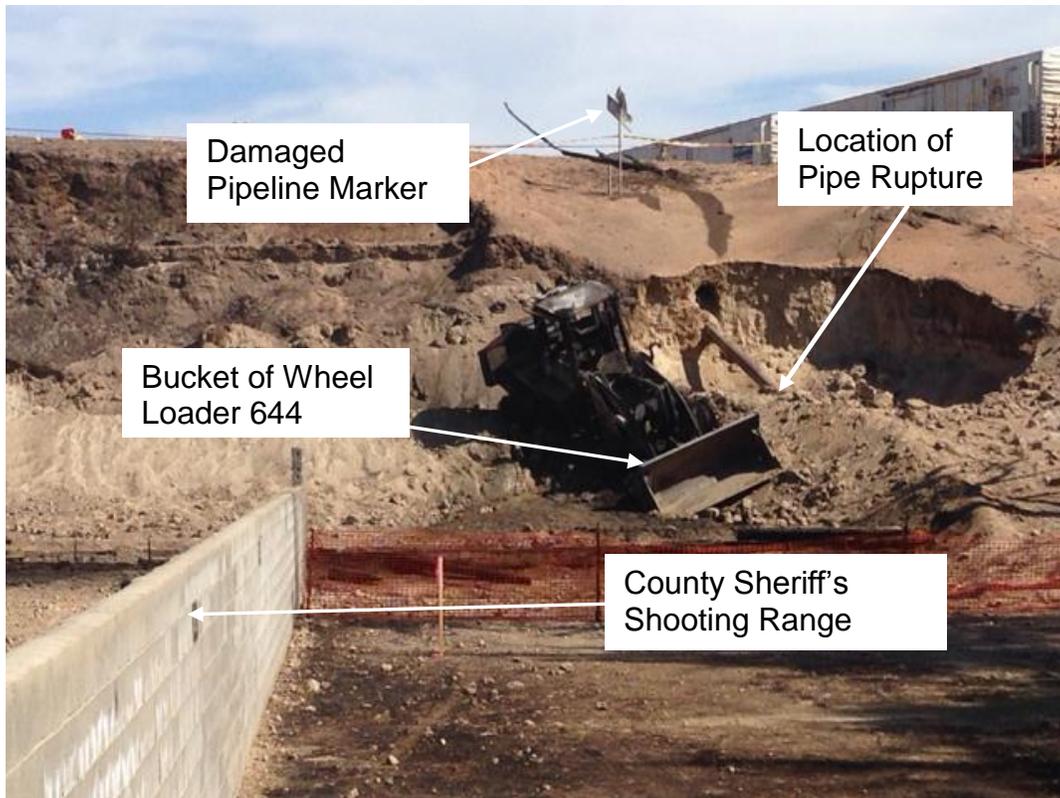
**Figure 3:** Ruptured Pipeline and a Portion of the Shooting Range

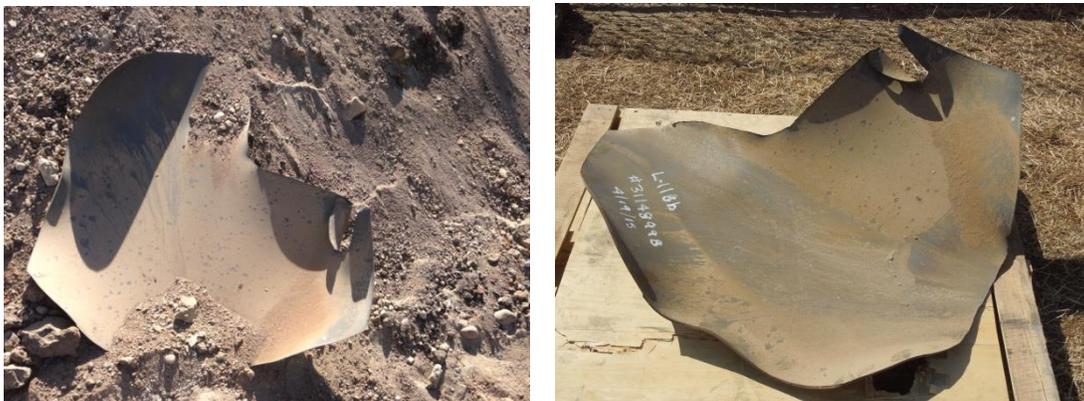
**Figure 4:** Ejected Portion of the Pipeline

The pipeline rupture and subsequent ignition injured inmates working on the shooting range collecting lead bullets, and ejected a portion of the pipe about 34 feet away. Figure 3 shows the base of the slope, the slope where the access bench was under construction, the bucket of wheel loader, the damaged pipeline marker and the surrounding areas of the shooting range. Figure 4 shows the portion of pipeline that was ejected from the incident site. According to the Executive Summary of the Exponent Report (page iv), the significant gouging, scraping and deformation present could have only been caused by contact with the front-loader bucket. The Exponent Report concluded that the bucket punctured the pipeline and formed two cracks: each

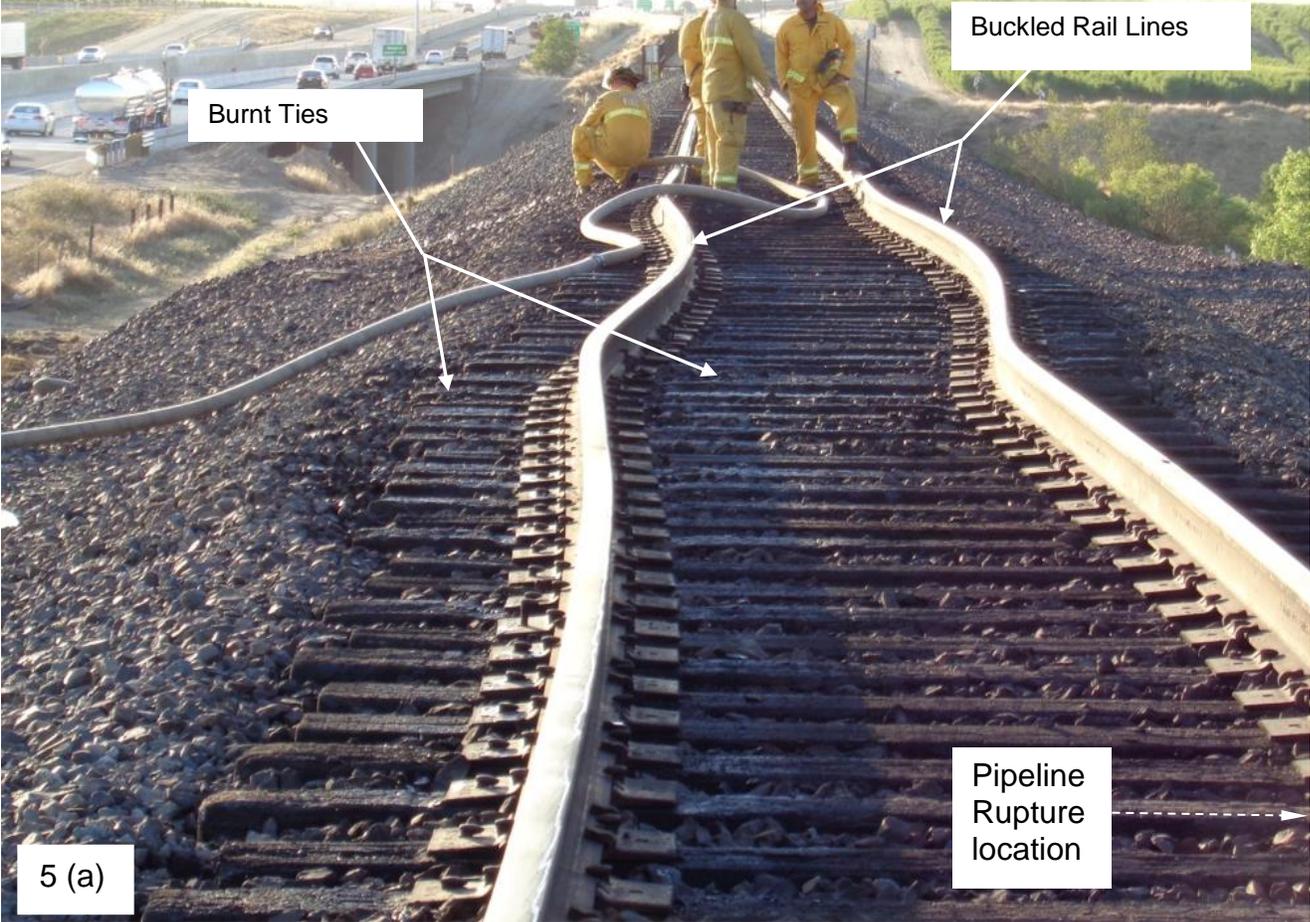
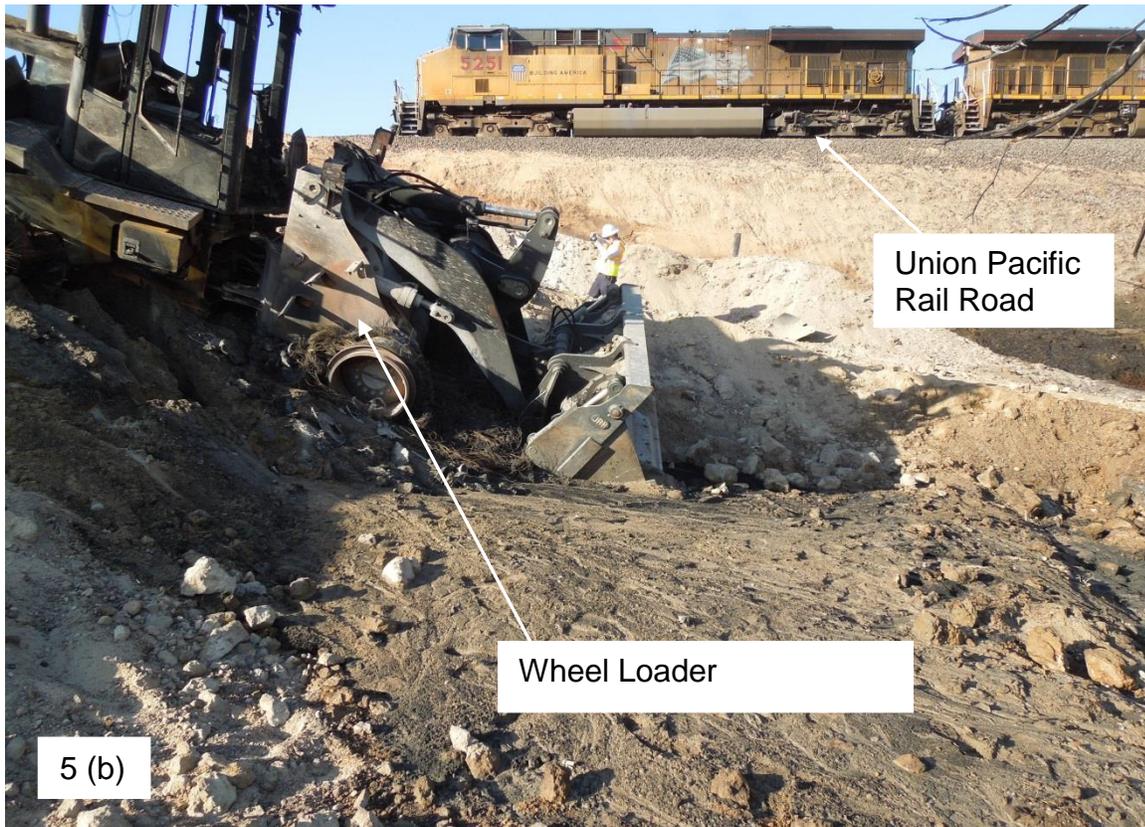
**Figure 5:** (a) Damaged Adjacent Union Pacific Railway Lines (b) the Wheel Loader

The rupture happened adjacent to the Union Pacific Railroad (UPRR) Mile point (MP) 194.75, at PG&E's Fresno Sub-Division Line 118-B. About 300 feet of railroad main track was damaged. The flames burned the ties and the stresses due to the train in combination with the heat from the fire may have damaged the rail. Approximately 200 feet of main track buckled. Figures 5 (a) and (b) show the damaged UPRR section of the rail lines and the wheel loader.

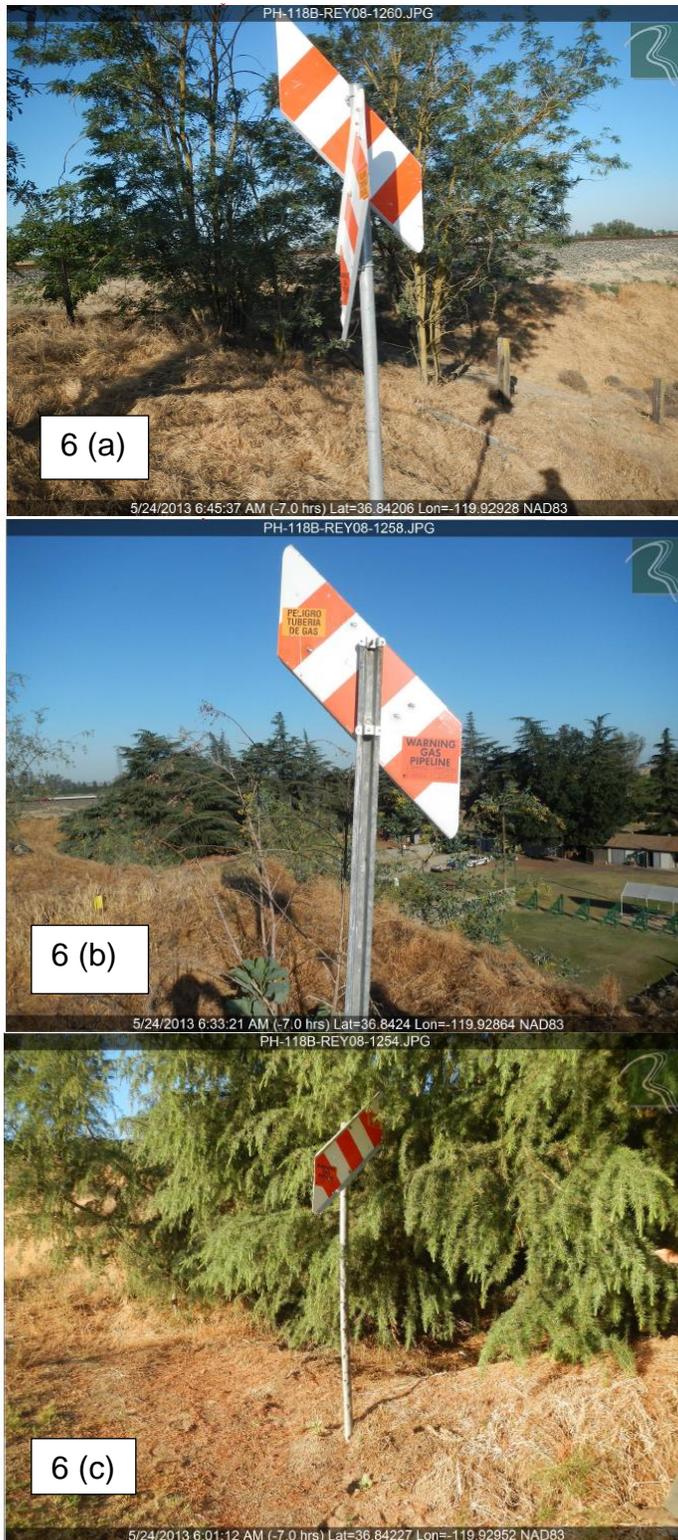
Prior to the incident, PG&E had installed pipeline markers near the incident location. Figures 6 (a) (b) and (c) show the line markers closest to the incident site along with their respective GPS coordinates.

**Figures 6 (a), (b), (c):** Line markers and depth of cover in early 2013 at the incident location.

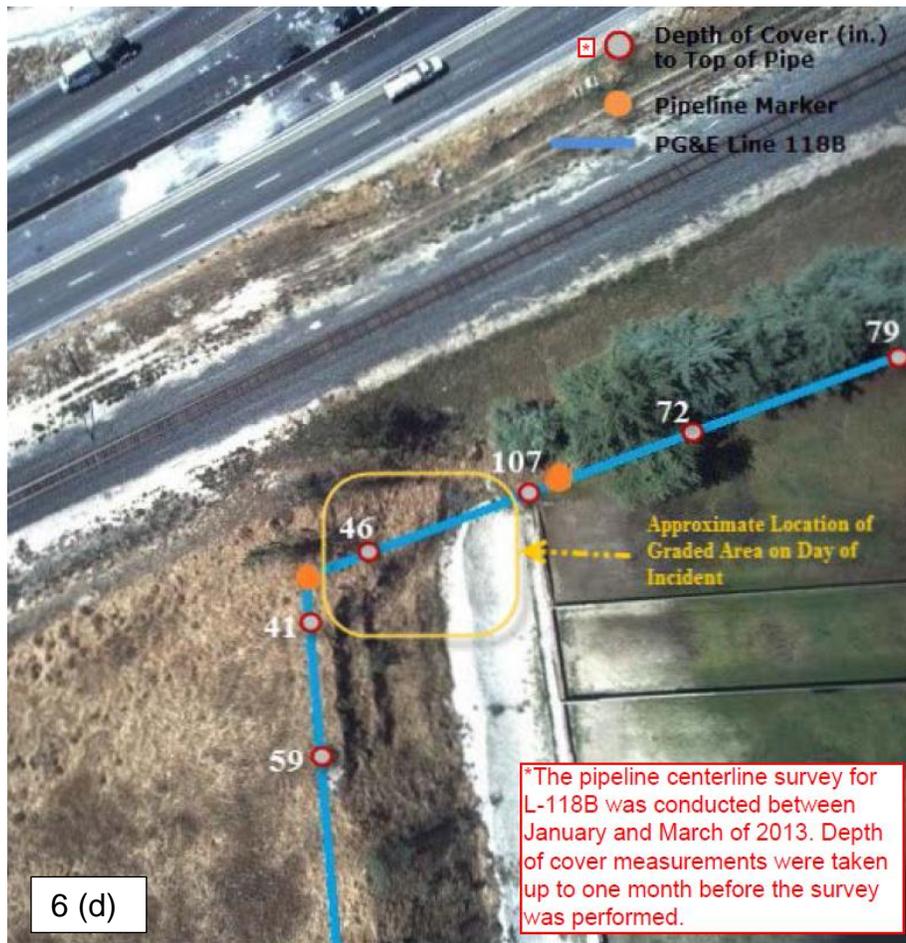
In the immediate zone of the incident, the qualified contractors collected data every 50 feet. They captured the depth in inches to the center of pipe at each point, with a vertical tolerance of +/- 25% of the depth. Figure 6(d) shows that the survey found depth of cover at the points nearest to the location of where the pipeline was damaged of 41 inches, 46 inches and 107 inches.

Figure 6 (d): PG&E 2013 centerline survey results

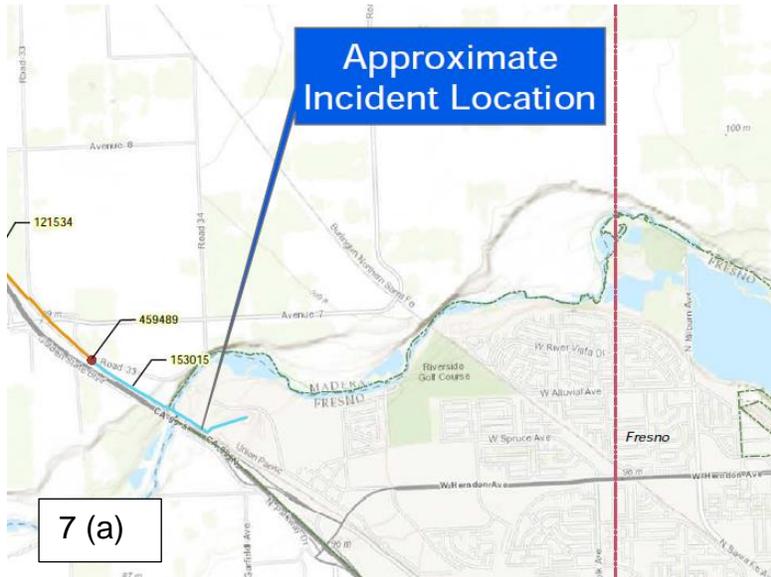
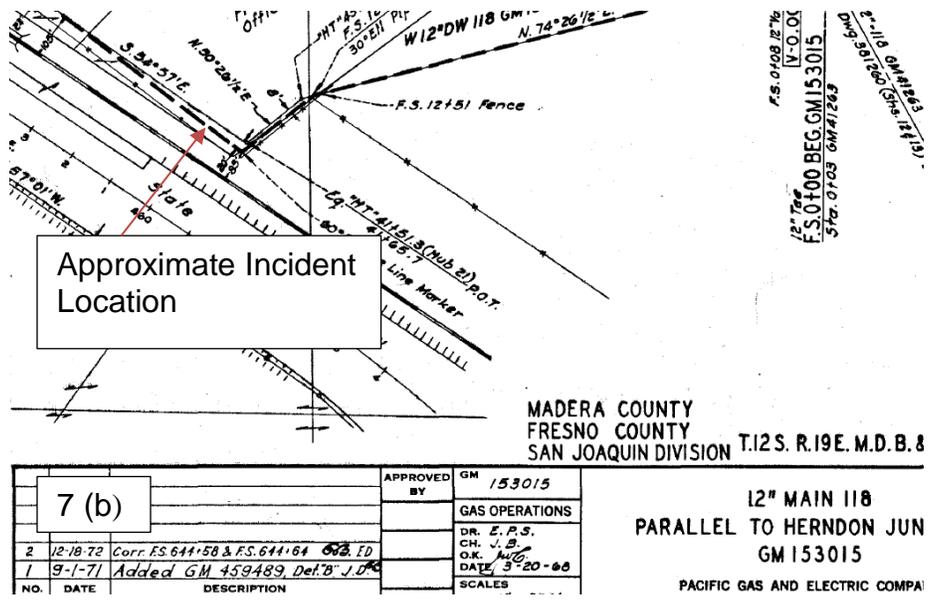
PG&E gas pipeline L-118B was constructed in 1962. On September 5, 1962, a strength test conducted on the pipeline showed a holding pressure of 1575 psi for 24 hours, which is nearly four times the MAOP. The pipeline was placed into service on November 19, 1962. Easement records include restriction from diminishing or substantially adding to the ground cover over the pipeline. Figure 7(a) shows the location of the incident site and identifies drawing number 153015 that contains the as-built drawing. Figure 7(b) shows a portion of as-built drawing 153015 prepared in 1968 identifying facilities around the incident location. The as-built drawing does not specify the depth of cover over the pipeline.

Figure 7 (a), (b): As built plans showing the installation of the pipeline in 1962

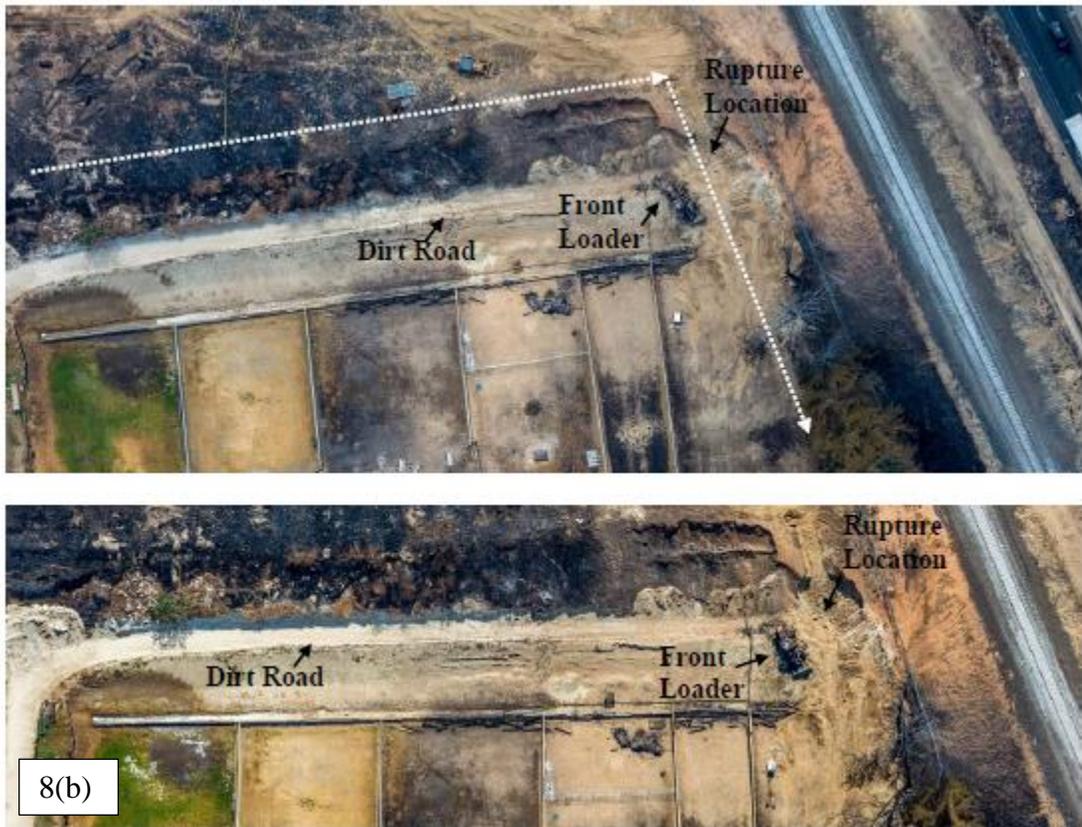
**Figure 8: (a)** Aerial photograph of the incident site after the incident and pipe excavation. The area of pipe rupture is shown by a dotted red line; (b) Aerial photographs of the incident scene taken after the incident and pipe excavation.

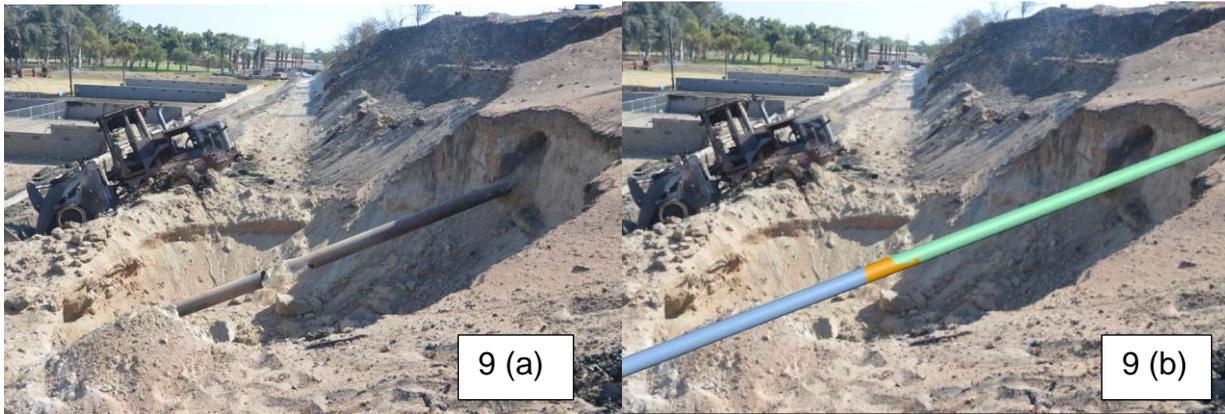
**Figure 9:** (A) Incident scene after the rupture, and (B) A Three-dimensional Reconstruction of the Pipe Overlaid on the Incident Scene

4. The bucket punctured the pipeline and formed two cracks: each propagated circumferentially in opposite directions around the pipe. Figure 9(a) show the incident scene after the rupture and 9(b) shows a three-dimensional extrapolated reconstruction of the ruptured pipe.
5. There is no evidence that progressive damage such as corrosion, stress corrosion, or fatigue was present or contributed to the rupture.
