PUBLIC UTILITIES COMMISSION

GI-2016-05-PGE13-02B

SUBJECT: General Order 112 Inspection of PG&E's Sacramento Division

SUMMARY OF INSPECTION FINDINGS

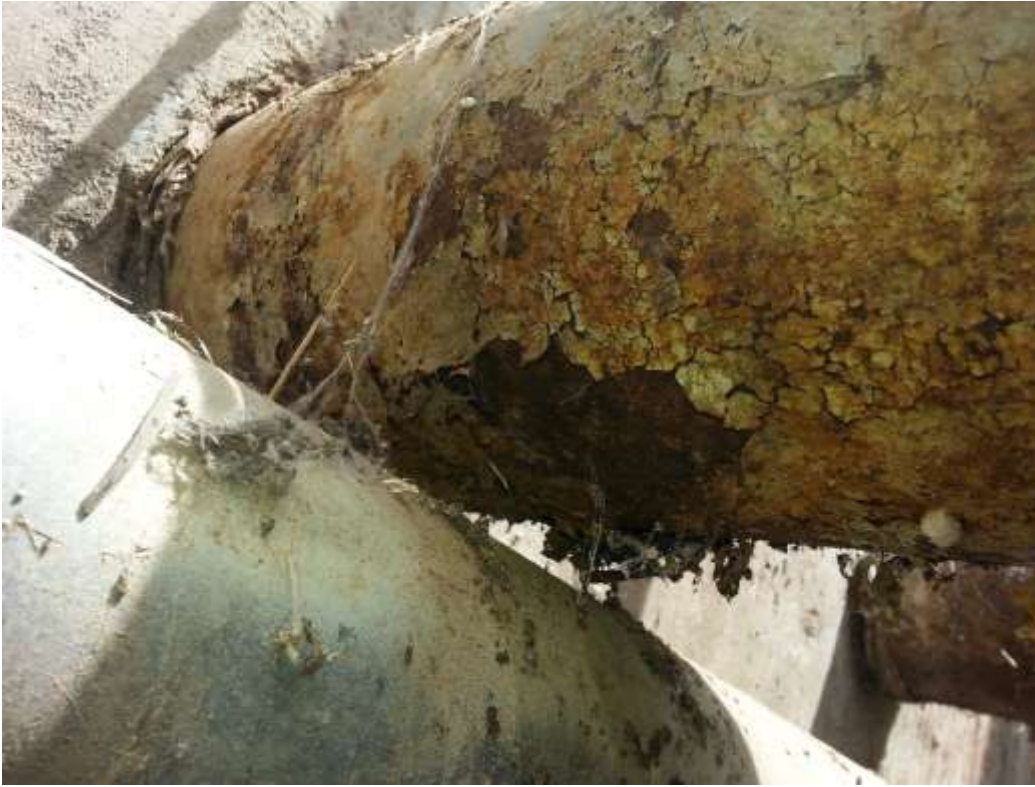
3. SED inspected Regulator Station No. B-19 and observed that regulator R3 failed to lock up. The Division found sulfur deposits on the pilot stem and rebuilt the pilot assembly. SED observed corrosion at Regulator Station No. B-19 (see Figure 1) and requested PG&E to evaluate the type of corrosion and take corrective action.

Figure 1. A photograph of corrosion at Regulator Station No. B-19.

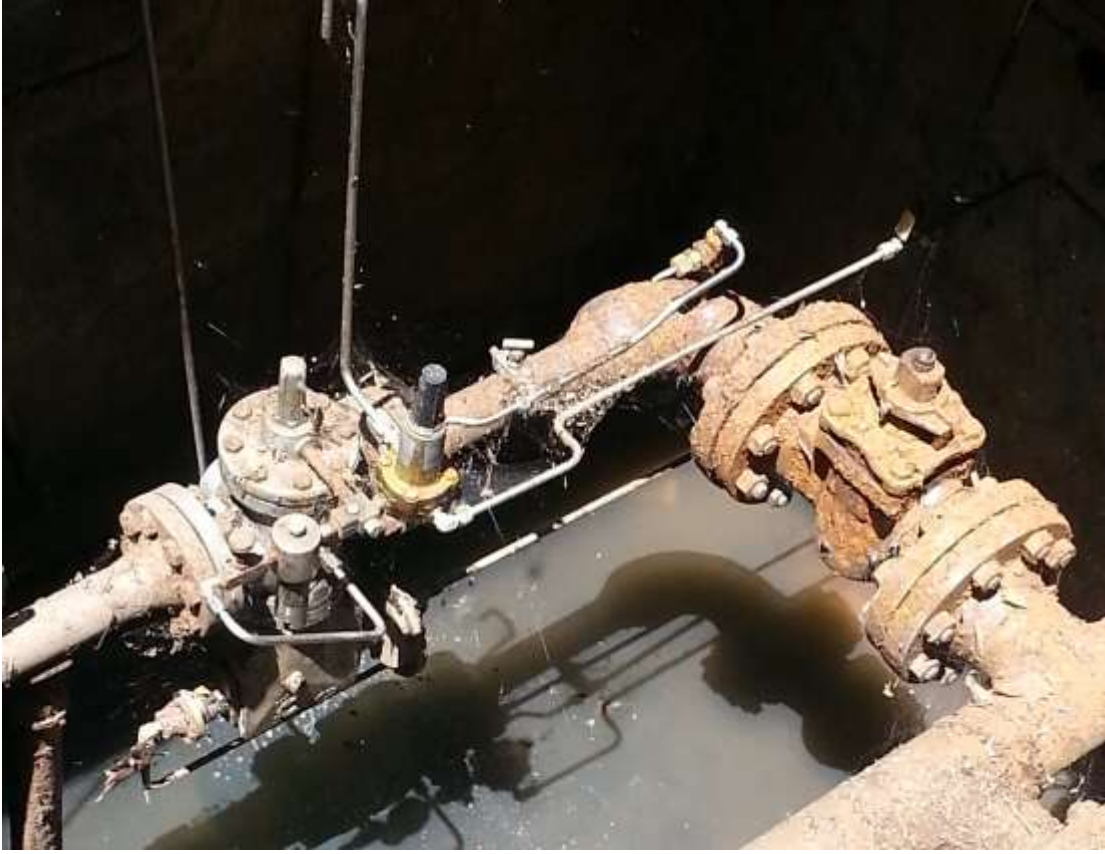
10. SED inspected Regulator Station No. D-22 and observed corrosion (see Figure 2). SED requests PG&E evaluate the type of corrosion and take corrective action.

Figure 2. A photograph of corrosion at Regulator Station No. D-22.
