Re: GI2015-04-SCE70-02A-05-07-09
Southern California Edison Response to CPUC General Order (G.O.) 112-E¹
Operation and Maintenance Inspection of Southern California Edison Company's
Liquid Petroleum Gas (LPG) distribution system in the City of Avalon, CA

Inspection Report and SCE Response

CPUC 2015 Inspection of SCE Catalina Gas System

April 20-24 and November 23, 2015

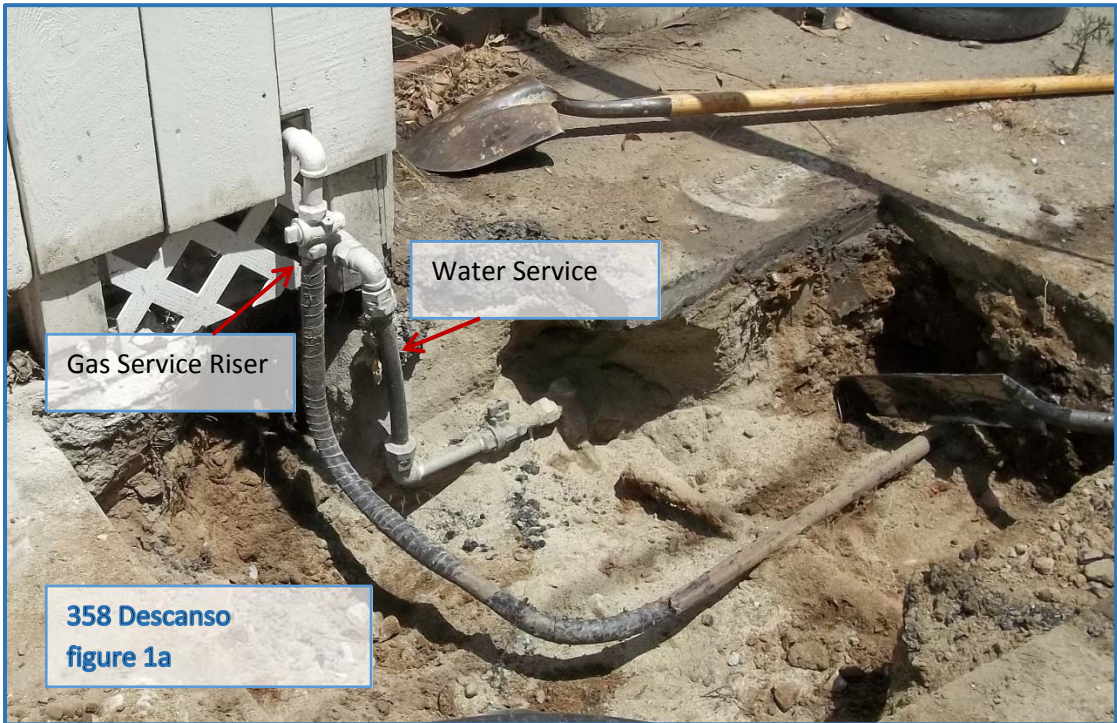
358 Descanso
figure 1a

Gas Service Riser

Water Service

Item 1: *358 Descanso Ave*, the riser has been relocated to eliminate exposure to intermittent and occasional traffic found in this area. Adjustment was completed on or before 07/30/2015. See figure (1a) and figure (1b).

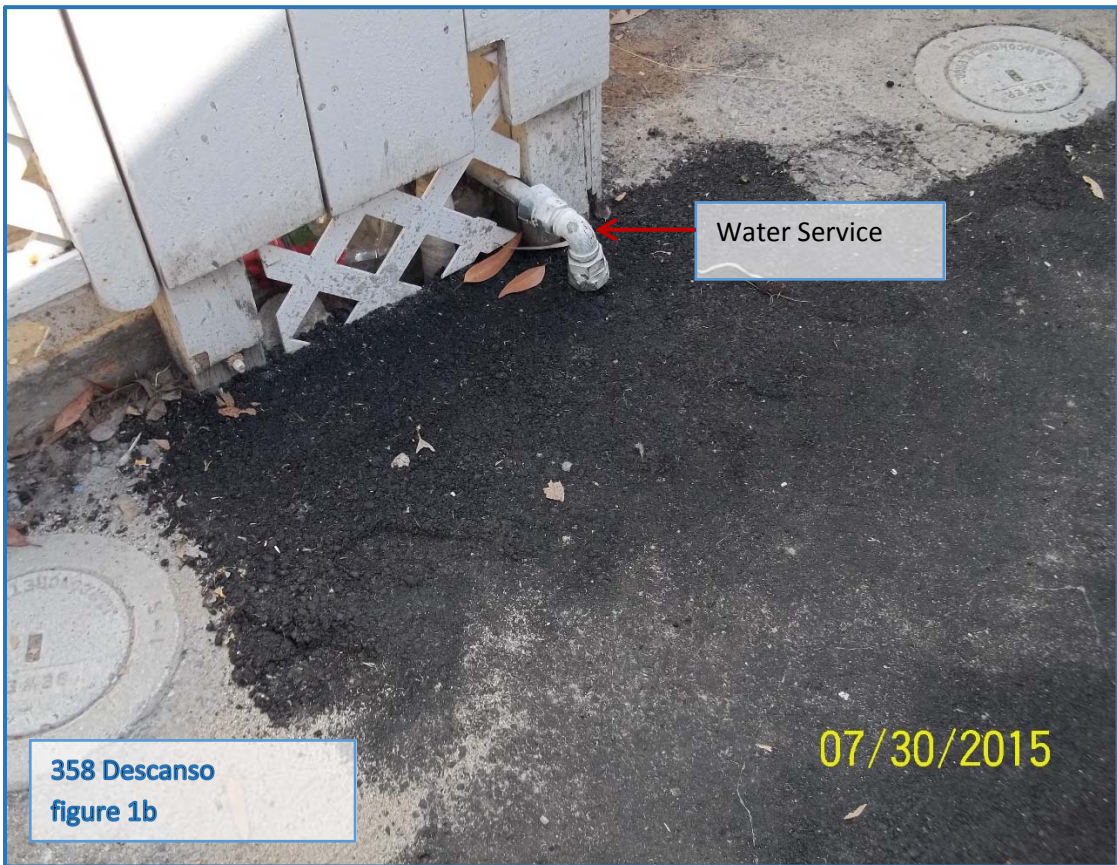
358 Descanso
figure 1b

Water Service
