Public Housing Broadband Site Visit Report

CALIFORNIA ADVANCED SERVICES FUND
BROADBAND PUBLIC HOUSING ACCOUNT

July, 2019

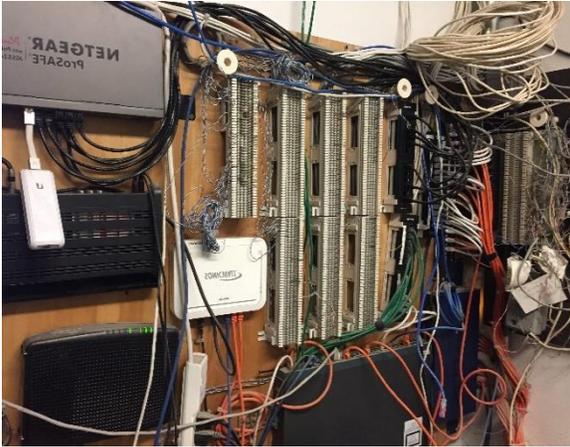
Figure 3: The Fairfax Hotel MDF Room

At The Fairfax Hotel site, the MPOE was at the basement of the building and the Public Housing IT Engineer mentioned to staff the reason of low-performance in the fourth quarter of 2018 was due to an outage that took place by the water flooded into the IT/MDF room from the basement window. Staff determined there was no safe entry or proper access to the IT/MDF room to fix the residential internet services down issues and to check whether the issue pertaining to the ISP or the network. Staff also found the cables from the switches, router, firewall, and ISP modem, in the MDF room, were not wired properly over the cable tray ladder with no proper tie-wraps for the cables going out to the WAPs through a conduit, as you can see below in [*Figure 3*](#).

- Poor operations and maintenance of the infrastructure – all indoor wiring at the MPOE, cables going to the WAPs were hung on the walls and roofs in a bundle, with no cable tray ladder or using conduits. Did not follow industry standards and best practices
- None of the proper Wi-Fi tools were found that could help the grantee to troubleshoot their network
- None of the monitoring tools were available to measure the performance, availability of the network and could generate a dashboard report for quarterly reporting
- Multiple CalSPEED tests were conducted at both the sites and all test results failed to meet the grant’s minimum internet speed requirement

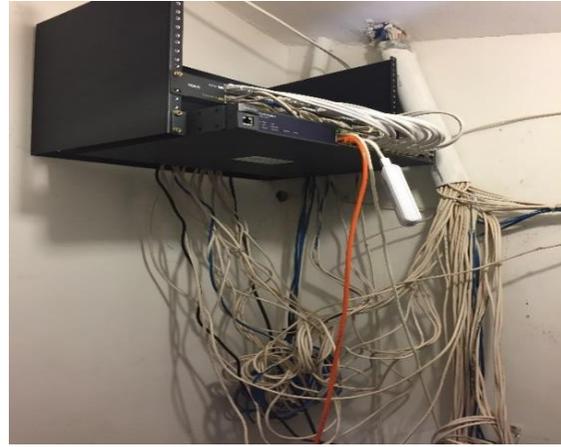
Figure 4: The Stanford Hotel MDF Room

At The Stanford Hotel site, the MPOE was also in the basement without proper ventilation in a small cabinet with several other Comcast dwelling network equipment. Lack of proper airflow between these network equipment to dissipate the heat generated by the equipment. Staff found it was hot in this small closet due to the heat being generated from the equipment. [*Figure 4*](#) below, shows that the cables were not properly trayed on the cable ladder tray nor run through a proper conduit and was hanging like spaghetti with no labeling. Public Housing IT Manager mentioned the reason for a dip in performance during the 4th quarter 2018 was due to the ISP was down because of heavy rains.

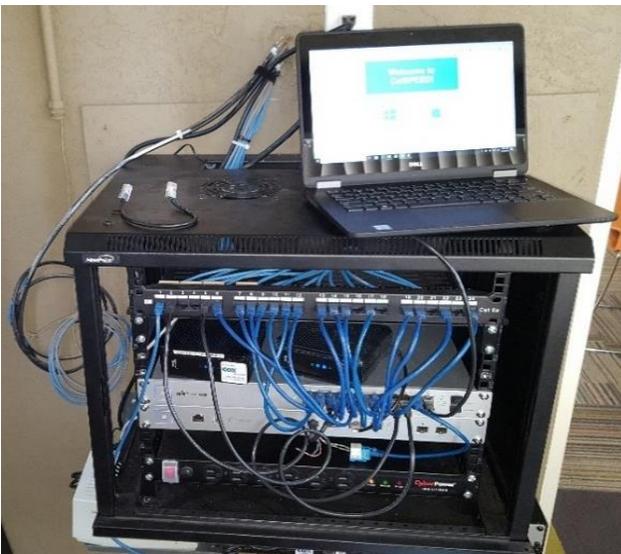
Figure 289: Manzanita (Cypress Cove) MDF Room

At Manzanita Apartments a.k.a. Cypress Cove staff found that the project site was problematic and not in operations. When staff requested for Engineering Design documents, to understand the site network architecture and topology, with Community Housing Works (CHW) IT Manager the response was negative. As per CHW IT Manager, CHW terminated the contract immediately after deployment without taking proper transition. Staff was told that CHW terminated the contract with the network vendor, as CHW thought could operate the network without network vendor support. Also, staff found on this site that the subscribed ISP bandwidth was not adequate to meet the grant's minimum internet speed requirement per resident. The staff did the active survey on this site and found that neither the staff's phone device nor IT Manager's phone device was latching to any of the wireless access points (WAPs) with a provided password by the CHW IT Manager. On further investigating into the issue staff found from the IT Manager that CHW did not have the correct password nor the access to radio units, POE switches, and WAPs. After observing all these issues at the site, the staff decided to abort this site visit and went back to the CHW site office to help this grantee to bring the site back to operations. The staff then took the details of the network vendor from the CHW IT Manager to call the network vendor and request for support. Fortunately, the staff knew this network vendor, it was Innovative IT. On a call with network vendor and CHW IT Manager, staff requested to network vendor to iron out the old differences and support the grantee to bring back the network to operations and transition the engineering design documentation for the grantee's future reference. The network vendor agreed with staff and assured to support the grantee immediately to bring the network back to live for this site. Staff left this site stating to the grantee that the site should be up in running ASAP to comply with the grant requirements. See below pictures, [Figure 49](#) through [Figure 50](#), which were captured by staff during a site walk which found that the grantee has followed the standards during deployment but was problematic and non-operational.

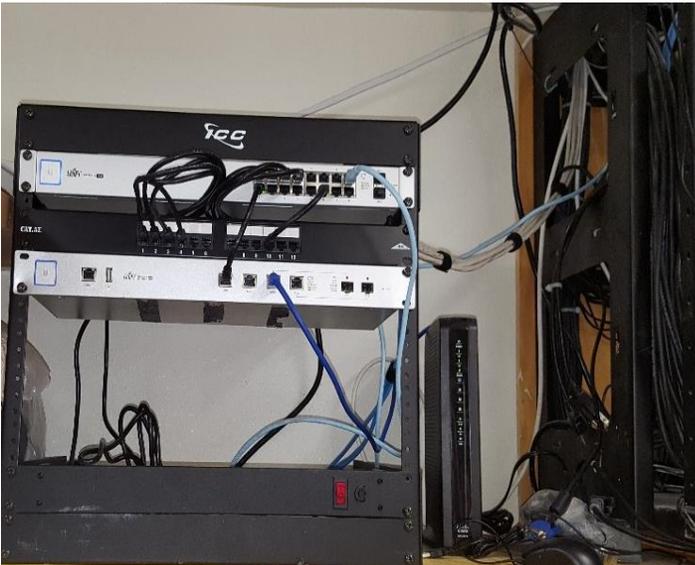
Figure 51: Cedar Nettleton MDF Room

At Cedar Nettleton Apartments staff found that the project site had a spotty network connection with poor coverage. When staff requested for Engineering Design documents, to understand the site network architecture and topology, with Community Housing Works (CHW) IT Manager the response was negative. As per CHW IT Manager, CHW terminated the contract in between the deployment without taking proper transition and gave a contract to another networking vendor. Staff was told that CHW terminated the contract with the first network vendor, thinking the CHW IT team could design better but ended up hiring

another networking vendor. The heatmap generated by the new network vendor for this site shows that the coverage area was not properly mapped with the WAPs to ensure proper coverage for all the residential units. The staff did an active survey on this site followed the site survey checklist and conducted few CalSPEED tests, as per the heatmap provided by the grantee, pointed out the coverage gaps to CHW IT Manager. CalSPEED tests either completely failed or the speed was very bad and not meeting the grant's speed requirement. Staff recommended to the grantee to redo the heatmap and redline the design to adjust the WAPs, repeaters, and radios accordingly to improve the coverage so that all the residential units can avail the minimum internet speed as per grant's requirement. Also, staff found on this site that the subscribed ISP bandwidth was not adequate to meet the grant's minimum internet speed requirement per resident. Staff left this site stating to the grantee that the site should fix the coverage gaps ASAP to comply with the grant requirements. See below pictures, *Figure 51* through *Figure 54*, which were captured by the staff during the site walk, which found that the grantee has followed the standards during deployment but was low performance.

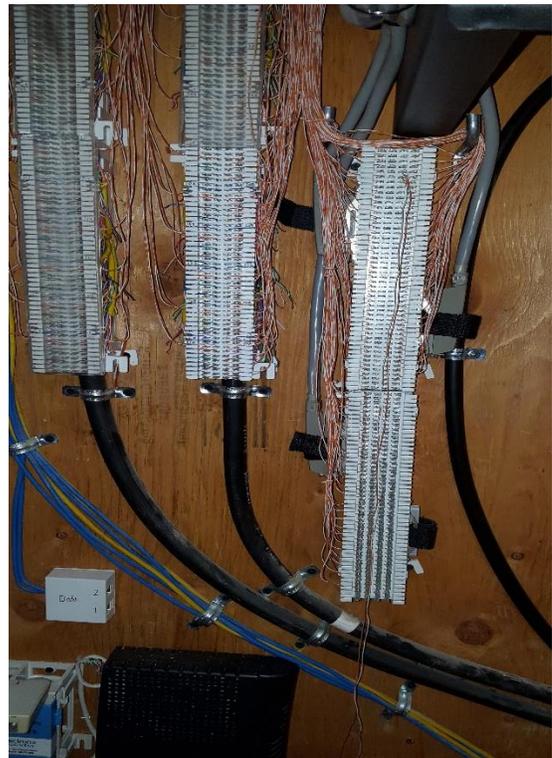
Figure 372: The Orchard MDF Room 66-Block

- For both the sites, the grantee had a contract with the network vendor for operations and maintenance (O&M) and quarterly performance reporting
- Indoor and Outdoor wiring and cables were run through proper conduits and 66 blocks at The Orchard and were wired properly but the face cover to the 66 blocks was missing

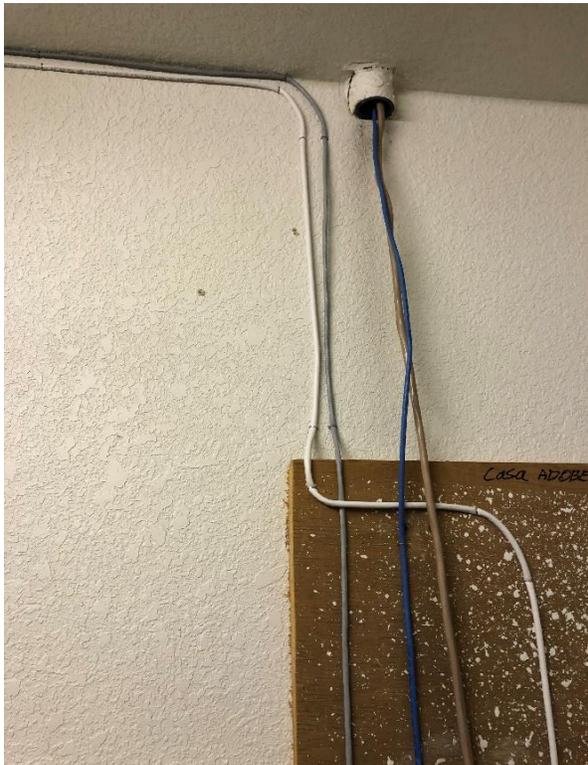
Figure 395 Casa Adobe Cabling from MPOE to WAPs

- No proper labeling was found at the MPOE, so it's not easy to identify which cable is connected to which WAP or network device
- Single-band 2.4 GHz radio technology used, and it could be highly interference prone

- Indoor wiring or cabling on a wall must be cable clipped and not to be stapled. It's prudent to run cables on the overhead tray with properly tie wrapped or through a conduit pipe. Current wiring of Cat6e cables on all the sites was stapled and seen pinched (as shown in the above cabling pictures Figure 63 to 65). This could degrade the network performance and can easily cause wear and tear of the cable
