PROJECT MEMORANDUM
SCE DPV2 TRANSMISSION PROJECT

To: Billie Blanchard, Project Manager, CPUC
From: Vida Strong, Aspen Project Manager
Date: September 23, 2014
Subject: Monthly Report for July 21 through August 30, 2014

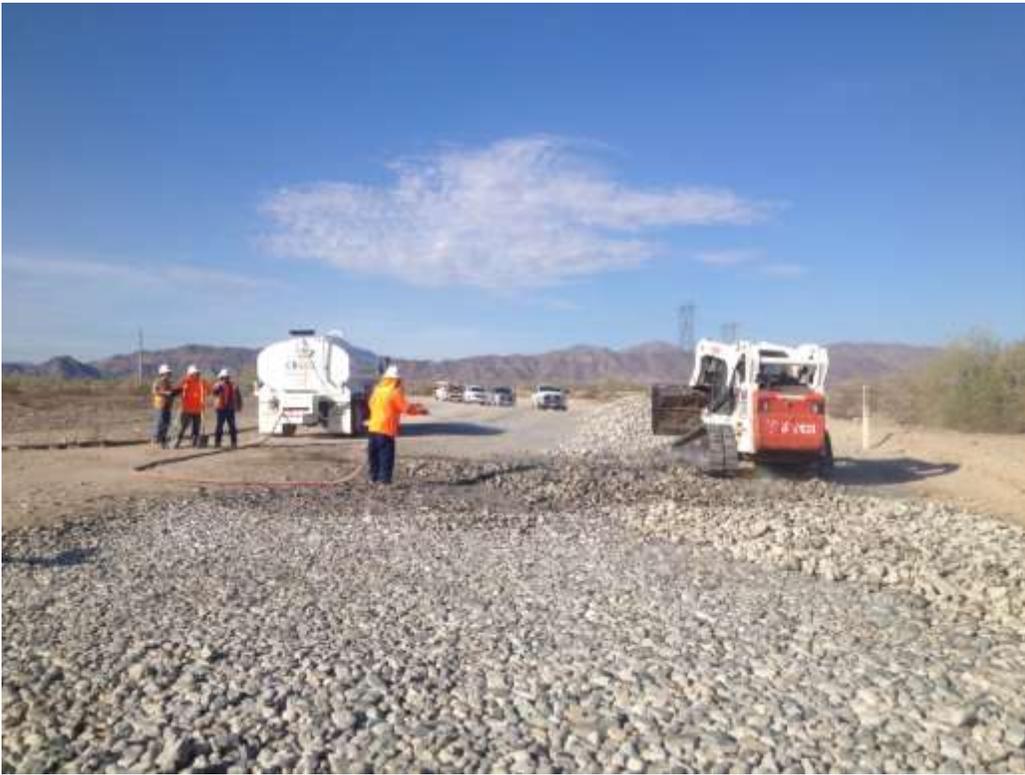
Figure 1. Construction entrance stabilization (Photo courtesy of FRED).

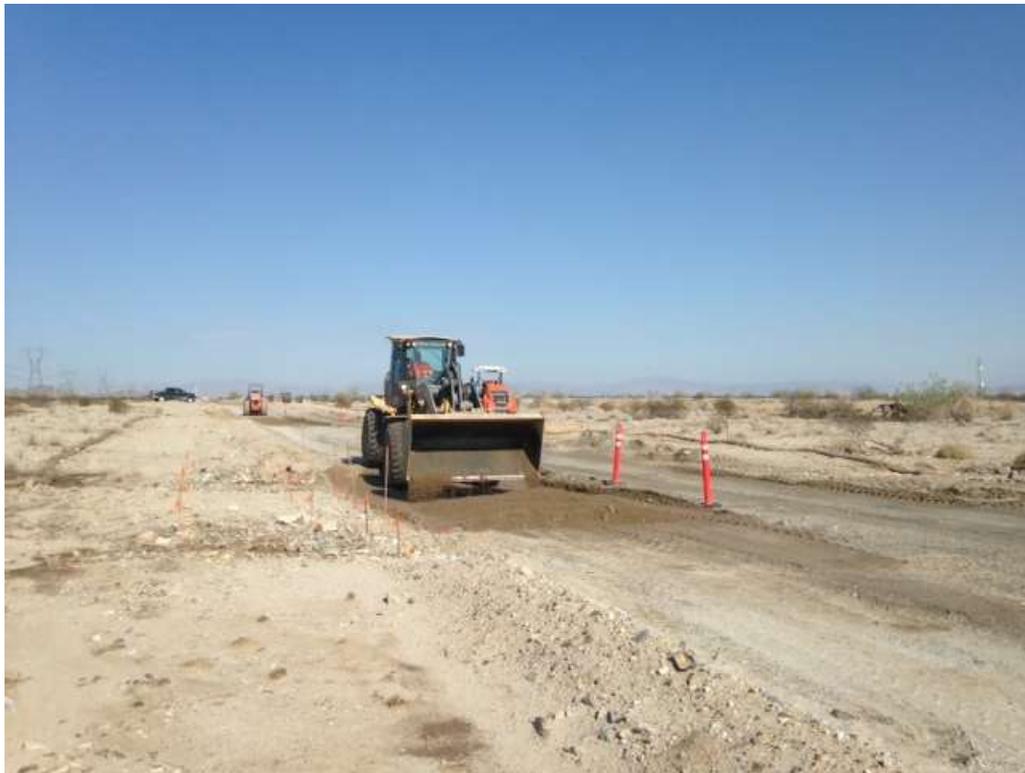
Figure 2. Grading activities along the access road.

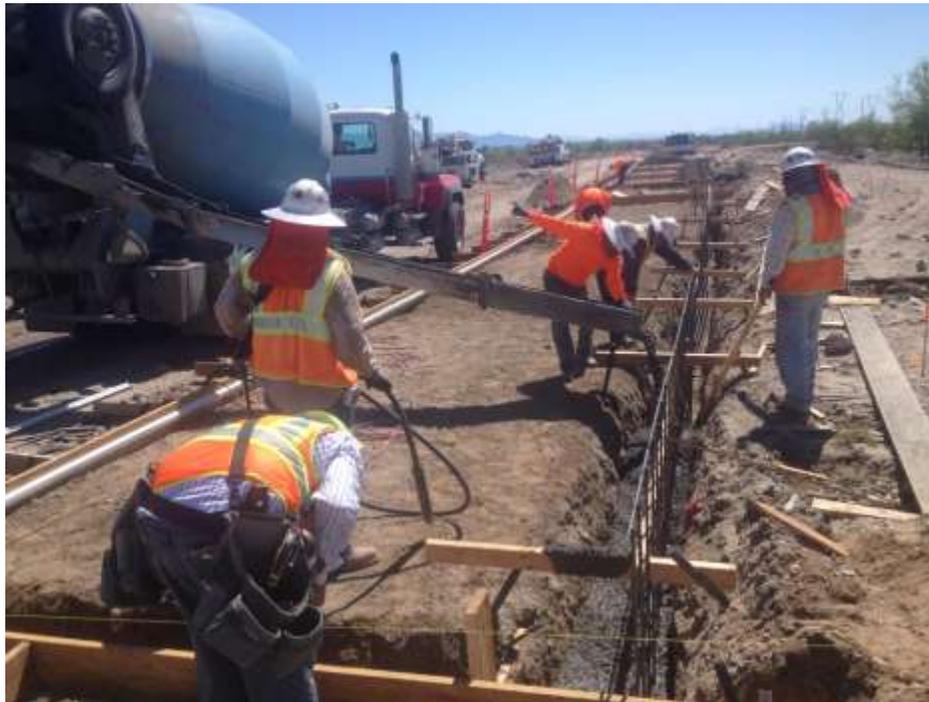
Figure 3. Concrete pouring for Arizona crossing along access road (Photo courtesy of FRED).

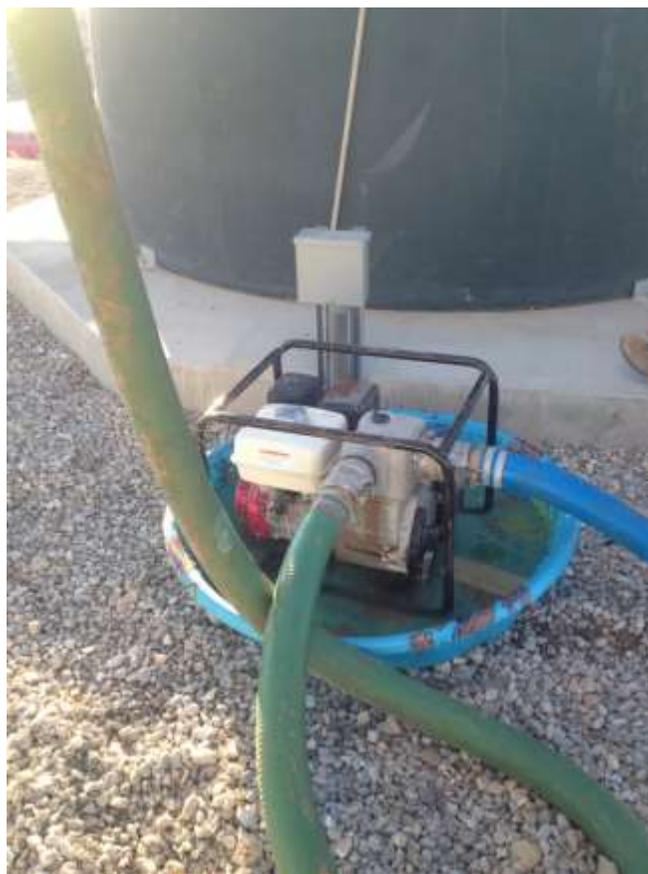
- On July 23, the onsite Biologist swept the staging area where the contractor had staged their water tank and discovered the motor that was used to pump water from the ground water tank up to the dump tank was placed in proper containment; however, the containment filled with water from the leaking hoses and created an oil, gasoline, and water mixture (see Figure 4). The Biologist notified the contractor foreman and the SCE site representative. The issue was resolved as the motor was removed and put into separate containment. The contaminated water was covered with visqueen until the contractor arrived with spill drums for proper containment and disposal.

Figure 4. Pooled contaminated water near water tank in staging area (Photo courtesy of FRED).

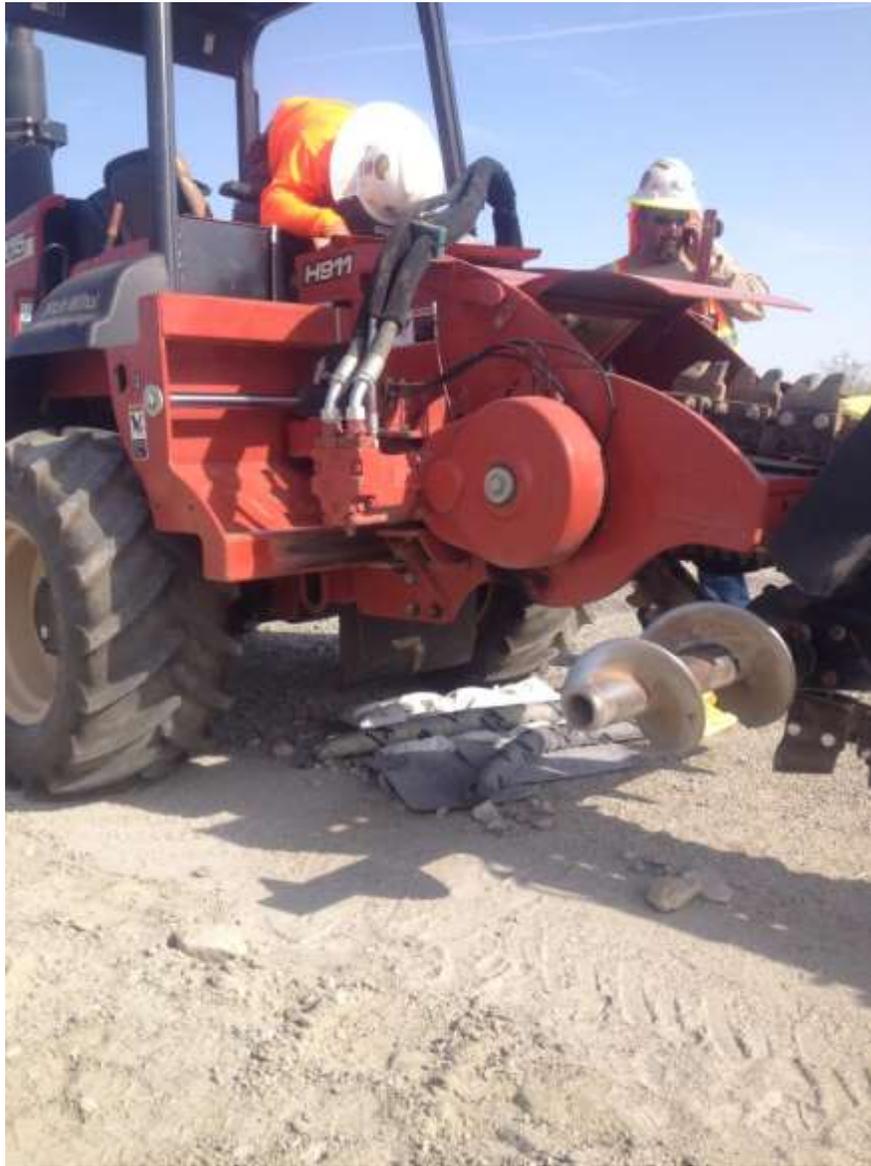
- On July 31, a hydraulic leak was discovered on a line associated with the "ditch witch" excavator. The General Monitor observed the crew work quickly to contain the spill. The crew was unable to move the ditch witch, so they used adsorbent pads to soak up what was on the ground and the small drips that continued to leak from the piece of equipment (see Figure 5). When the crew was able to fix the broken hose, they moved the piece of equipment and dug up all of the contaminated soil and placed it into a hazardous material bin. It was estimated that approximately less than a gallon was spilled (40-60 ounces).

Figure 5. Hydraulic leak from excavator being contained by crew (Photo courtesy of FRED).
