Re: Monthly Report Summary #38 for Aliso Canyon Turbine Replacement Project

CPUC Site Inspection Report

Aliso Canyon Turbine Replacement Project CPUC Site Inspection Form

Project	Aliso Canyon Turbine Replacement	Date:	July 25, 2017
Project Proponent	Southern California Gas Company and Southern California Edison	Report #:	VS135
Lead Agency:	California Public Utilities Commission	Monitor(s):	Vince Semonsen
CPUC PM:	Andrew Barnsdale, Energy Division	AM/PM Weather:	Partly cloudy and warm with a slight breeze
E & E CM:	Lara Rachowicz	Start/End time:	1000 to 1130 at SCG
Project NTP(s):	Central Compressor Site (CCS) (NTP-3), 12-kilovolt (kV) power line (NTP-3), and PS-42 Fill Site.

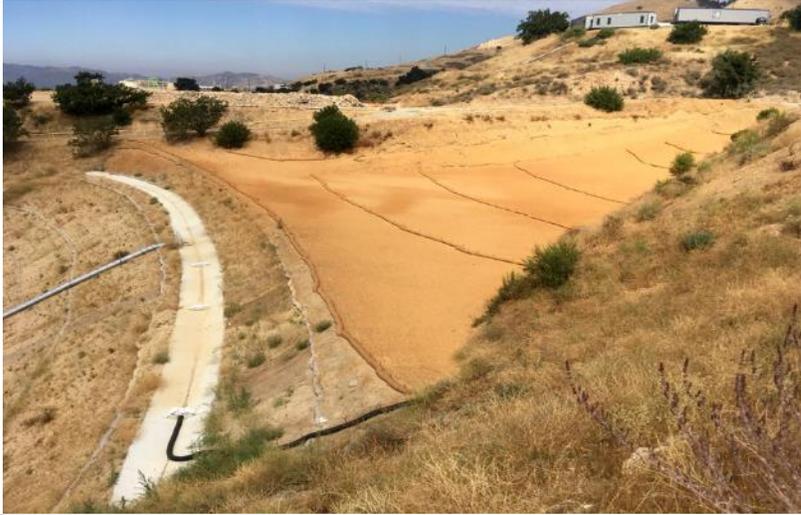
The PS-42 Fill Site appeared to be completed and stable (Photo 1). There were large quantities of mustard growing within the cleared and otherwise undisturbed portions of the PS-42 Fill Site.

Photo 1 – The PS-42 Fill Site appeared to be completed and stable.
7/25/17	A1 Pole Site and Natural Substation

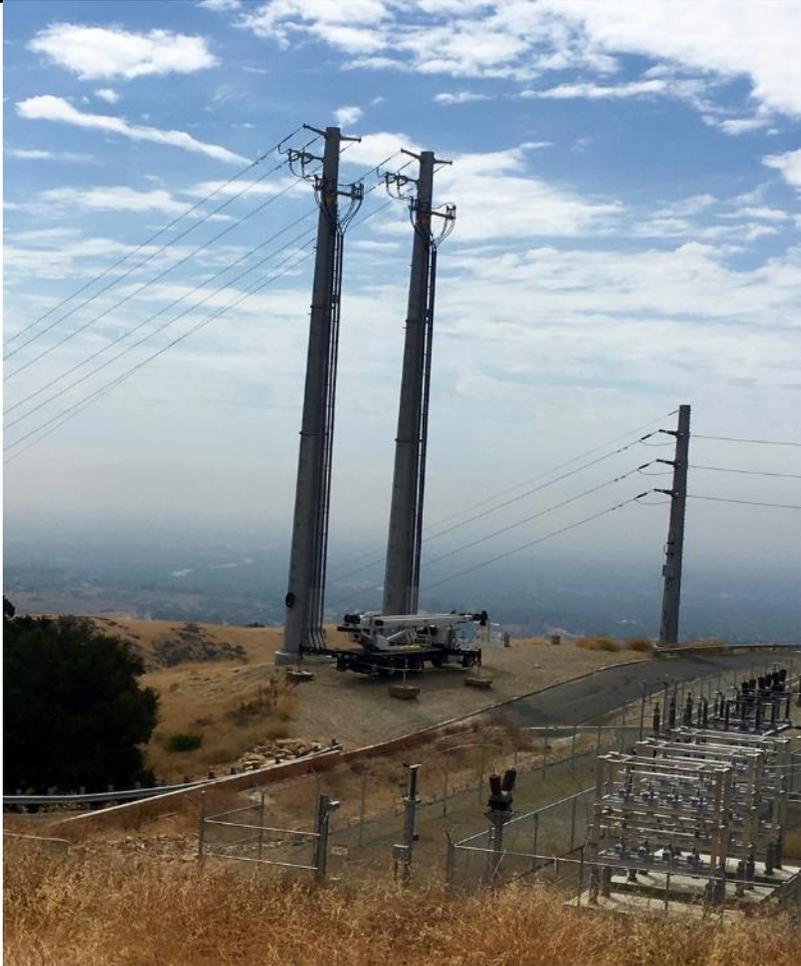
At the A1 pole site near the Natural Substation, no construction activities were observed; however, a man-lift was parked near the base of the poles (Photo 2). Leftover stakes and construction fencing were visible immediately downslope from the poles (Photo 3).

Photo 2 – A man-lift was parked below the poles.

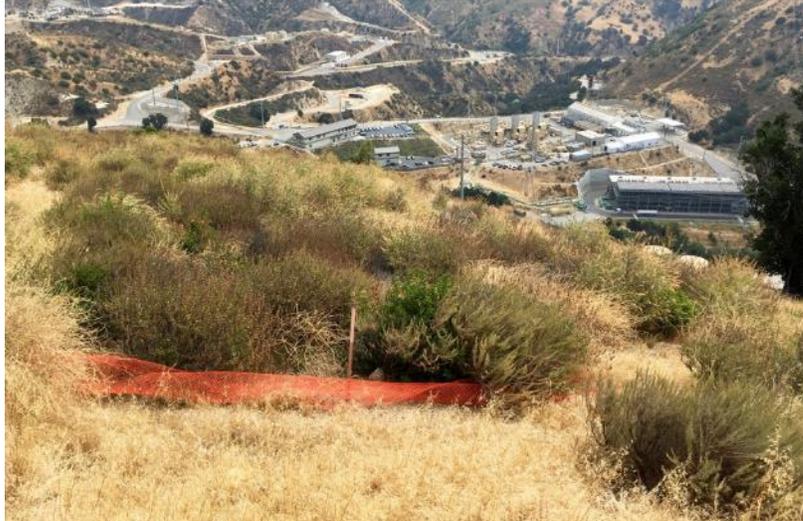
Photo 3 – A piece of leftover orange construction fencing is visible immediately downslope from the Natural Substation.
7/25/17	Oak Tree Mitigation Site

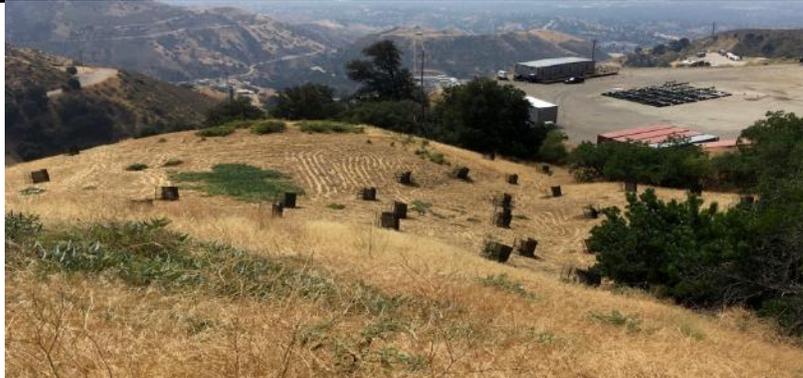
The oak seedlings/saplings within the Oak Tree Mitigation Site appeared to be healthy, with some growing out of the top of the cages. The area had been mowed and the cages were well maintained (Photo 4).

Photo 4 – Oak trees appeared to be in good condition; the area had been mowed and the cages were in good repair.
7/25/17	12 kV Poles

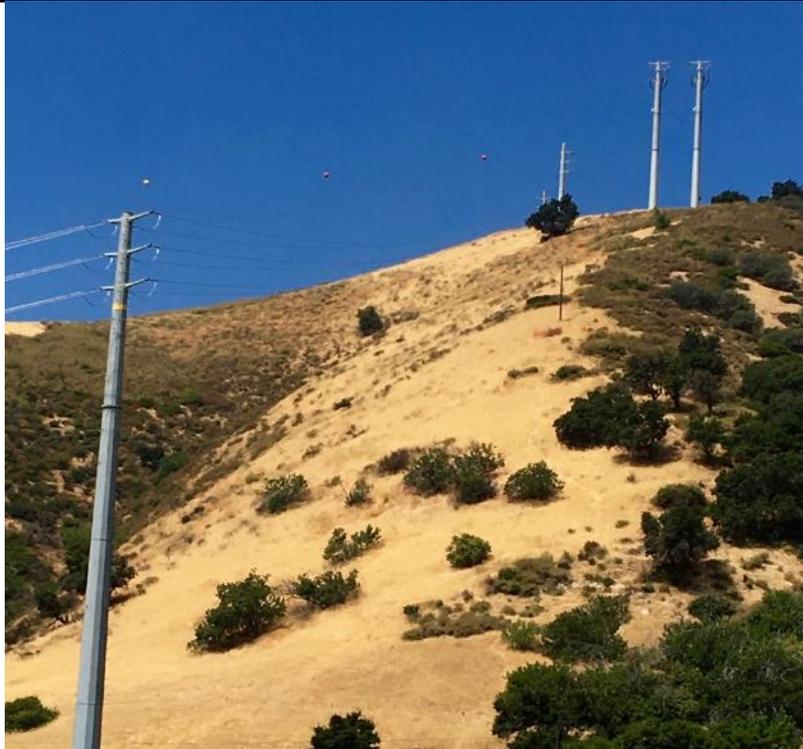
At the 12 kV PPL poles, some orange construction fencing remained around the New ADSS Inset Pole (Photo 5).

Photo 5 – Looking up the hill towards the new ADSS Inset Pole from the new Admin/IM Building.

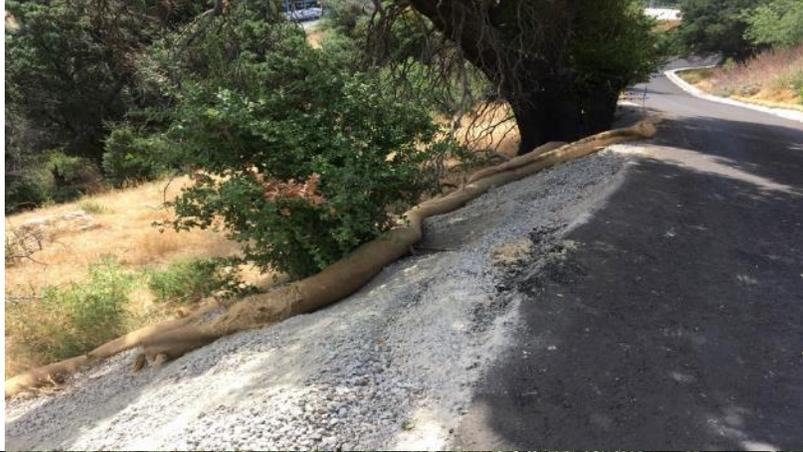
At the A2 pole crane pad and access road, the best management practices (BMPs) required maintenance/repair. Degraded straw wattle had slid into the road shoulder and was wrapped around an oak sapling (Photo 6). At several locations, oak and willow branches were growing through orange construction fencing (Photo 7). During removal of the fencing, care should be taken to minimize the damage to the tree branches.

Photo 6 – BMPs had slid into the road shoulder and were wrapped around an oak sapling.
7/25/17	A2 Pole Site

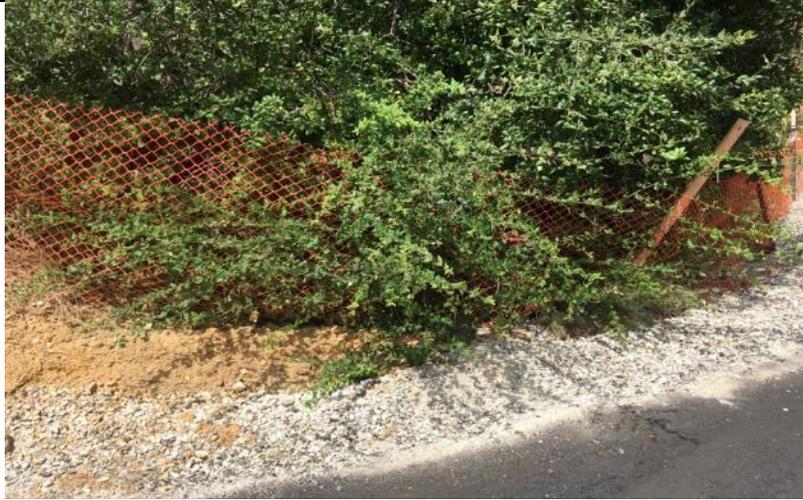
Photo 7 – Construction fencing had oak tree branches growing through it
7/25/17	CCS

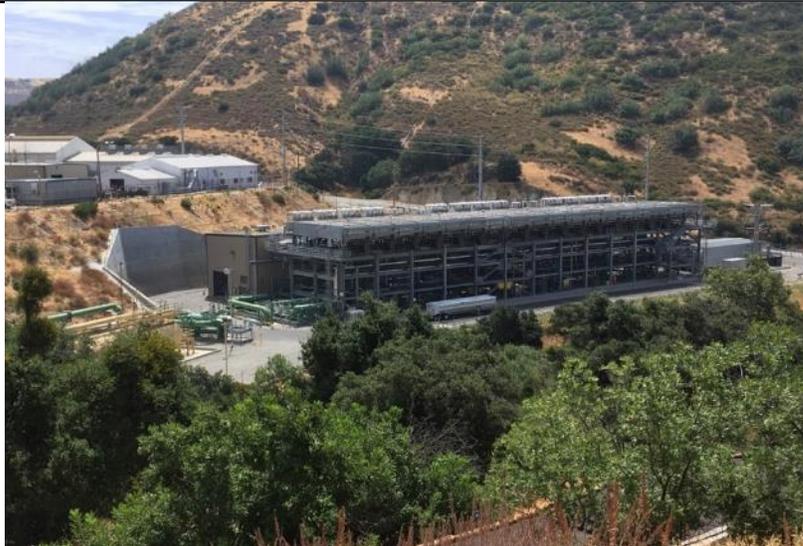
Photo 8 – Overview of the CCS; there was minimal activity during the site visit
