Aliso Canyon Turbine Replacement Project Construction Non-Compliance Report

Incident Date:	<u>March 5, 2015</u>	Report No.:	<u>NCR-03</u>
Date Submitted:	<u>April 16, 2015</u>	Location:	<u>Aliso Canyon Natural Gas Storage Field</u>
Level:	<u>Level 3 Non-Compliance</u>	Relevant Plan/Measure:	<u>MMCRP; SWPPP; NPDES General Permit; APM BR-1b; APM BR-2; APM BR-5; APM GE-2; NTP-3</u>
Current Land Use:	<u>Disturbed; Coast live oak</u>	Sensitive Resources:	<u>Hydrology, Biology (Oak trees)</u>

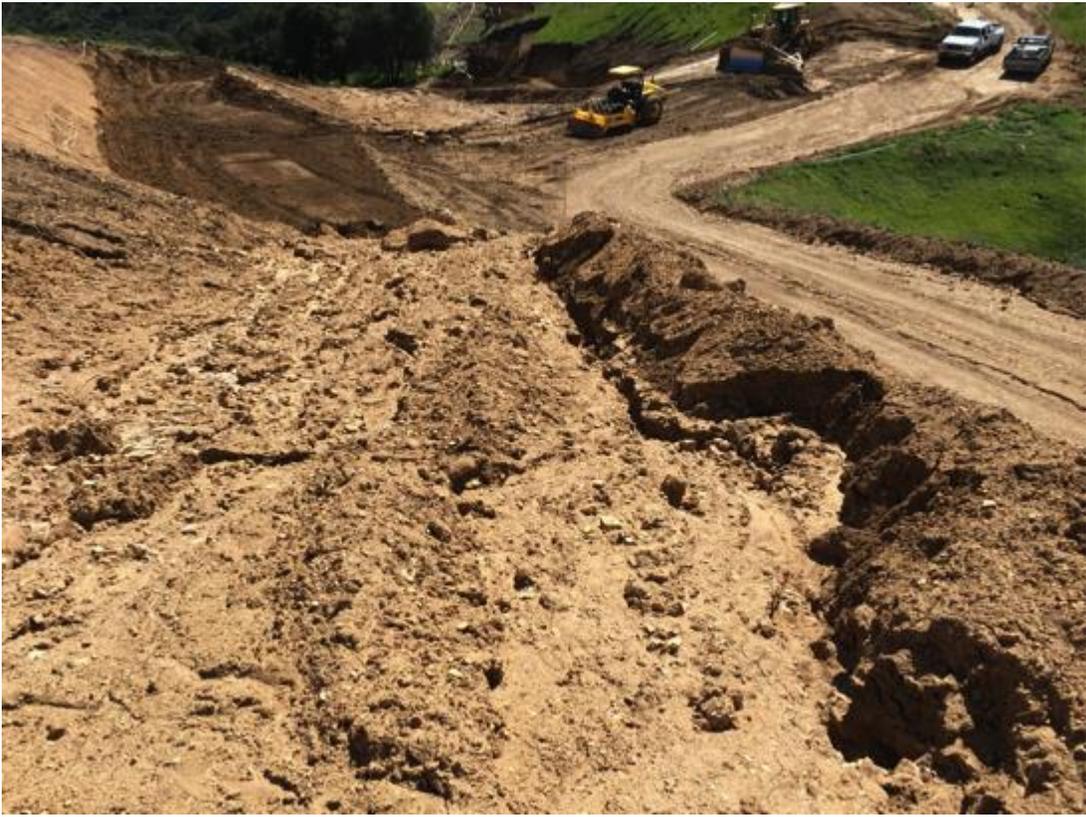
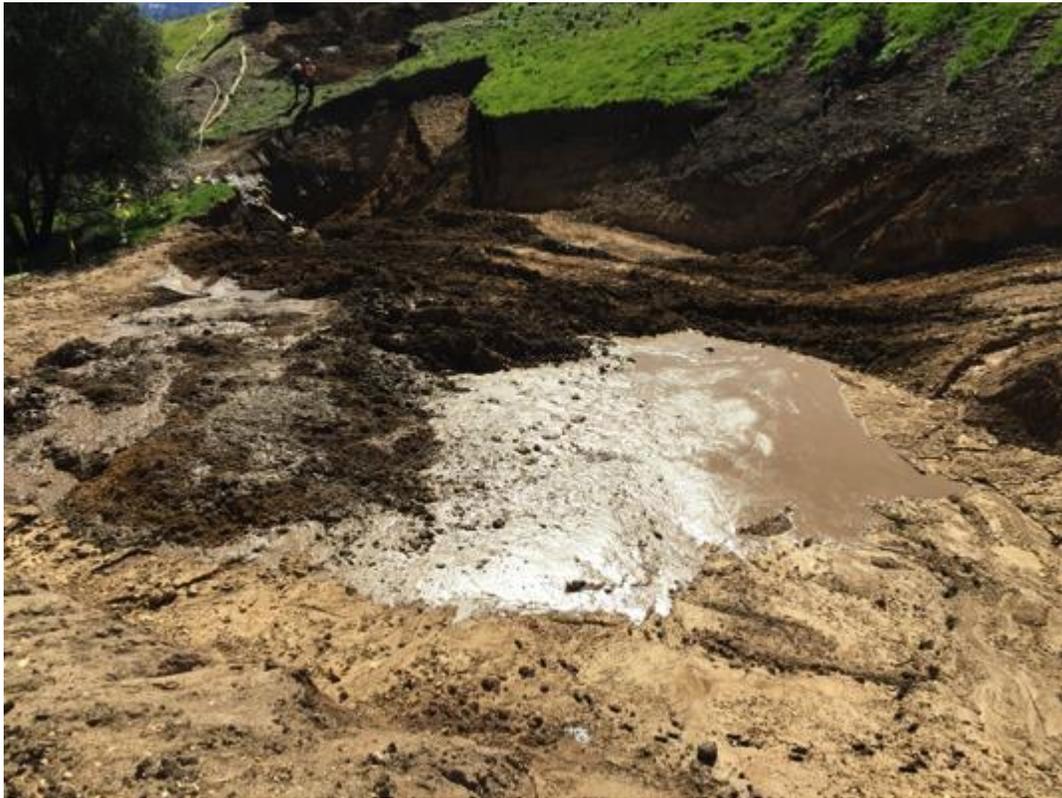
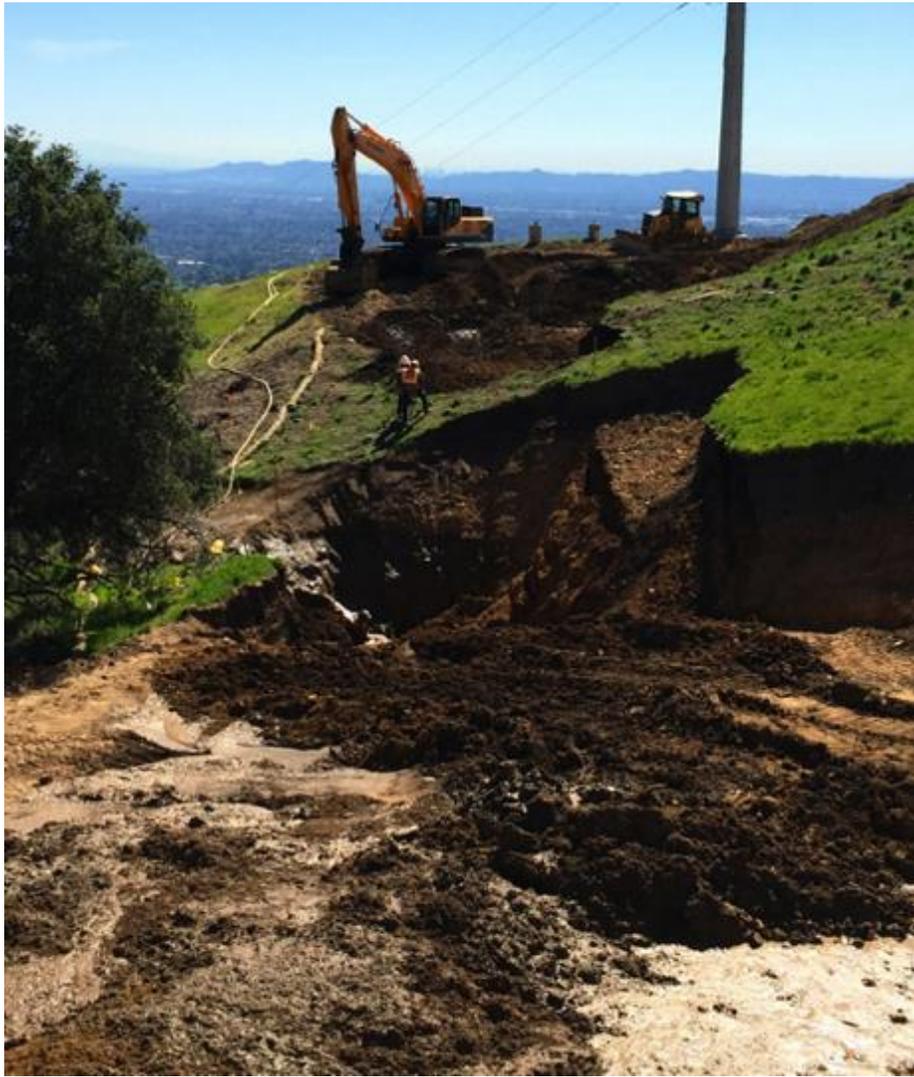
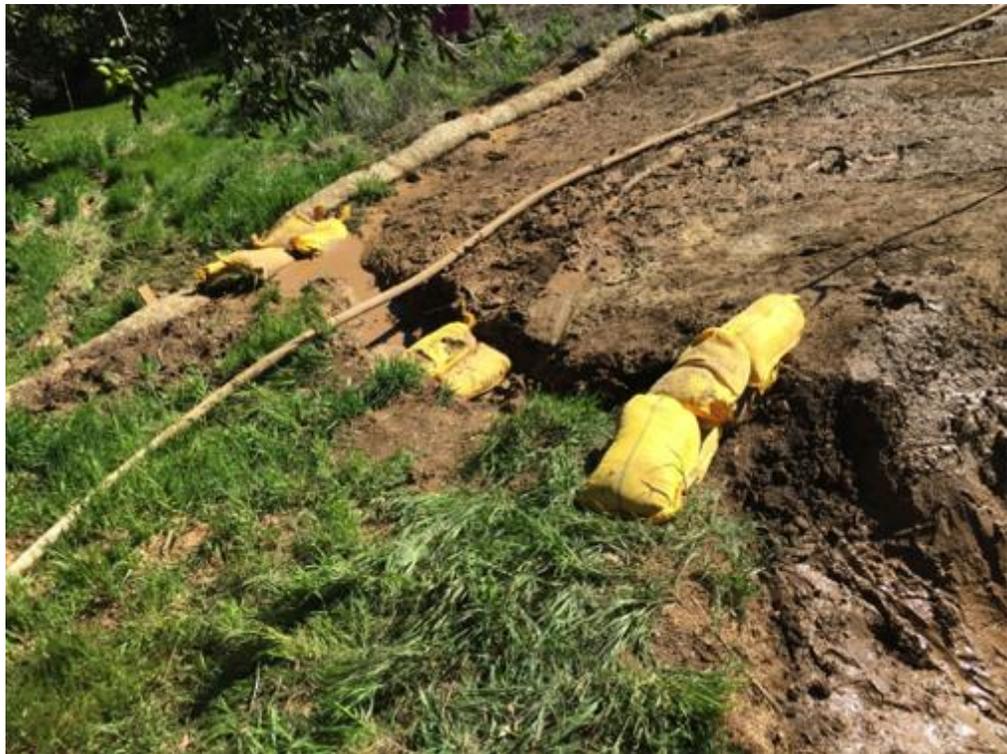
Photos from March 5, 2015

On Thursday March 5, 2015 during the weekly site inspection visit, the CPUC's Compliance Monitor, Vince Semonsen, noticed evidence of erosion at the Natural Substation and Natural Substation Access Road work site (Natural Substation). According to the Compliance Monitor, no BMPs were installed on steep slopes with exposed soil, including on the access road being constructed, causing water to reach a high speed as it moved uninhibited down these slopes. Some BMPs (e.g., fiber rolls) were installed around the perimeter of the work site, but sediment-laden water traveling at high speed overtopped perimeter BMPs. Runoff subsequently traveled into the adjacent oak tree swale, causing erosion and transporting sediment into the oaks.

In accordance with the project's MMCRP, proper BMPs (e.g., silt fencing, fiber rolls on steep slopes) should have been installed to prevent erosion and, in particular, to protect the oak trees from sediment deposition (APM GE-2). Photos from the inspection show erosion rills down the middle of the access road that was being constructed, an overflowed excavation/containment area at the base of the access road, missing and degraded BMPs, and evidence of erosion and sediment deposition under the oak tree canopy below the Natural Substation (see Attachment 1). In addition, no exclusionary fencing to protect the oak trees had been installed, as required by APM BR-1b, APM BR-2, and APM BR-5.

- Waiting for the forecast to predict that a storm is at least 50% likely before installing BMPs in active construction areas is not erring on the side of caution and increases the risk of being caught without enough time to prepare BMPs. As in the case of the March 2015 storm, the forecast changed quickly from when it was initially forecasted as small and unlikely on a Thursday/Friday to certain and large over the weekend. SCG should consider installing BMPs on active slopes if no work will occur on a slope for several days, especially if there is a chance of precipitation;

- While active construction is occurring and some slopes are not protected by BMPs, SCG should consider increasing perimeter/runoff control and runoff control beyond what would be needed if slopes were also protected;
