Re: Monthly Report Summary #4 for the Valley-Ivyglen 115-kV Substation (VIG) Project

Valley – Ivyglen Subtransmission Project CPUC Site Inspection Form

Project:	Valley – Ivyglen Project	Date:	October 22, 2020
Project Proponent:	SCE	Report #:	VS008
Lead Agency:	California Public Utilities Commission	Monitor(s):	Vincent Semonsen
CPUC PM:	Patricia Kelly, Energy Division	AM/PM Weather:	Overcast and cool, winds are calm
CPUC-CM (WSP):	Chuck Cleeves	Start/End time:	0600 hrs – 1000 hrs
Project NTP(s):	NTP-1.

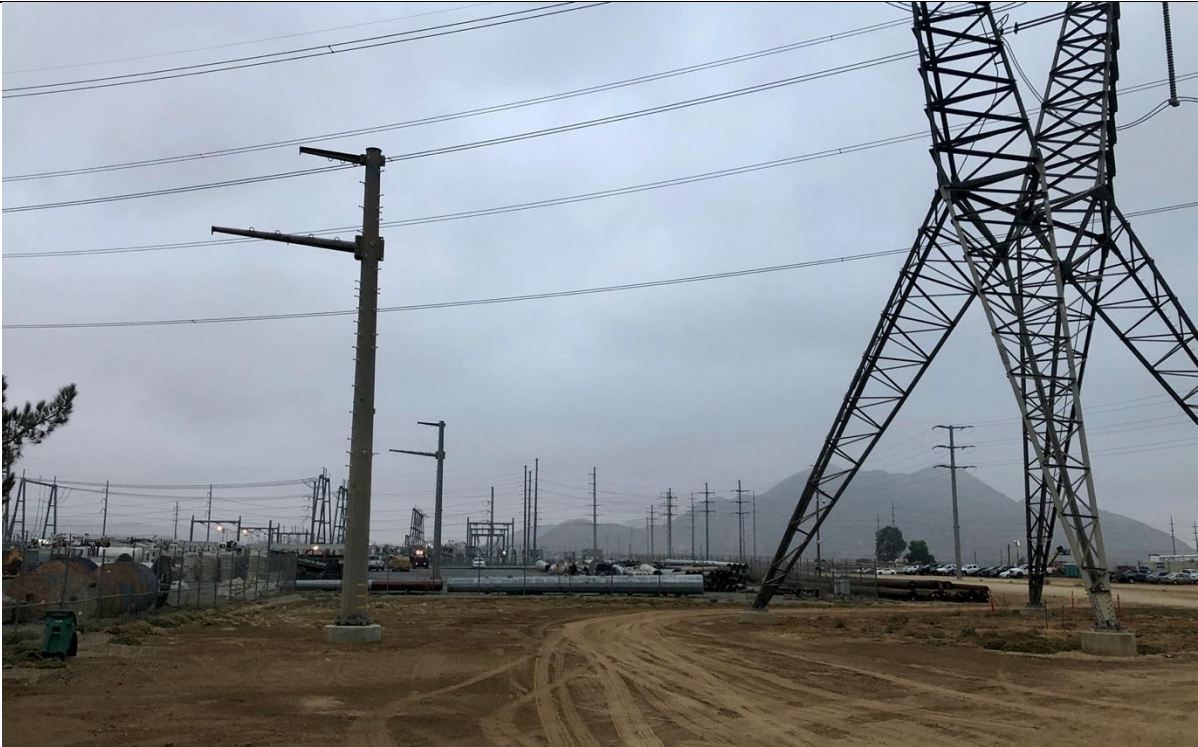
Photo 1 – Newly installed TSPs 003 and 004 just west of the Valley Substation. Photo facing east

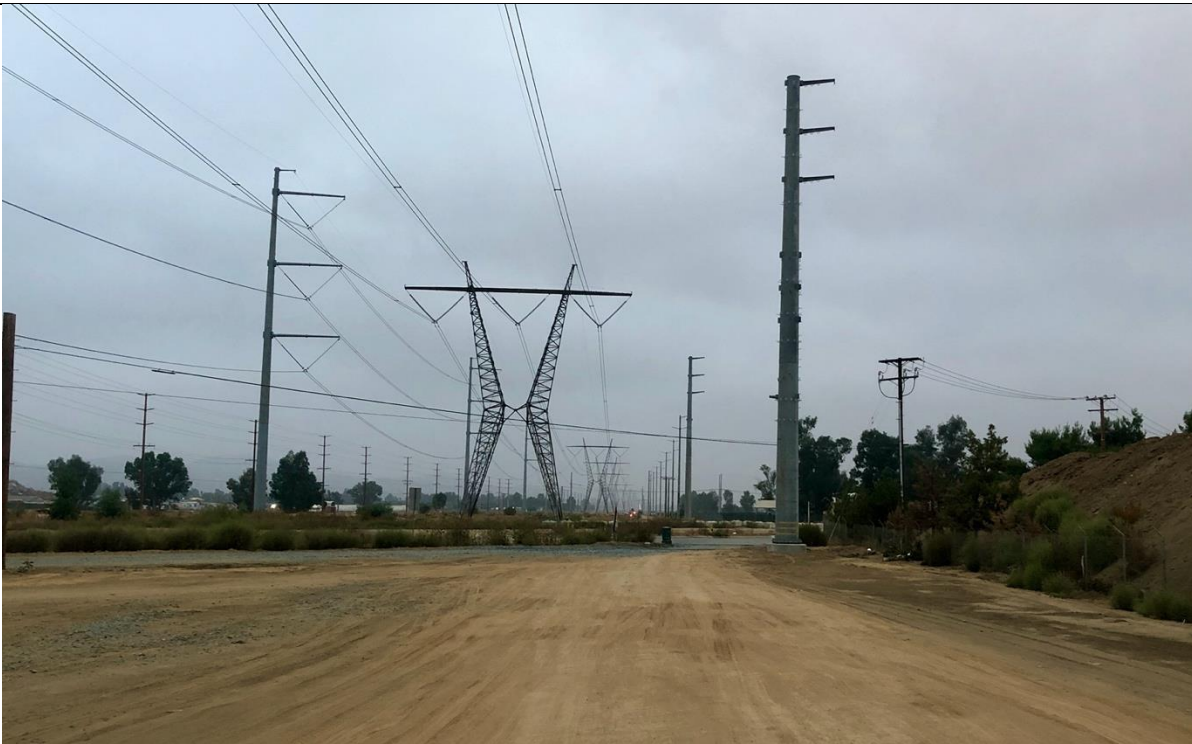
A photograph showing a wide, unpaved dirt road in the foreground, leading towards a series of high-voltage power line towers. The towers are steel lattice structures with multiple cross-arms. The sky is overcast and grey. There are some trees and bushes along the sides of the road. The overall scene is an industrial or utility site.	Photo 2 –A number of newly installed TSPs heading west from the Valley substation. Photo facing west

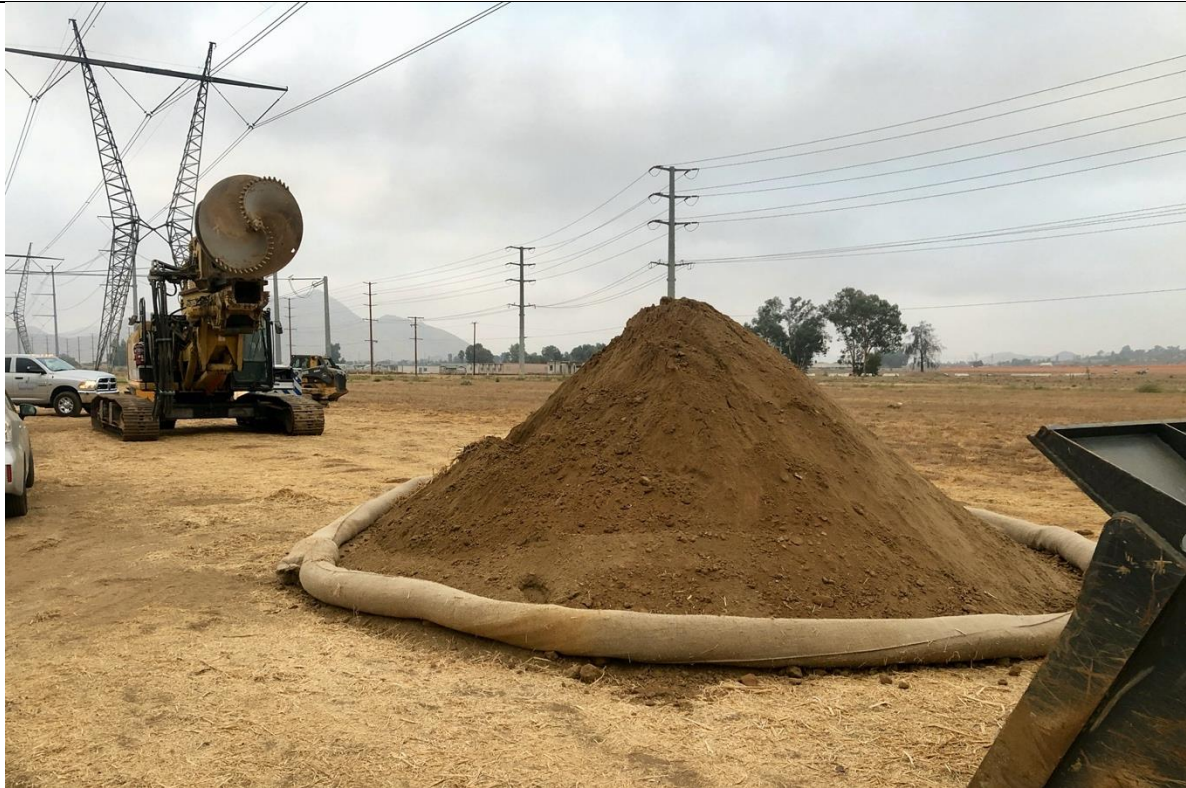
Photo 4 – The spoil pile from drilling the foundation hole at tower site #0018E. Photo facing north

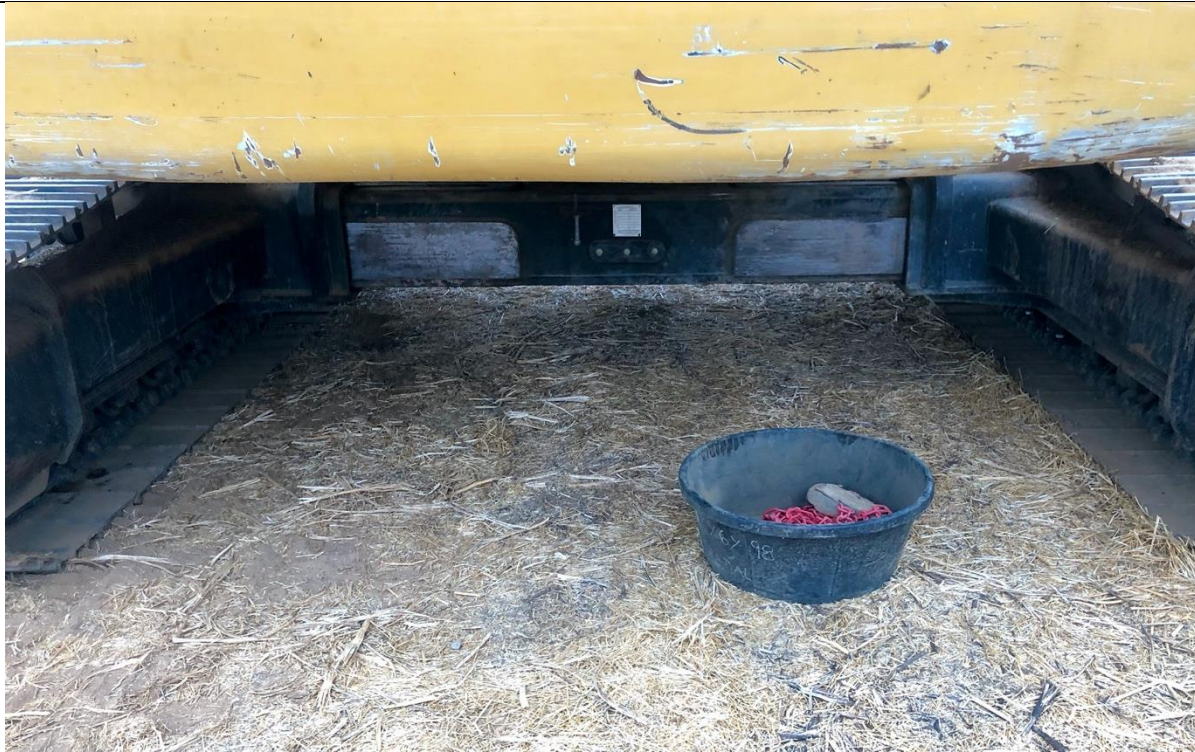
Photo 5 –
Secondary
containment under
some equipment –
note the small size
of the drip pan and
the material in it.

<p>MITIGATION MEASURES VERIFIED (Refer to MMCRP Report only on MMs pertinent to your observations today)</p> <p>All of the project personnel appeared to be WEAP trained.</p>
<p>RECOMMENDED FOLLOW-UP (i.e., items to check on next visit, minor issues to resolve)</p> <p>Check on habitat enhancement possibilities.</p>
<p>COMPLIANCE SUGGESTIONS OR ADDITIONAL OBSERVATIONS (i.e., suggestions to improve compliance on-site, environmental observations of note)</p> <p>Secondary containment needs to be upgraded.</p>

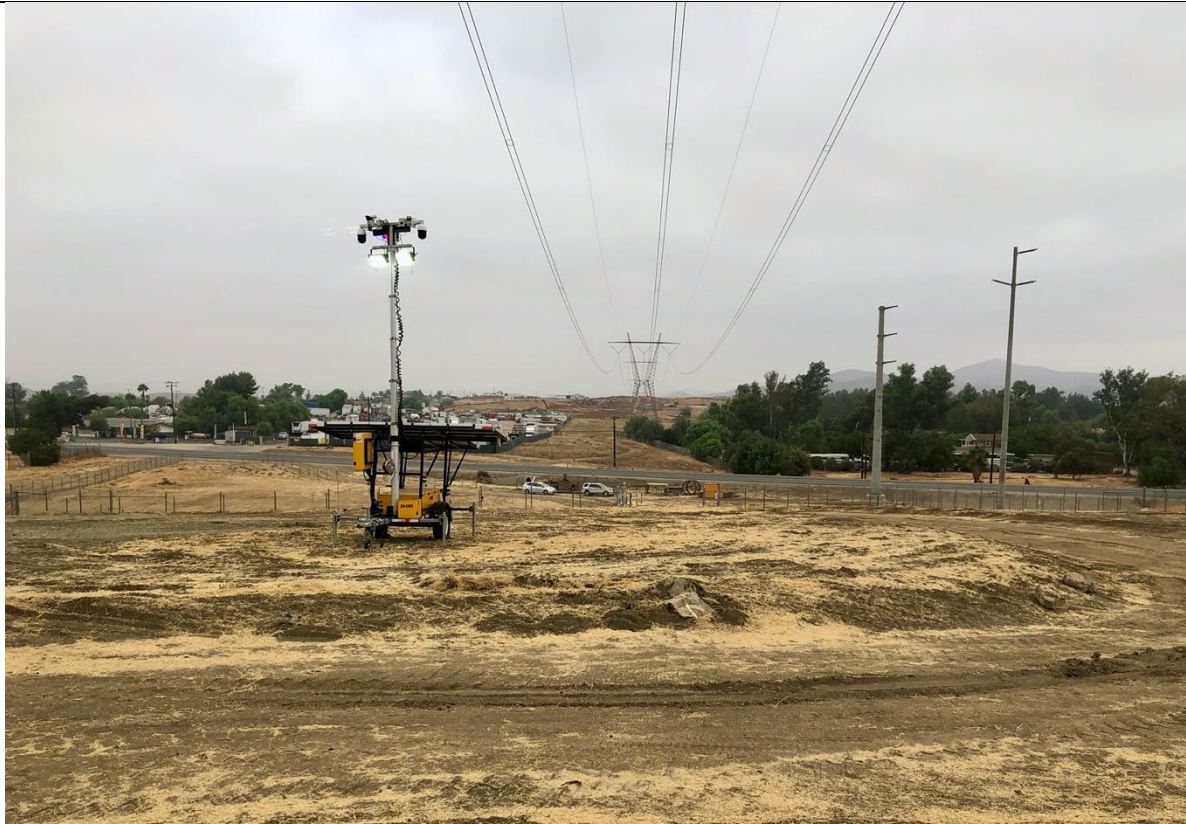
Photo 6 – New
TSP's were installed
Where segment 1
reaches Hwy 74.
Photo facing east

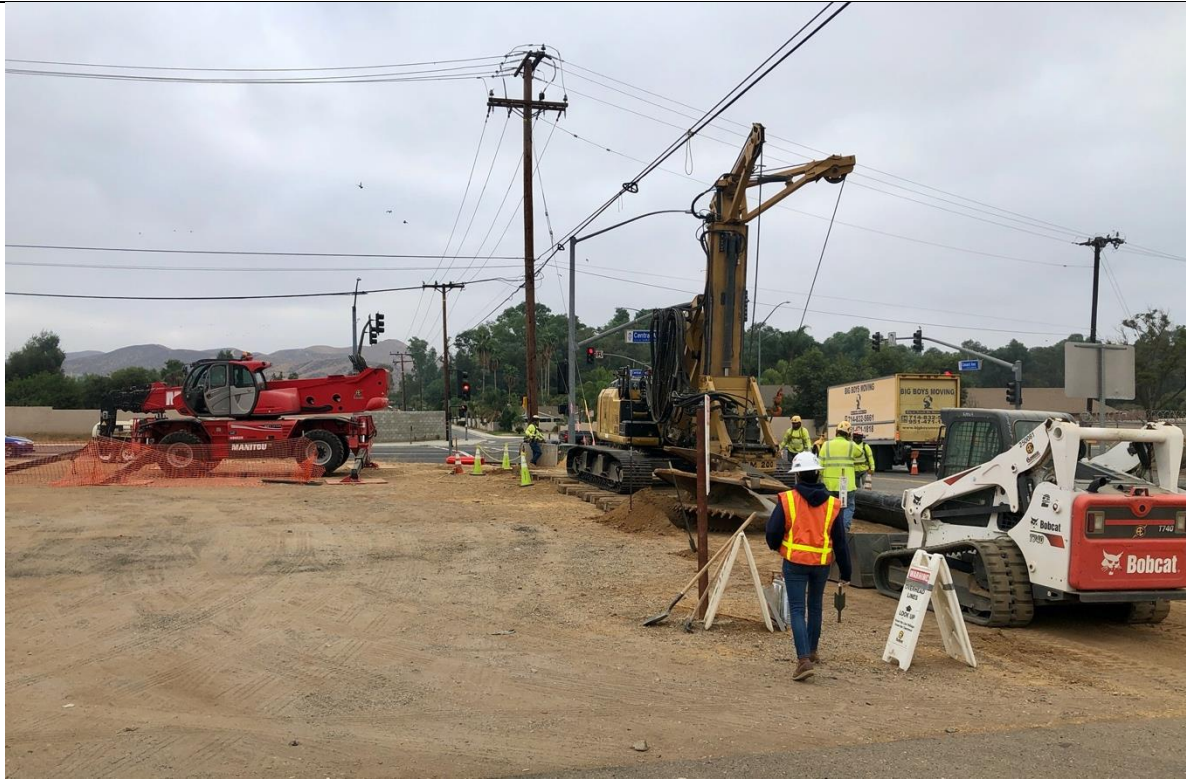
Photo 7 –
Foundation work at
Pole site 302E.
Photo facing south

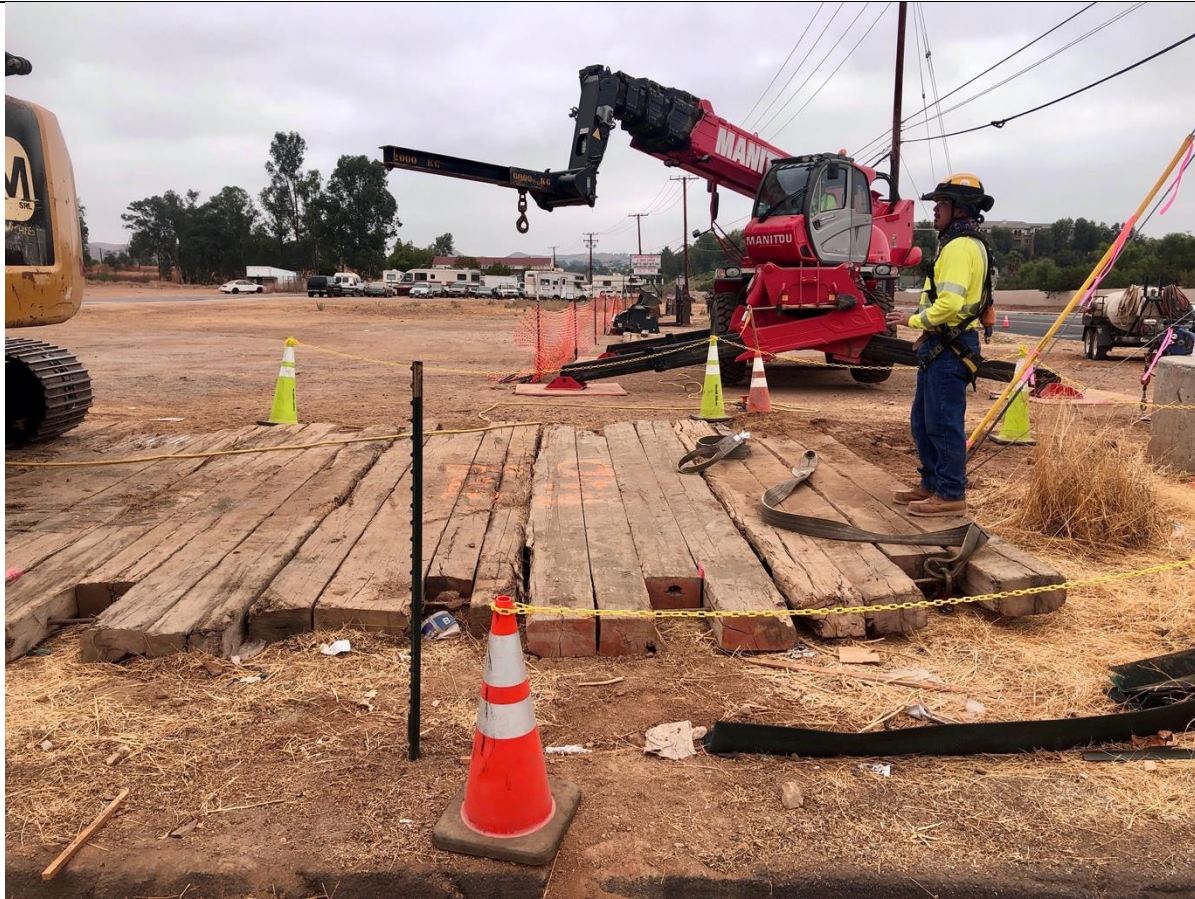
Photo 8 – The foundation hole had been drilled and covered overnight with wood planks. Photo facing east

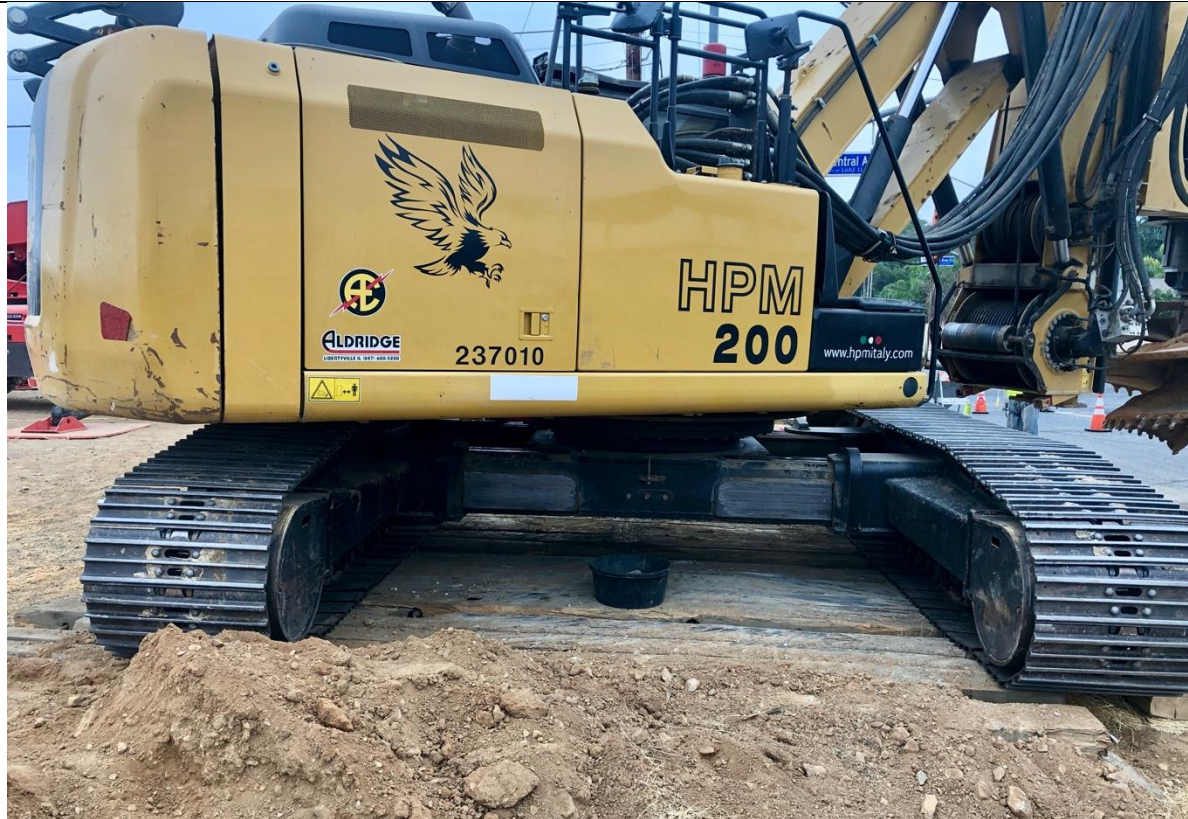
Photo 9 – The very small drip pan under the drilling rig.

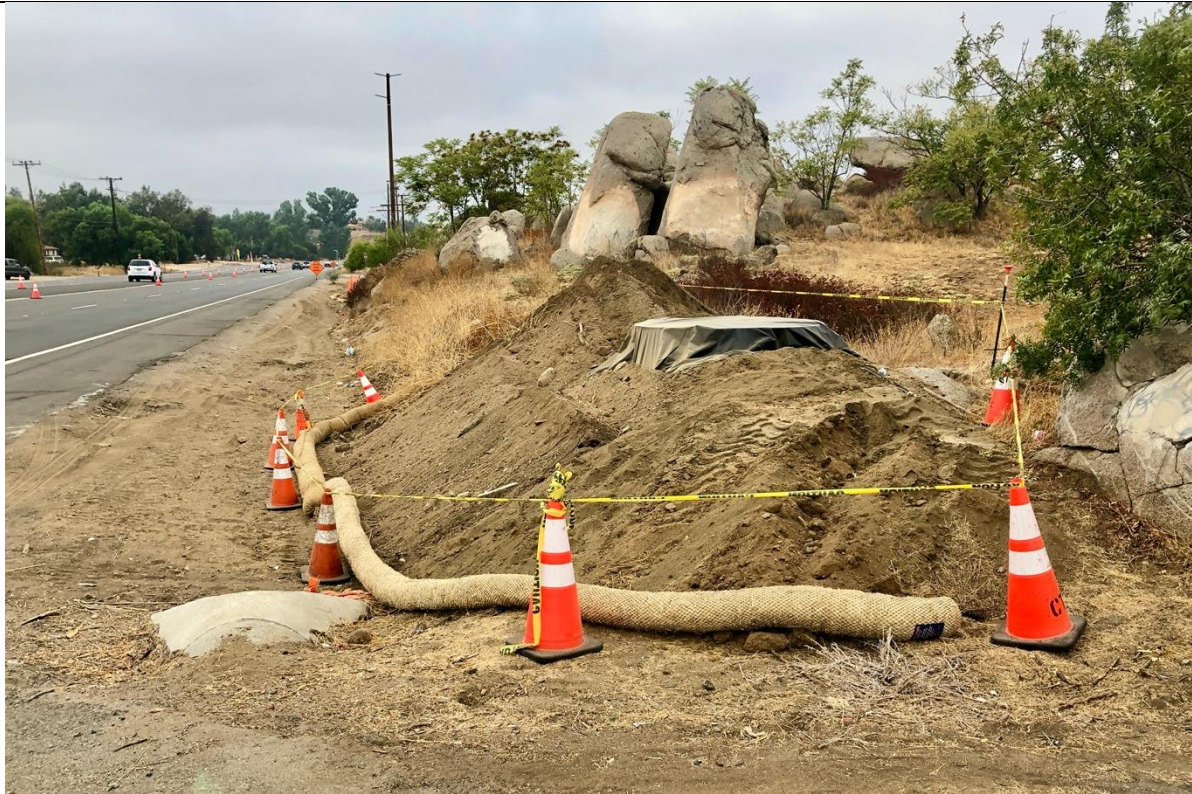
Photo 10 -
Excavation site for
wooden pole #212.
Photo facing west

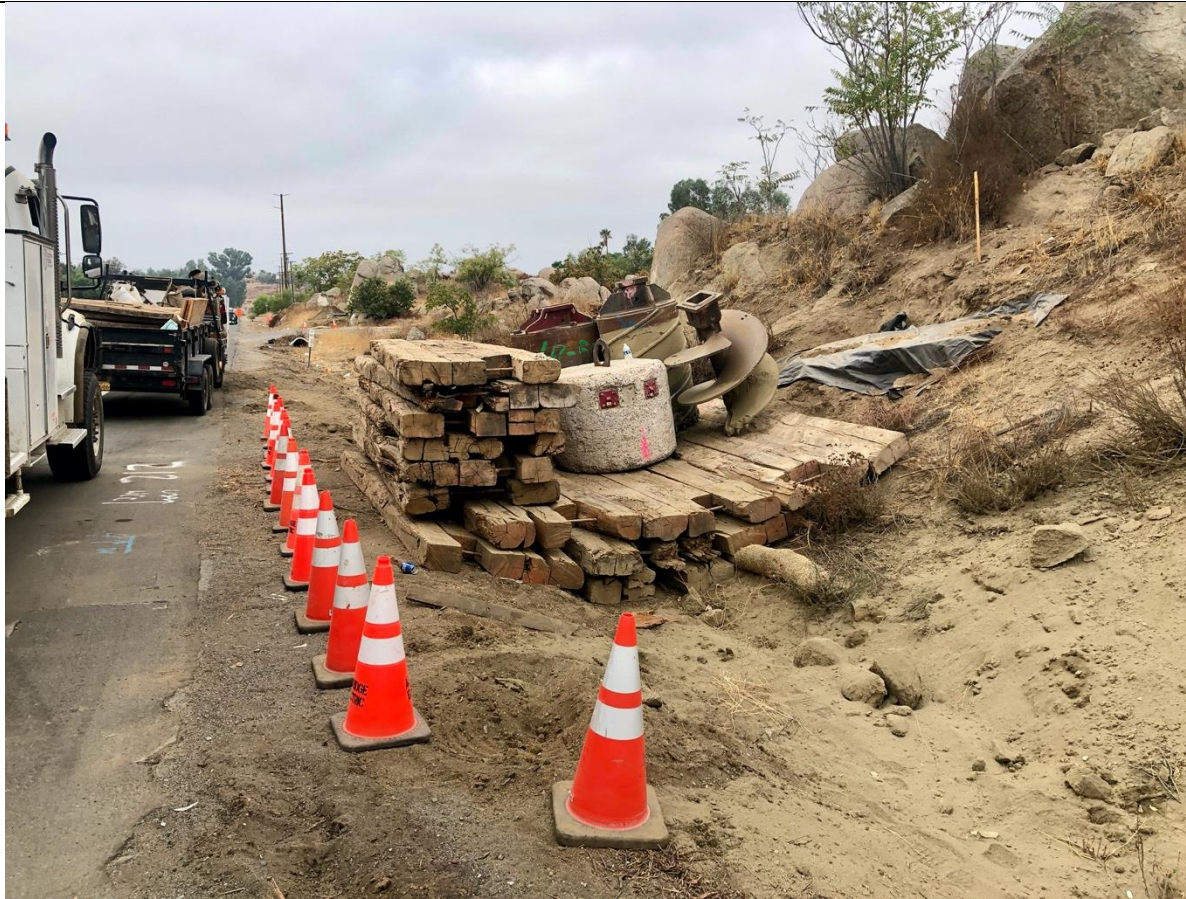
Photo 11 – Drilling
operation to begin at
pole site #213.
Photo facing west

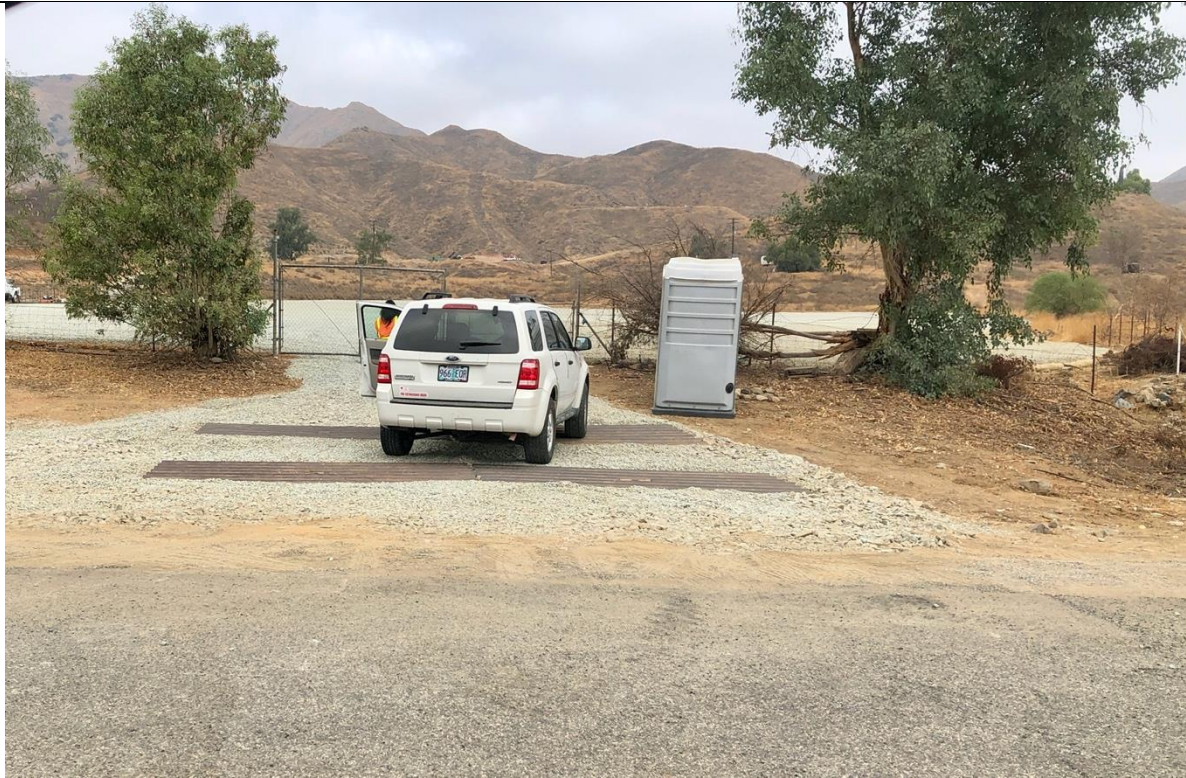
Photo 12 – Entrance
to the Concordia
yard with exit/entry
BMPs installed.
Photo facing east

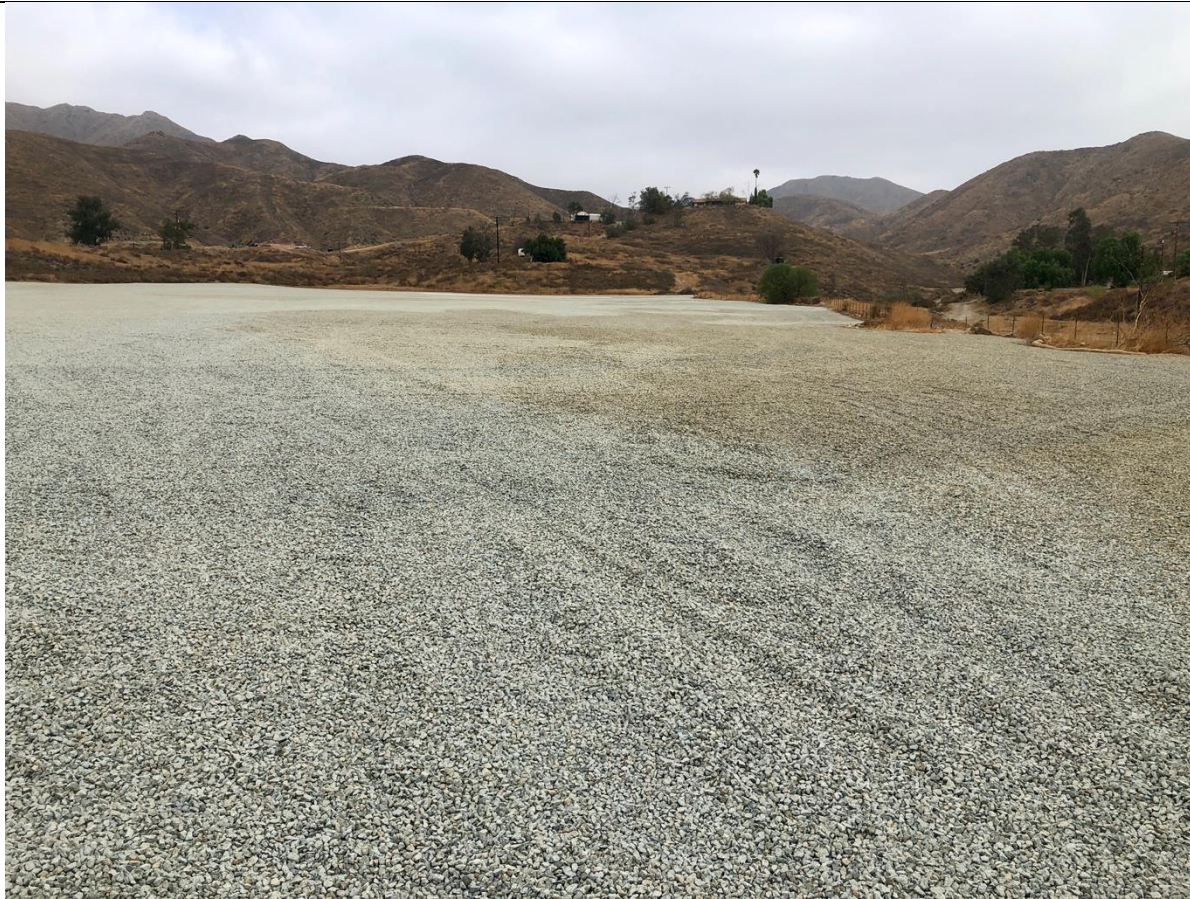
Photo 13 – Gravel
has been spread out
over the entire 6
acres of the
Concordia yard.
Photo facing east

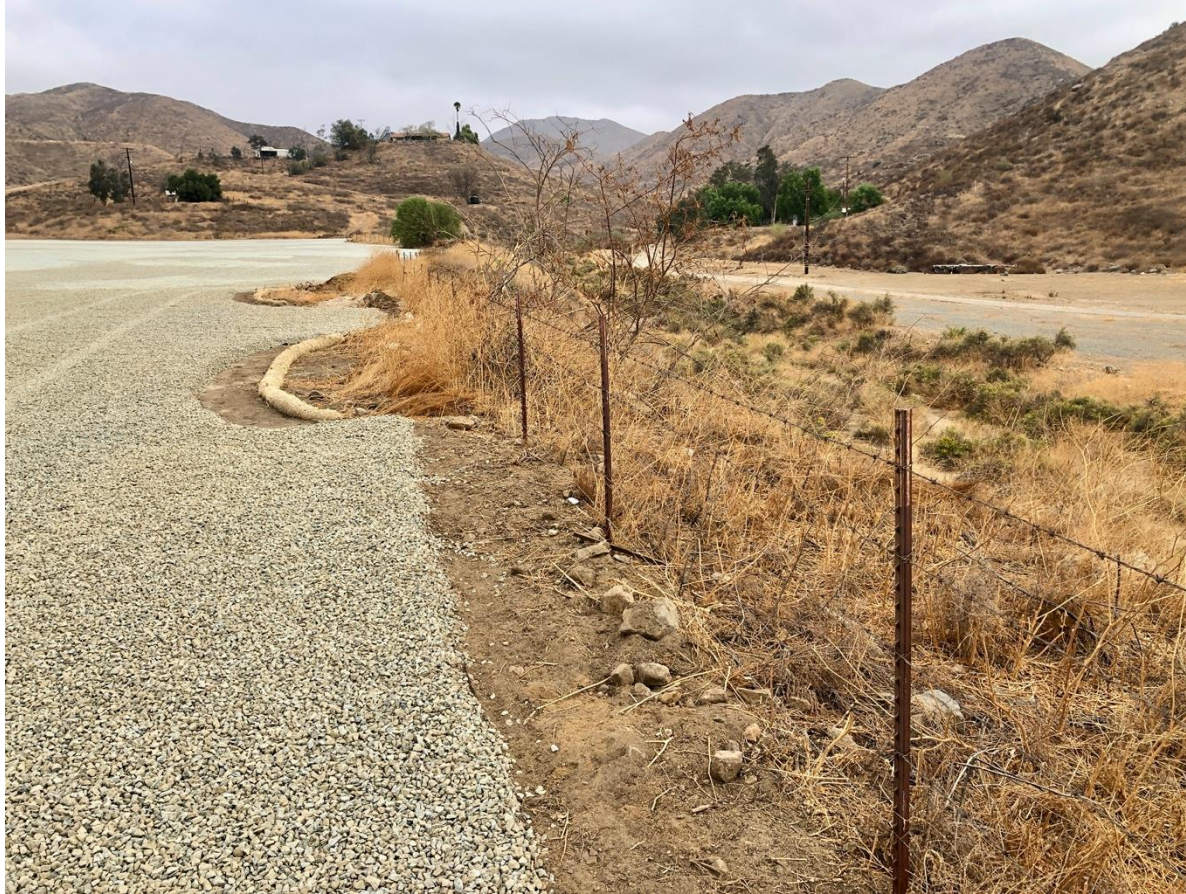
<p>AREAS MONITORED (i.e., structure numbers, yards, or substations)</p> <p>Segments 1, 2 and 8</p>
<p>DESCRIPTION OF OBSERVED ACTIVITIES (i.e., mitigation measures of particular focus or concern, construction activity, any discussions with first-party monitors or construction crews)</p> <p>I was onsite for the 6 am tailboard held at the Valley Substation. The Environmental Project Manager introduced me, and I described my role in the project. The EPM had a crew of four onsite environmental monitors.</p> <p>Since my last site visit, the drilling subcontractor (Aldridge) was now on site and has been drilling and installing tubular steel pole (TSP) foundations. The EPM and I stopped to look at some of the newly installed TSPs outside the Valley Substation (Photos 1 & 2). According to the EPM, the spoil from the drilling excavation was spread out on the access roads. A water truck sprays the access roads at least once a day.</p> <p>We stopped at tower #0018E, about a half mile west of the Valley substation. The Aldridge crew drilled and poured the tower foundation yesterday and was now beginning to strip the forms (Photo 3). A concrete washout bin was on site, and the spoil pile was ringed with straw wattles (Photo 4). Unfortunately, the secondary containment under the larger pieces of equipment was relatively small, and they left some other construction materials in the drip pan (Photo 5). I pointed this out to the EPM, suggesting a larger pan without any materials, and she said she would bring it up with the Aldridge crew.</p> <p>We traveled where the transmission corridor crosses over Hwy 74, transitioning from Segments VIG1 and VIG2. At this location, a set of new TSPs numbered 162E through 166E were installed (Photo 6). Some equipment was parked at this location, all of which have a secondary containment matting underneath them; the matting is called Polyback. The polyback appears to work well as secondary containment, but it was covered in invasive seeds. The EPM and I discussed the conditions limiting the spread of invasive weeds, and she said all of the equipment was washed before being brought onsite. We agreed that the weed seed stuck in the polyback was not an issue since the polyback is new when it's laid out, and the seed was mostly burr clover, a species common to this area.</p> <p>At the intersection of Hwy 74 and Conard, where the project switches from Segment VIG2 to Segment VIG3, an Aldridge crew was working on the foundation for TSP #302E (Photo 7). This was a large foundation hole they had already drilled and covered with wooden beams (Photo 8). My concern with the wooden beams was that several gaps would allow small wildlife to fall into the hole; better coverage was suggested. They have installed some metal corrugated metal pipe (CMP) to line the foundation hole. Here, the secondary containment for the large equipment was just one tiny drip pan (Photo 9). The use of some polyback would be recommended for containment here.</p> <p>I drove back to pole sites 212 and 213, which had been left for the Aldridge team to drill (Photo 10). A crew arrived to upgrade the BMPs for these sites, adding additional fencing and securing the coverage (Photo 11).</p> <p>My last stop was at the Concordia Yard, which has being set up with exit/entry BMPs (Photo 12). They have also laid gravel throughout 6 acres (Photo 13). A crew arrived onsite to begin the installation of a particular type of sediment fencing around the yard, focusing on the southern border of the yard that runs along an ephemeral drainage (Photo 14).</p>

Photo 14 – Silt fencing and construction fencing will be installed around the entire yard. An ephemeral drainage exits just to the south of the yard. Photo facing east
