April 8, 2020

Re: Monthly Report Summary #28 for the South Orange County Reliability Enhancement (SOCRE) Project

SITE INSPECTION CHECKLIST (Based on monitor's observations during site visit; responses do not imply that monitor observed all staff, crews, and parts of the project during this inspection)

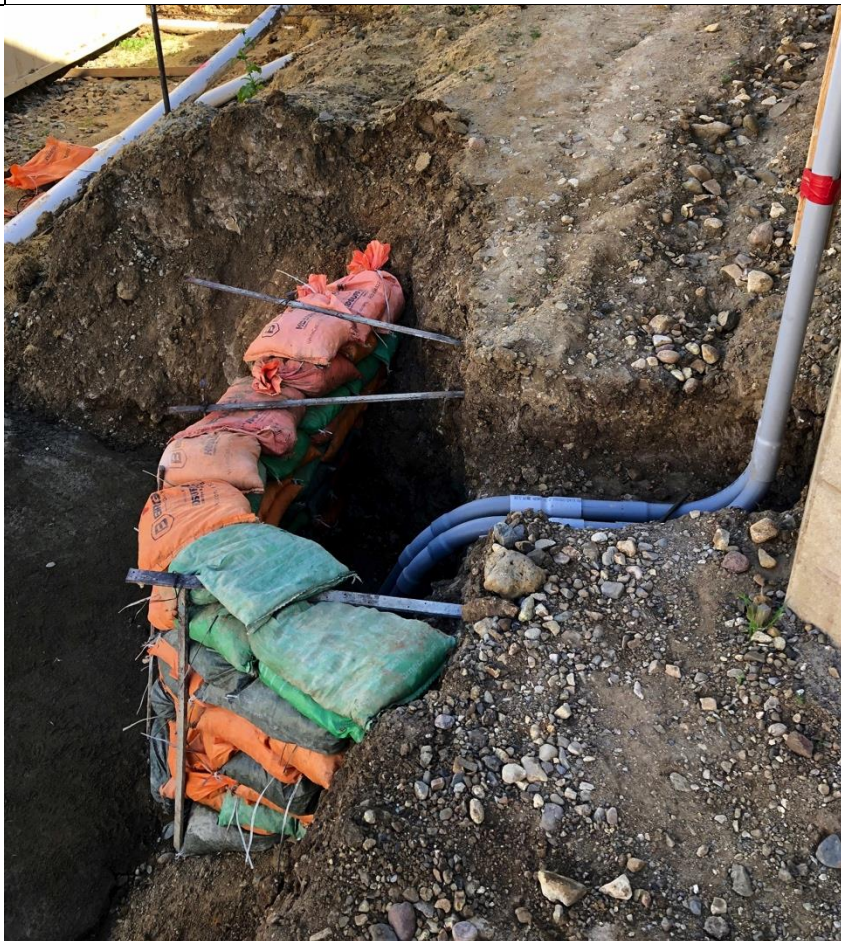
Photo 8 – Electrical lighting conduit work.
02/05/20	San Juan Capistrano Substation	 	Photo 9 – Pipe carrying site drainage from the 12-kV substation facility area, now connected to the offsite drainpipe. Photo facing northeast.

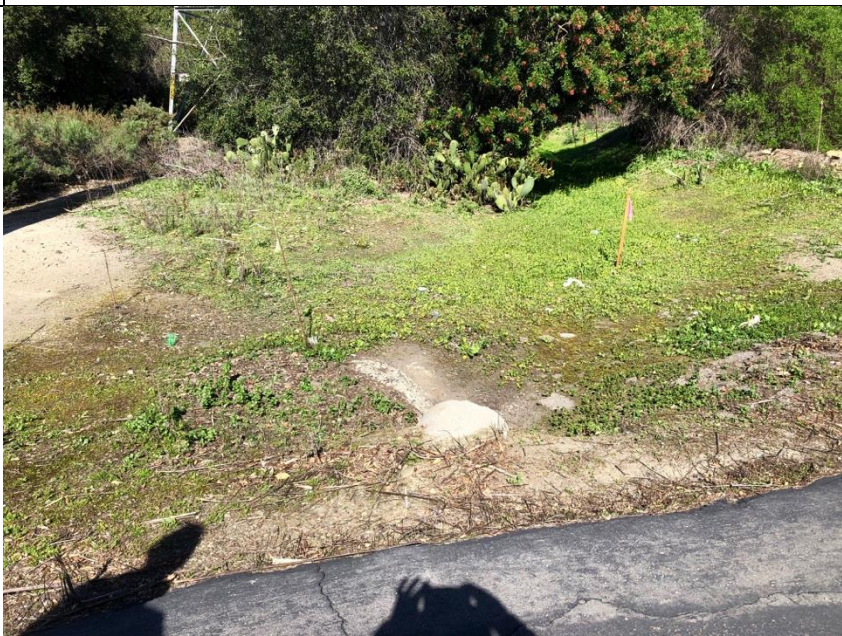
Photo 12 – Small drainage at new tower location #9.
02/05/20	New staging area on Prima Deshecha Landfill along Avenida La Pata

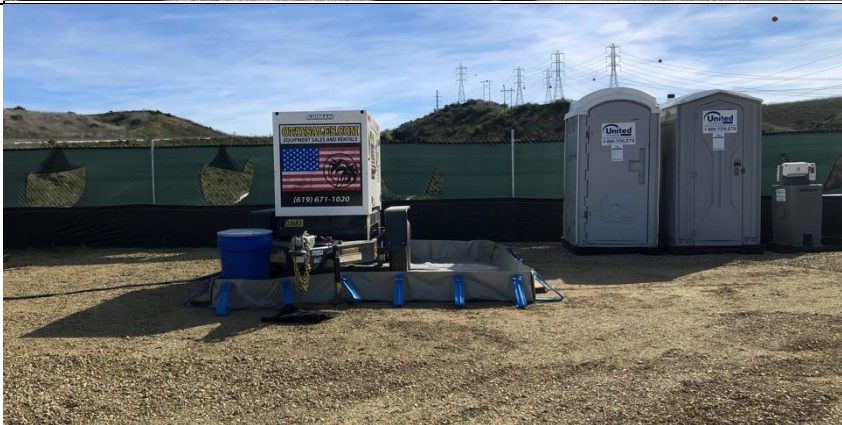
Photo 13 – New staging area for the transmission line work. Photo facing south.
02/05/20	Transmission line route, tower location #35

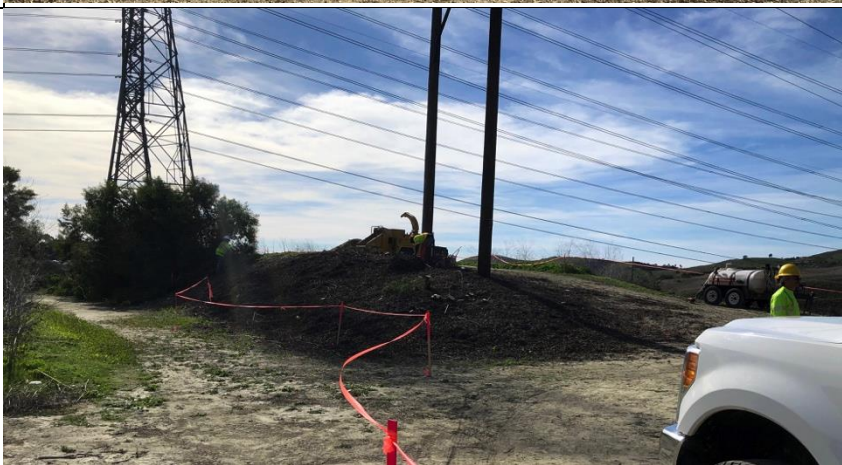
Photo 14 – Vegetation clearing at tower location #35. Photo facing west.

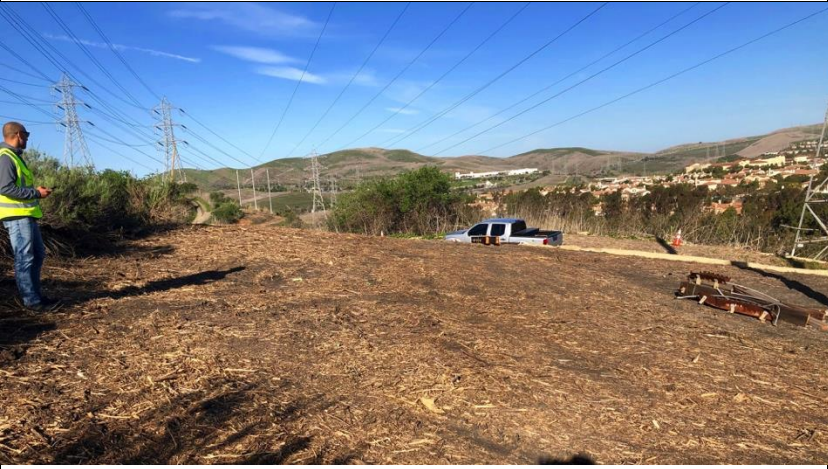
I met with the Lead Environmental Inspector (LEI) and we inspected the transmission line work together. The first location for inspection was tower location #37, which had been cleared of vegetation within the construction boundary limits (Photo 9). There were some haphazardly placed BMPs at this location that would not be effective during a rain event. The LEI and I discussed upgrades needed to prevent erosion in the event of a storm. Facing west, I observed tower location #36, where vegetation had been cleared around the new tower site (Photo 10). We did not drive to tower location #36.

Photo 9 – Cleared area at tower location #37. Photo facing northwest.
02/13/20	Transmission line route, tower locations #36 and #37

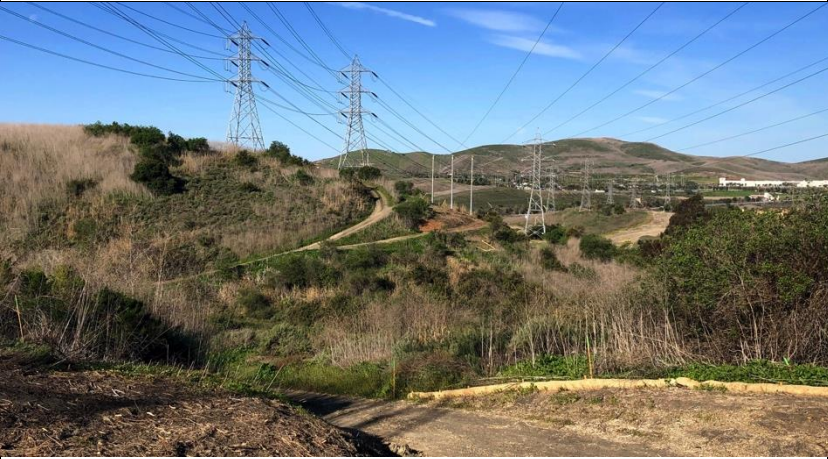
Photo 10 – Looking west from tower location #37 toward tower location #36. Photo facing west.
02/13/20	Transmission line route, tower location #39

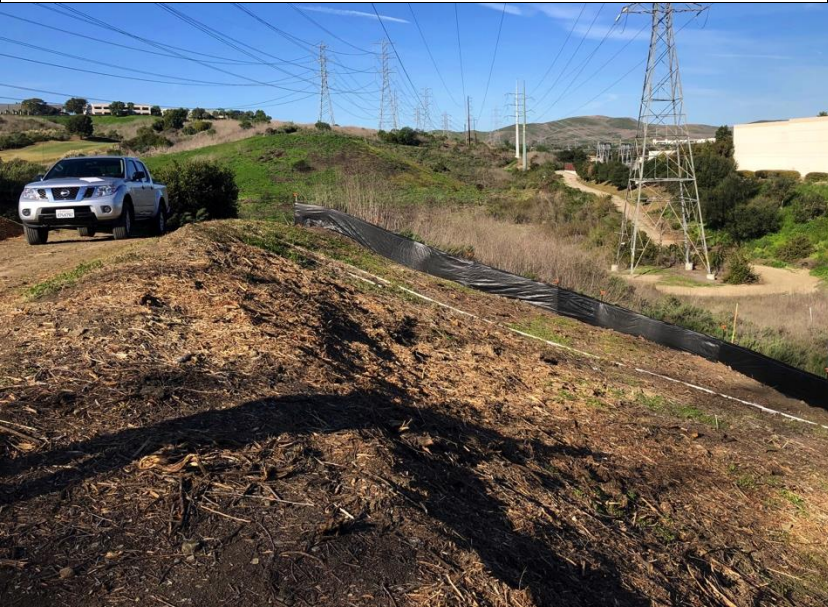
We proceeded to tower site #39, which had been cleared of vegetation and had wire-reinforced silt fencing installed along the lower portion of the workspace (Photo 11). This location is close to a jurisdictional wetland that supports a stand of riparian vegetation. In this area, I observed several species of birds, including blue-grey gnatcatchers (*Poliioptila caerulea*), the more common species of gnatcatcher.

Photo 11 – Cleared area and BMPs installed at tower location #39. Photo facing west.

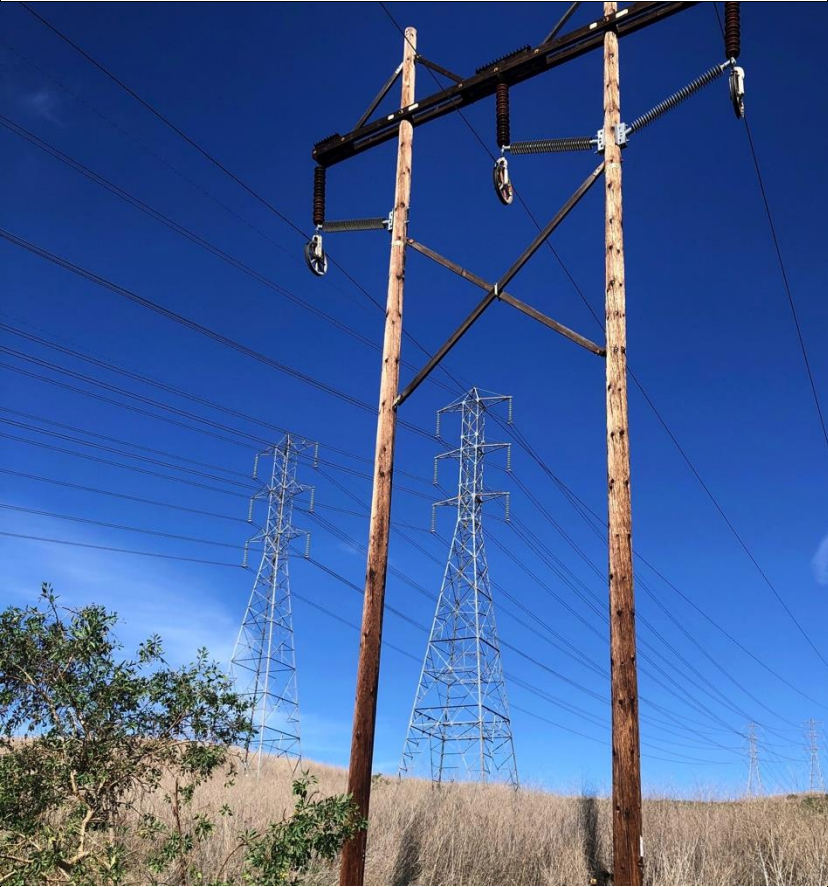
Our next stop was tower location #29 where a pair of red-tailed hawks (*Buteo jamaicensis*) (RTH) had begun nesting in the adjacent Southern California Edison (SCE) towers. The pair of hawks was observed sitting in one of the towers. After the nest buffer reduction was approved, a crew installed the "travelers" on the wooden poles (Photo 12). An avian biologist observed the work and stated that they did not seem disturbed by the work and continued to build the nest while the work was being completed.

Photo 12 – New tower location #29; note the raptor nest in the adjacent SCE tower. Photo facing north.
02/13/20	Transmission line route, tower location #34

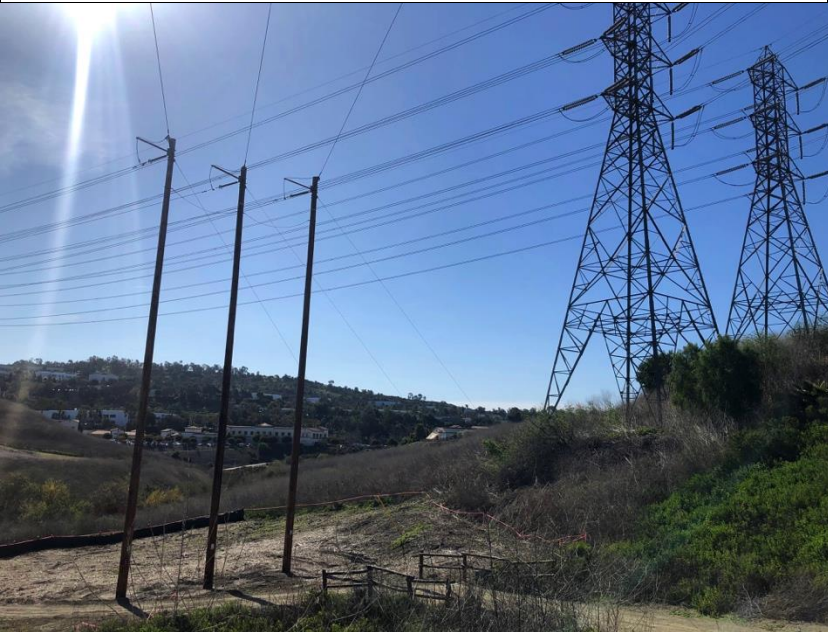
At tower location #34, another pair of RTH was setting nesting in the adjacent SCE towers. One of the birds was observed in a tower. The LEI said they were declaring it an active nest and will be preparing a report for a nest buffer reduction request. Crews have already cleared the vegetation and installed wire-reinforced silt fencing but have yet to install the travelers on the wooden poles. Since the nest has now been declared active, work will be paused until a nest buffer reduction is approved (Photo 13).

Photo 13 – Tower location #34. Photo facing southwest.

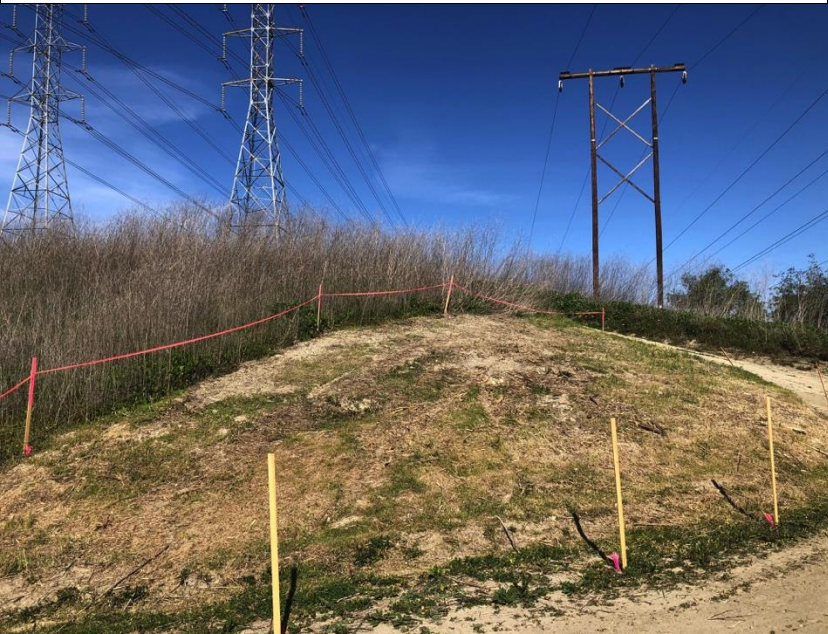
At tower location #33, vegetation has been cleared, BMPs installed, and travelers installed on the wooden poles (Photo 14). An old stick nest exists in the nearby SCE towers, but, so far, no nesting activity has been observed. Tower location #32 is similar to #33; no raptor nesting activity has been observed, the workspace has been cleared, BMPs have been installed, and the travelers have been installed on the wooden poles (Photo 15).

Photo 14 – Tower location #33. Photo facing north.
02/13/20	Transmission line route, tower location #32

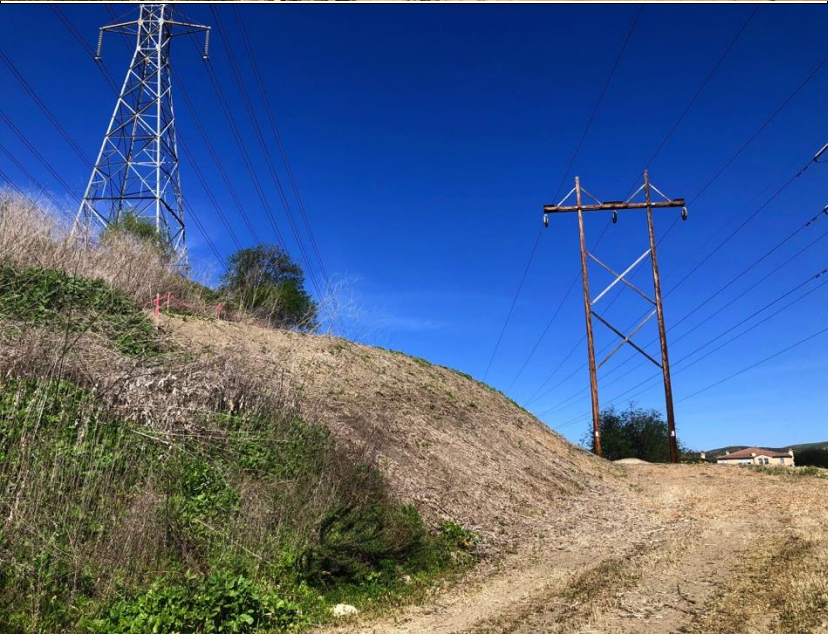
Photo 15 – Tower location #32. Photo facing north.

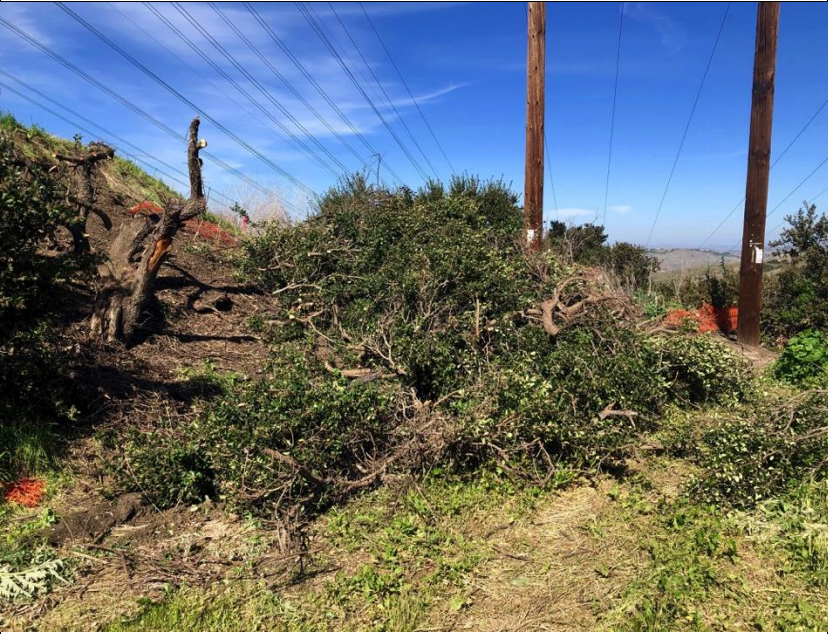
Photo 18 – Vegetation removal at location #21. Photo facing north.
02/13/20	Transmission line route, tower locations #18 and #19

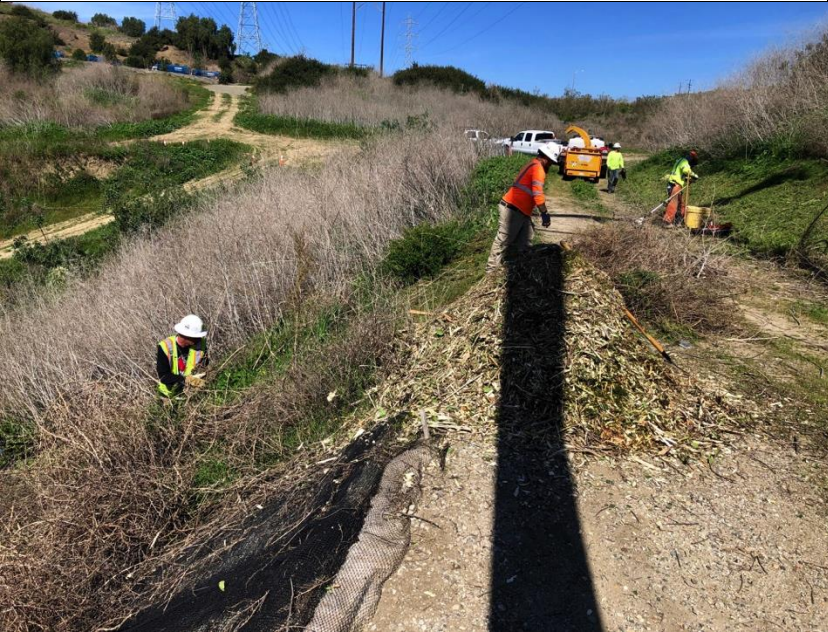
Photo 19 – Vegetation removal at tower locations #18 and #19. Photo facing north.

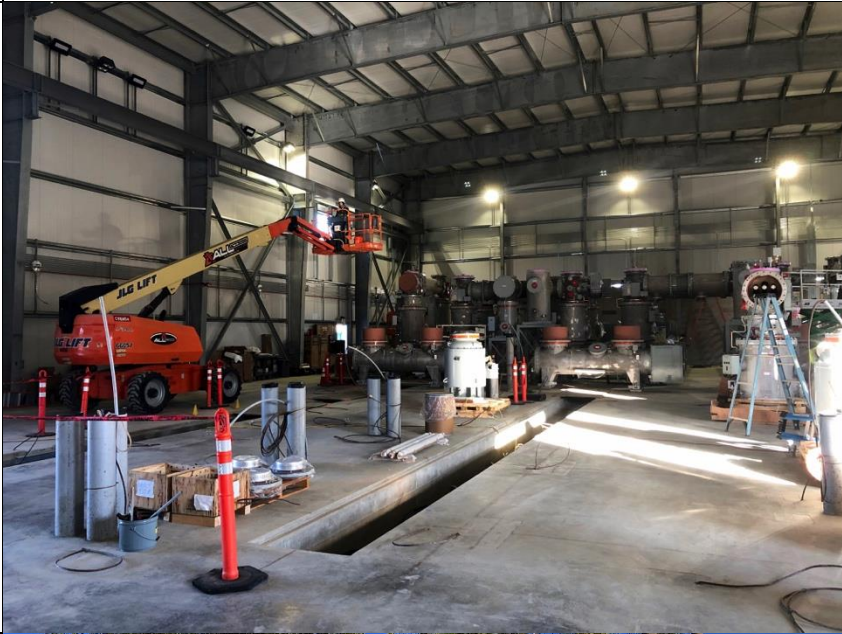
Photo 6 – Inside the 138-kV GIS building.
02/20/20	San Juan Capistrano Substation

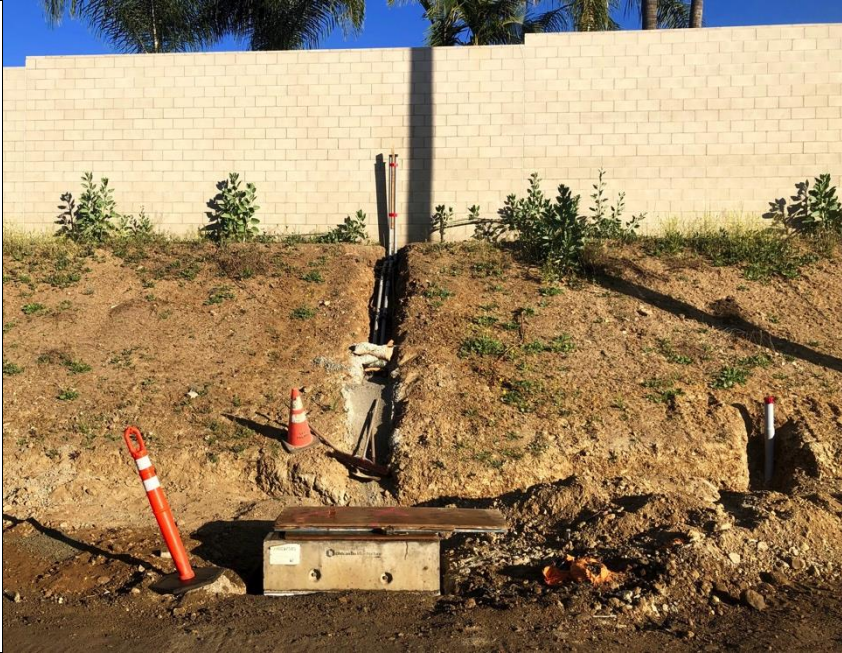
Photo 7 – Electrical conduit installation upslope to the northern wall. Photo facing north.

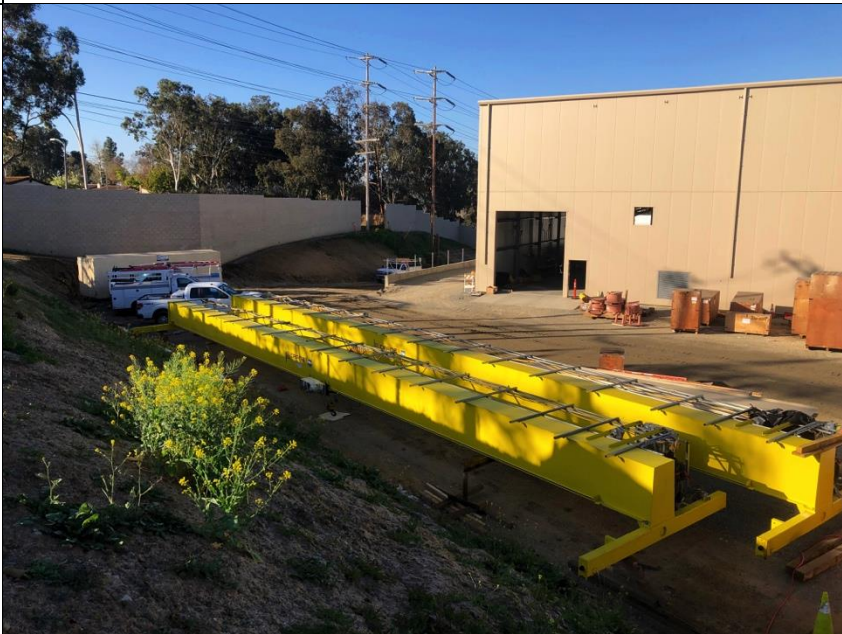
Photo 10 – Cranes to be installed within the 138-kV GIS building. Photo facing southwest.
02/20/20	Transmission line route, tower location #34

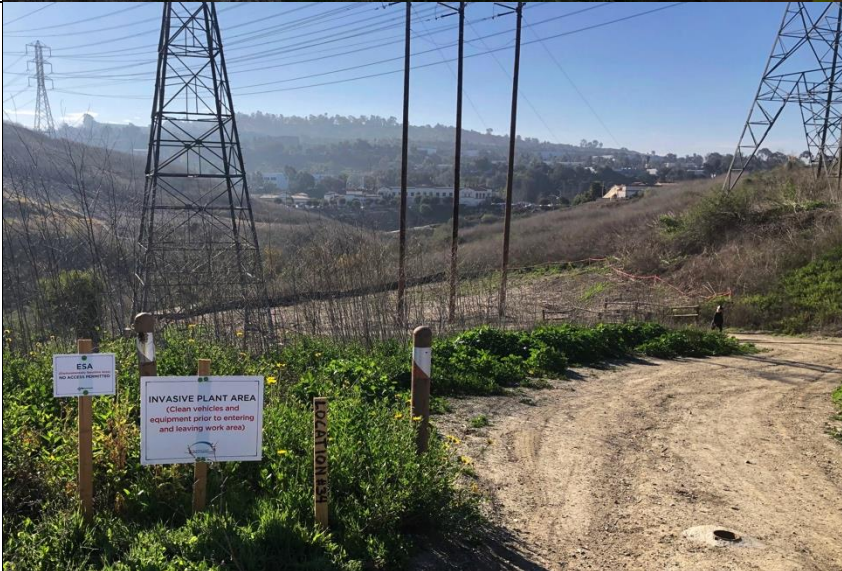
Photo 11 – Tower location #34. Photo facing south.
02/20/20	Transmission line route, tower location #29

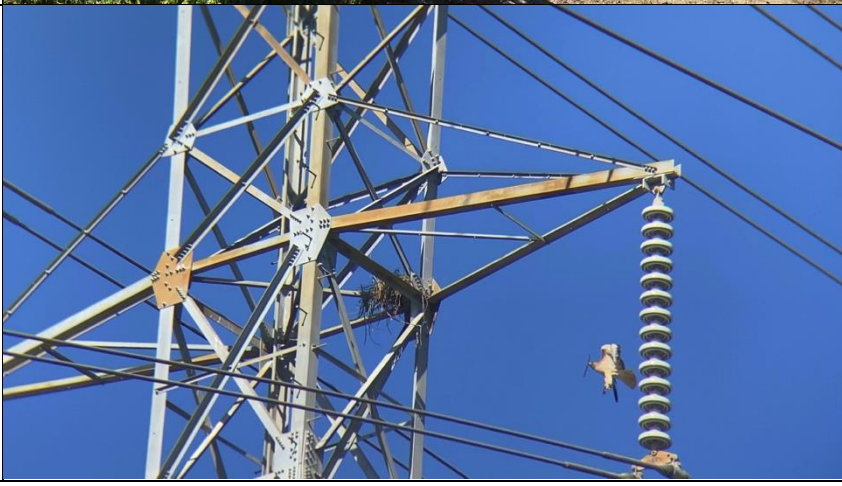
At tower location #29, the active RTH nest was being monitored by two Environmental Inspectors (EIs); one is an approved avian biologist. A nest buffer reduction was approved at this site, allowing a crew to install the travelers. According to the avian biologist, the birds were observed bringing nesting material to the nest while work was ongoing (Photo 12).

Photo 12 – Nesting RTH in the SCE tower near tower location #29. Photo provided by the avian biologist.

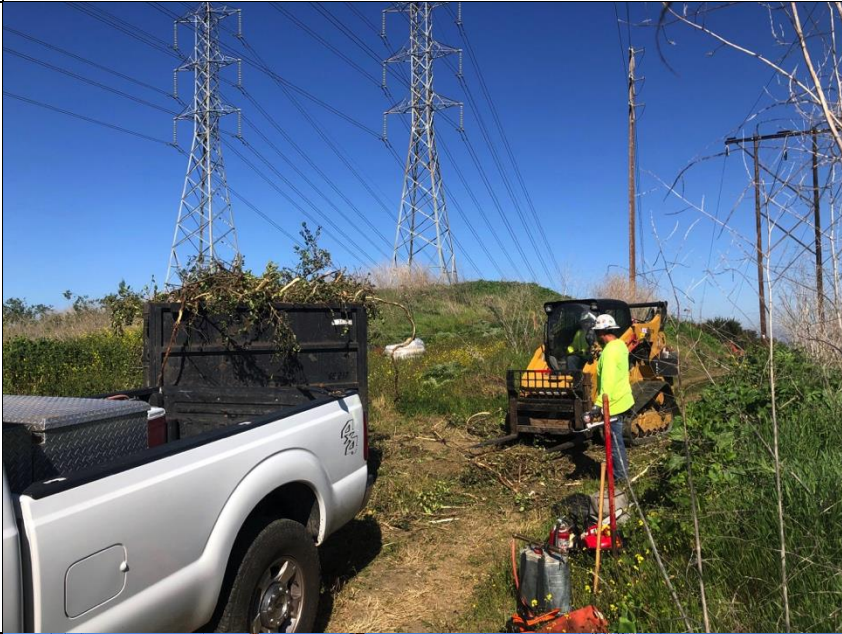
Photo 13 – Vegetation clearing at tower location #21. Photo facing north.
02/20/20	Transmission line route, tower location #21

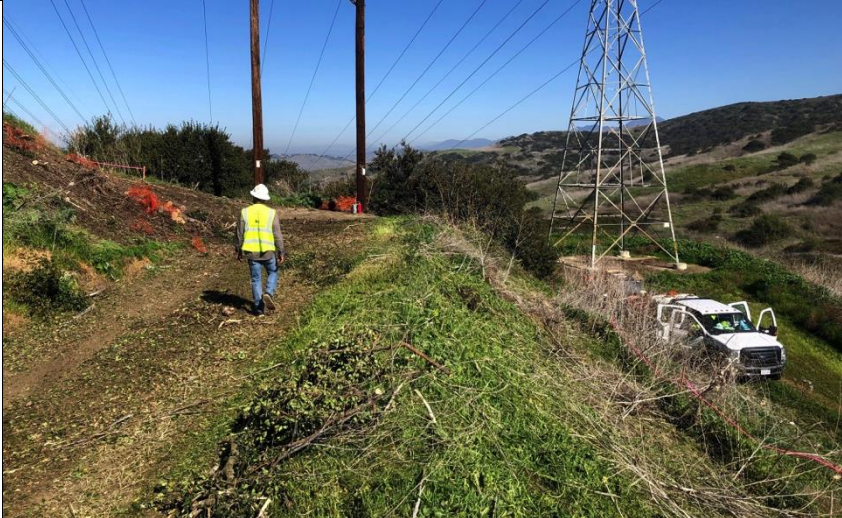
Photo 14 – Vegetation clearing outside of the nest buffer. Photo facing north.

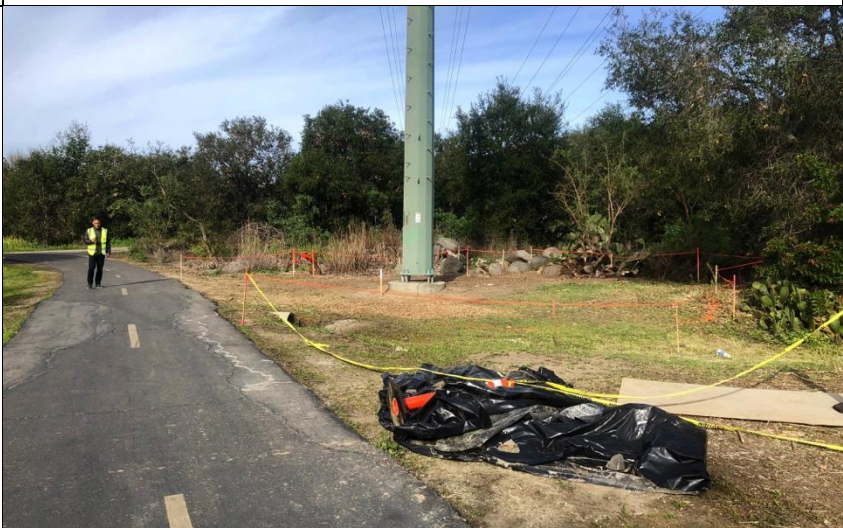
Tower location #9 is located adjacent to San Juan Creek. The workspace has been staked and cleared, and a test bore was recently drilled to evaluate the substrate; tailings from the test bore remain onsite and covered in black plastic (Photo 2). Some BMP material was left onsite to be installed in case of a rain event (Photo 3). The test bore, which was 75 feet deep, revealed mostly sandy soil with ground water at about 18 feet. The foundation at this location will require a 75-foot-deep by 8-foot-diameter hole, which will require a large amount of drilling and concrete, use of water and drilling fluids, and removal of water and mud. Modifications that may require some additional vegetation clearing to the workspace were discussed, as well as the use of some additional areas for baker tanks and truck turnarounds. The minor project modification request will be submitted for review and approval.

Photo 2 – Tower location #9. A test bore was drilled with tailings covered by plastic. Photo facing northwest.
02/27/20	Transmission line route, tower location #9

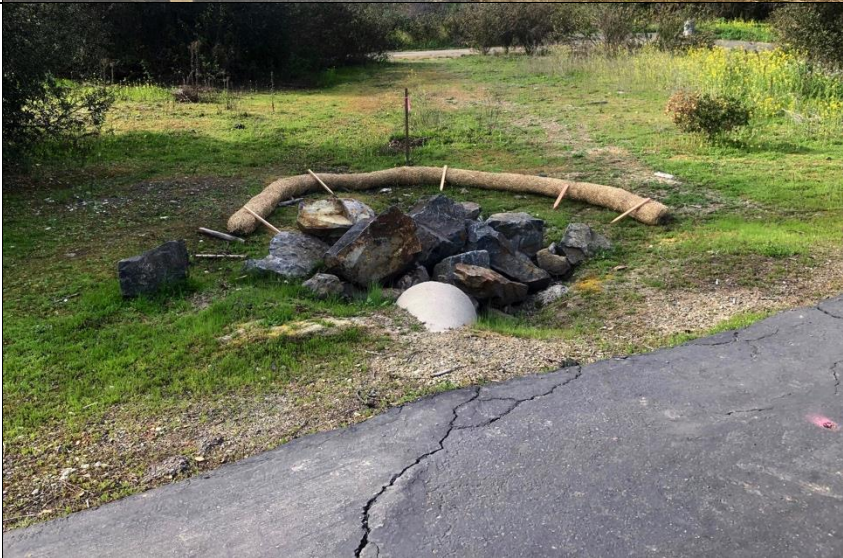
Photo 3 – BMPs at tower location #9. Photo facing southwest.
02/27/20	Transmission line route, tower location #10

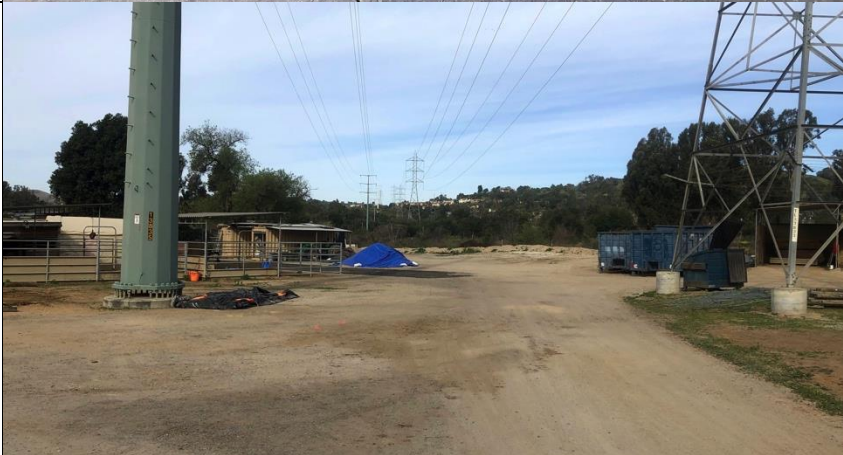
Photo 4 – Tower location #10, within an active horse stable facility. Photo facing northwest.

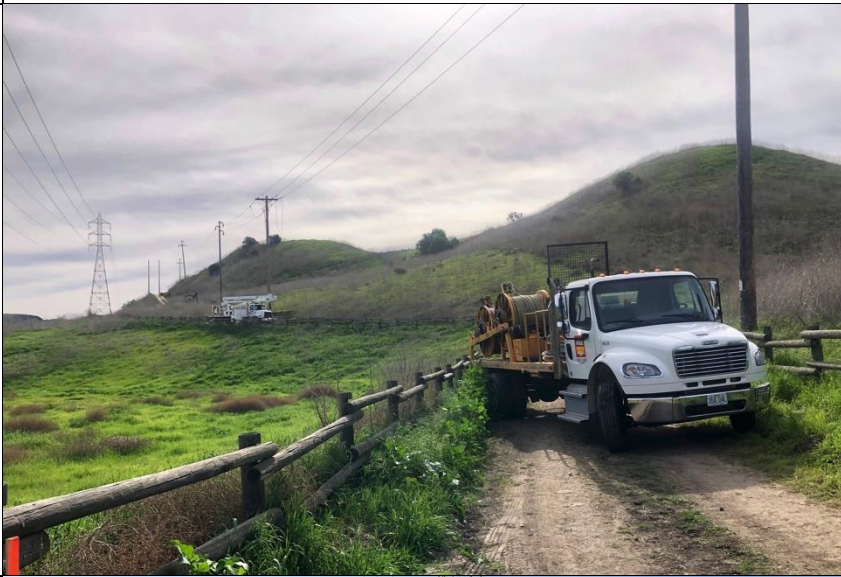
At tower location #12, I observed a stringing crew setting up to pull wire (Photo 5). We discussed expanding the access road area leading to the tower location to mitigate the tight turns in the current configuration. The area impacted by this expansion was level and vegetated with annual grasses and weeds. Some of the site vegetation clearing was already completed (Photo 6).

Photo 5 – Wire stringing crew at tower location #12. Photo facing south.
02/27/20	Transmission line route, tower location #12

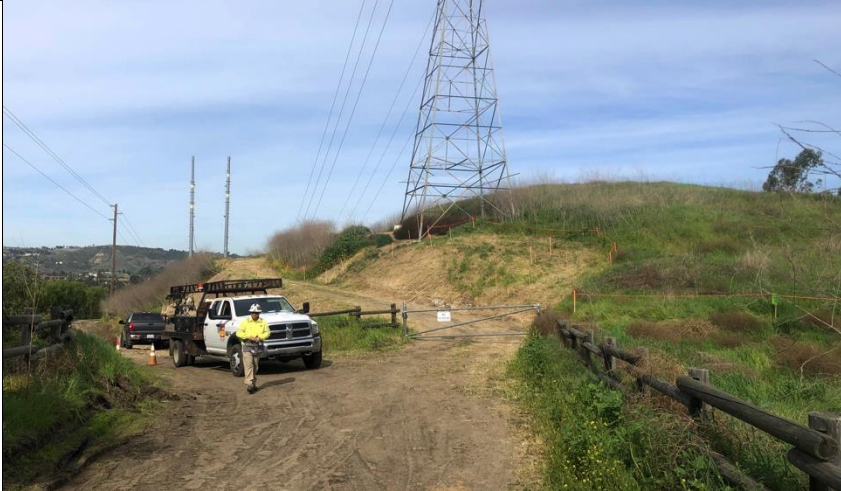
Photo 6 – Vegetation clearing completed at tower location #12. Photo facing north.
02/27/20	San Juan Capistrano Substation

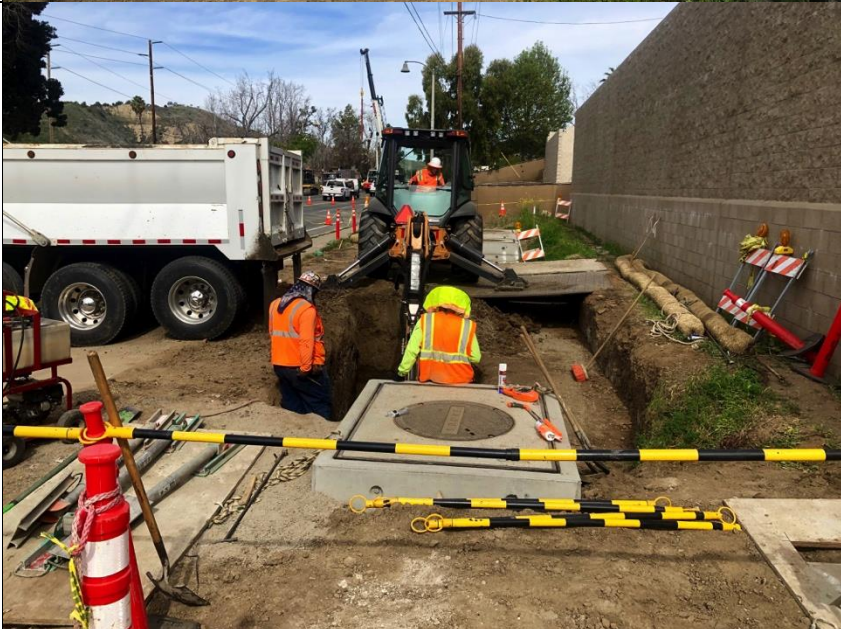
Photo 7 – Conduit trenching and installation along Camino Capistrano. Photo facing north.

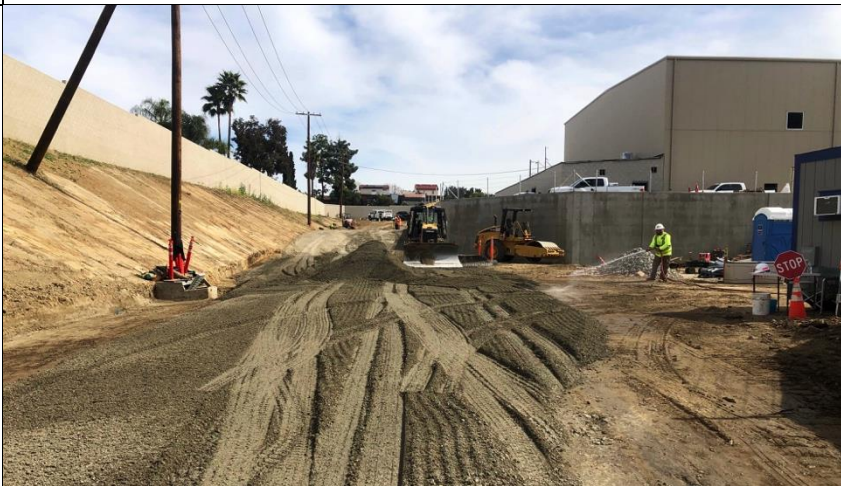
Photo 10 – Road base was delivered and compacted. Photo facing east.
02/27/20	San Juan Capistrano Substation

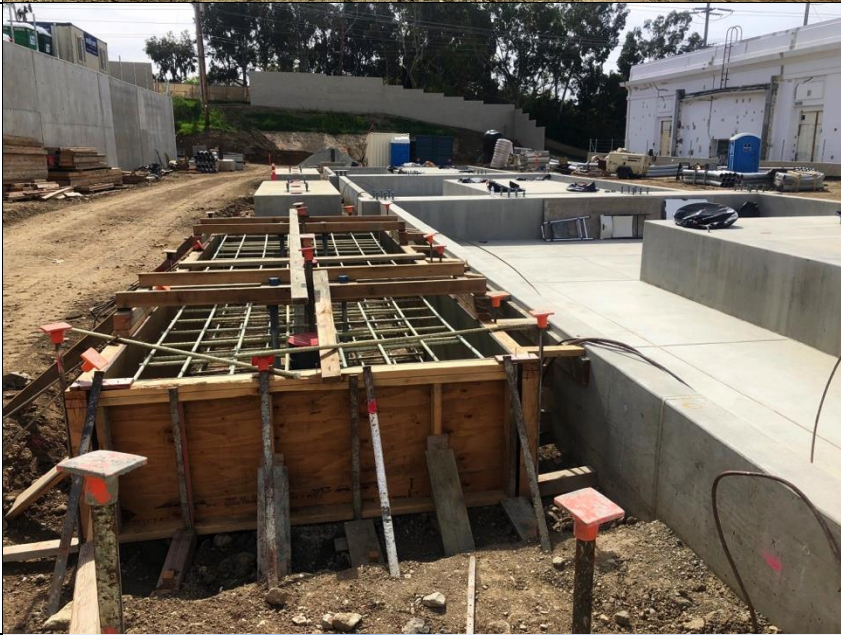
Photo 11 – Foundation forms next to the transformer catch basin. Photo facing south.
02/27/20	San Juan Capistrano Substation

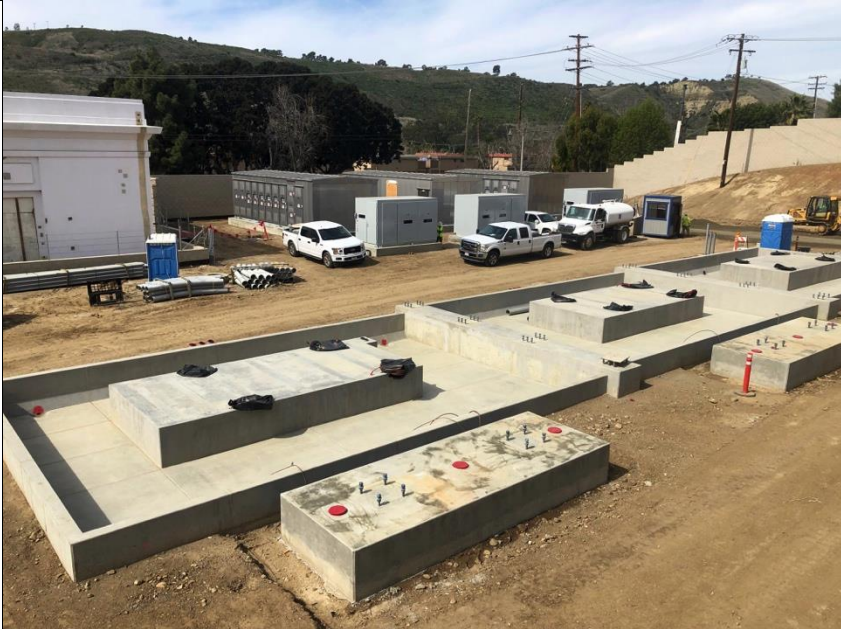
Photo 12 – Overview of the transformer foundations and the newly installed switch racks. Photo facing northwest.
