Re: Monthly Report Summary #41 for the South Orange County Reliability Enhancement (SOCRE) Project

South Orange County Reliability Enhancement Project CPUC Site Inspection Form

Project:	South Orange County Reliability Enhancement (SOCRE) Project	Date:	March 6, 2021
Project Proponent:	San Diego Gas & Electric (SDG&E)	Report #:	VS115
Lead Agency:	California Public Utilities Commission (CPUC)	Monitor(s):	CPUC/ WSP USA Inc. (formerly Ecology and Environment, Inc.) Compliance Monitor
CPUC PM:	Andrew Barnsdale, Energy Division	AM/PM Weather:	Sunny, cool, and calm
CPUC CM (WSP):	Joe Donaldson	Start/End time:	0630 to 1030
Project NTP(s):	Notice to Proceed (NTP)- 3, NTP-5, NTP-6, and NTP-7

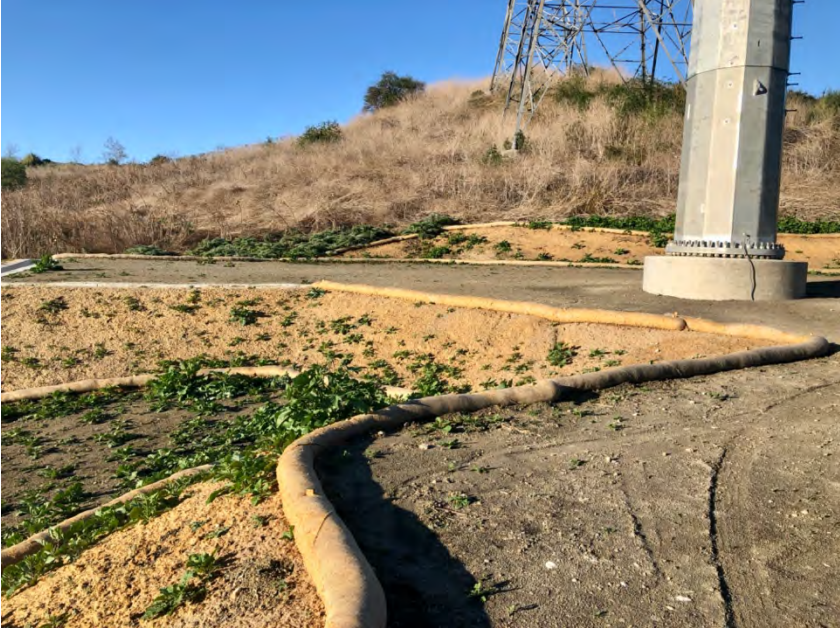
I stopped at tower location 34 and found there were no erosion issues (Photo 2). Red-tailed hawks (*Buteo jamaicensis*) were nesting in the nearby lattice towers.

Photo 2 – Restored work areas around tower location 34 showing no erosion issues. Photo facing west.
03/06/21	SOCRE transmission corridor

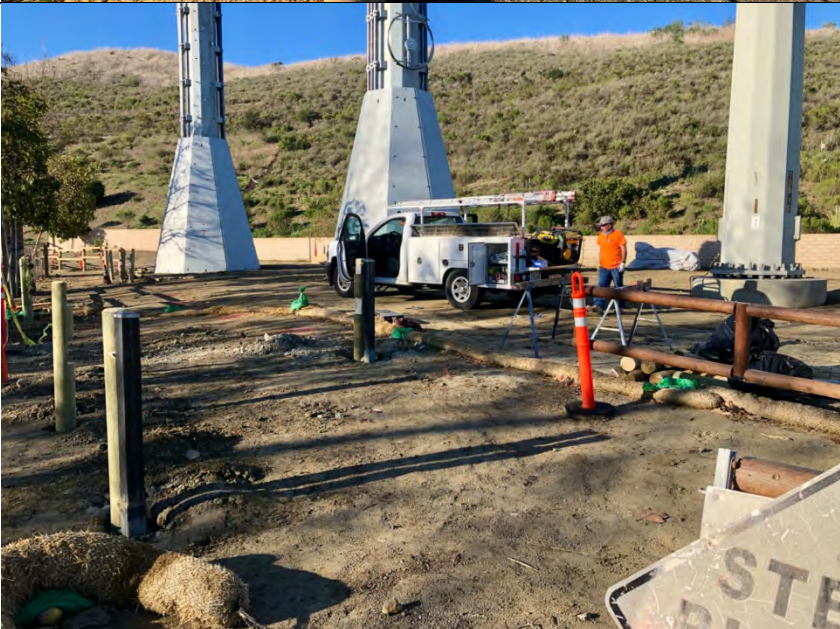
At tower locations 16 and 17, work was underway to replace the fencing (Photo 3). I spoke with the crew onsite working for the homeowners association. The best management practices (BMPs) in this area required upgrades.

Photo 3 – Fence replacement work being done by the homeowners association at tower locations 16 and 17. Photo facing west.

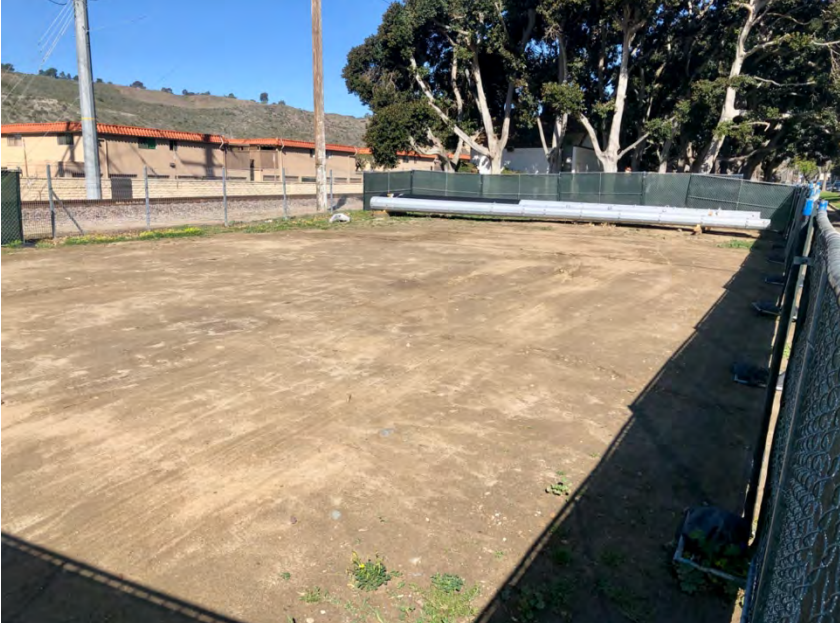
At the substation, a new staging area had been fenced off across the street where the bore pit had been (Photo 7).

Photo 7 – Staging area reinstated west of Camino Capistrano and the substation. Photo facing north.

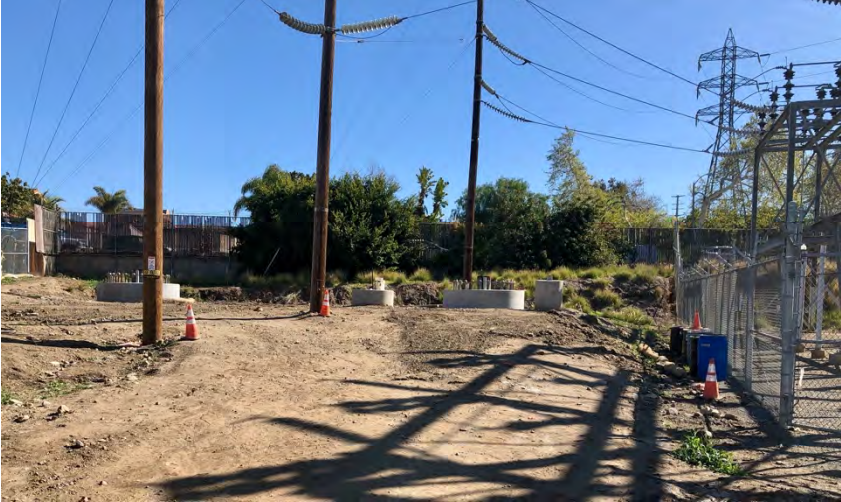
I met with the Environmental Inspector (EI), and we walked to the substation construction area. The previous storm caused rainwater runoff, but the water was controlled by the BMPs (Photos 8 and 9). A crew was onsite installing gravel on the slopes of the substation.

Photo 10 – Installation of gravel on slopes within the substation. Photo facing east.
03/06/21	San Juan Capistrano Substation

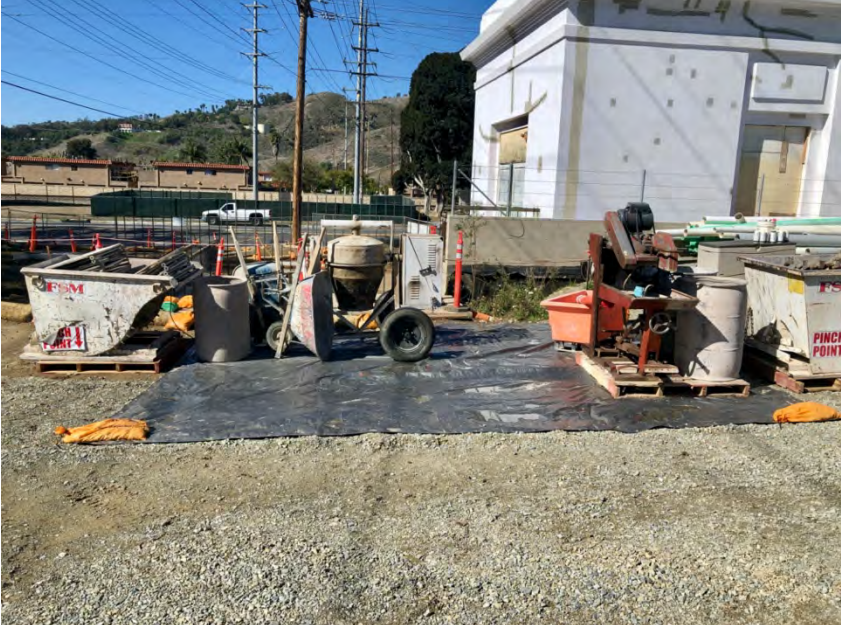
A crew was placing a mortar mixing station near the south entrance of the substation with excellent secondary containment (Photo 11).

Photo 11 – Mortar mixing station with secondary containment. Photo facing west.

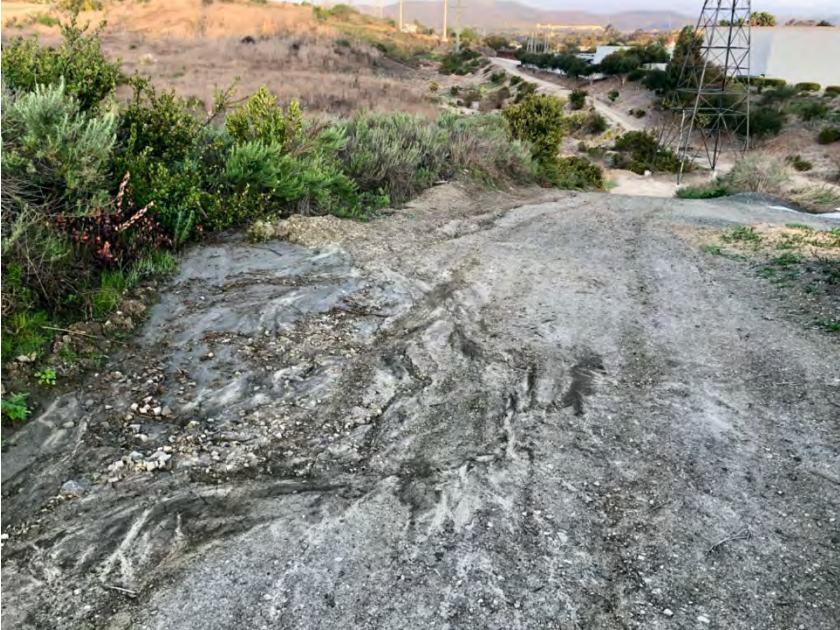
I walked to tower location 39, where the tower pad was in good condition with no erosion issues. The steep access road next to the tower pad had erosion issues because the water bar had filled with sediment (Photo 5). The rainwater that had run down the access road was not diverted by the water bar and continued running down the steep roadway, eroding a small rill and depositing sediment into the road near the wetland (Photo 6). Pampas grass (*Cortaderia selloana*) was growing within the wetland adjacent to the access road and additional workspace.

Photo 5 – Access road near tower location 39 showing the sediment filled water bar. Photo facing northwest.
03/18/21	SOCRE transmission corridor

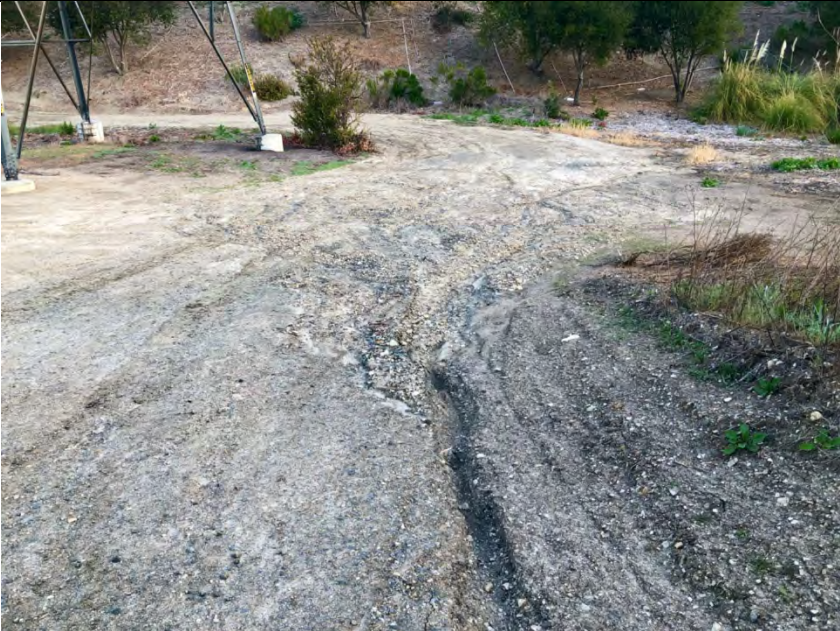
Photo 6 – Erosion and sediment on the access road below tower location 39. Photo facing north.

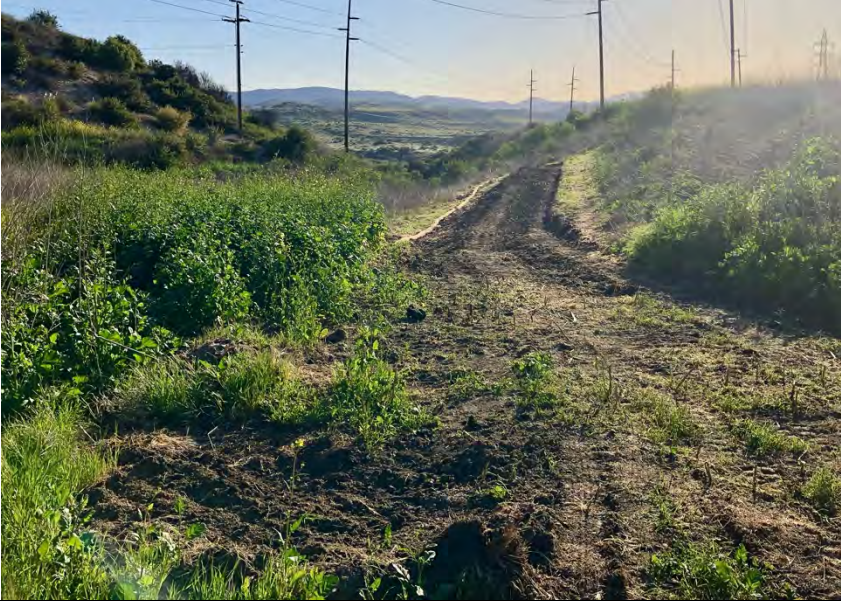
No work was occurring along the transmission corridor, but the EI said work had been completed recently near tower location 42. This work was in preparation for the Phase 2 transmission line work around the Talega Substation. We traveled to tower location 42 where I observed the grading work along the existing access road south of the tower location (Photo 4). Approximately 70 feet of road had been leveled with best management practices (BMPs) added below the grading work (Photo 5). The vegetation around this location was primarily annual grasses and weeds. It appeared that soil sampling had been conducted within the graded area. According to the EI, nesting bird surveys were completed by the avian biologist and none were observed.

Photo 4 – Grading work in preparation for Phase 2 activities near the Talega Substation. Photo facing east.
03/31/21	SOCRE transmission corridor

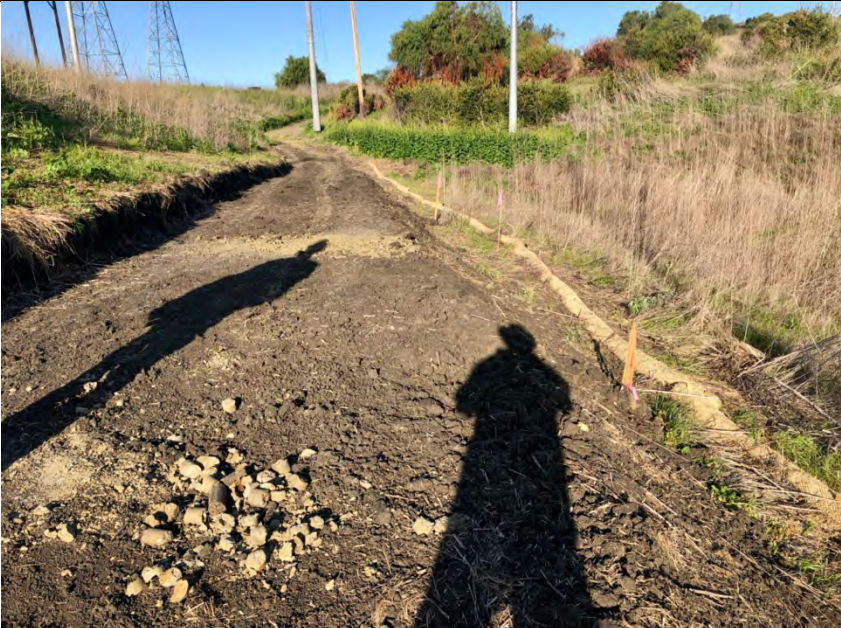
Photo 5 – BMPs added to the graded access road. Photo facing west.

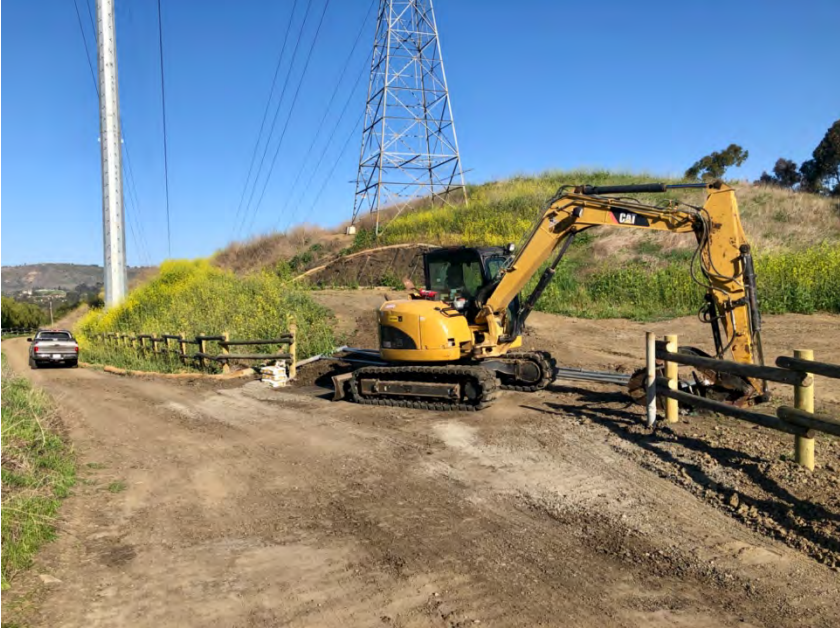
Near tower location 12, a crew was replacing a gate and installing new gate posts (Photo 7).

Photo 7 – Gate replacement near tower location 12. Photo facing north.
03/31/21	SOCRE transmission corridor	 	Photo 8 – Restored temporary staging area between tower locations 12 and 13. Photo facing southeast.
