Re: Monthly Report Summary #42 for the South Orange County Reliability Enhancement (SOCRE) Project

South Orange County Reliability Enhancement Project CPUC Site Inspection Form

Project:	South Orange County Reliability Enhancement (SOCRE) Project	Date:	April 14, 2021
Project Proponent:	San Diego Gas & Electric (SDG&E)	Report #:	VS118
Lead Agency:	California Public Utilities Commission (CPUC)	Monitor(s):	CPUC/WSP Compliance Monitor
CPUC PM:	Andrew Barnsdale, Energy Division	AM/PM Weather:	Partly cloudy, cool, and calm
CPUC CM (WSP):	Joe Donaldson	Start/End time:	1430 to 1600
Project NTP(s):	Notice to Proceed (NTP)-1, NTP-3, NTP-5, and NTP-7

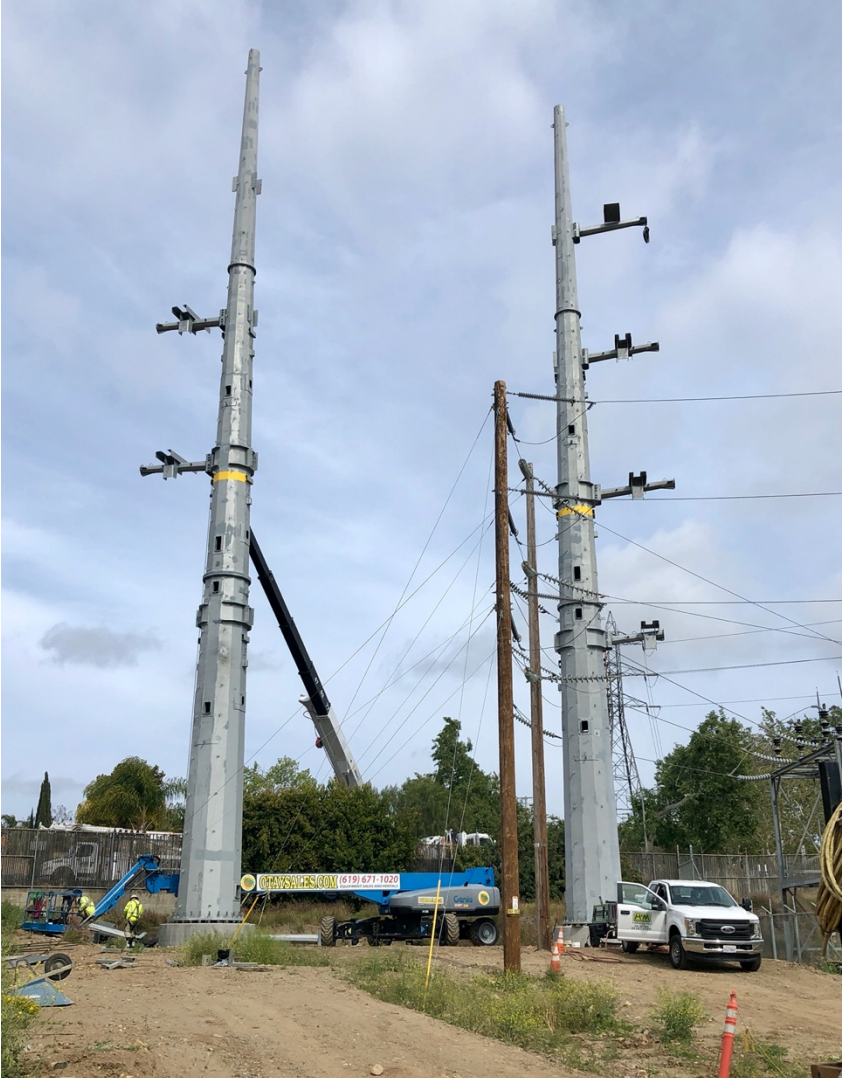
Crews were installing two large tubular steel poles (TSPs) located at the east end of the project site near the 12-kV substation facility (Photo 6). The work was being completed with a large crane parked outside the substation near a public roadway; traffic control measures were in place while work was underway. The work area appeared clean and well contained.

Photo 6 – Installation of two TSPs near the 12-kV substation facility. Photo facing east.
