**Re: Monthly Report Summary #47 for the South Orange County Reliability Enhancement (SOCRE) Project**

CPUC Site Inspection Reports

## South Orange County Reliability Enhancement Project CPUC Site Inspection Form

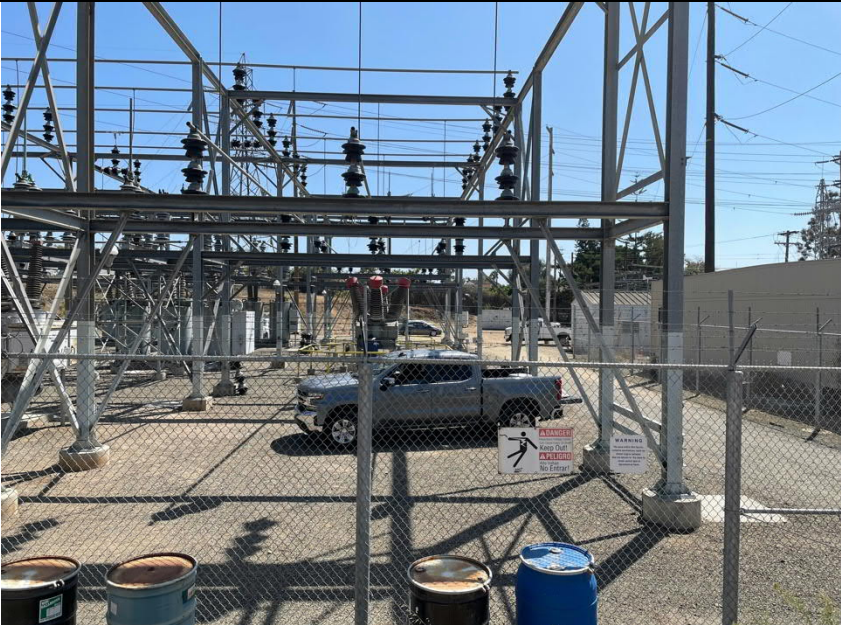
There was a crew working within the 12-kV substation facility performing lead paint removal (Photo 1). They had recently moved one of the transformers out of the 12-kV substation facility and installed it on a new foundation (Photo 2).

Photo 1 – Crew working within the 12-kV substation facility. Photo facing south

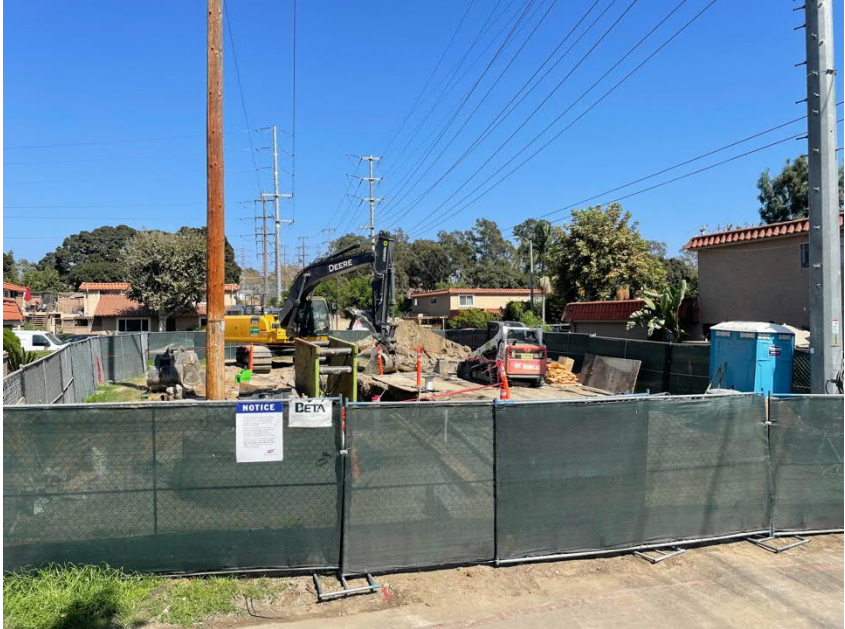
Photo 6 – The work site has been closed and secured for the holiday weekend. Photo facing east.

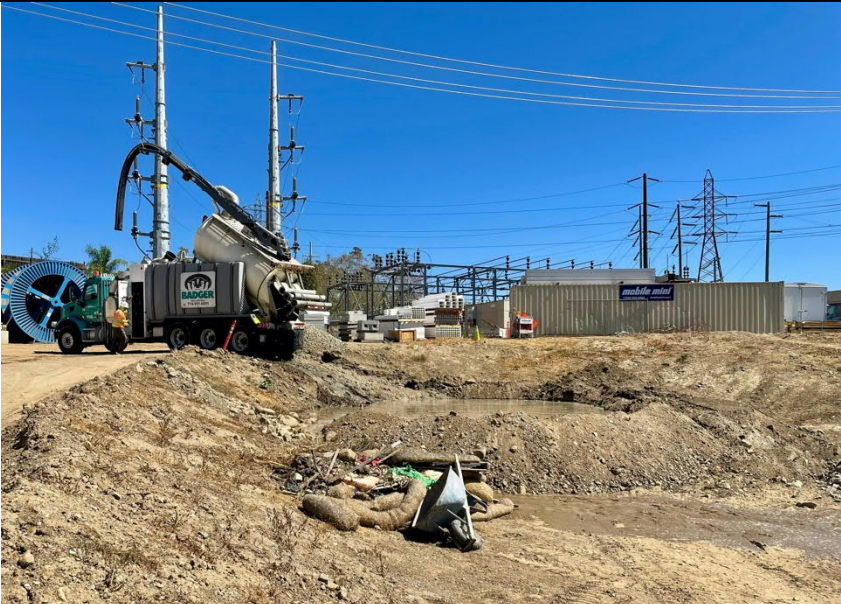
Driving in, I had observed a hydrovac truck unloading into a catch basin created within the substation (Photo 1). Because the catch basin was almost full, this load broke through the basin sidewall and the water began to drain out (Photo 2). I signaled to the operator and we plugged the hole in the bank of the catch basin. I then called the Environmental Inspector (EI) who was working at the tubular steel pole (TSP) west of the railroad tracks. Some of the water drained into a conduit vault but none of the water entered a drain inlet. The EI said he would speak with the crews to make sure they didn't drive through the muddy water and cause a track-out problem.

Photo 1 – Hydrovac truck unloading muddy water into an onsite catch basin. Photo facing east.
