Re: Monthly Report Summary #50 for the South Orange County Reliability Enhancement (SOCRE) Project

South Orange County Reliability Enhancement Project CPUC Site Inspection Form

Project:	South Orange County Reliability Enhancement (SOCRE) Project	Date:	December 1, 2021
Project Proponent:	San Diego Gas & Electric (SDG&E)	Report #:	VS134
Lead Agency:	California Public Utilities Commission (CPUC)	Monitor(s):	CPUC/WSP USA Inc. Compliance Monitor
CPUC PM:	Andrew Barnsdale, Energy Division	AM/PM Weather:	Sunny and calm with mild temperatures
CPUC CM (WSP USA Inc.):	Joe Donaldson	Start/End time:	1400 to 1500 hrs.
Project NTP(s):	Notice to Proceed (NTP)-3, NTP-4, and NTP-6

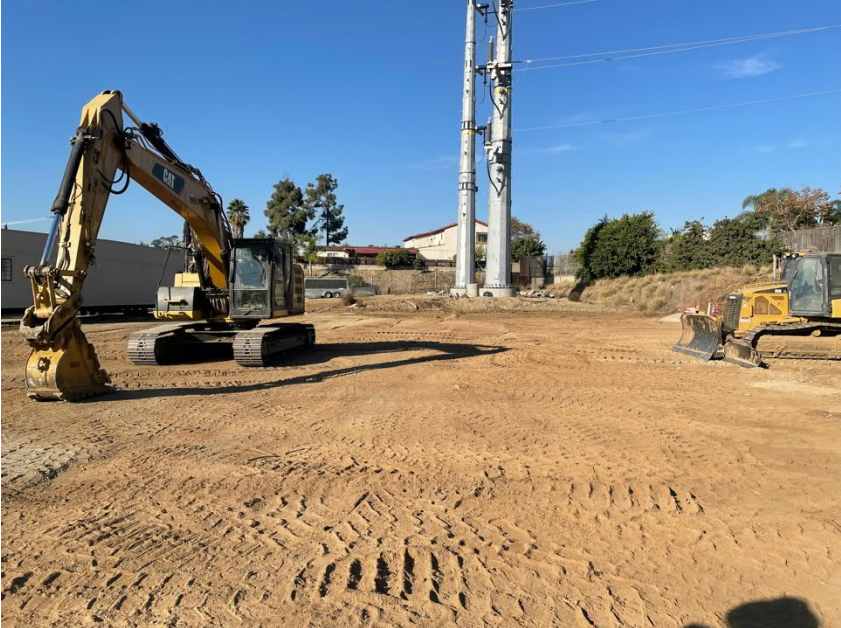
Photo 2 – Exposed soil on the site of the former 138-kV substation facility. Photo facing north.
12/01/21	San Juan Capistrano Substation

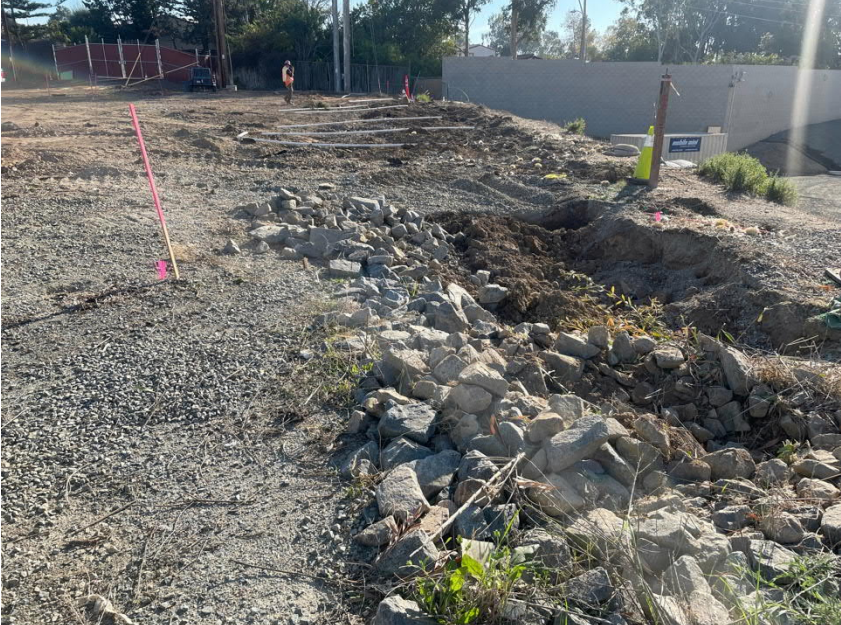
The first and largest area was the clearing of the former 138-kV substation in the eastern portion of the San Juan Capistrano Substation site. The former infrastructure and most of the former foundations have been removed (Photo 1). Equipment onsite continued to break up old concrete. At the time of the visit, most of the area consisted of exposed soil (Photo 2). Crews had also begun excavation of the western edge of the former 138-kV substation where some of the old drainage channels were located (Photo 3). According to the onsite Environmental Inspector (EI) grading was planned for this area. We discussed the need for BMPs to protect this area in the event of rain. The EI said that the crew had a sound plan for the containment of rainwater runoff.

Photo 3 – Excavation along the western end of the former 138-kV substation facility. Photo facing south.

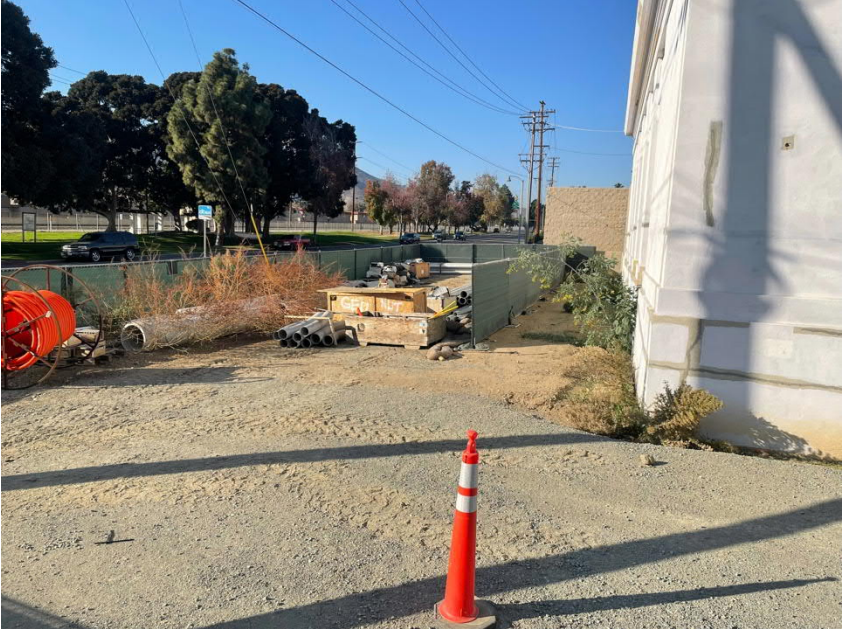
Photo 6 shows the area between Camino Capistrano and the former utility structure where some materials had been stored.

Photo 6 – Material storage area between the former utility structure and Camino Capistrano. Photo facing northwest.
